**EFC Working Party 15 « Corrosion in Refinery » Activities**
EUROPEAN FEDERATION OF CORROSION <http://www.efcweb.org/Working+Parties-p-104085/WP%2B15-p-104111.html>

**EFC Working Party 15 « Corrosion in Refinery »**
EUROPEAN FEDERATION OF CORROSION

**EFC WP15 Corrosion Refinery Industry
10th April 2019 Meeting**

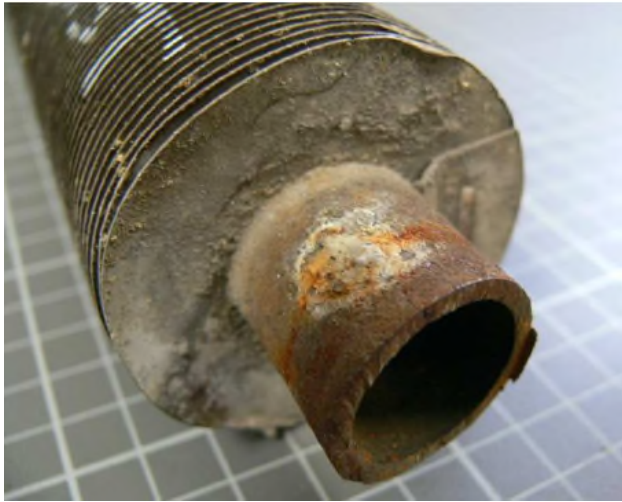
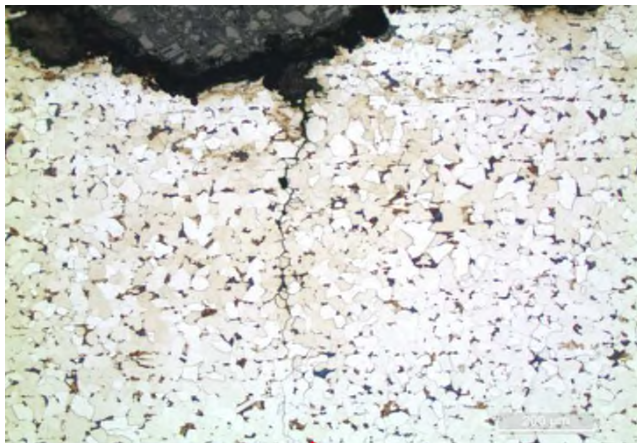
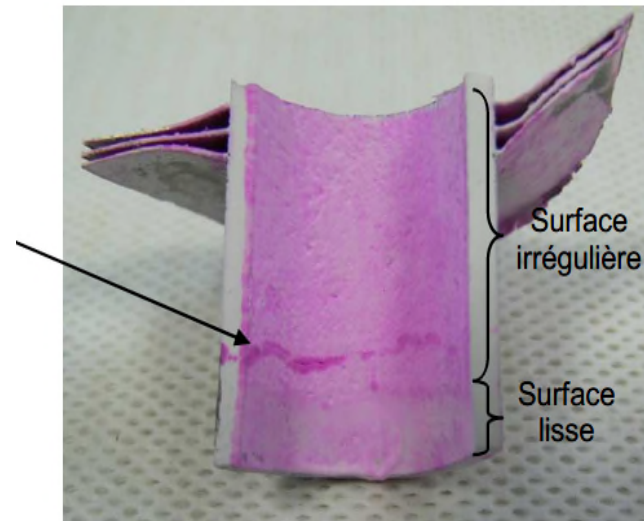
3 : AIR COOLER (EXPANDED JOINT)

HDS unit
DEA 25 %
P : 11 barg
T in/out: 55-70°C/35-55°C

CS expanded jointed
2,4 mm thick; 25,4mm diameter
Lifetime 35 years

crack

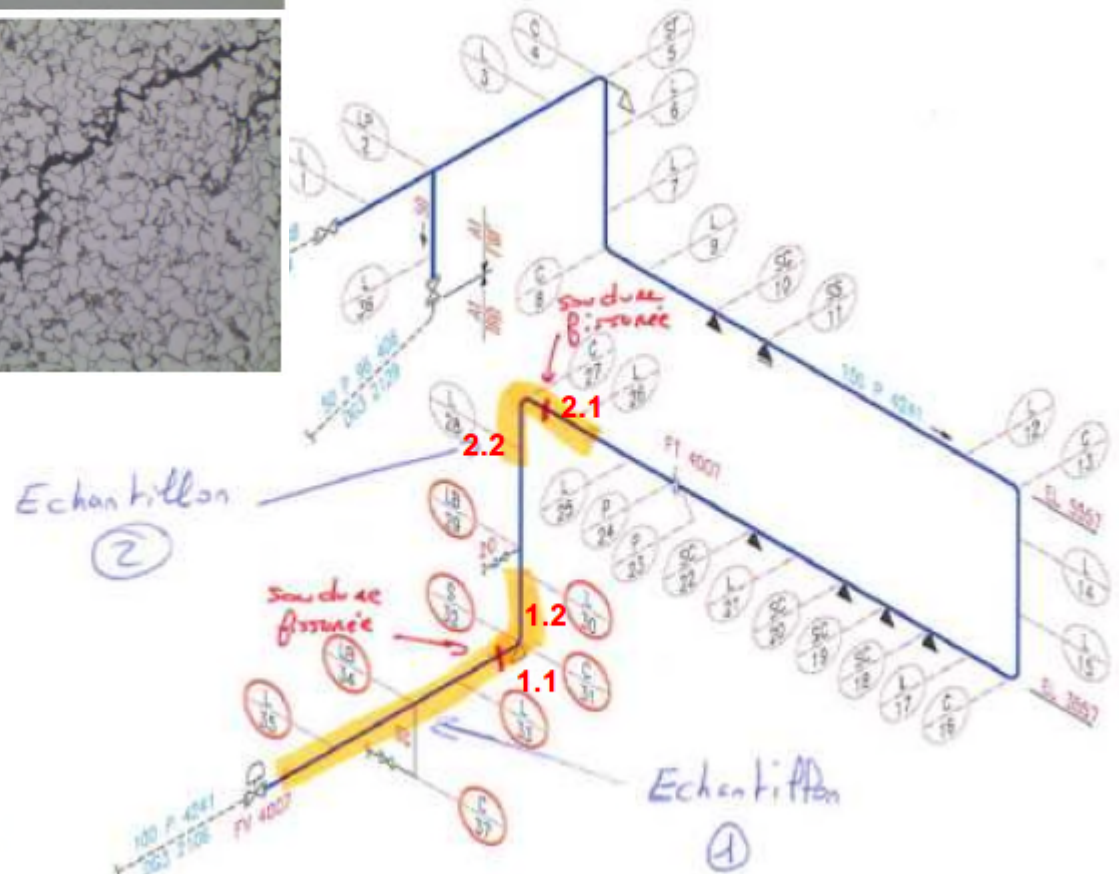
4 : LEAN AMINE PIPING

HDS unit
DEA 30 %
P : 10 barg
T: 50-70°C

- Inspection plan should also focus on PWHT equipment & piping for lean amine cracking detection.
- For manufacturing:
 - ✓ **PWHT quality for a good stress relieve efficiency**
 - ✓ Respect rules of the art (welding, joint expansion).
 - ✓ Use Stainless Steel taking into account technical and economical reasons

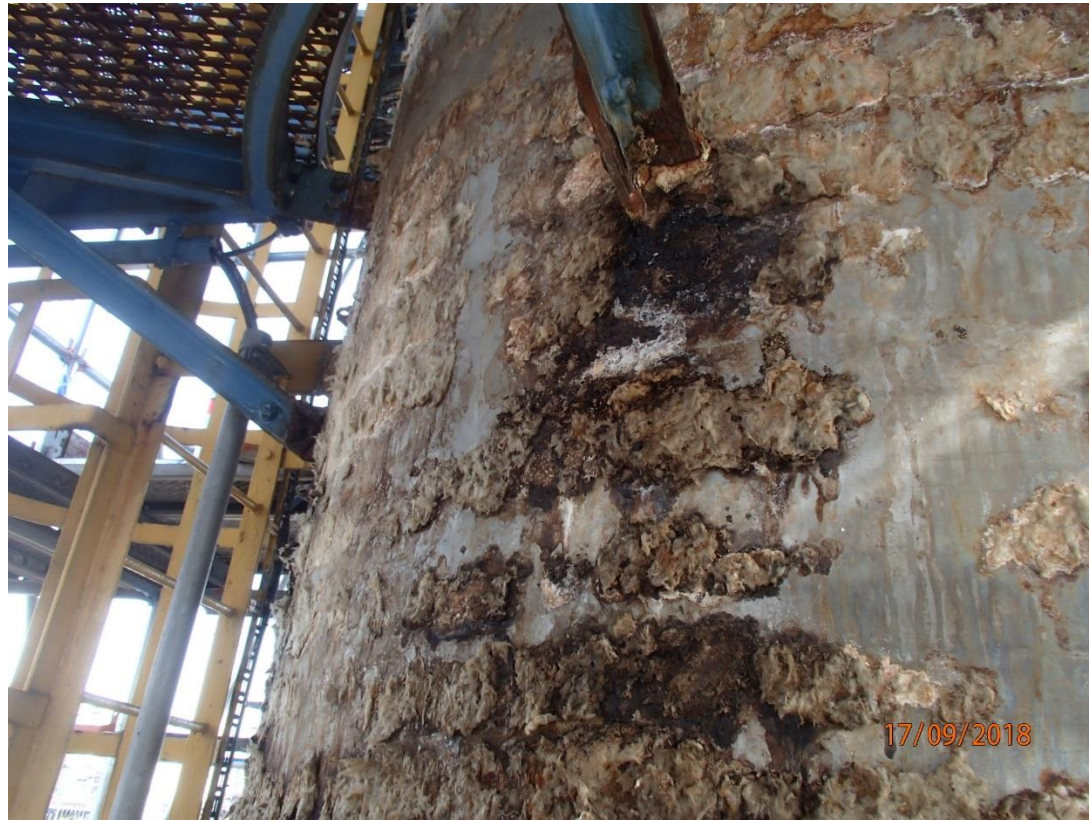
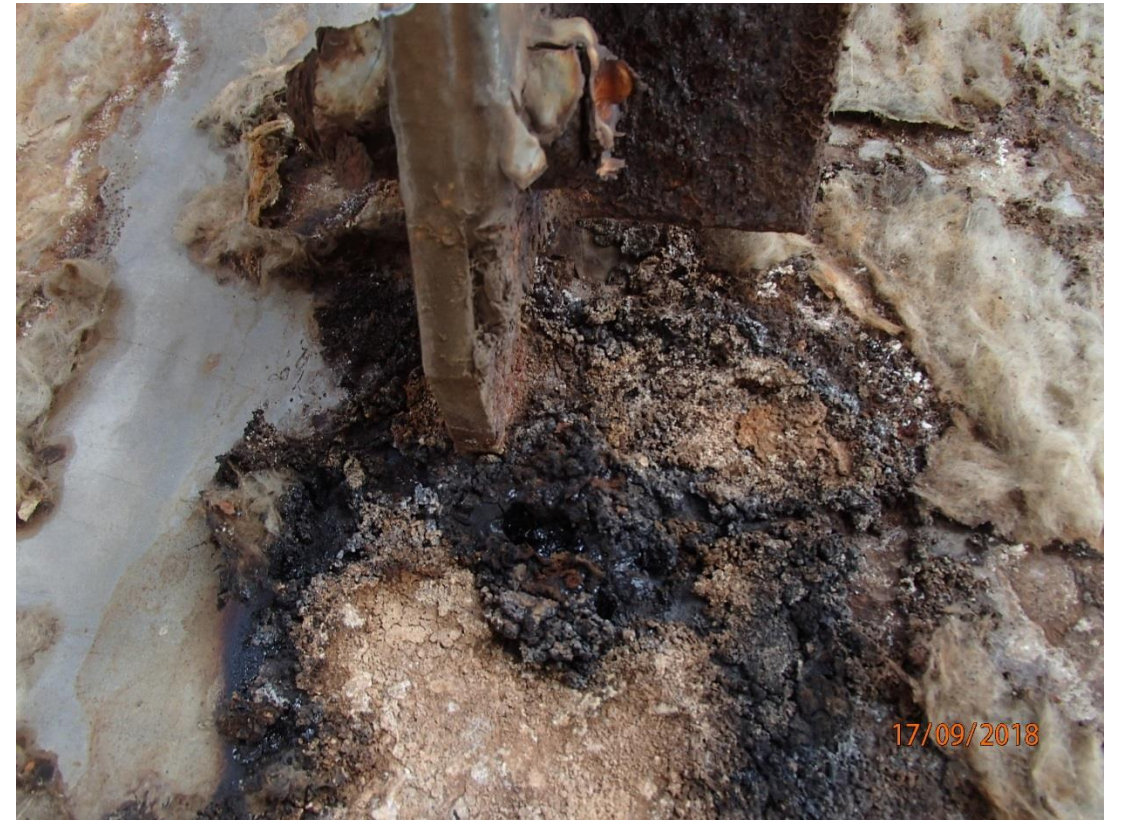
MEA-Regenerator with removed insulation

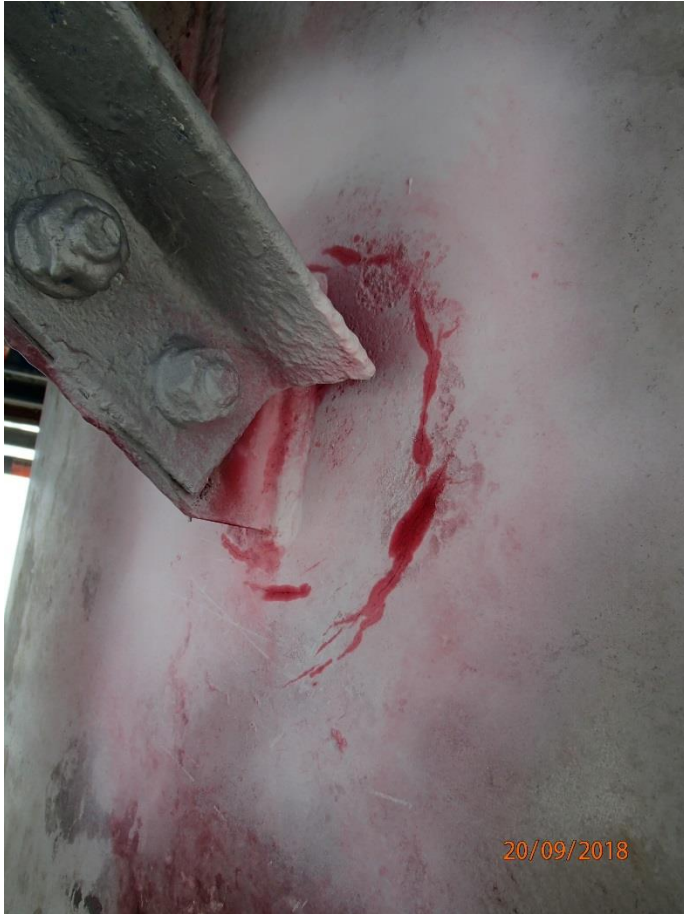
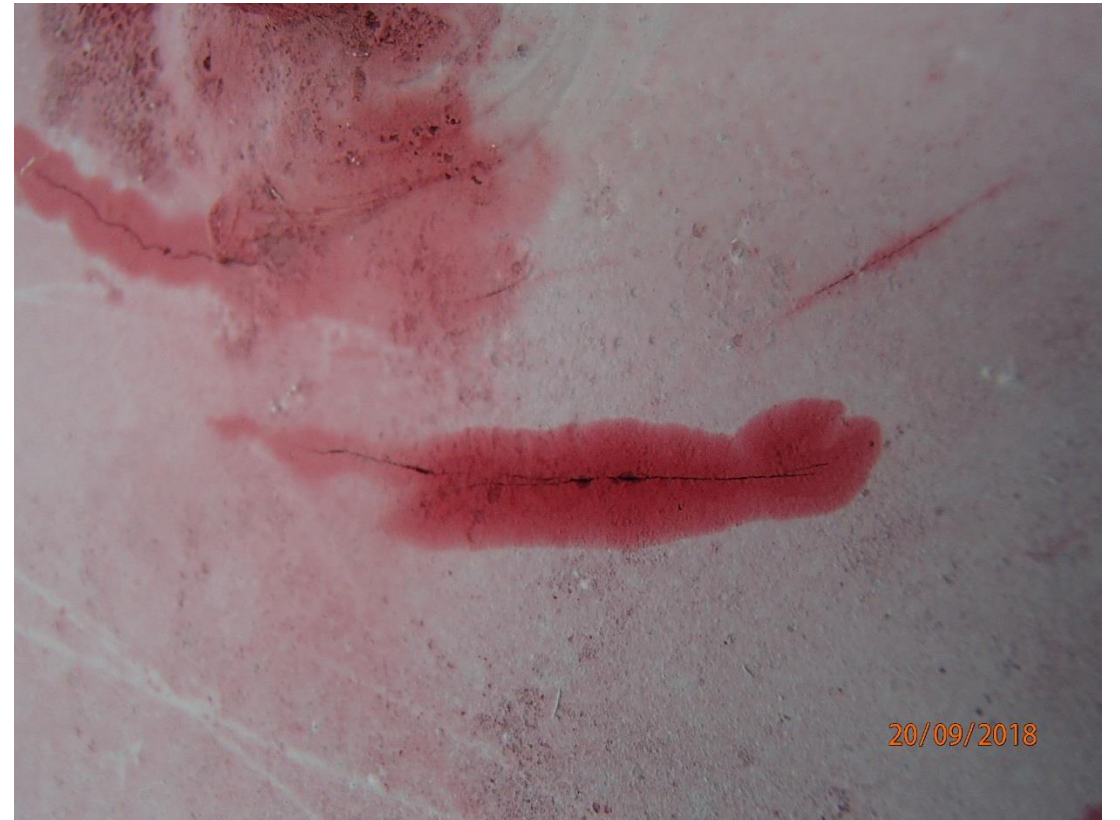
Crack indication after PT

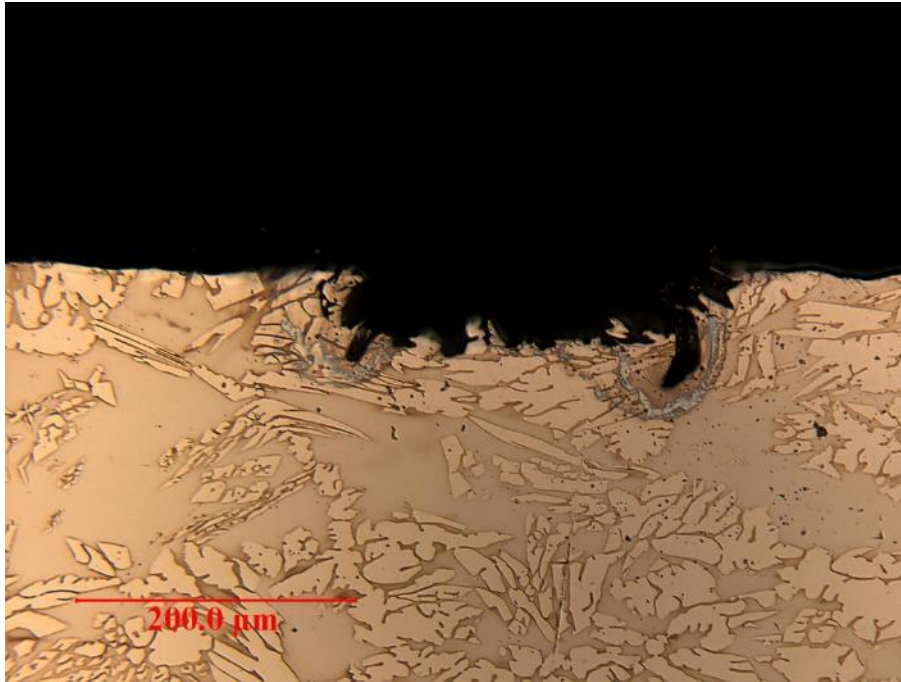
Corrosion site on calibrated zone

- Corrosion sites corresponds to superficial selective dissolution of ferrite
- Fracture surface seems to be ductile

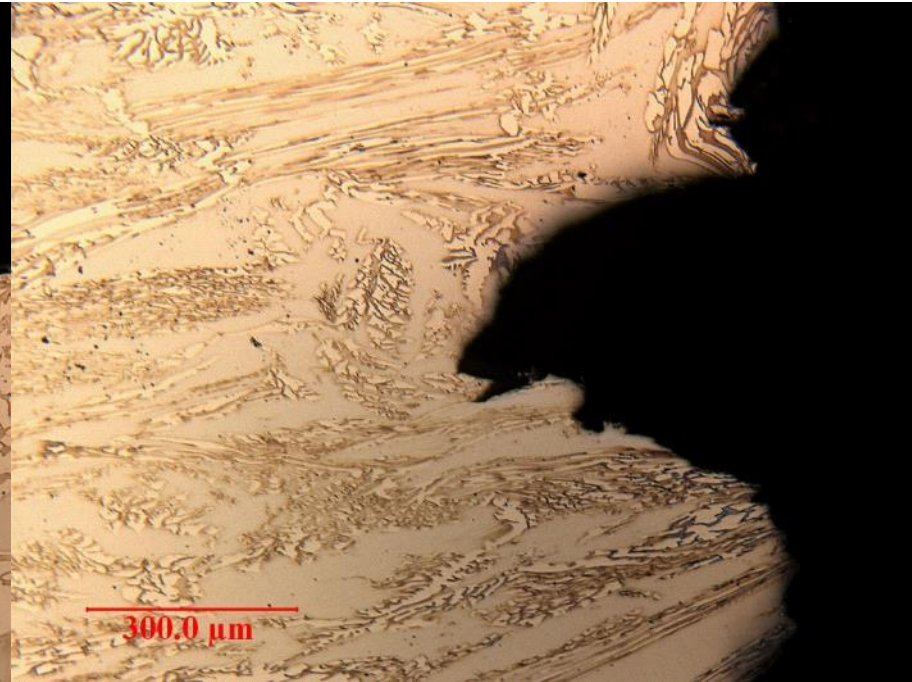
Cross section of fracture surface

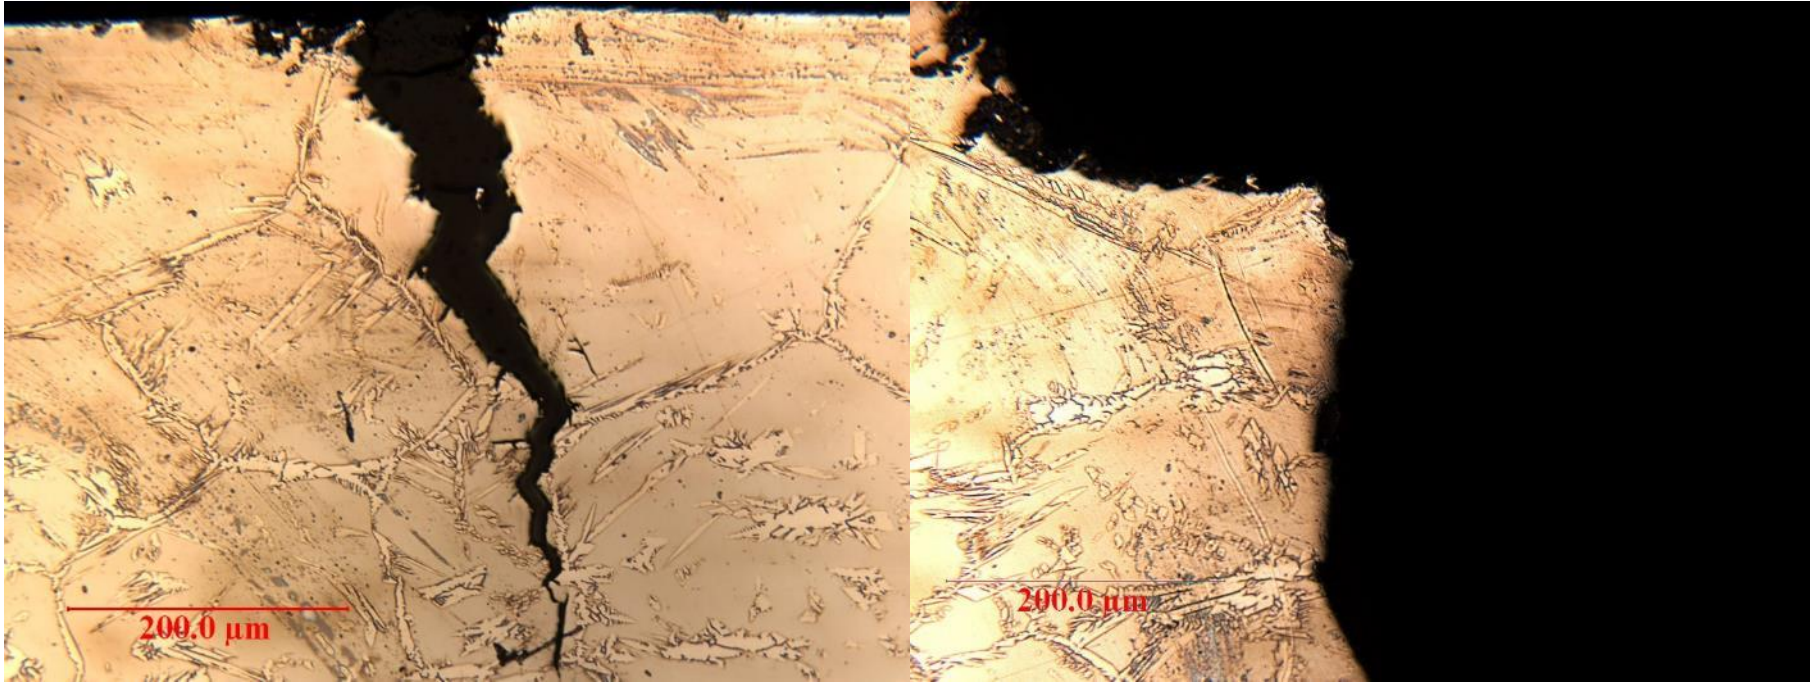
Secondary crack on calibrated zone

Cross section of fracture surface

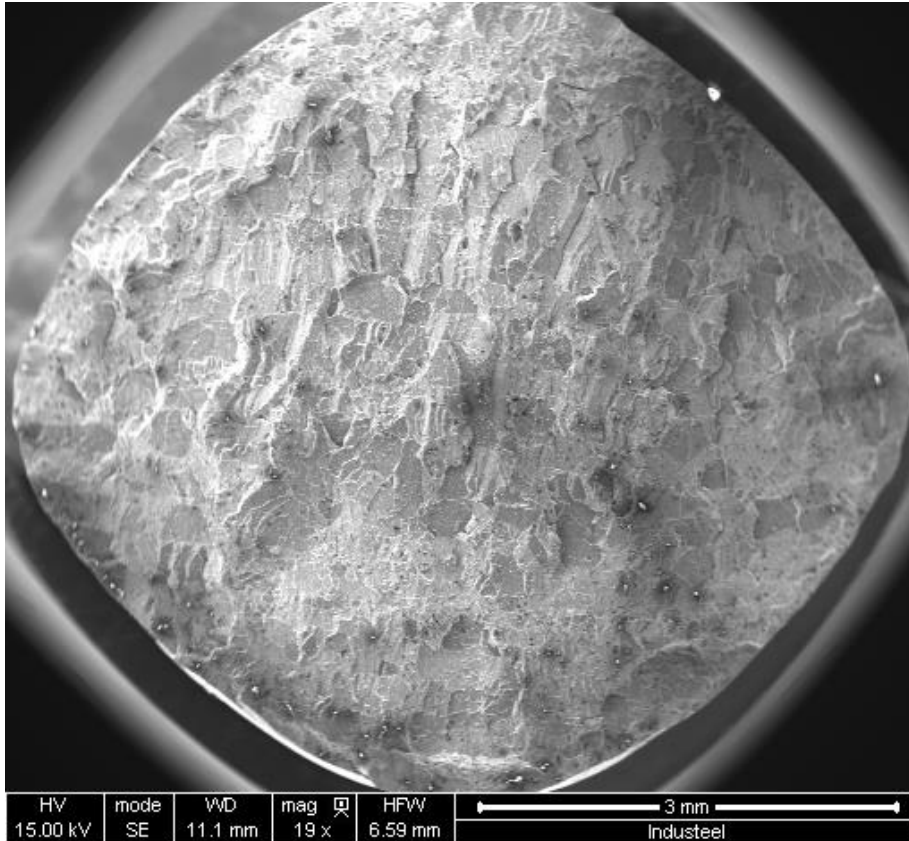
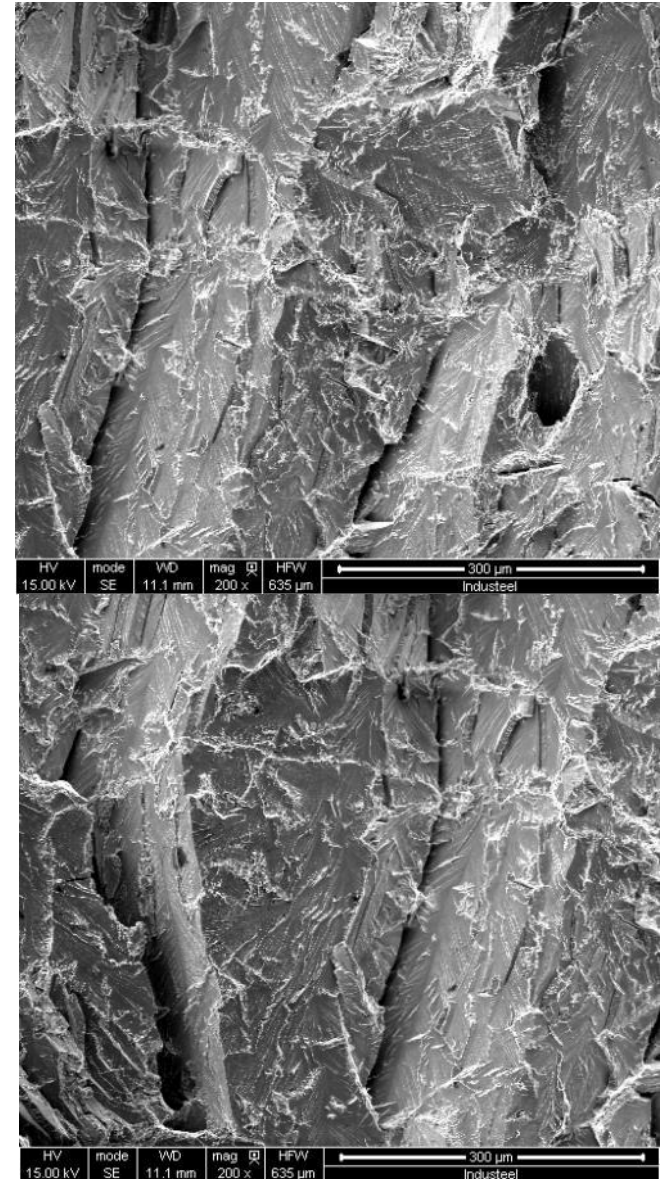
- Fracture surface is fully brittle

High sensitivity to stress corrosion have been observed though macroscopic and microscopic characterizations

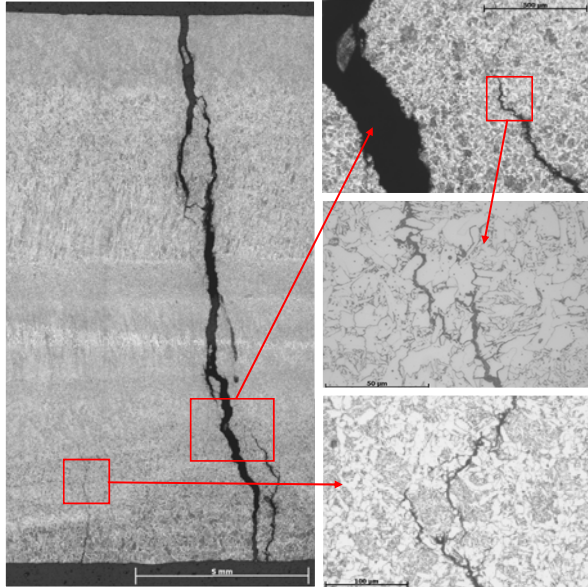
Micrographic examination

- Branched cracks with deposits inside (transversal to the weld)
- Starting from internal surface
- Intergranular propagation
