Participants EFC WP15 meeting 13th September 2007 Freiburg

EFC WP15 Activities

External corrosion control program at the Humber Refinery

CORROSION IN REFINERY INDUSTRY FAILURE ATLAS

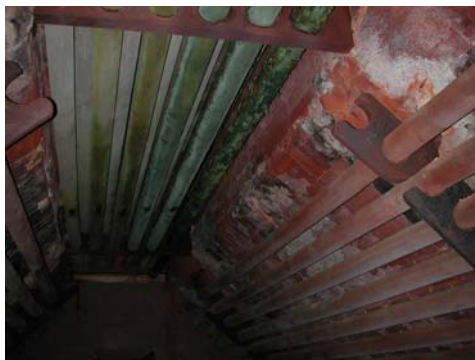
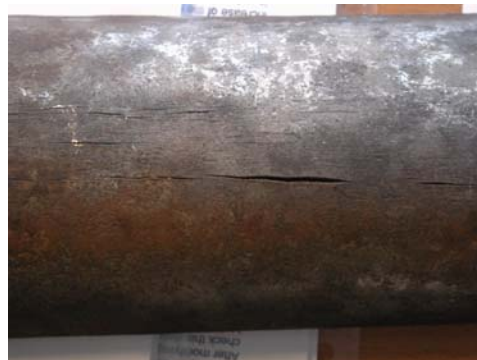
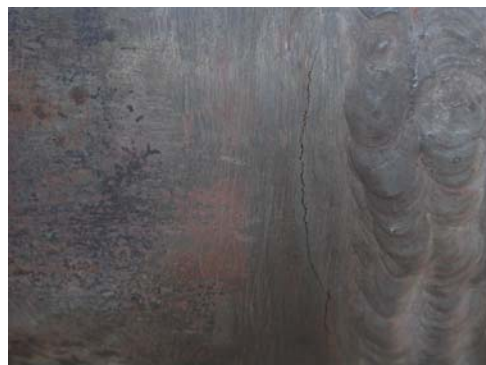
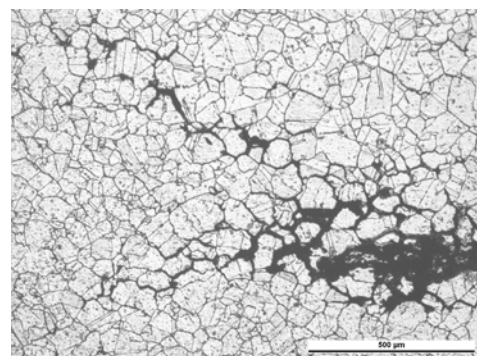
several longitudinal cracks on the fire side of heater tube some of them near HAZ. The ones near HAZ were penetrating the tube.

ASPECT : SS304 tubing is fully sensitized. Replica taken on several positions did show intergranular cracks. Some of them were not very deep. Green deposits containing high amount of sulfur and iron with some nickel and chromium have been observed.

Polythionic acid corrosion is suspected due to the detection of a sulfur layer on the outside faces of the tubes and to the highly sensitisation of the 304 stainless steel. Probably because of poor combustion practices leading to a reducing atmosphere in the heater.

Retubing to similar material (SS 304) and major repair of heater casing. Oxygen sensor moved from above convection zone to below convection zone.

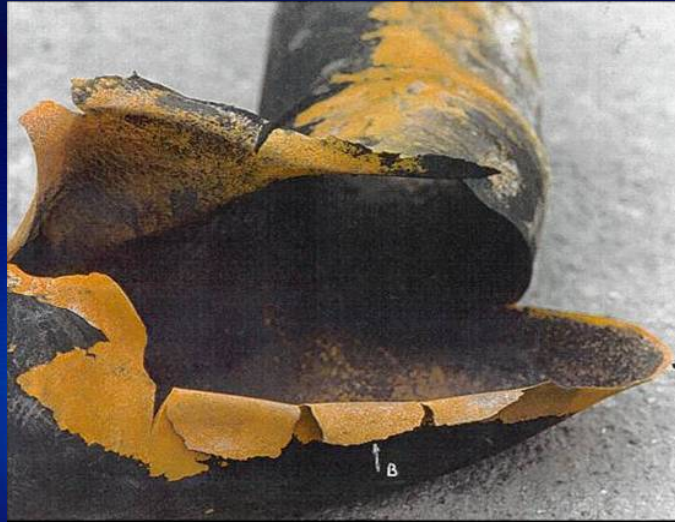
- The corrosion morphology indicated an aqueous phase running along the bottom of the pipe/outside of bend.
- No sulphide scale was evident at the thinned area of the pipe downstream of the water injection location.
- Black scale was evident further downstream of the failure indicating the presence of a protective iron sulphide film.

- The corrosion was caused by **ACIDIC SOUR WATER** due to presence of hydrogen sulphide (H_2S) in the aqueous phase.
- High system pressure (380psig) leading to high H_2S partial pressure.
- Low ammonia content in overhead system and sour water.
- H_2S content in sour water producing low pH.

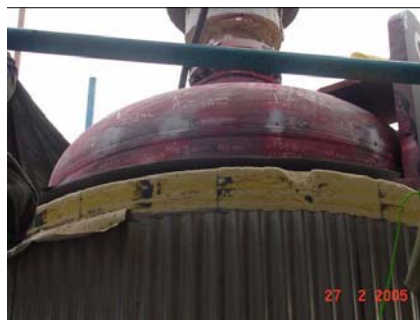
- Cracker product separation
 - Methane Pre-Stripper Column
- Incident
 - February 2005
 - Hydrocarbon leaks detected
 - Icing detected
 - Fugitive emissions were earlier detected but believed to be leaking flanges
 - Delagging of the vessel top
 - 5 Penetrating cracks detected in the top ellipsoidal head

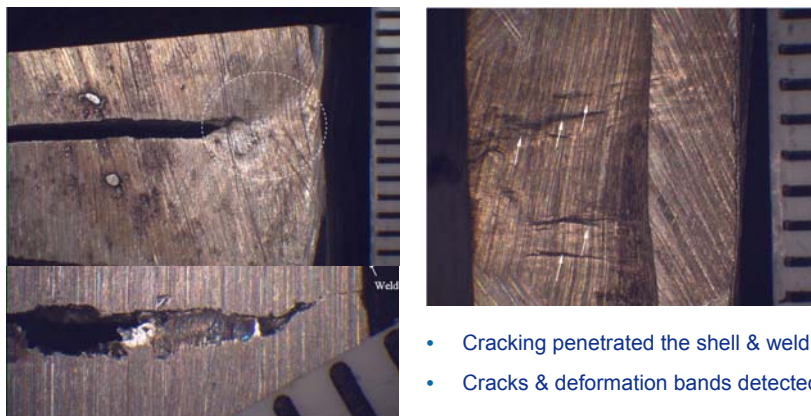
- Cracking penetrated the shell & weld
- Cracks & deformation bands detected

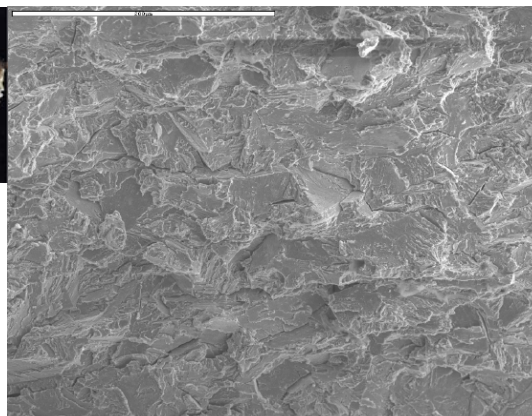
- Cracking in mixed-mode
- Intergranular & transgranular cleavage
- Positions 7, 8, 9,10,11,& 12

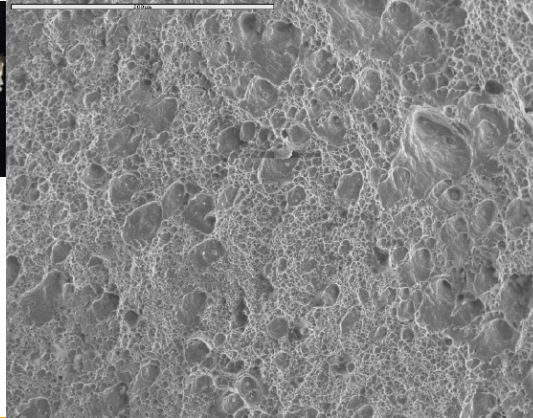
- Ductile fracture near the weld (position no. 13)

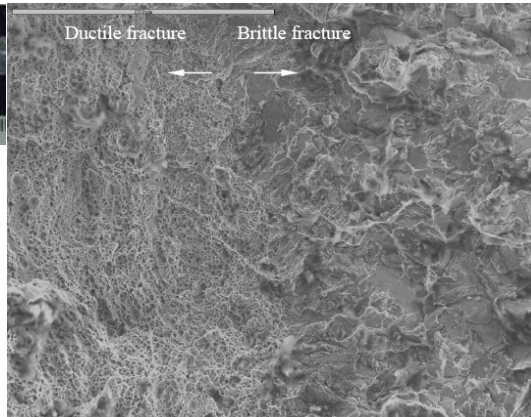
- Brittle to ductile transition at the heat affected zone

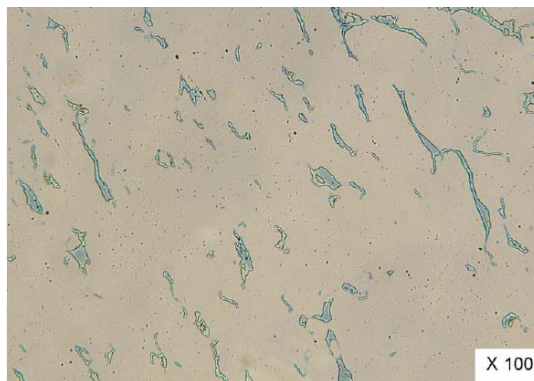
- Microstructure of the base material, electrolytically etched in NaOH
- Appr. 10% δ -ferrite
- No intermetallic phases

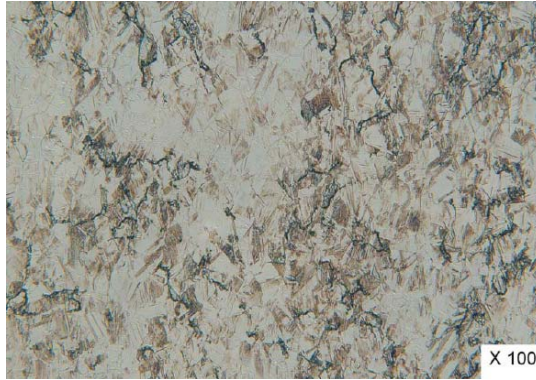
- Microstructure of the base material, electrolytically etched in 10% oxalic acid
- Note the presence of martensite in deformed austenite grains
- δ -ferrite noted

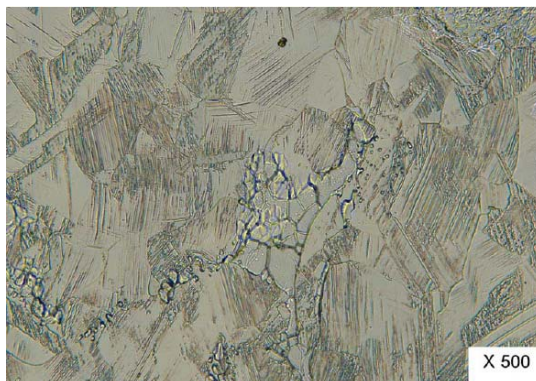
- Microstructure of the base material electrolytically etched in 10 % oxalic acid
- App. 50% martensite in deformed austenite grains.
- Presence of δ -ferrite

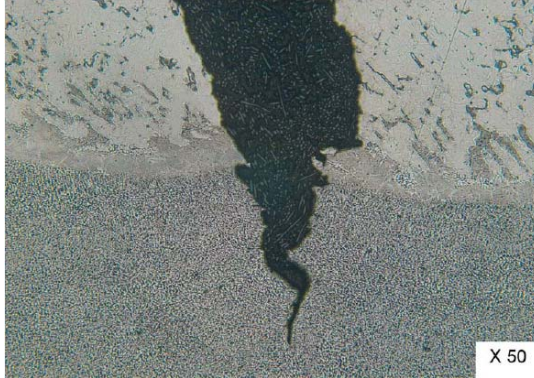
- Crack tip area etched electrolytically in 10% oxalic acid
- Note that the crack has propagated through the heat affected zone (HAZ) and into the weld.

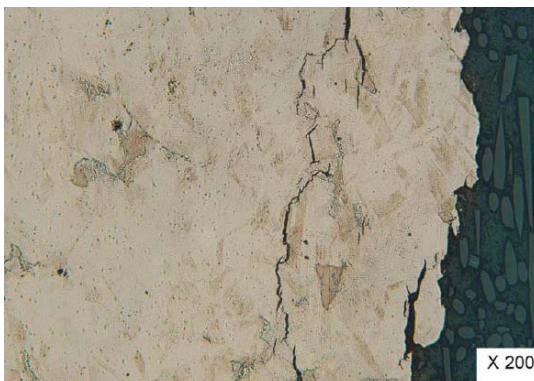
- Microstructure of the base material with a parallel crack to the main fracture

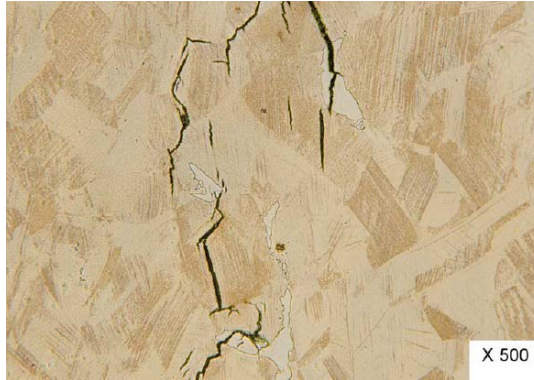
- Base material with a crack parallel to the fracture
- Cracking through the austenitic grains, but following secondary grain
- Boundaries
- Cracking through the martensite phase, and deformation twins also observed
