## CORROSION IN REFINERY INDUSTRY FAILURE ATLAS

**CASE HISTORY**    n° 2        Date    April 2012

**Process: Hydrodesulfurisation  
Equipment: H<sub>2</sub>S Stripping tower**

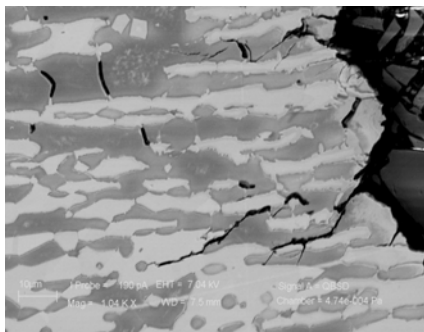
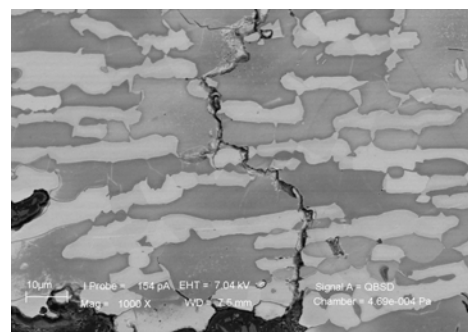
Cracking initiated in HAZ of the top plate: its length is 1.5 m.  
This equipment that originally was in carbon steel, was replaced in 2007 by a superduplex stainless steel grade due to the severe corrosion encountered.

cracks

Condensation / stripping of cold reflux (50 ° C - 10 to 20 ppm chloride) arriving in an area at 190 ° C.  
Chloride concentration leading to stress corrosion started in the weld HAZ of the upper plate.  
Other aggravating cause mentioned: thermal fatigue due to condensation / repeated stripping.

**TYPE OF CORROSION :** Chloride stress corrosion cracking  
**API 571 CLASSIFICATION:** 4.5.1

Chloride stress corrosion cracking

Improved separation of water in the top.

Partial replacement of equipment.

Superduplex stainless steels should be avoided for this type of service. Alloys with high nickel content (eg Incoloy 625) should be preferred.
