CORROSION IN REFINERY INDUSTRY FAILURE ATLAS

CASE HISTORY n° 4 Date April 2012

Process: Fluid Catalytic Cracking Equipment: Mounting hardware for instrumentation

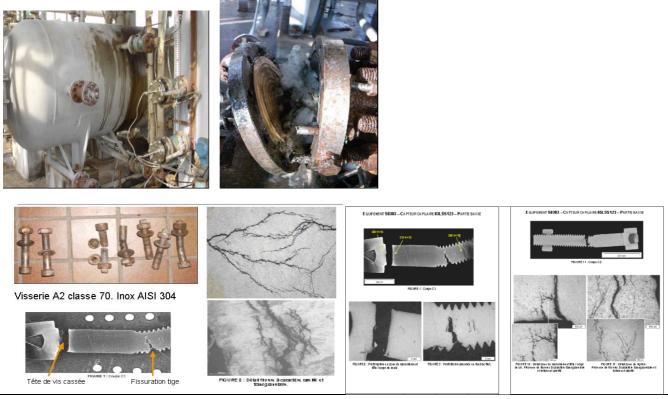
ASPECT : transgranular cracking

Stress corrosion in the presence of external chloride (from the driers) on AISI 304 stainless steel screws for assembly of the sensor.

TYPE OF CORROSION : Chloride stress corrosion cracking API 571 CLASSIFICATION: 4.5.1

Elimination of the source of chlorides from the purges of dryers containing chlorides of calcium that are above the separator.

Preventive replacement of screws and bolts in another grade of stainless steel: duplex 25 07 (S32750).
