CORROSION IN REFINERY INDUSTRY FAILURE ATLAS

CASE HISTORY n° 5 Date 31 March 2008

Process: Continuous Catalytic Reforming
Equipment: Furnace tubes

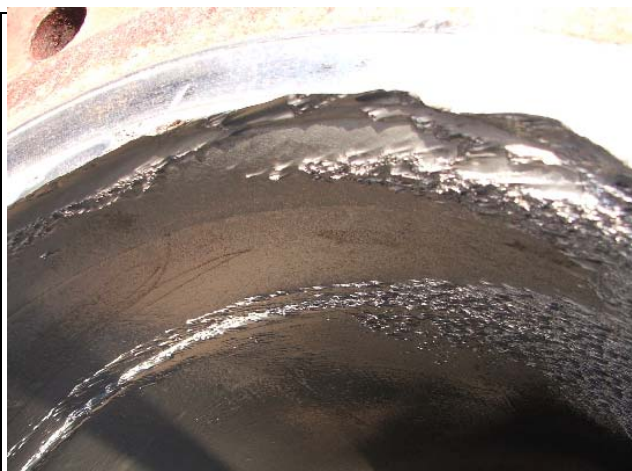
A big mass of dust in the outlet tube header in third and fourth furnace. Erosion losses on the inside surface of the headers caused by dust. Slow and uniform thinning of furnace tube walls.

Erosion on the inside surface of a tube header. Dust in the header was composed of graphite, iron, Cr_7C_3 carbide, and traces of catalyst material

Removal of dust from the tube headers and repairing the erosion losses. Collecting one tube from the fourth furnace to establish the reasons of the incident by means of destructive examinations. After examinations, the furnaces were put into operation for another four years.

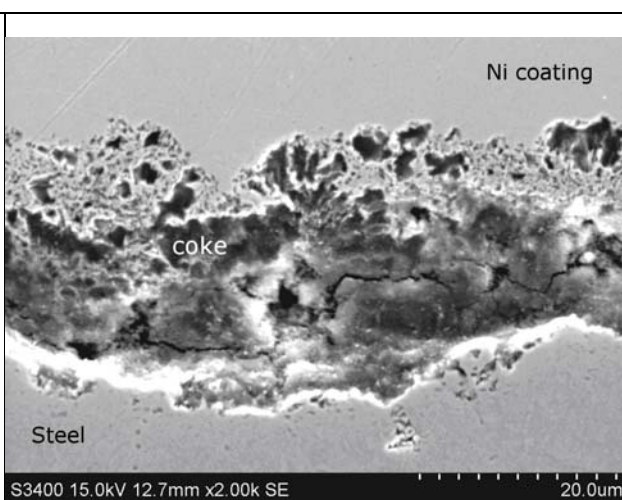
Coke layer on the inside surface of 9Cr-1Mo steel tube, composed of graphite, iron and Cr_7C_3 carbide

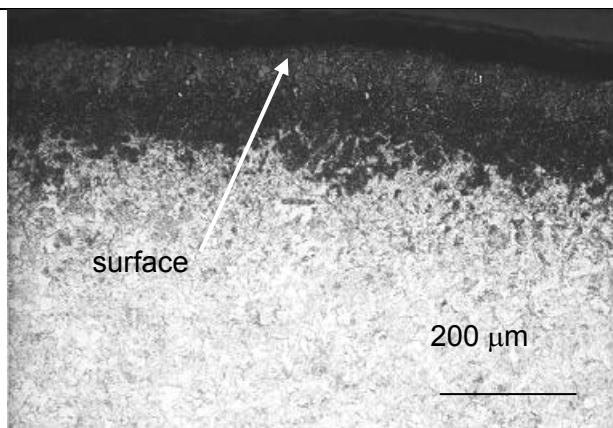
Carburized layer beneath the inside surface of 9Cr-1Mo steel tube

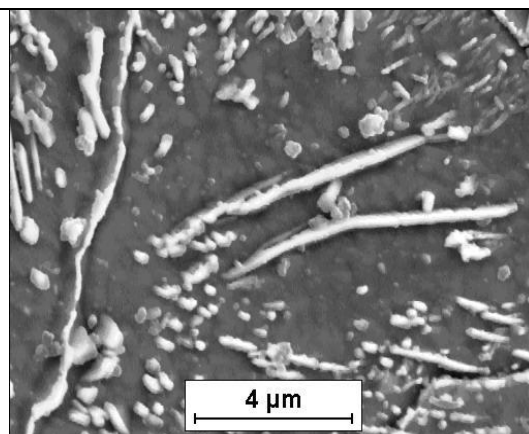
Middle-wall material of 9Cr-1Mo steel tube : degraded primary alloy carbides in metal matrix (alloy ferrite) containing 9 % Cr and 1 % Mo

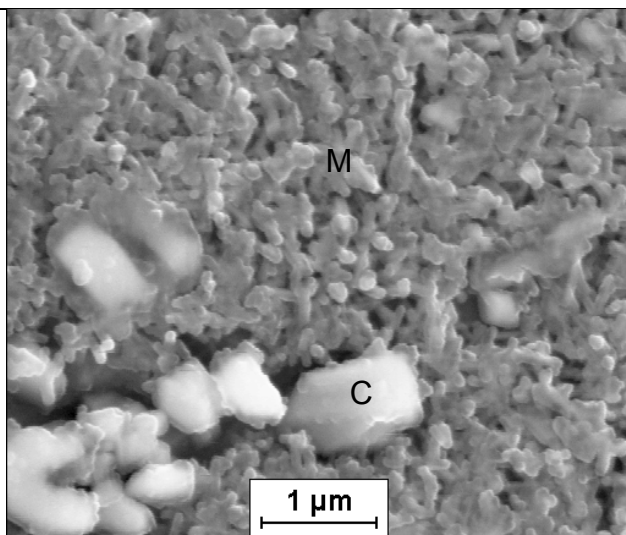
Degraded primary carbides (C) in the "matrix" (M) composed of fine carbides, 30 μm from the inside surface. Chemical composition in **C**: 25% Cr, 4% Mo, in **M**: 15% Cr, 2% Mo

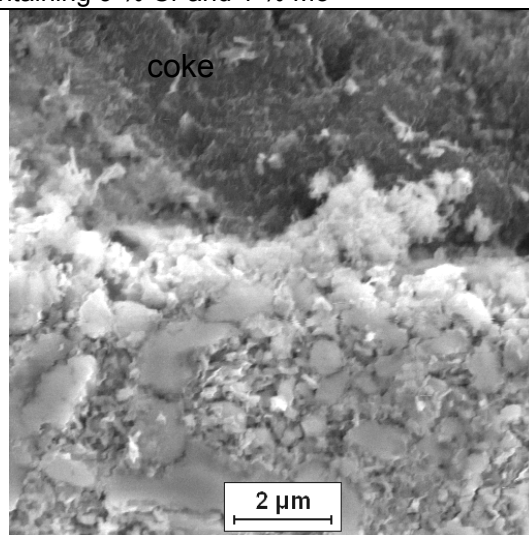
A partly disintegrated layer of fine carbides at the inside surface covered with coke

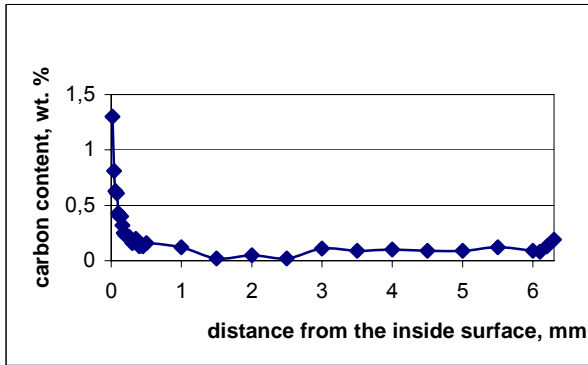
Carbon profile beneath the inside surface of 9Cr-1Mo steel tube

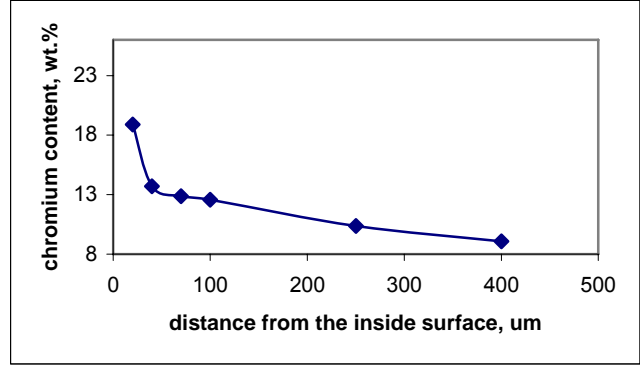
Chromium profile beneath the inside surface of 9Cr-1Mo steel tube
