CORROSION IN REFINERY INDUSTRY FAILURE ATLAS

CASE HISTORY n° 7 Date April 2012

**Process : HF alkylation
Equipment: piping**

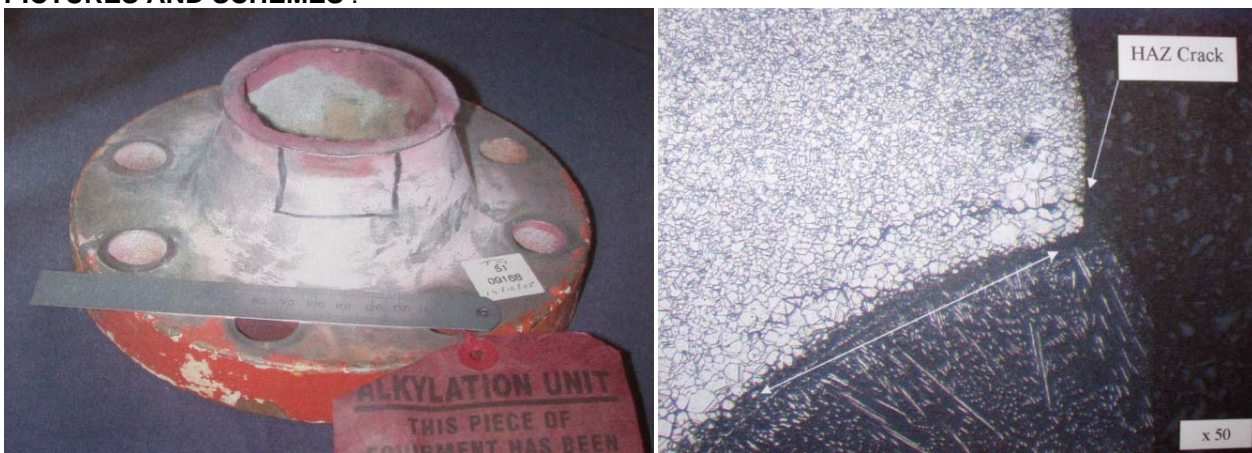
- The source of the leak was a crack that developed in the affected area of the weld of a flange on a pipe. The crack is transgranular.
- A media which can cause cracking of Monel 400, is the presence of HF, oxygen and moisture.
- The survey shows that for a provision of a pump, the equipment is not neutralized prior its provision. Therefore the piping remained in air with the presence of HF, oxygen and moisture. The line was cracked in the location where the residual welding stresses were maximal.

TYPE OF CORROSION : HF stress corrosion cracking

Stress corrosion cracking by HF containing oxygen and moisture

Replacement of defective flange and heat treatment line for stress relieving.

To avoid this type of failure, it is recommended to perform a stress-relieving heat treatment of welds , and systematically neutralizing the equipment before opening for availability.
