CORROSION IN REFINERY INDUSTRY FAILURE ATLAS

CASE HISTORY n° 8 Date April 2012

Process: Fluid Catalytic Cracking
Equipment: Regenerator

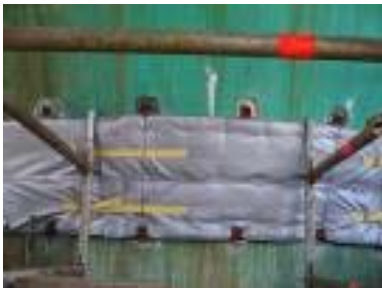
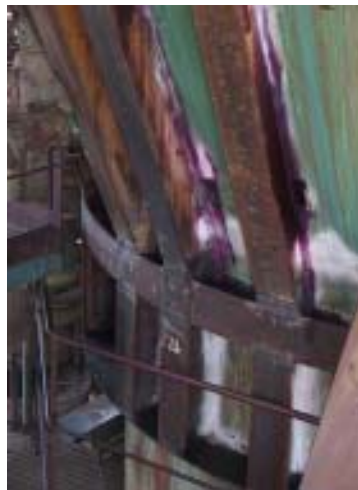
Fifty grooved cracks at the weld connection between the cone and shell of the regenerator.

The problem occurred following a modification of the internal insulation system: the concrete has been replaced by ceramic fiber causing a decrease in wall temperature.

The wall temperature is around 50 ° C, because there is no internal flow. An injection of fluidization air is performed and the accumulation of catalyst favors thermal insulation.

TYPE OF CORROSION : carbonate stress corrosion cracking
API 571 CLASSIFICATION: 5.1.2.5

The suspected mechanism is cracking under stress (zones of welds, reinforcement) in the presence of carbonates. The water is due to internal condensation in cold area.

The development of the phenomenon was stopped by positioning insulation to increase the external wall temperature. A mechanical reinforcement has been installed to ensure the resistance of the device before replacement of the shell.
