STRESS CORROSION TESTING OF COPPER IN NEAR NEUTRAL SULFIDE SOLUTIONS

Claes Taxén (claes.taxen@ri.se)

Rise Kimab, Kista Stockholm, Sweden

Swedish Nuclear Fuel and Waste Management
Co, Stockholm, Sweden

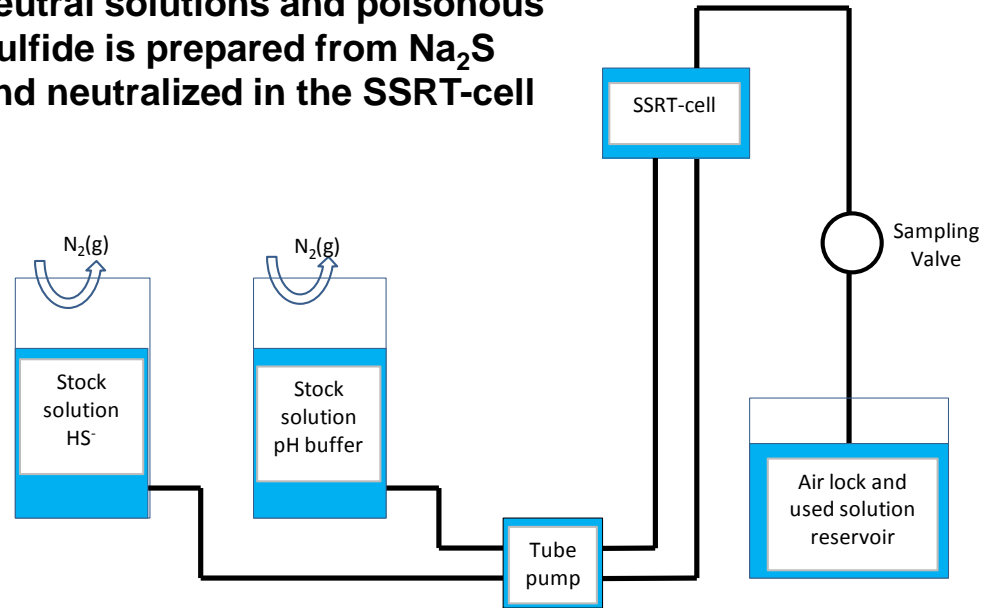
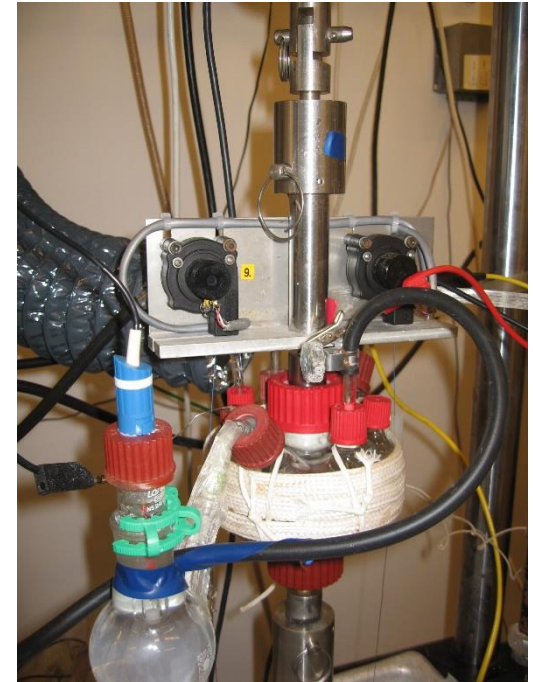
The experimental setup

- Sulfide (HS^-) is volatile as H_2S in neutral solutions and poisonous
- Sulfide is prepared from Na_2S and neutralized in the SSRT-cell

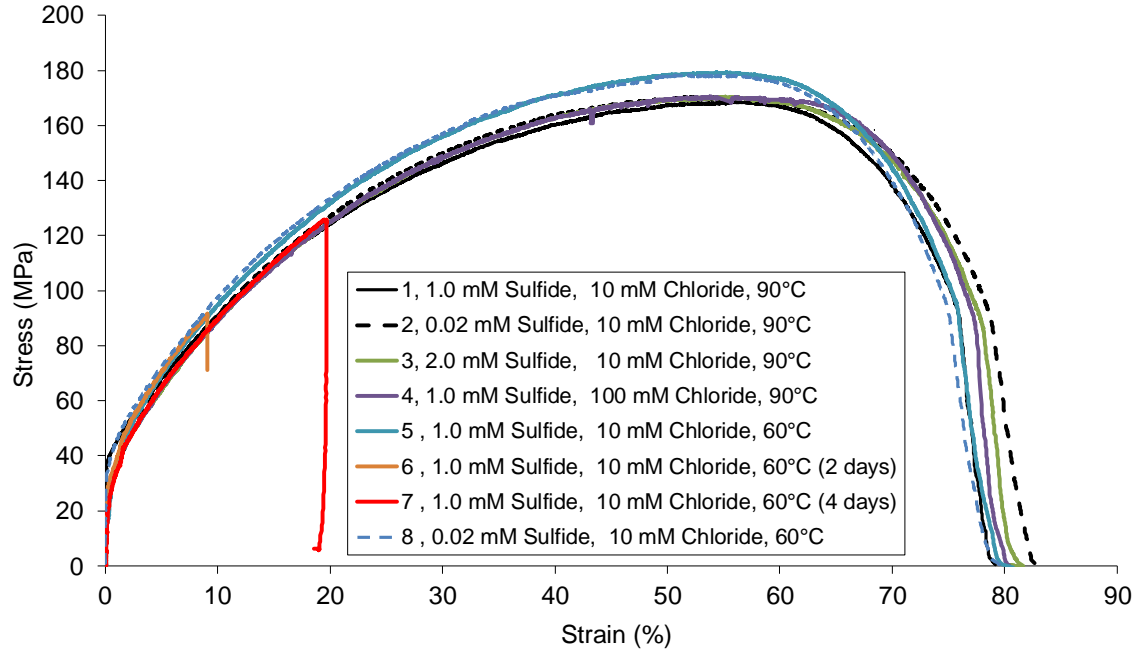
Results – Stress-strain

- Very ductile appearance
- No influence of sulfide
- Slightly lower Maximum stress at 90°C than at 60°C
