EFC WP15 Activities

Welcome to the EFC Working Party Meeting

"Corrosion in Refinery and Petrochemistry"
WP15

1 September 2022

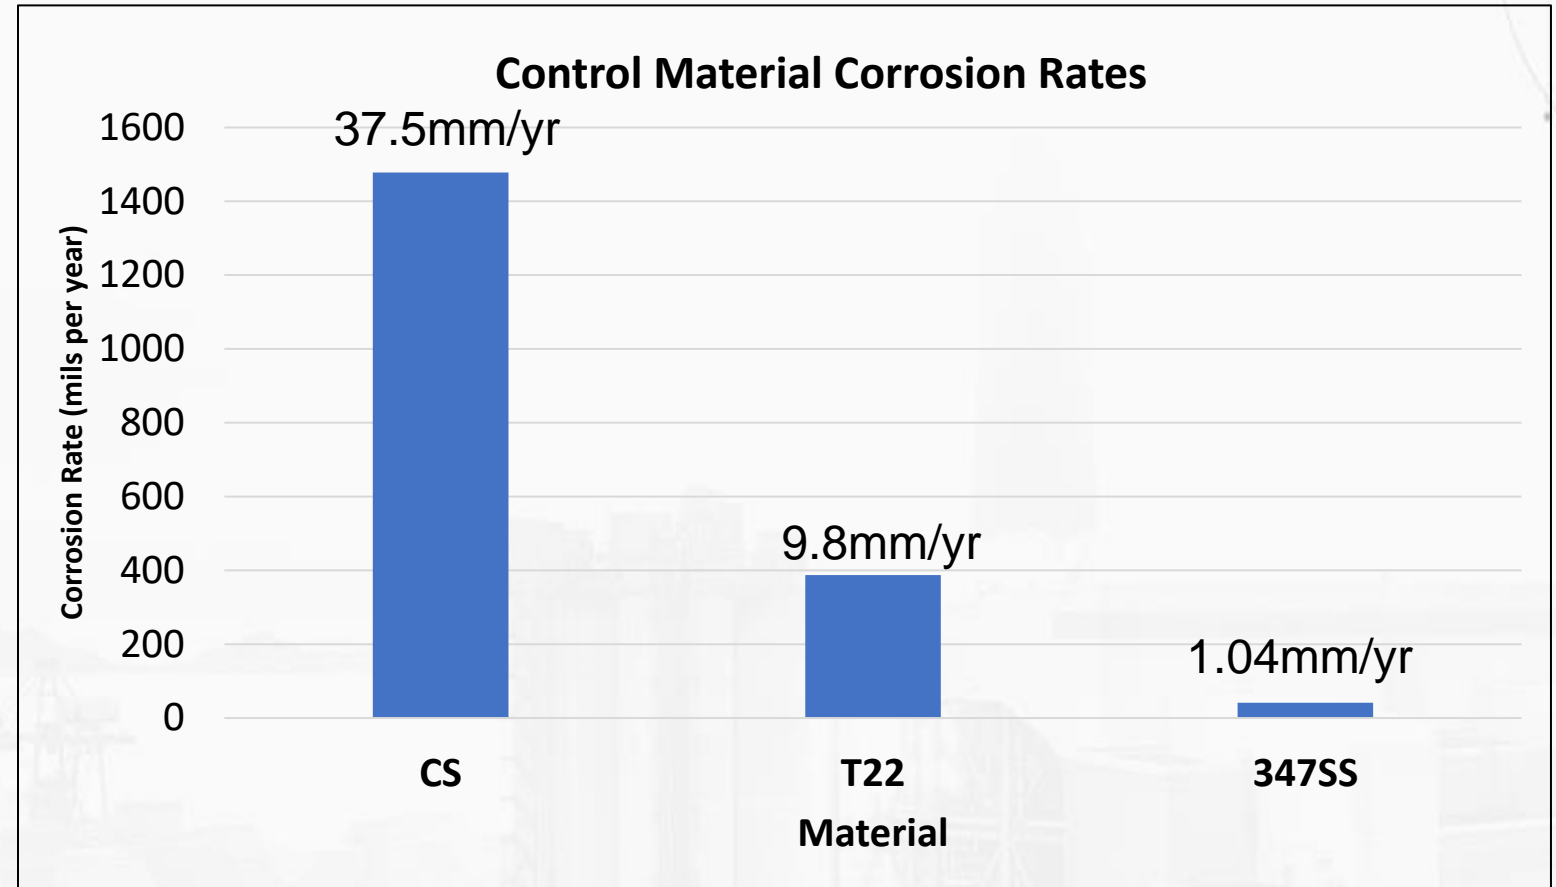
Test Results – Soy Oil

- Coupon thickness loss was determined and converted to annualized thickness loss
- SEM imaging and EDS used to identify corrosion product

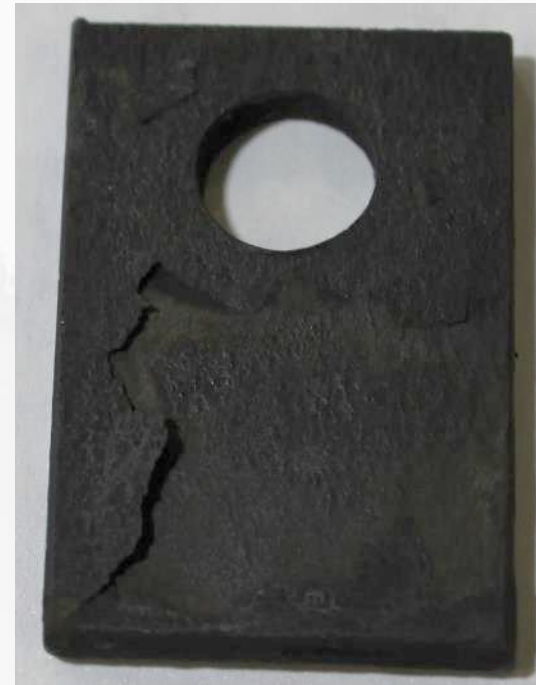
Test Results – (2.25Cr1Mo)

- Significant corrosion deposits and thickness loss
- Annualized corrosion rate (Approx.) – **9.8mm per year**

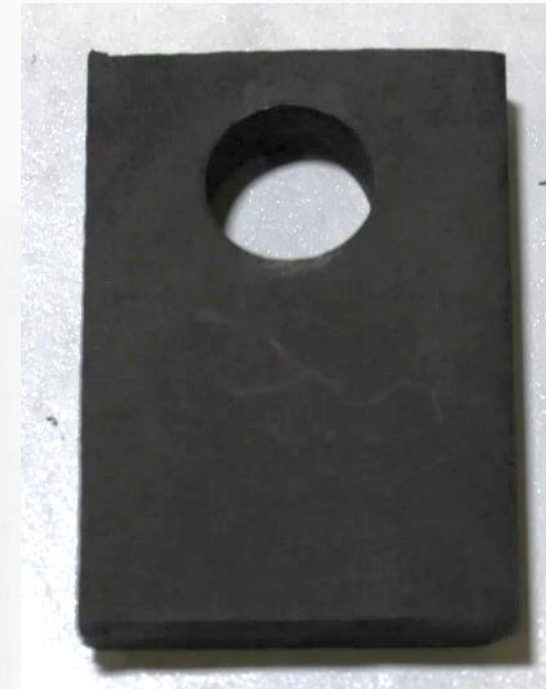
Test Results – 347SS (18.5Cr11Ni)

- Relatively minor corrosion deposits and thickness loss
- Annualized corrosion rate (Approx.) – **1.04mm per year**

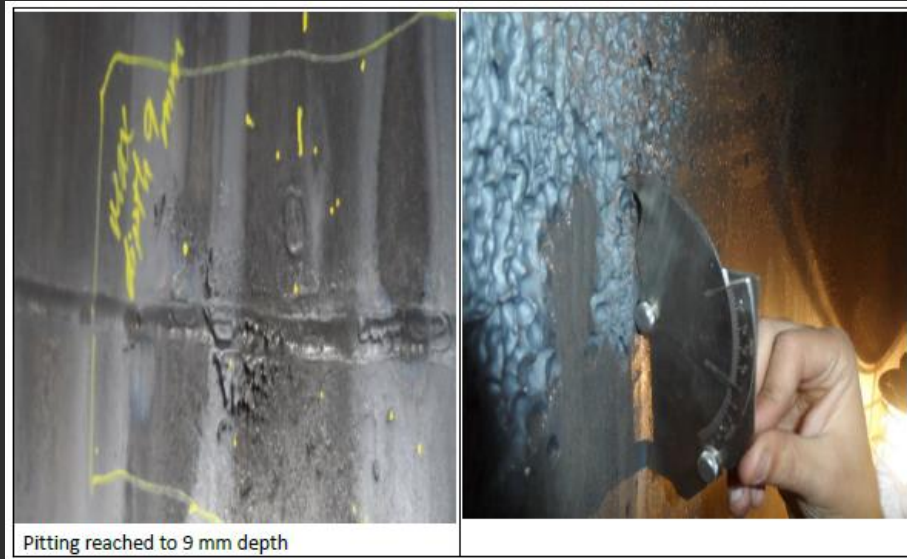
Inspection Report Amine CO2 Stripper Column:

- The process fluid: Process gas/ Rich MDEA/CO2.
- The affected part of shell material: SA 516 Gr.70 thickness: 12 mm. with corrosion allowance 3 mm.
- The Design pressure: 3.6 Bar.
- The Design Temperature: 150°C
- Internal Diameter: 2300 mm.
- Operation temperature about 103°C

- Upper part: SS-316L
- Lower part: SA-516 Gr.70

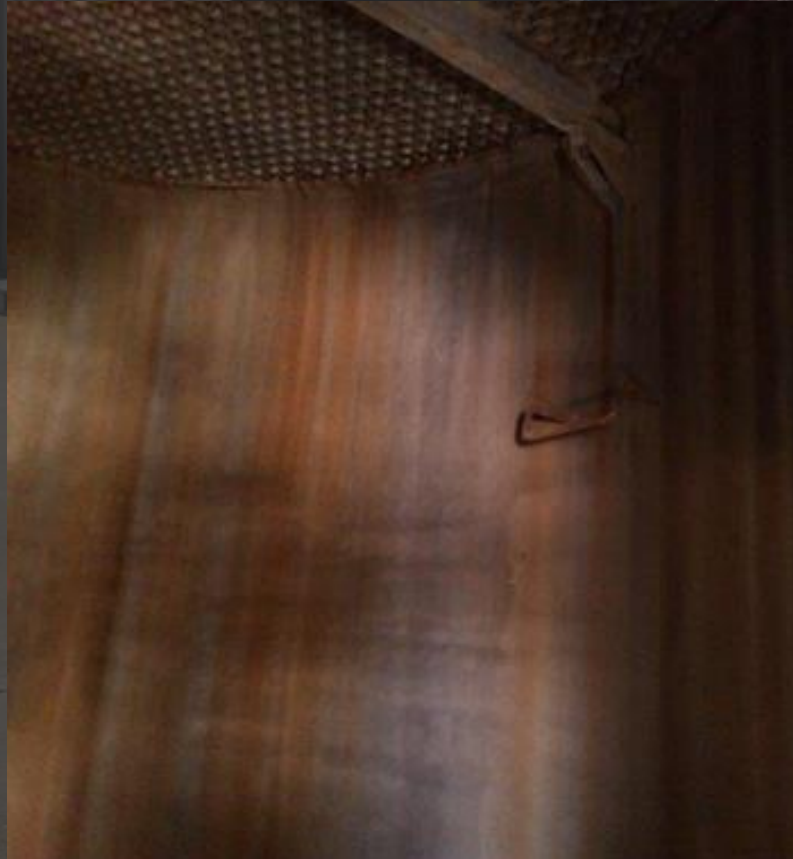
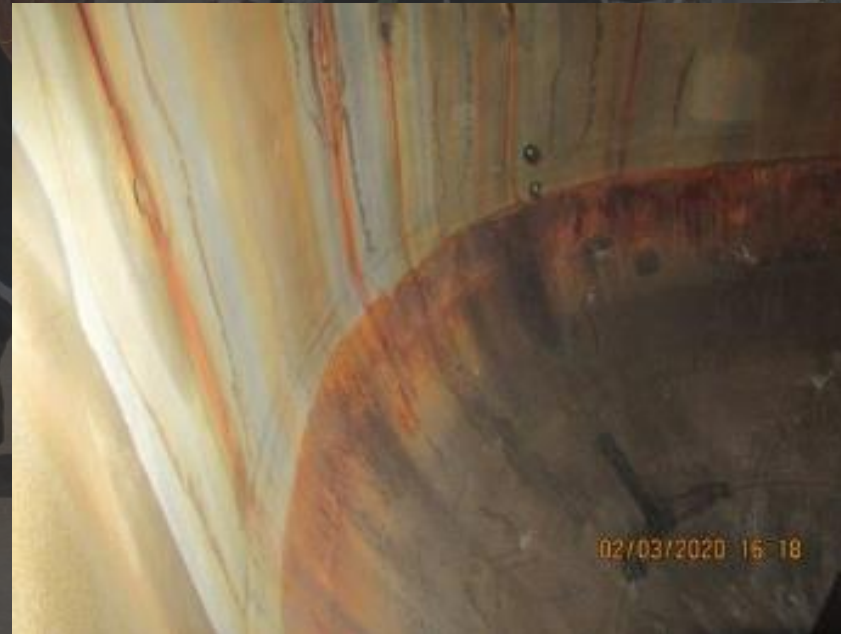
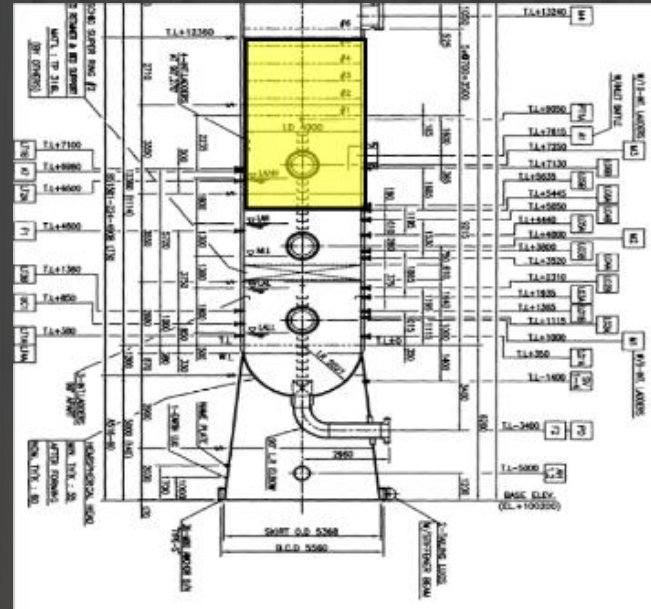
AGR AMINE ABSORBER TOWERS

Inspection Results:
IGS HVTS cladding is in excellent condition.

- No repairs required.

IGS HVTS cladding was applied to the vessels below the CRA weld and in other discrete locations where pitting corrosion was identified during the turnaround within the critical path schedule provided by the client.

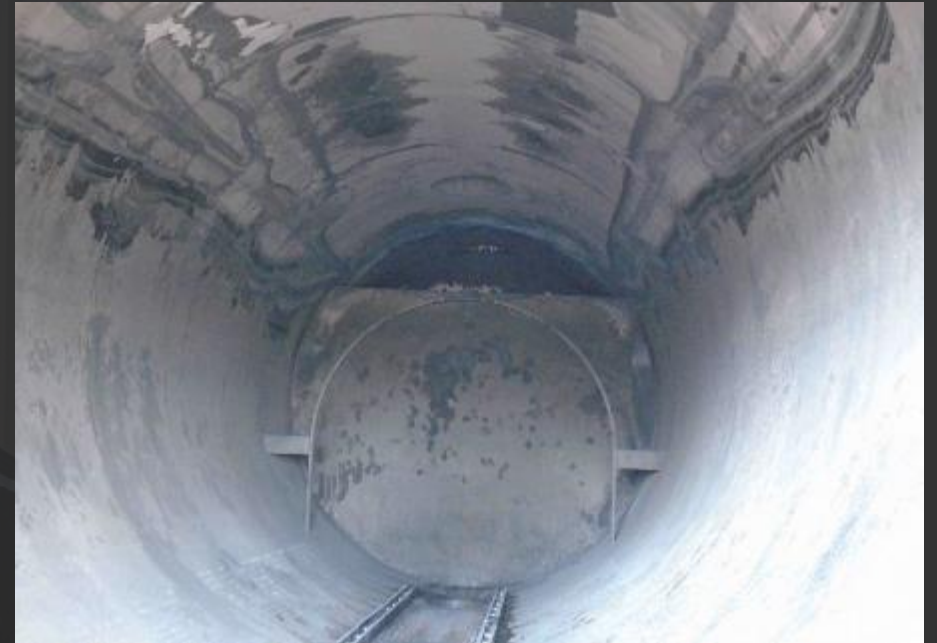
AMINE REBOILERS (e.g. MDEA)

Amine reboiler experiences aggressive corrosion and wash out in the hot, vapour phase in the top 1/3rd of the vessel, worst in the 11 to 1 o'clock position. Additional corrosion on the tube sheet and weld seams of the vessel. When working with MDEA (weakest base) and in the hottest parts of the process (e.g. the reboiler), HSAS will regenerate to acids, e.g. formic/acetic acid vapours that will then re-condense on the vessel walls where the temperature decreases = aggressive corrosion damage.

HVTS applied CRA cladding installed to freeze the internal surface condition in the critical areas of the vessel shell and on the bundle tube sheet.

Internal inspection of the reboilers in the following turnaround demonstrated the performance of the CRA cladding as a corrosion barrier in these conditions.

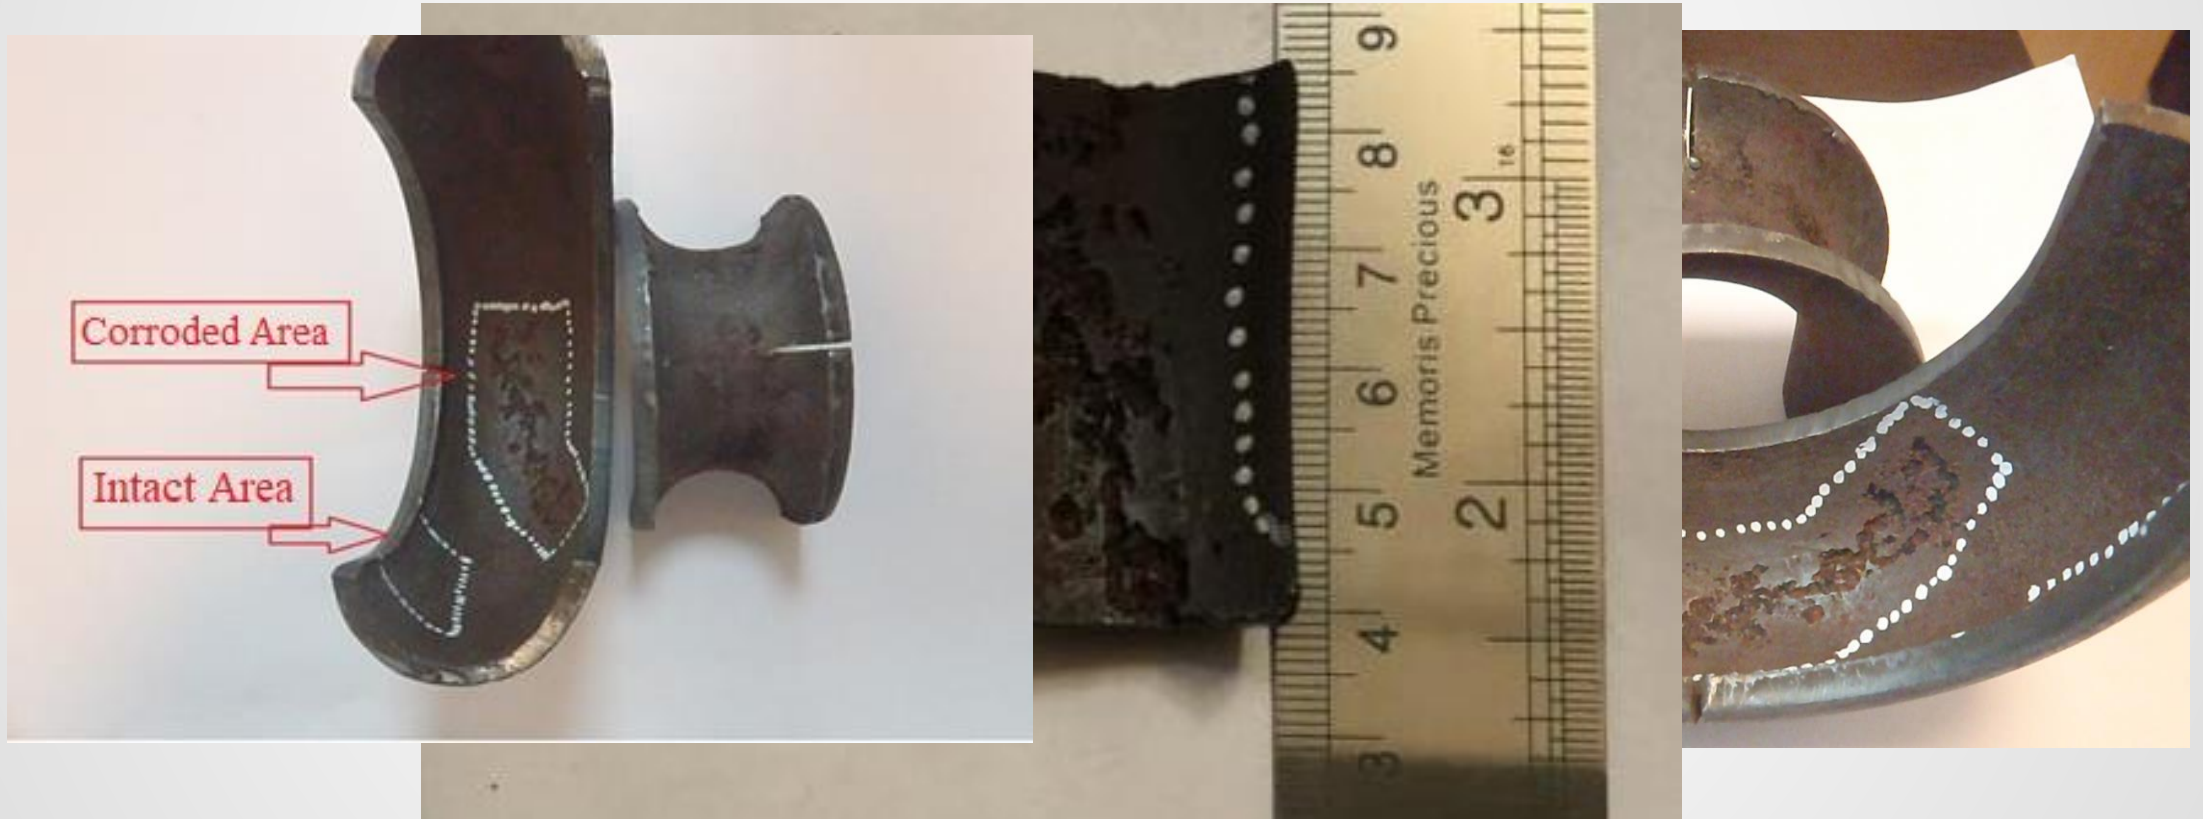
- One of the U-bends with high corrosion rate was cut
- A longitudinal Sectional-cut was done
- Two areas were selected to morphological microscopic investigation by SEM and also elemental analysis by EDX

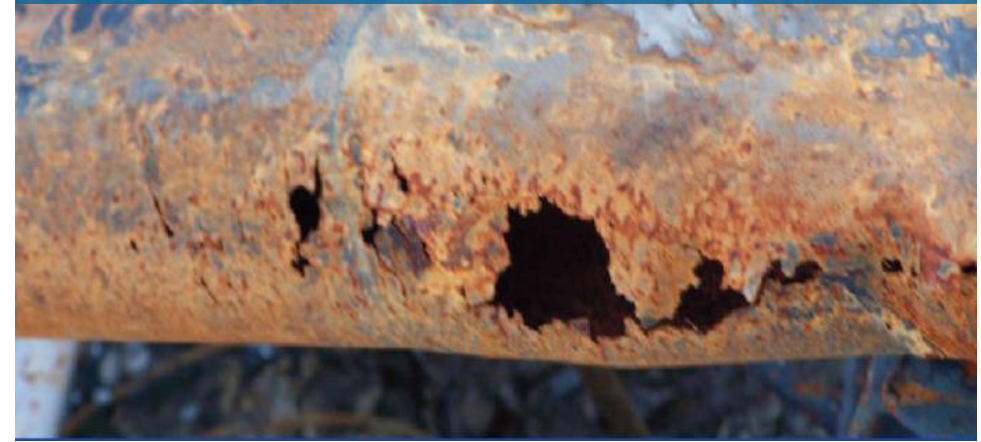
CUI on pipe causing perforation

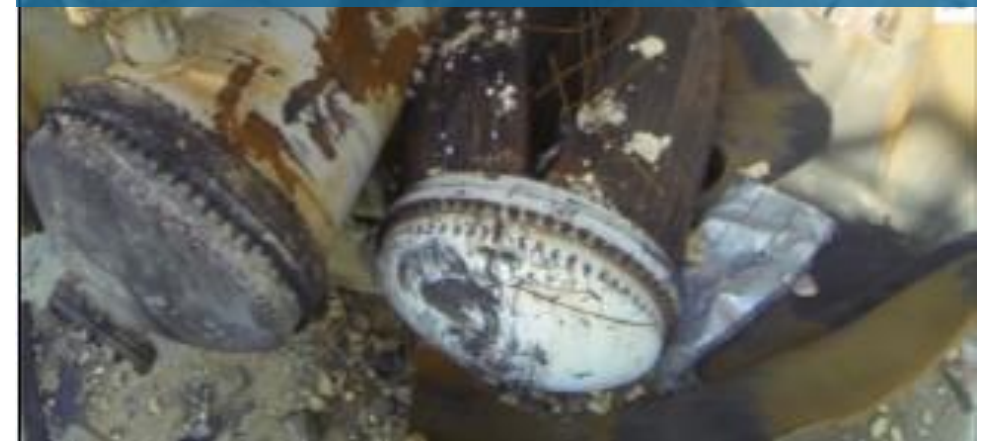
CUI-induced heat exchanger in olefins plant³

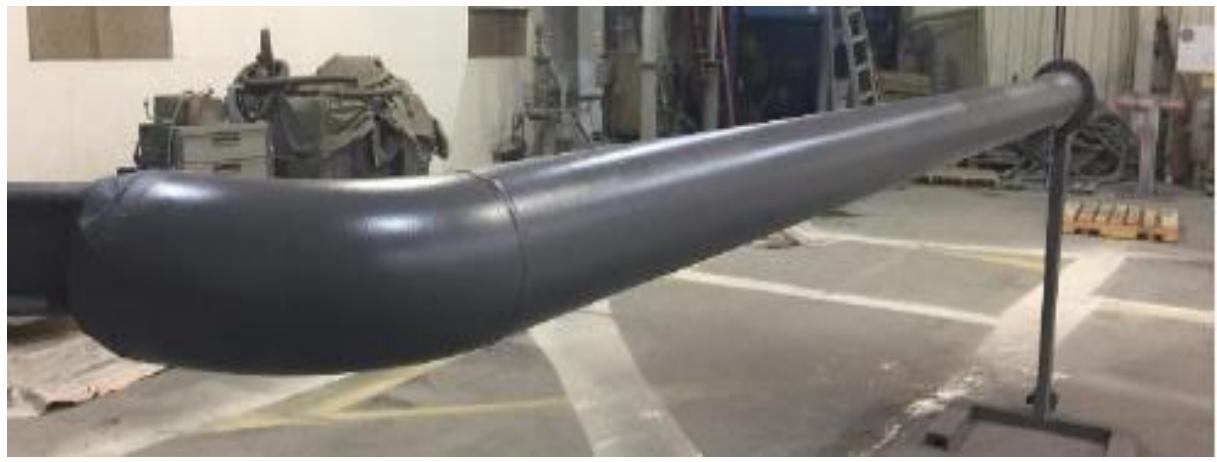
Freshly applied PPG HI-TEMP 1027 HD gray

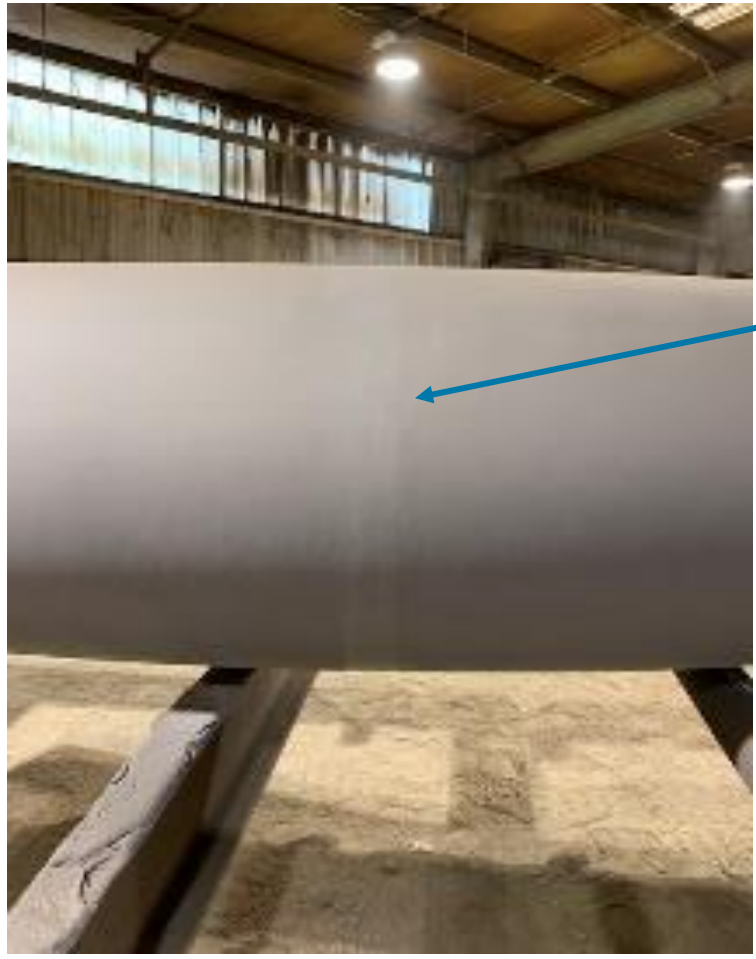
No damage to coating after being moved 24 hours after application

PPG HI-TEMP 1027 HD gray, 24 hours after application

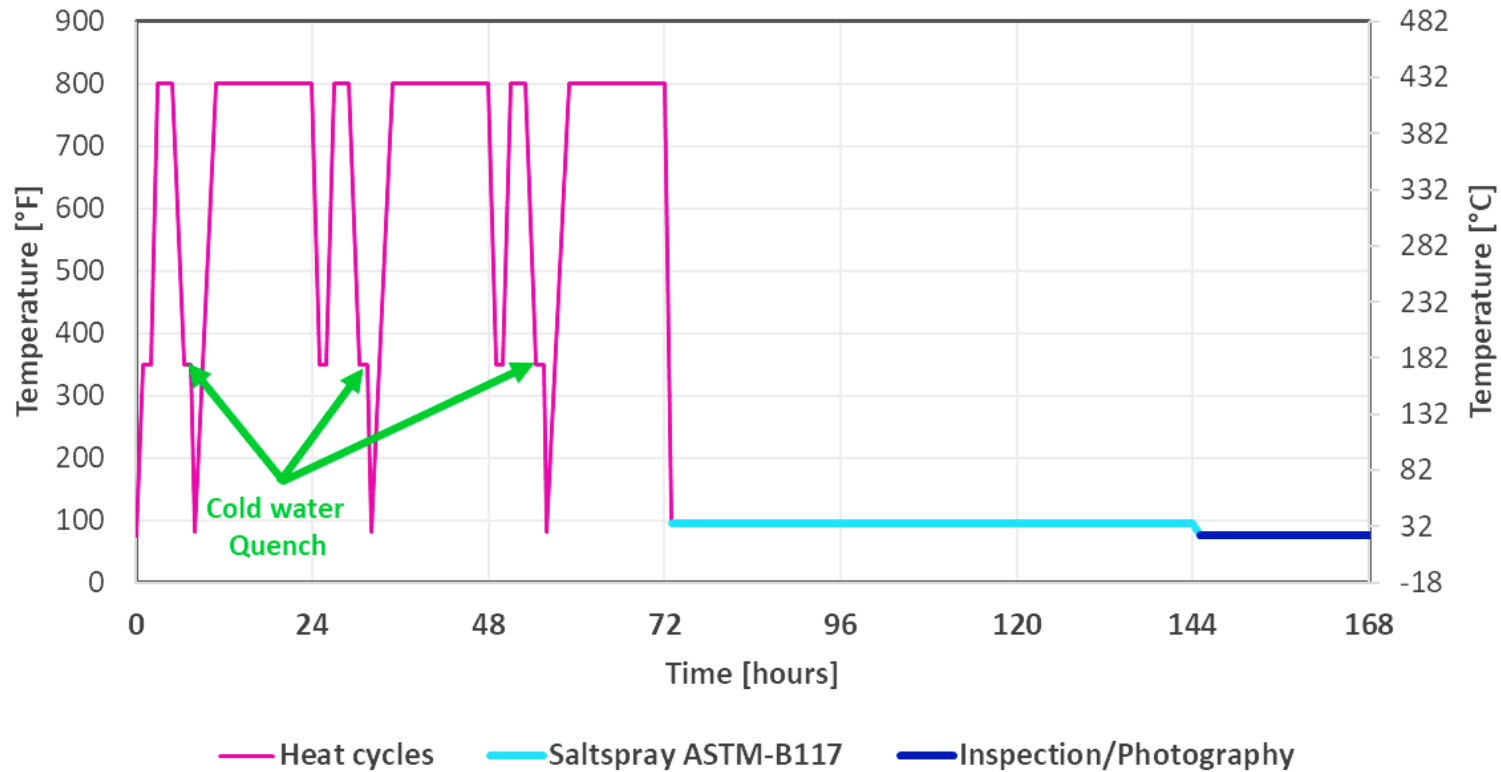
Temperature vs. Time

- (Dry) Thermal Cyclic and
- (Wet) Corrosion test (with salt fog)
