EFC WP15 Activities

"Corrosion in Refinery and Petrochemistry" WP15

23 March 2021

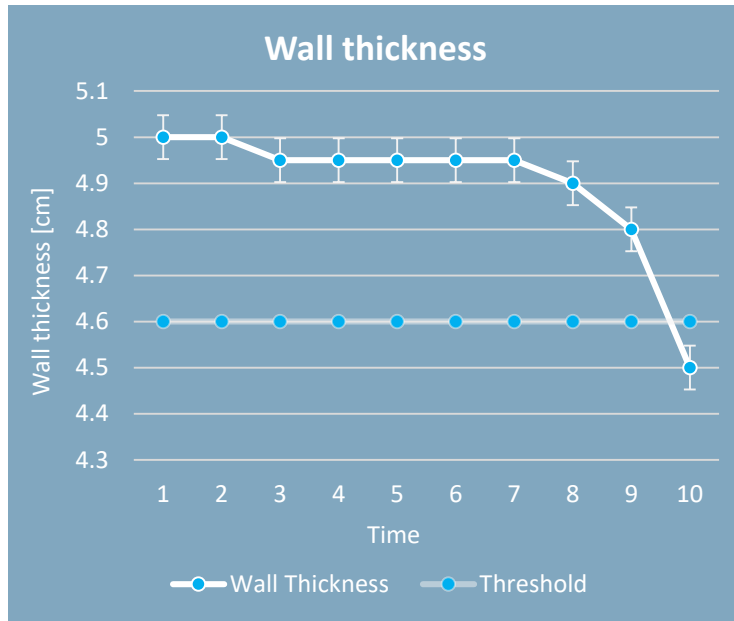
Coating sensor operates in advance of conventional wall thickness sensor

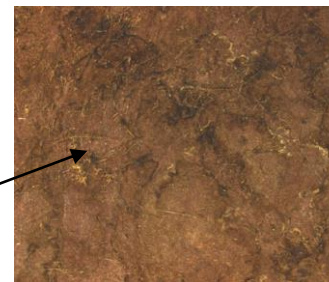
Coating	A (30cycles)
Blistering	0
Rusting	0
Cracking	0 (S0)
Flaking	0 (S0)
Chalking	0

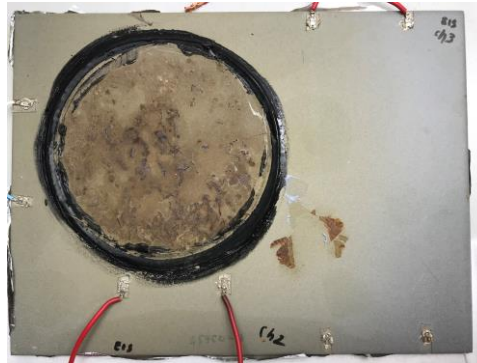
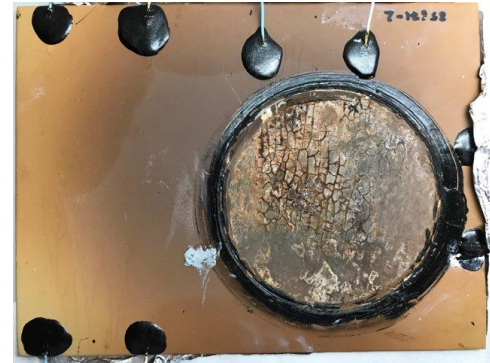
Able to distinguish between different degrees of failure by signal interpretation

- ❖ Signal interpretation is complex
- ❖ Needs to be achieved to same or better level as CVI
- ❖ Requires extensive calibration with anti-corrosive testing
- ❖ Additional physical examination for knowledge building

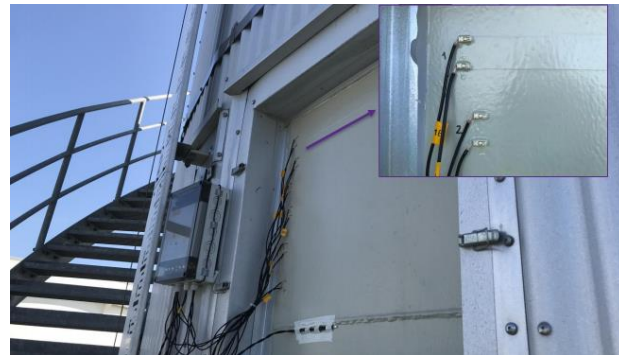
European refinery trial

- ❖ Equipment: Tank & Hot crude pipe
- ❖ Duration: 6 months to last evaluation
- ❖ # of sensor: 16 (multiple types)
- ❖ Electronics : 1st generation
- ❖ Conclusions
 - ❖ Similar signals from others sensors
 - Signal is robust
 - ❖ No change in signal
 - Coating performance is still good

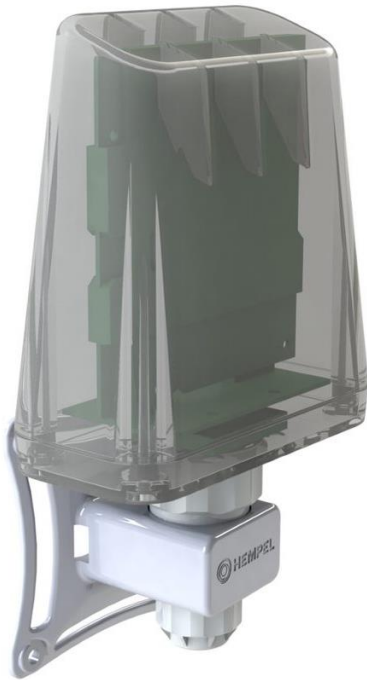
- ❖ 3rd generation units ready to ship for trial
- ❖ ATEX approved
- ❖ Advanced electronics offers even more data gathering options

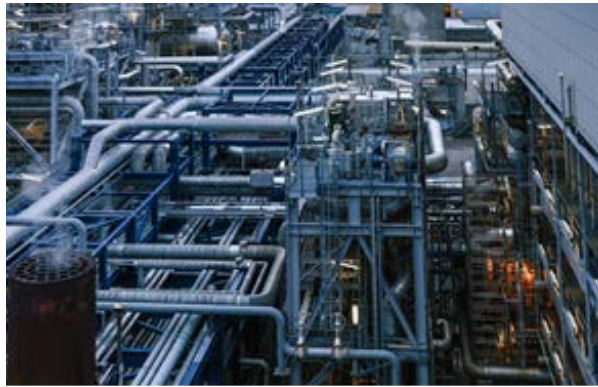
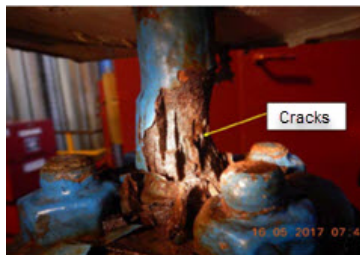
- One of the biggest threat to the Mechanical Integrity of the O&G facilities around the world
- Equinor's facilities in Norway have more than 5000 Km of insulated piping
- Location of the damage is scattered
- Extensive inspection / maintenance programs are developed based on the assumption that insulation material is always wet
- Surface maintenance cost in the order of 100 M\$/year
- Despite these efforts leakages still occur

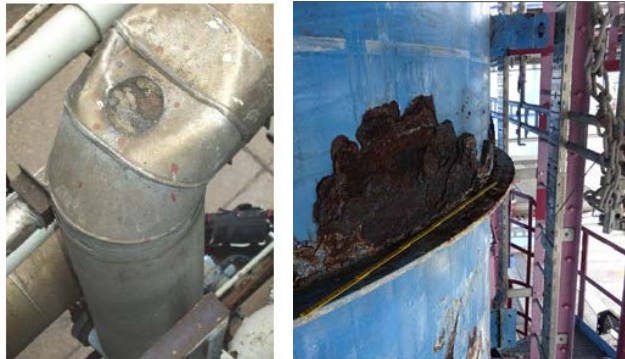
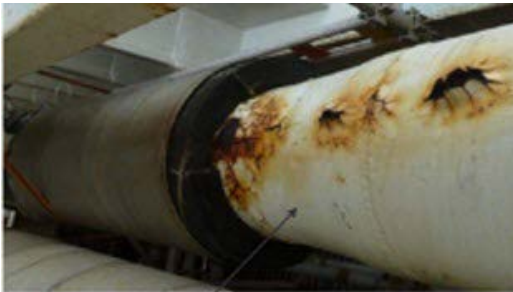
Insulation system

- Piping or other equipment
- Coating
- Insulation layer(s)
- Cladding / weather protection

- Water penetration
- Damages in coating
- Corrosion starts

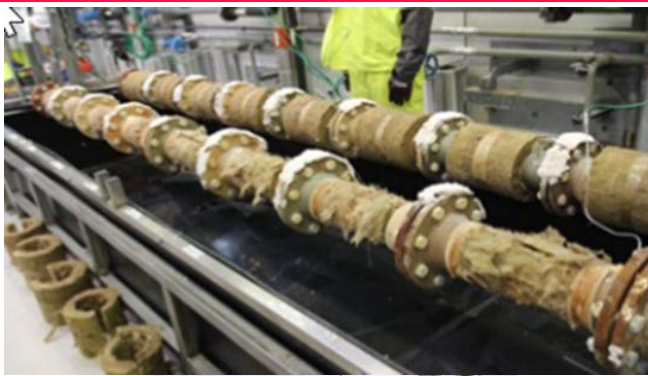
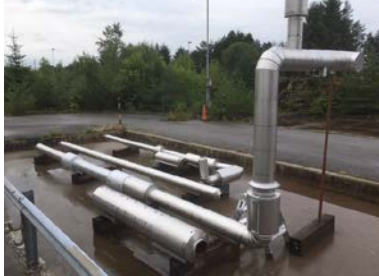
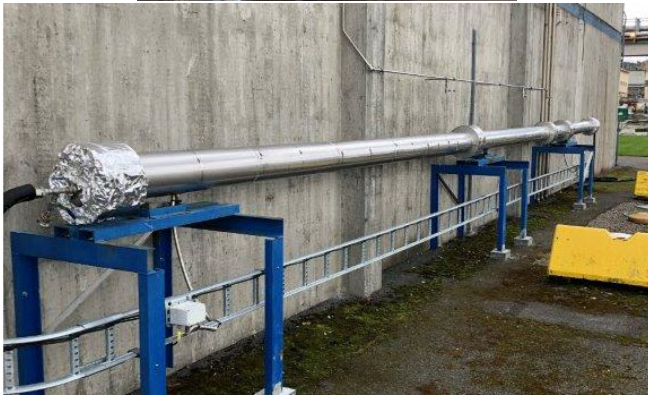
THE TESTING RIGS

- Testing of coating and insulation systems
 - How insulation systems affect CUI
 - How coating under insulations affect CUI
 - Qualify new insulation and coating systems
- CUI detection
 - CUI detection rig
 - State of the art on NDE
 - Results so far not satisfying enough to replace CVI
- Water Monitoring
 - CUI sensor rig
 - Long exposure in field

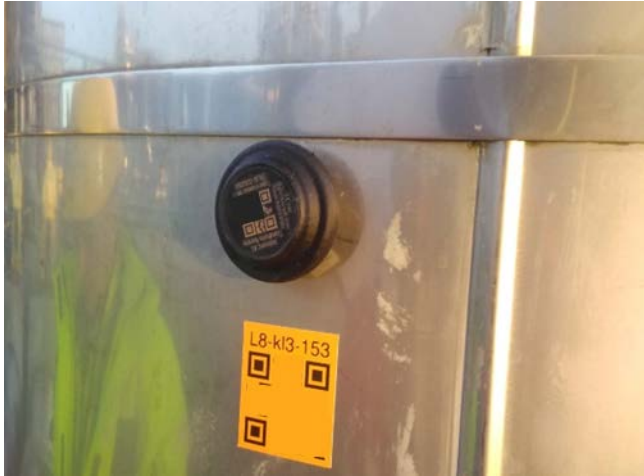
- Equinor is moving from inspection to water monitoring, thanks to the monitoring technologies development.
- Preliminary tests showed that water under insulation can be detected and located by measuring relative humidity
- On-going work:
 - Qualify use of sensors:
 - Measure relative humidity
 - Wireless data transfer
 - Good battery lifetime
 - Easy installation
 - Minimum replacement
 - Low cost
- Digital solution for management of data

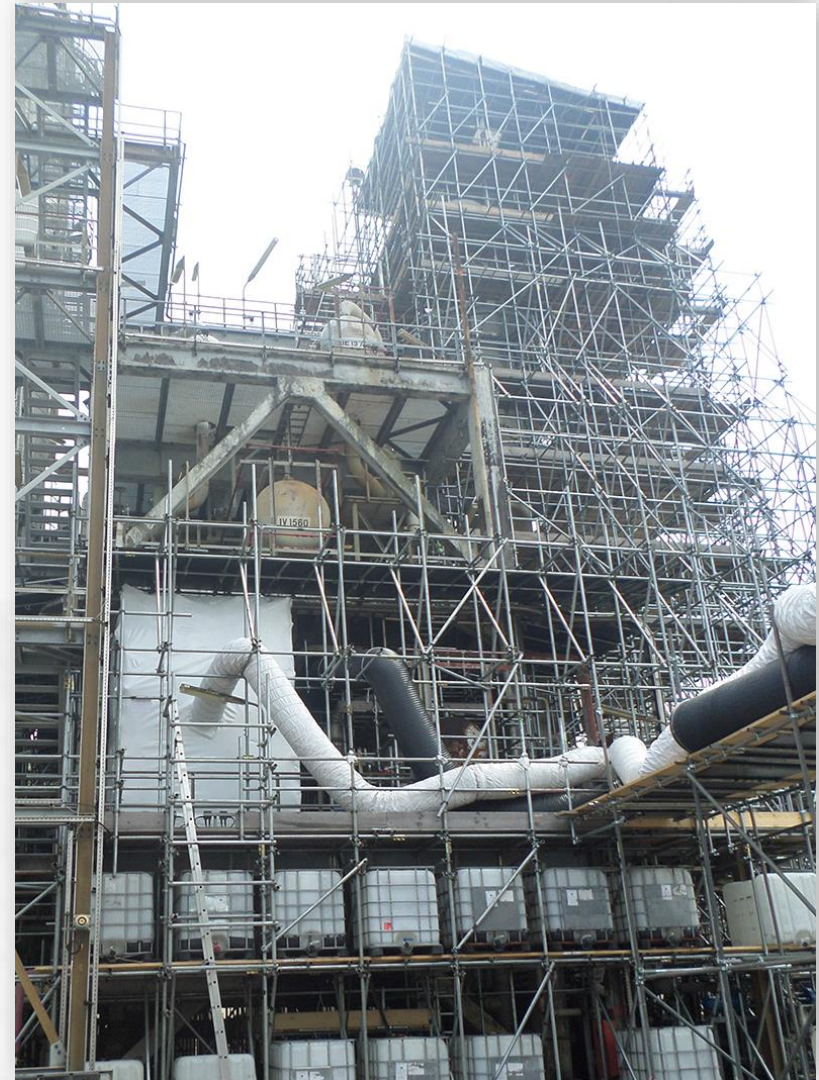
Consists of 5 Elements:

1. IGS shrink wrap habitat
2. IGS automatic shutdown system
3. IGS gas jet extraction system
4. IGS certified technicians
5. IGS pressure and climate control solution

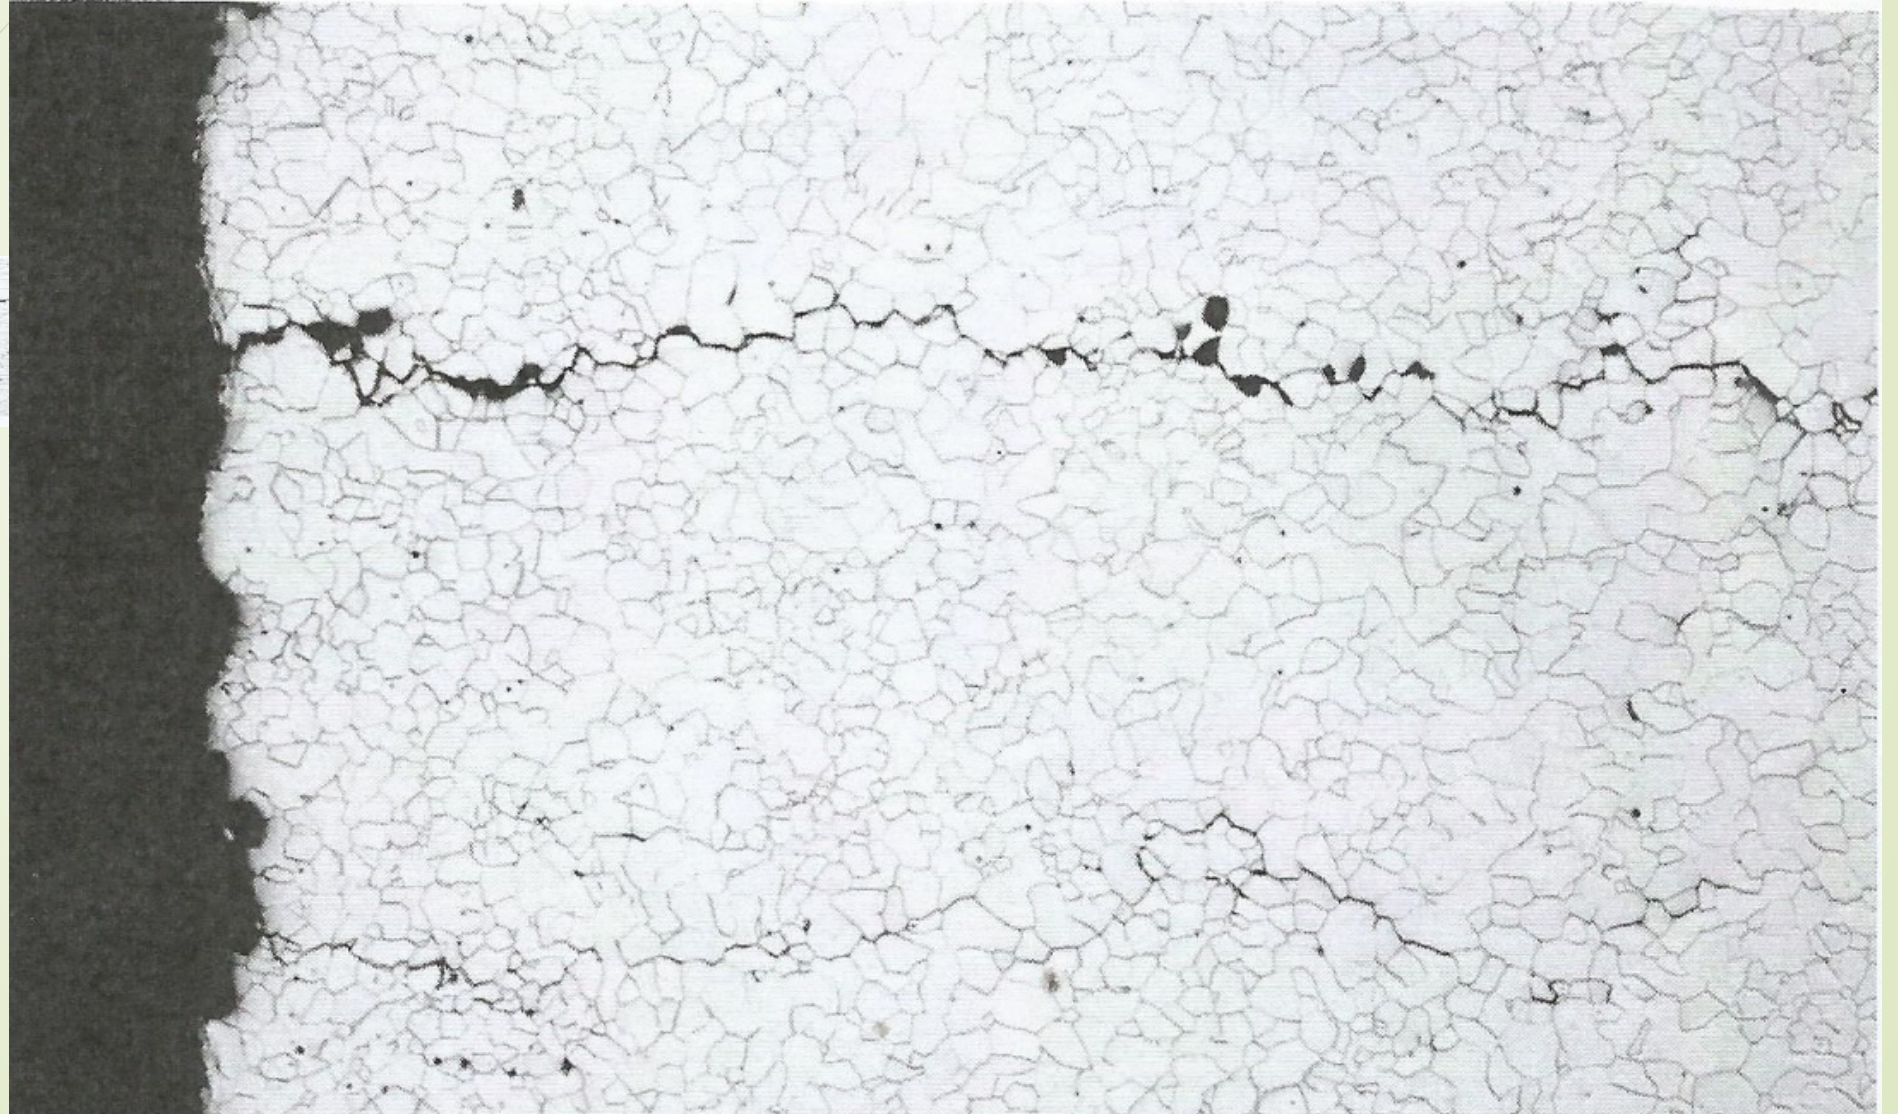
Intergranular SCC of carbon steel in methanol I.

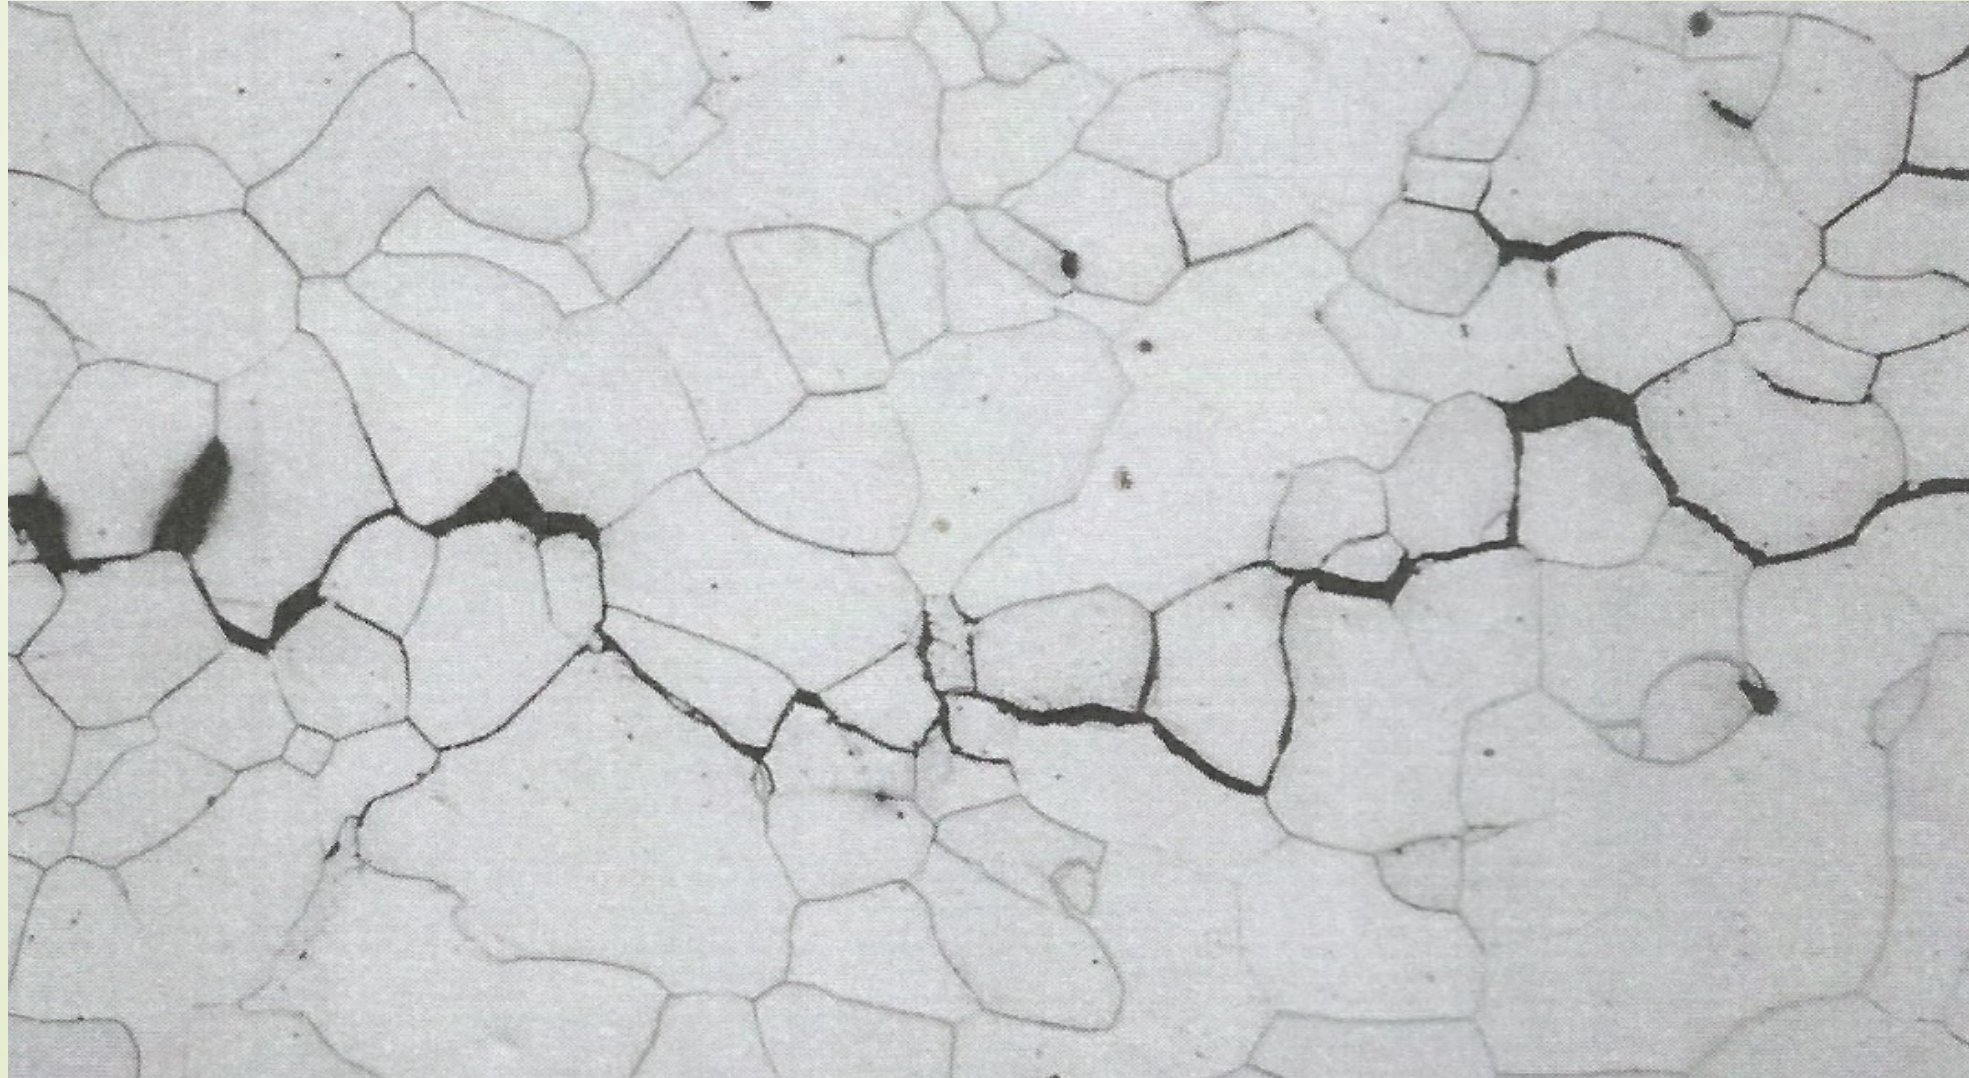
Intergranular SCC of carbon steel in methanol II.

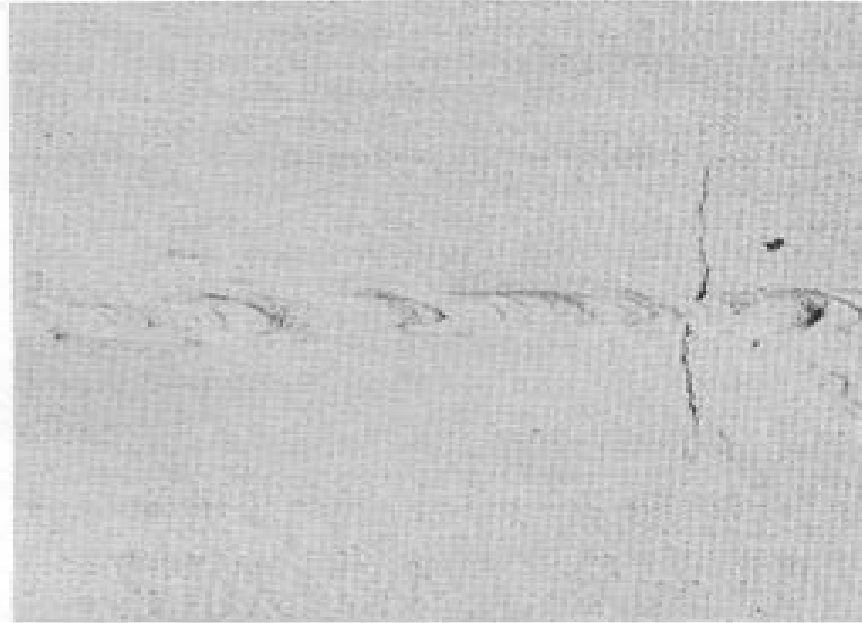
Stress corrosion cracking on the bottom of a methanol tank.

Fig. 6 Stress corrosion cracking observed on a welded vessel used as a storage for industrial grade methanol.

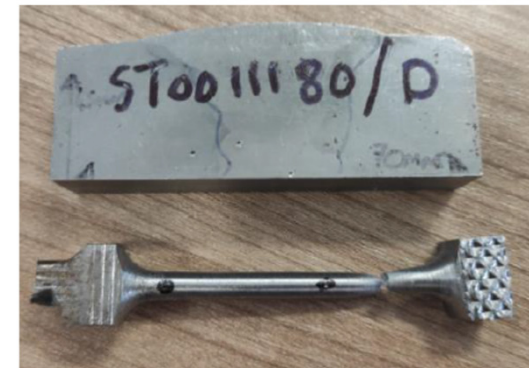
Figure 2.1 – LW5 - D

- Material strength and ductility results exceeded the minimum material spec requirements
- Majority of the fracture in the weld metal

Sample ID	Proof $R_{p0.2}$ (MPa)	UTS R_m (MPa)	Elongation on G.L (5.65 \sqrt{A}), %	Reduction of Area (%)
LW5 - D	405	494	21.0	57.0
LW5 - K	396	519	25.5	58.0
LW5 - L	436	458	9.5	30.0
LW5 - M	443	464	12.0	61.0
CW6 - J	364	437	19.0	50.0

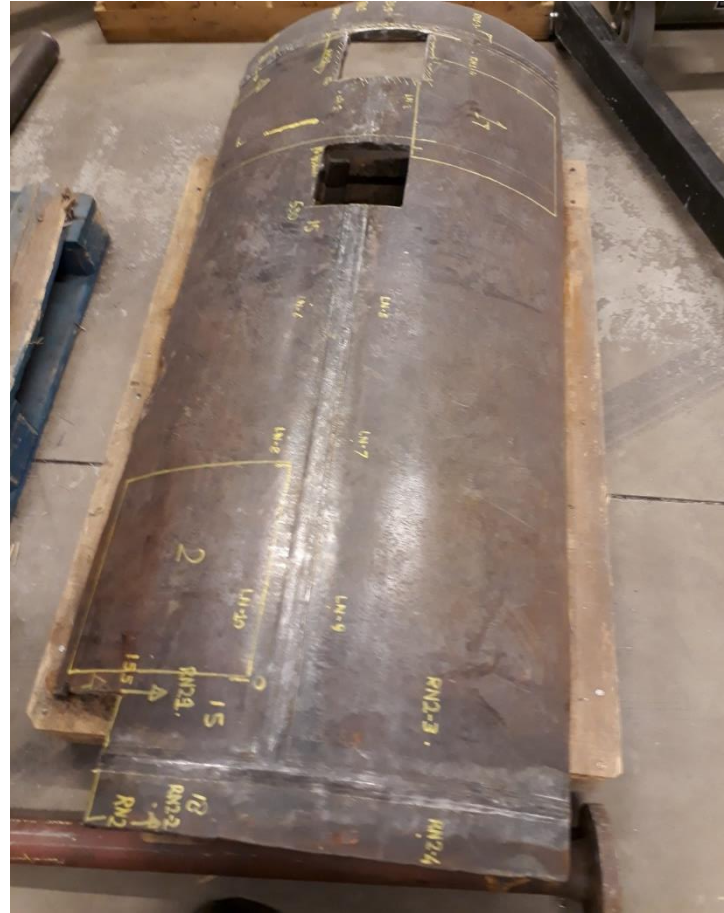
- HTHA suspicion before inspection
- HTHA not detected with field NDT
- HTHA confirmed in laboratory tests

- NDT was only able to find HTHA with optimized probes and procedures

NDT results zone 1

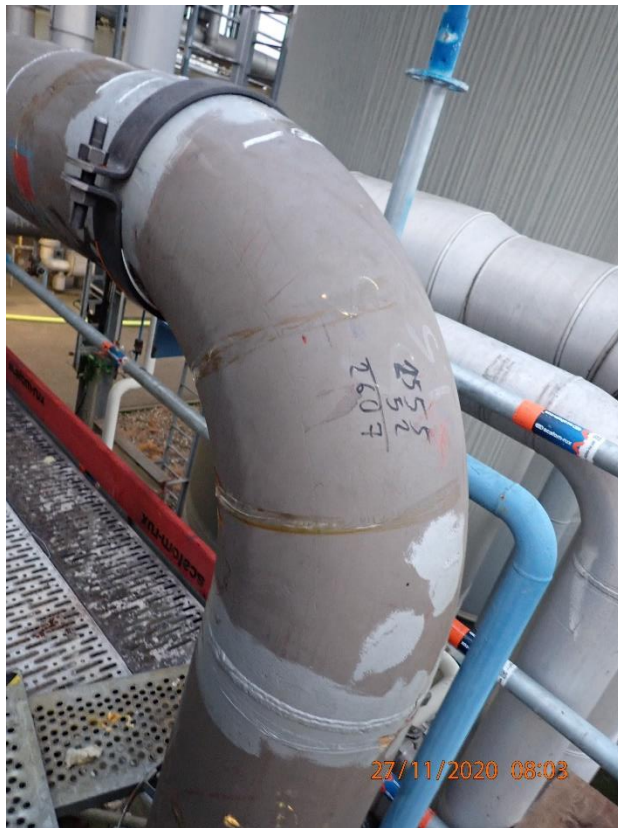
Leakage 1

- Demister of knock out drum STRD1403 was destroyed
- Without demister wet droplets were enabled to enter the subsequent line system causing stress corrosion cracking
- Root cause for destroyed demister in knock out drum: After 17 years in service without objections a thunderstorm in July 2019 (lightning strike near Steamreformer) triggered the emergency shut down of the plant causing a back flow in STRD1403 by sudden depressurizing

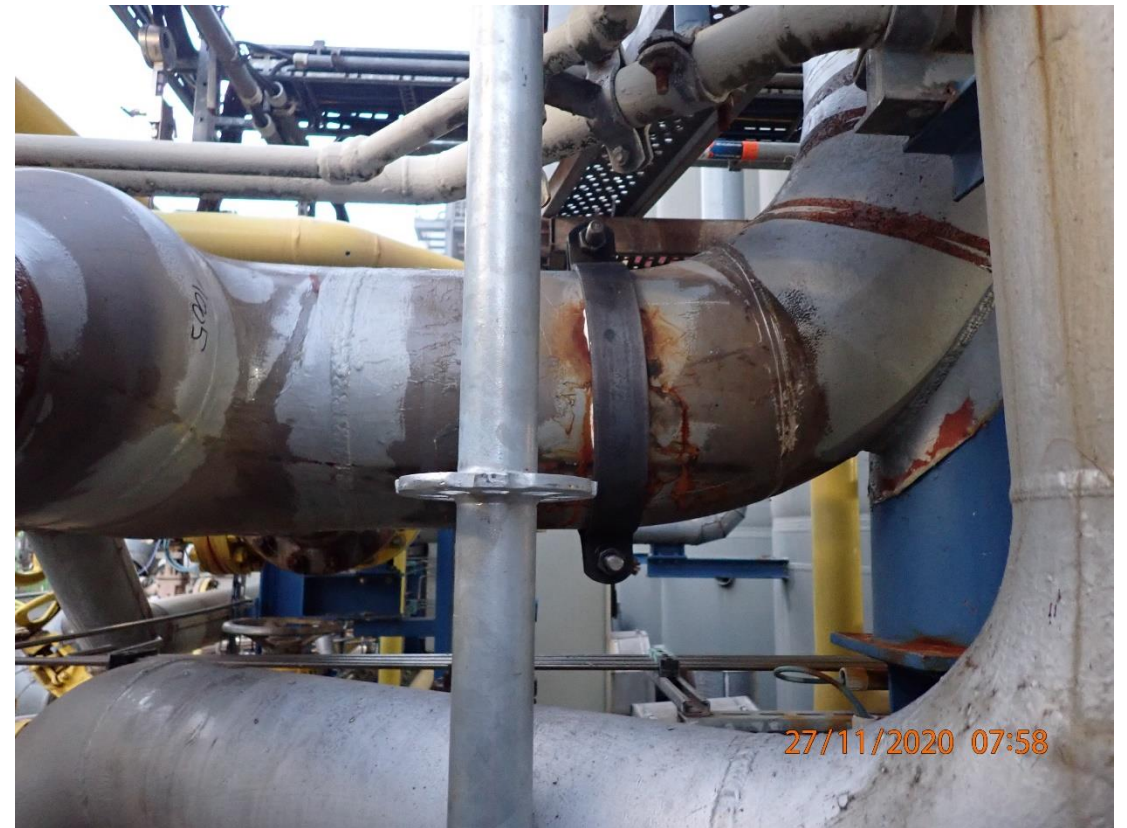
Leakage 2

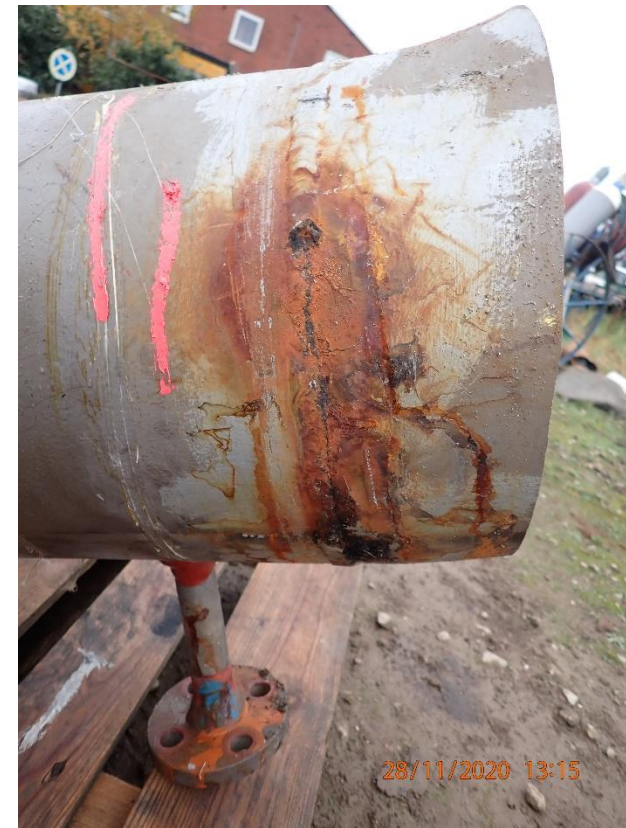
Leakage 2

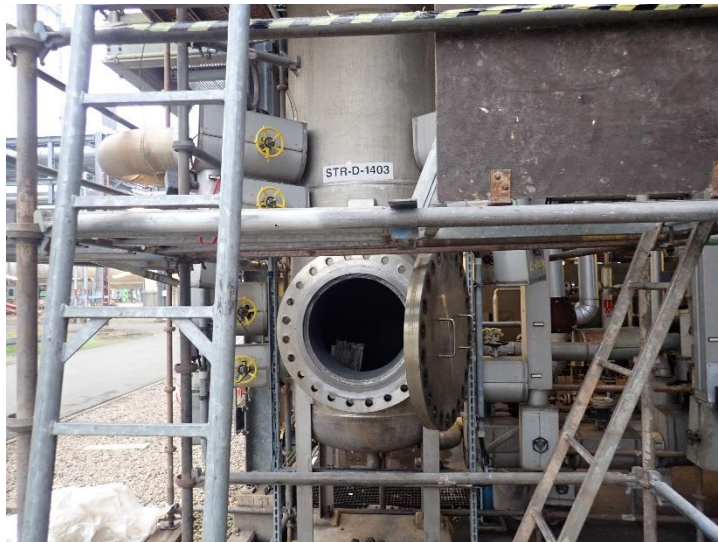
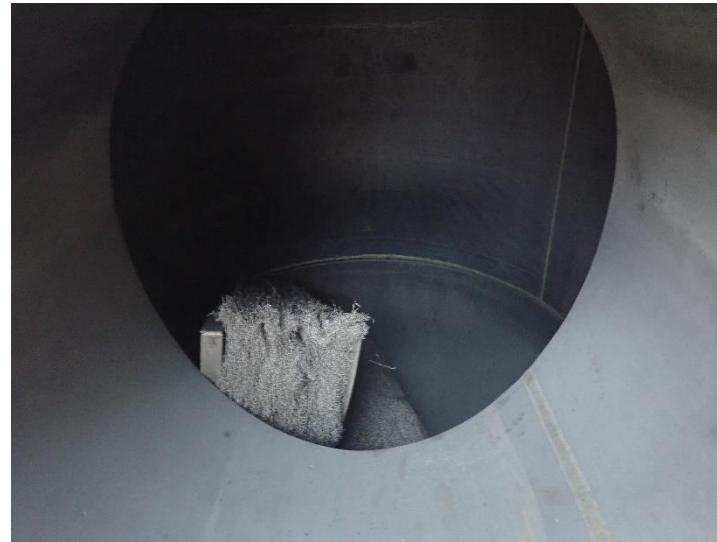
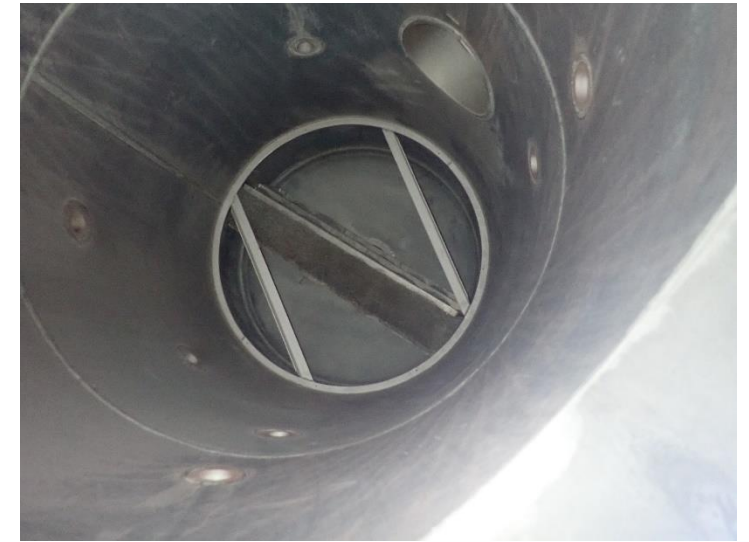
Result of root cause analysis:

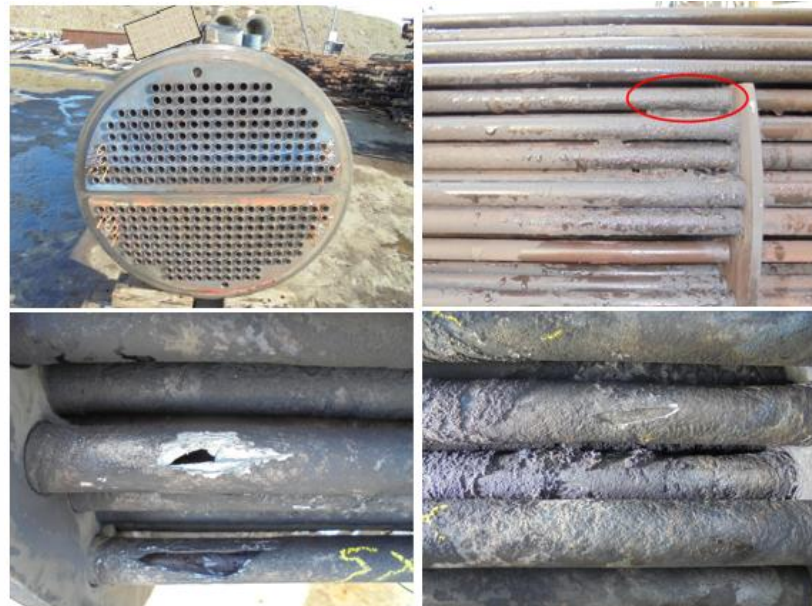
- ***SWS Column reboiler tube (NO KETTLE)***
- Material: titanium Gr. 7 (Pd alloyed....\$!)
- Age: 5
- In past: carbon steel, 316 SS and Superduplex 2507 (max 5 years life)
- Service T: 170 °C
- Extensive damages in some specific area of the bundle
- Heavy deposits

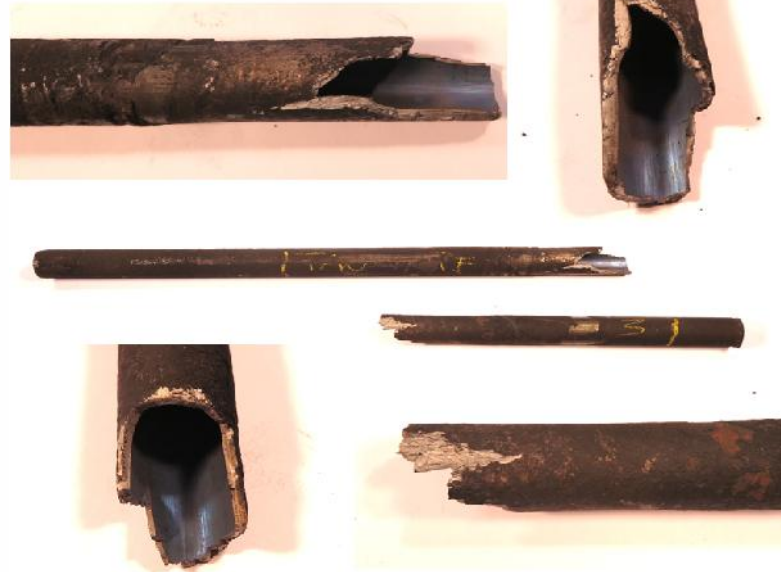
Tubo 3

- *Deposits and cracking*
- *No evident metal loss*

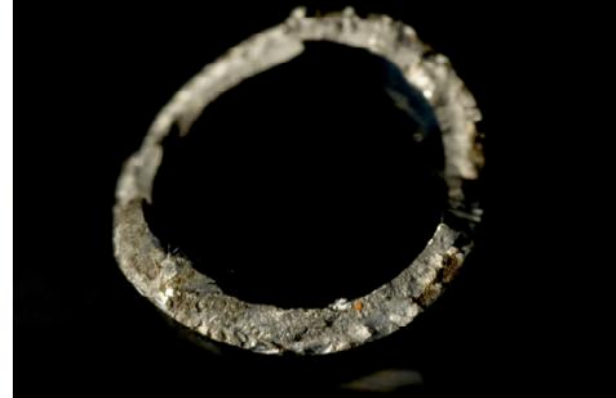
Tubo 3

Failure case #1

- *Extensive cracking in the external surface (shell side)*
- *Metallurgical degradation*
- *Severe brittleness*

- Titanium brittleness
- Hydrides formation
- Corrosion/hydrogen pick-up in alkaline environment (supposed...no info about pH)
- Corrosion species: OH- alkalinity ? Other salts?
- Galvanic couple to 316 SS baffles?
- Fouling could have increased aggressive compounds concentration (e.g. alkalinity, salts) on external surface → Evaporation effects?

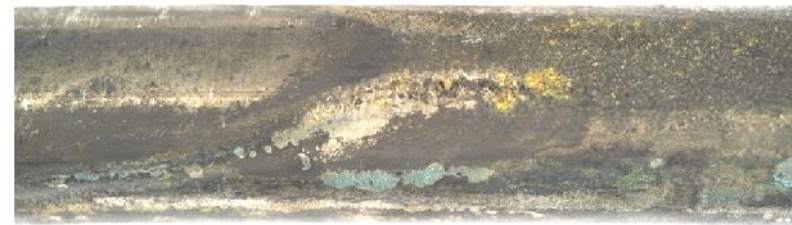
Failure case #2

- *External (shell side) corrosion attack upper rows of bundle*

- Corrosion in alkaline environment
- Very high pH
- Incipient evaporation and aggressive compounds & concentrations effects (e.g. alkaline salts) on external surface of upper rows
- Which Corrosion species?
 - OH- alkalinity ? T and pH are high enough for alkaline corrosion under concentration evaporative effects
 - Cyanides? Chlorides? Phenols ?
 - Other corrosive salts? thiosulphates? Formates? ...
- Heat Stable Salts (HSS) can be present in SWS (as in Amine solutions).
- Sodium salts? Neutralization of HSS by NaOH?
- Ammonia is stripped but in solution remain low volatile salts (corrosive?)

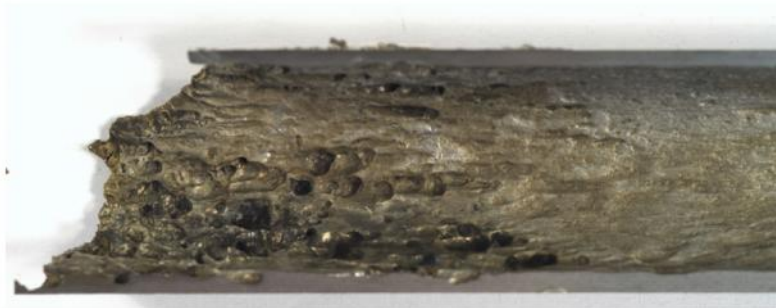
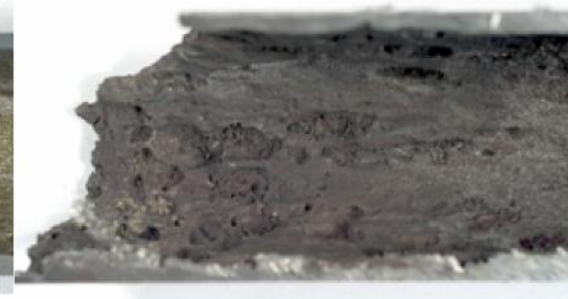
Failure cases

- *Internal corrosion close to tubesheet (inlet area)*

- Corrosion in alkaline environment
- Very high pH of injected water (> API guidelines)
- Partial water evaporation after injection and aggressive compounds concentrations effects (e.g. salts)
- Sour water injection accelerated corrosion; most probable cause of corrosion
 - OH- alkalinity ? T and pH are high enough for alkaline corrosion under concentration evaporative effect
 - Cyanides? Chlorides? Phenols ?
 - Other corrosive salts? thiosulphates? Formates? ...
- Sodium salts? Neutralization of HSS by NaOH (sodium thiosulfate is corrosive to CS at high pH)

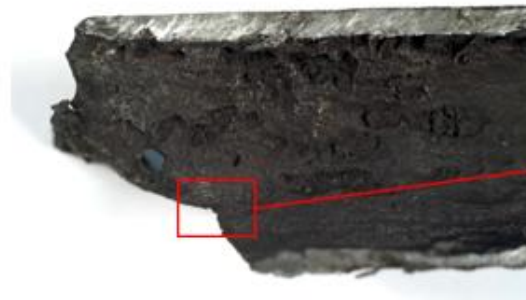
➤ SEM EDS

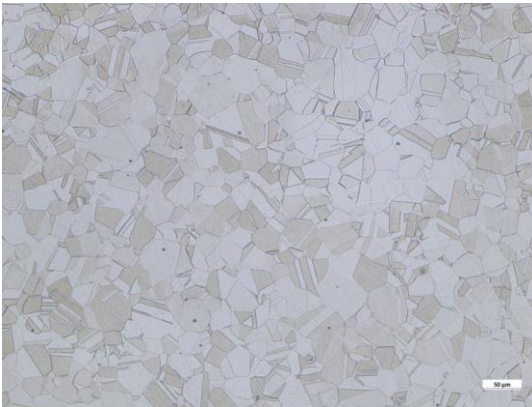
BALANCED CHEMISTRY => HIGH STRUCTURAL STABILITY

- Not prone to intermetallic phases or precipitates

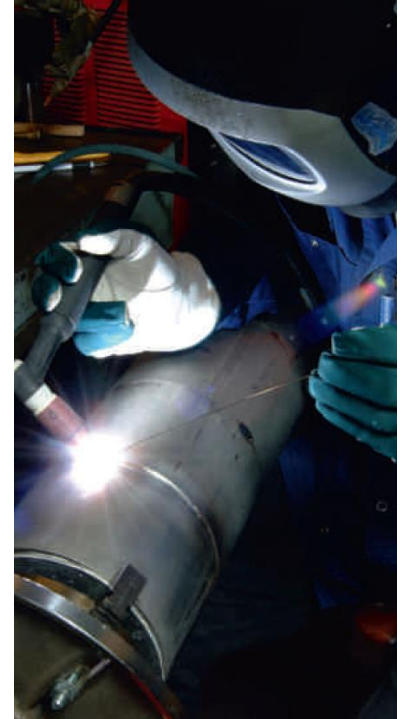
- Weldability verified in ASME IX testing
 - Welded joints excellent mechanical properties and corrosion resistance
- Welding recommendations
 - Filler metal Alloy 59 (ERNiCrMo-13, NiCr23Mo16).
 - TIG welding (GTAW).
 - Shielding/backing gas Ar+2-3% N₂
 - No preheating.
 - Interpass temperature max 100°C.
 - Heat input 1.2 kJ/mm.

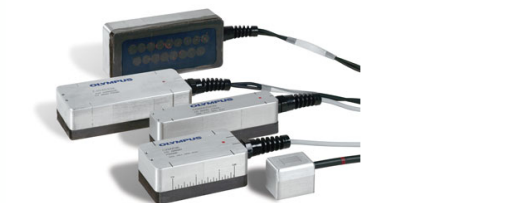
Olympus manufactures R/D Tech ECA probes for a wide range of applications. Probes can be designed to match the shape of the part being inspected. Standard designs are available to detect defects such as cracks and multilayer structures as well as corrosion.

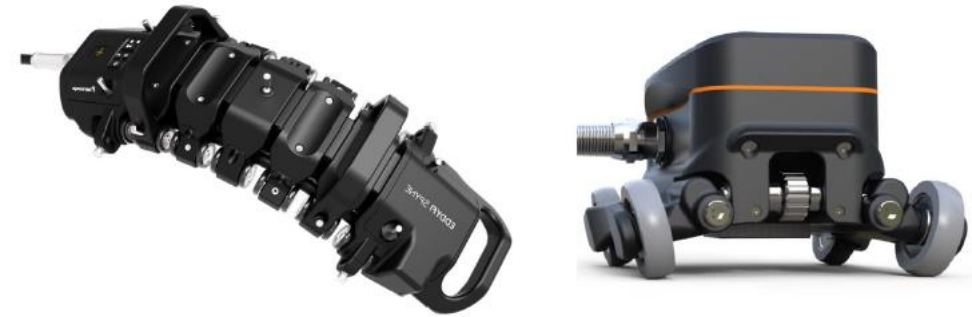
Left: Eddyfi's Spyne probe used for the detection of SCC; Right: Eddyfi's Sharck HR butt weld probe used for the detection and sizing of cracks along the seam weld.

Dig ID	A	B	C	D	E
Colonies detected both by MPI and Eddyfi	9	13	26	-	1
Colonies detected by Eddyfi and missed by MPI	3	6	4	Spiral tape lines	> 25
Colonies detected by MPI and missed by Eddyfi	0	0	0	0	0
Individuals cracks shorter than 3 mm detected by MPI and missed by Eddyfi (see pictures below)	2	0	3	0	3

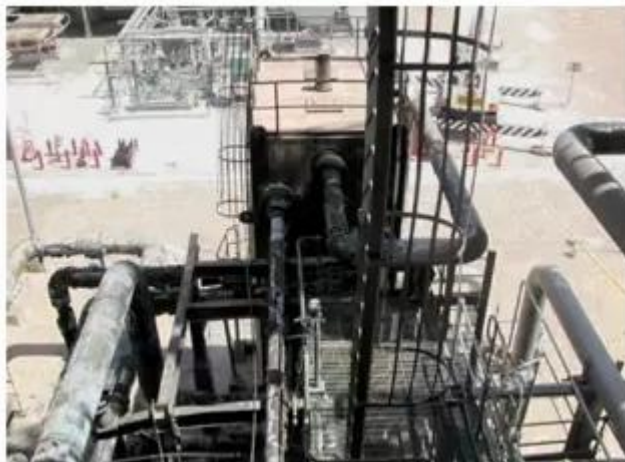
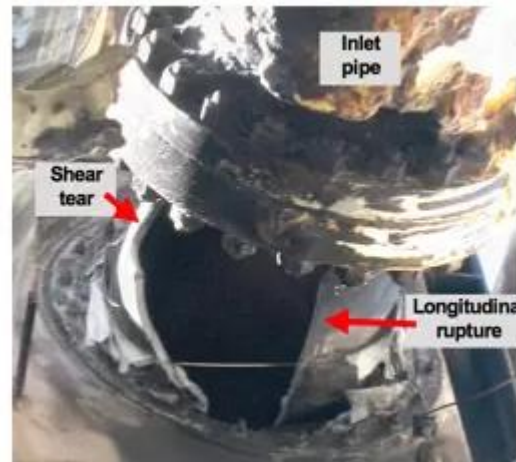
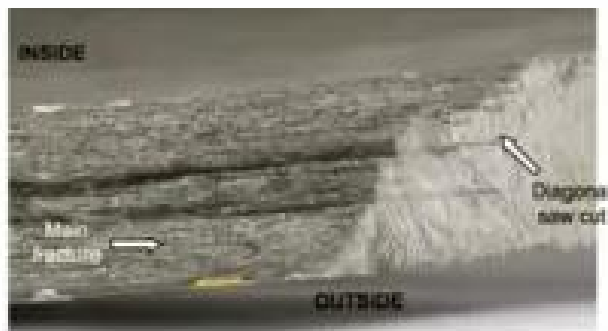
- *Aluminum LME heat exchanger in LNG plant*
