**Participants EFC WP15 meeting 11<sup>th</sup> September 2019 Seville (Spain)**

**EFC WP15 Activities**

## CUI, practical approach from a coating perspective

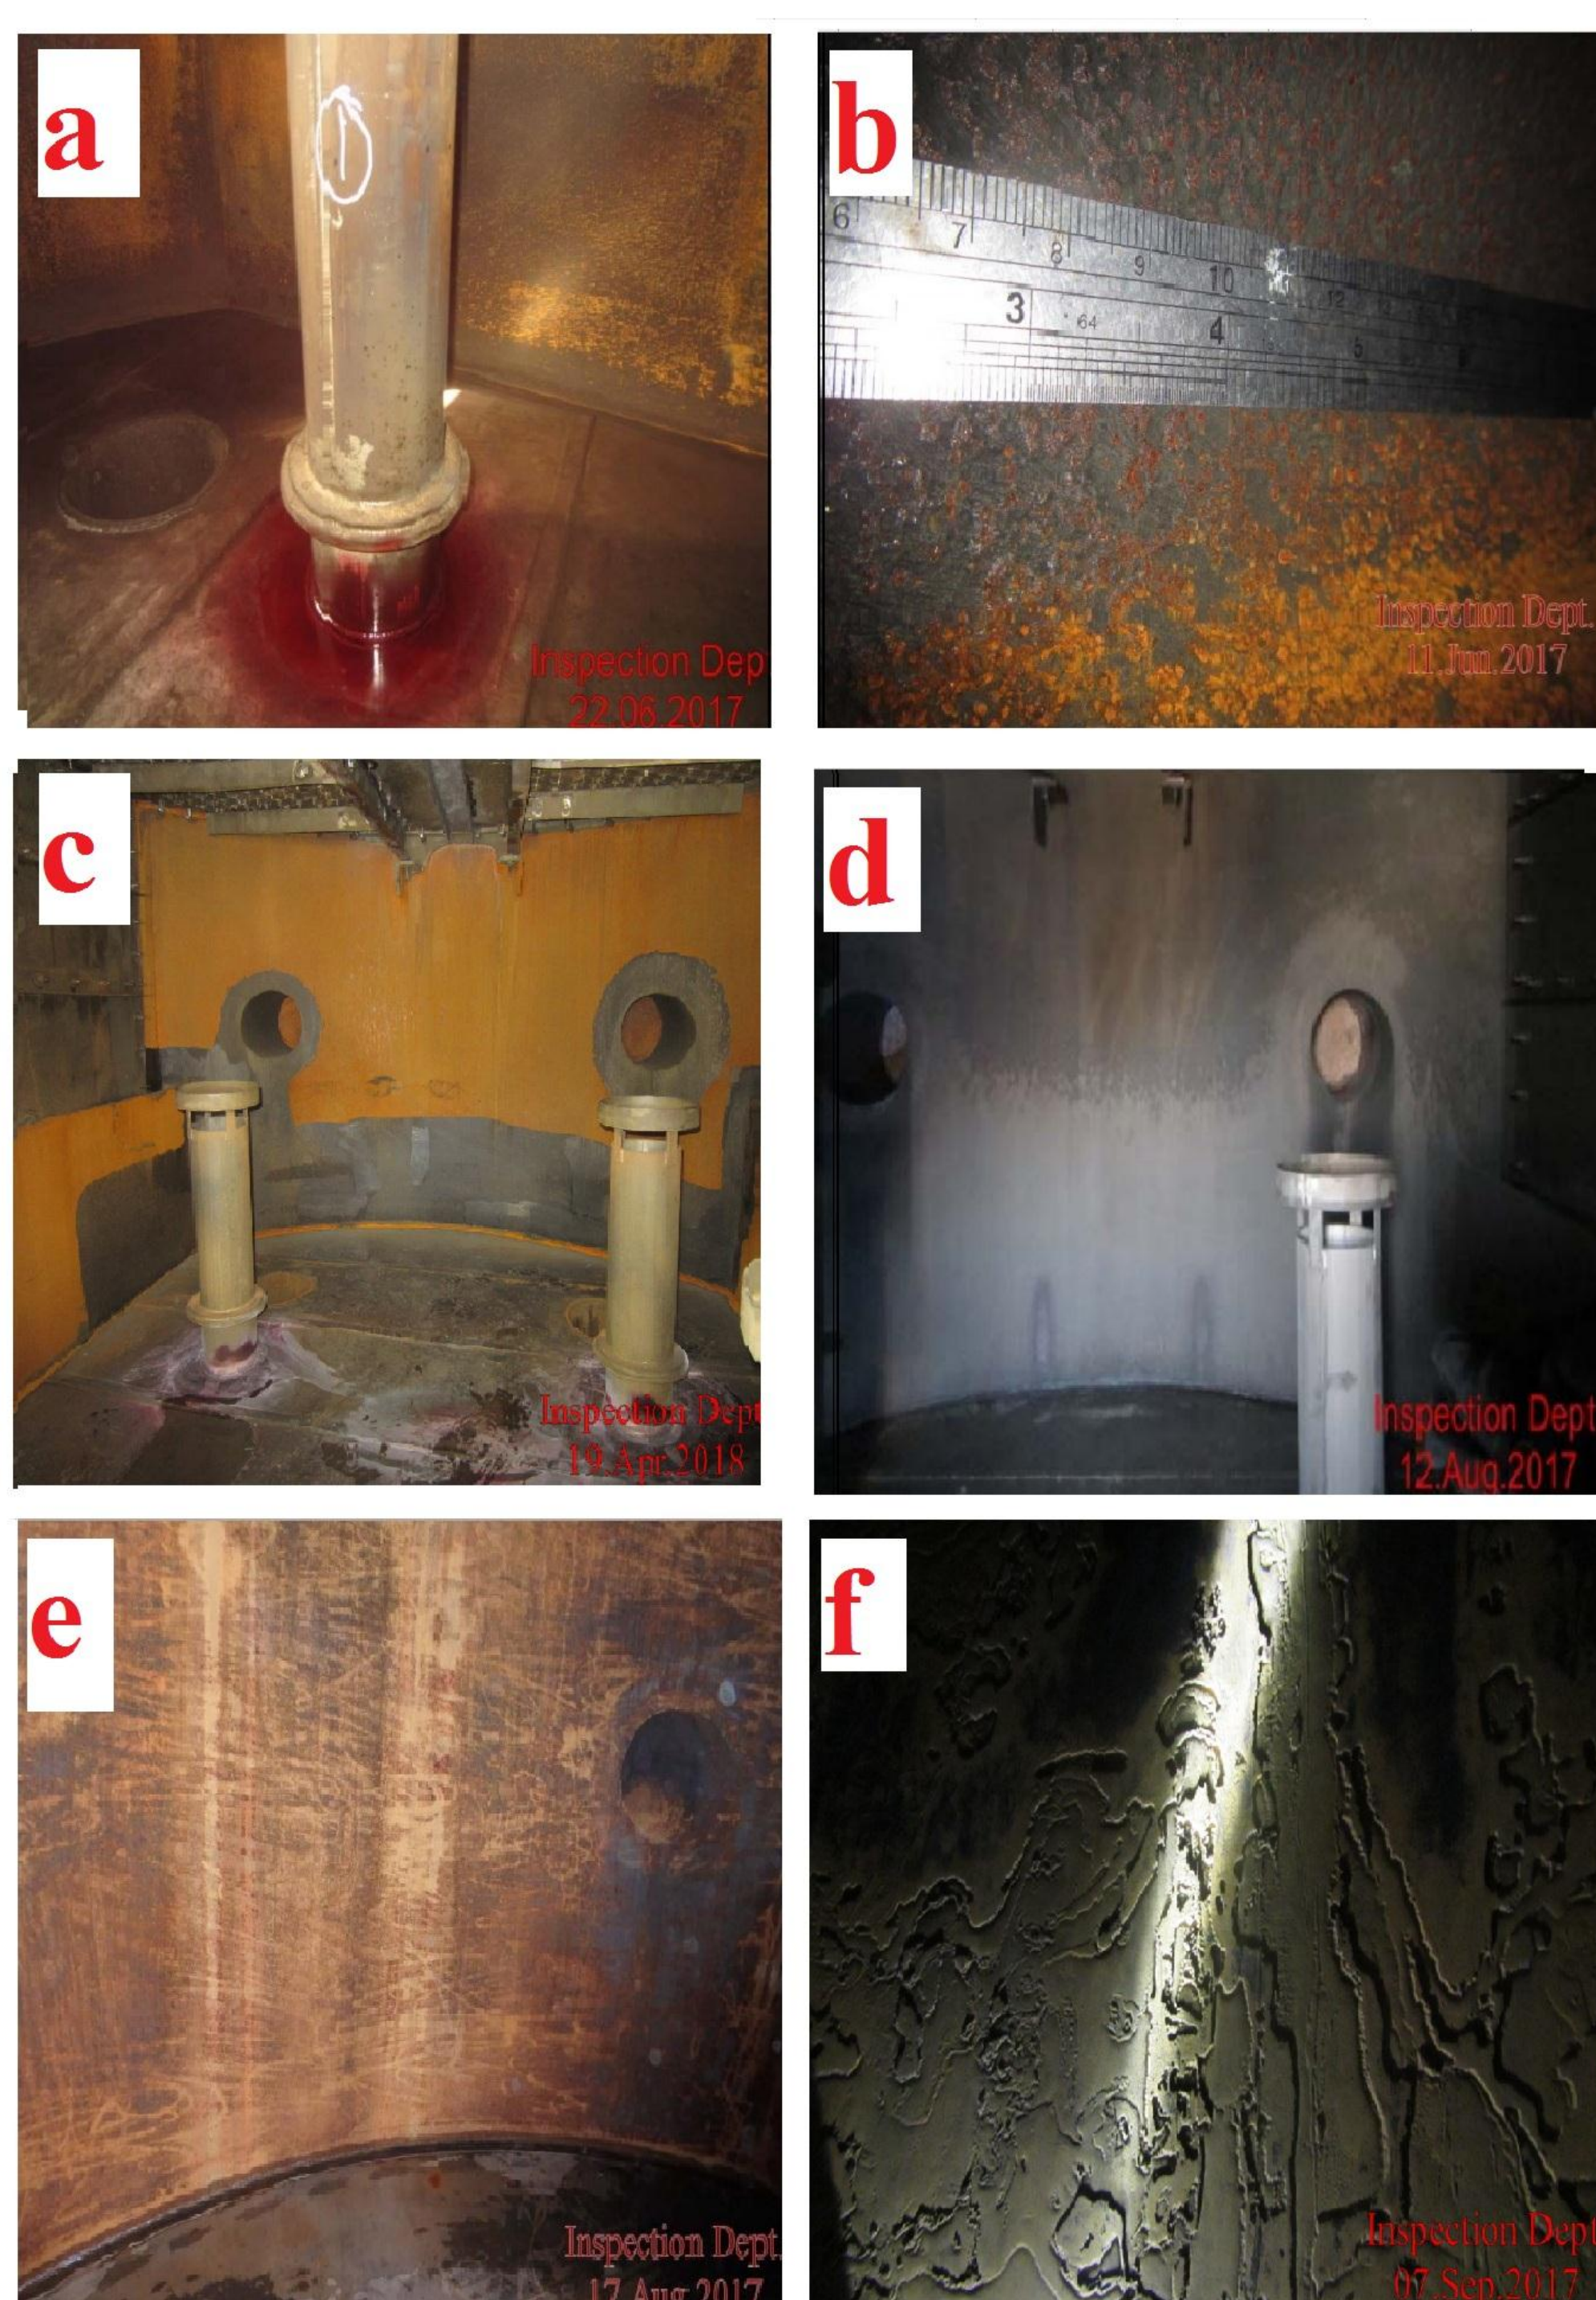
Figure 1: Comparison of corrosion extent in different amine treating units: a) Chimney tray area of GTU1, b) Chimney tray area of GTU 3, C) Chimney tray area of GTU4, d) Chimney tray area of GTU 5, e) Chimney tray area of GTU 6, f) Chimney tray area of SRU

A closed visual inspection was conducted in the first overhaul of the AGE (Acid gas Enrichment) unit in sulfur recovery plant. Severe corrosion with more than 3 mm of metal loss was observed on the bottom portion of the regenerator column (from the bottom dish end up to the chimney trays) and also on the side locations of the regenerator reboiler and some parts of weir plate. Further internal inspections were conducted in six other trains in gas sweetening units in order to compare the conditions from corrosion points of view. The corrosion was observed in only one of these trains. Samples were taken from suspected amine solutions in order to do more laboratory analysis. Comparative lab results in different amine units have been illustrated in figure 3.

- Comparing the corrosion extent in different amine treating units revealed that however amine solution in all of the trains were degraded but the corrosion was observed in trains with poor operating conditions (i.e. low temperature of rich amine feeding into the regenerator column).

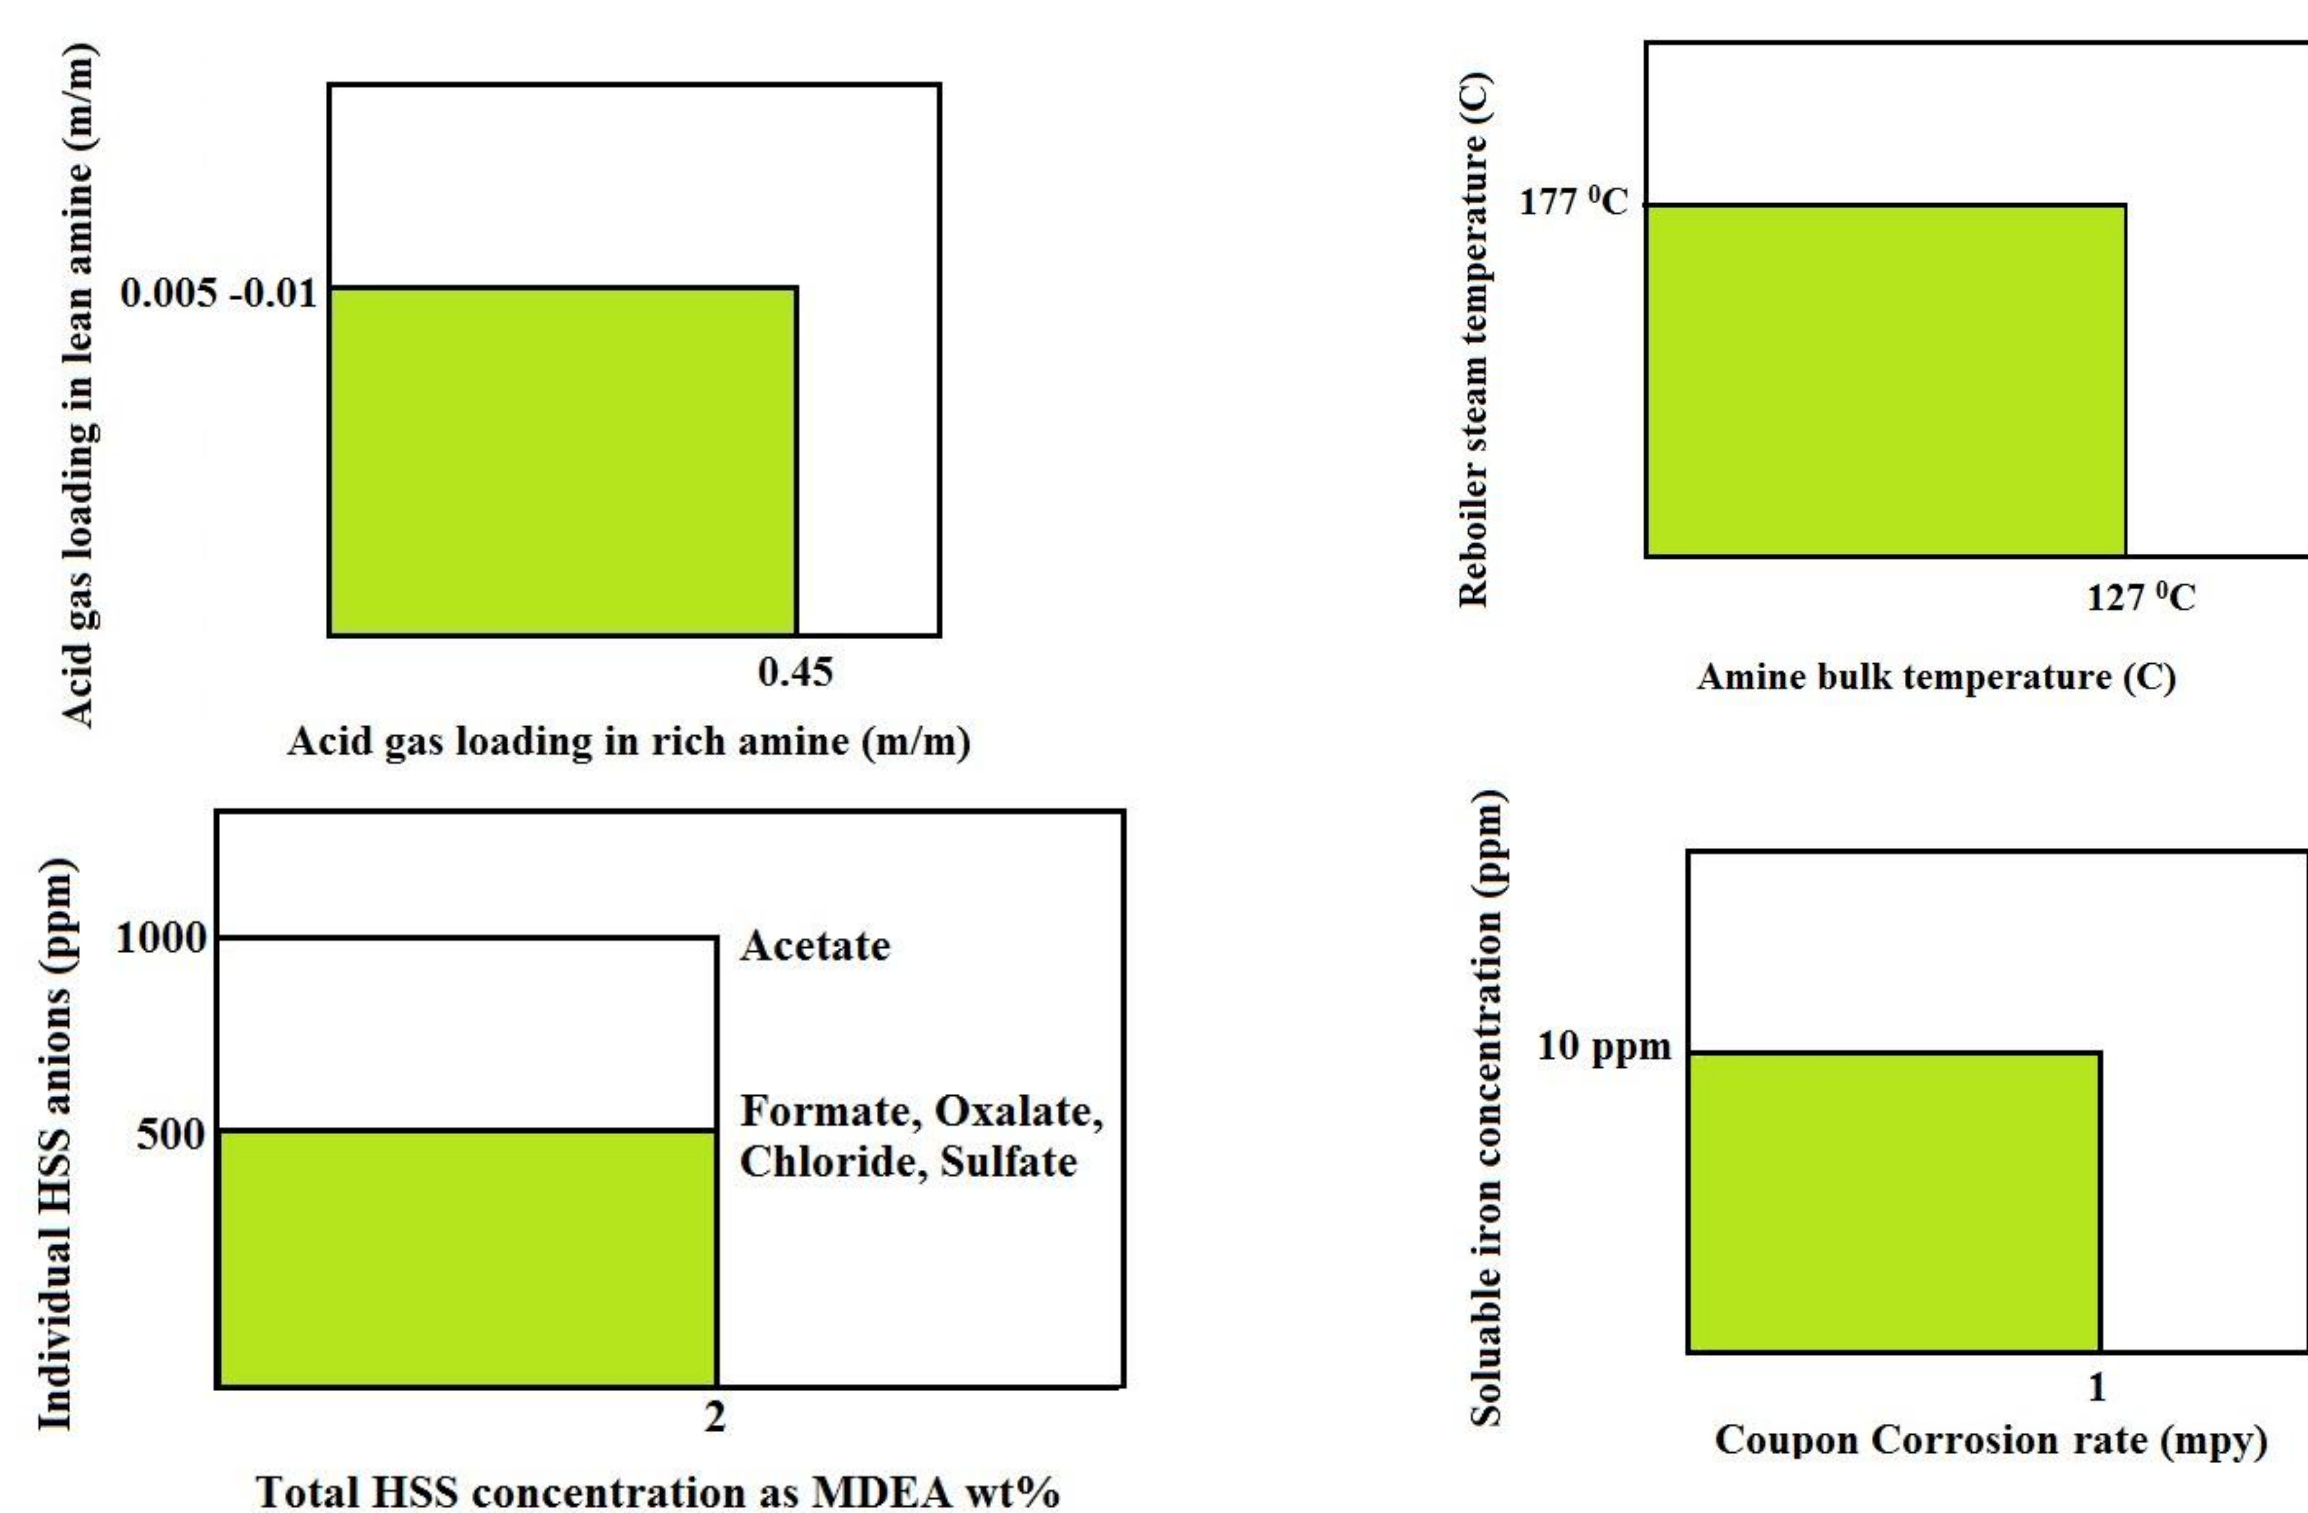
Figure 2: Some important IOW in amine units

- **Without having an appropriate IOW**, the RBI program would not have its required efficiency in maintaining the integrity of equipments and it is not enough to plan the future inspections only on prior records and prior history of the equipments and understanding of the process conditions

- Our experience showed us, a continuous monitoring of process conditions is required to prevent premature failures. Inspection intervals needs to be modified based on the changes in the operational conditions and this is **an IOW program** which is able to help the inspector in this regard.

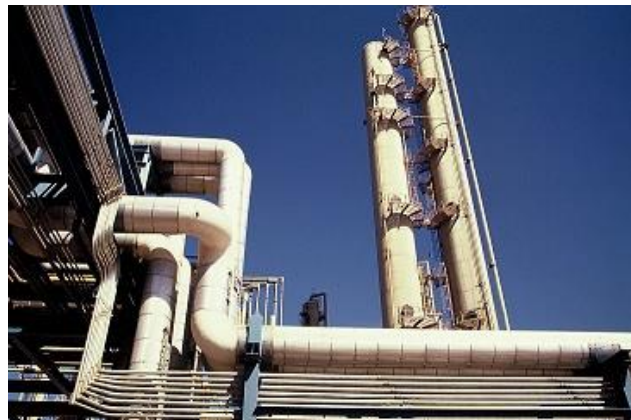
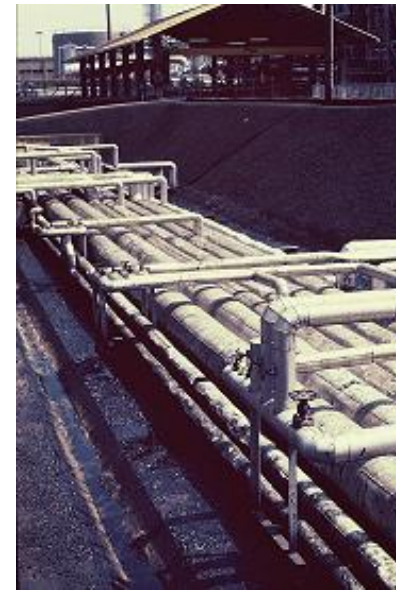
**For Different Reasons the Vapor Barrier and Waterproofing Covers Fail.**

**Once the Thermal Insulation System Becomes Permeable to the Humidity of the Environment, the Metallic Surface begins a Wet Corrosion Process, which will basically depend on the Operation-temperatures Cycles and the Pollution Levels of the Environment.**

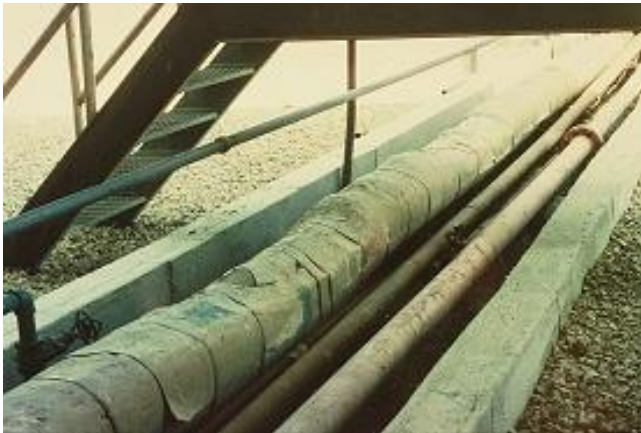
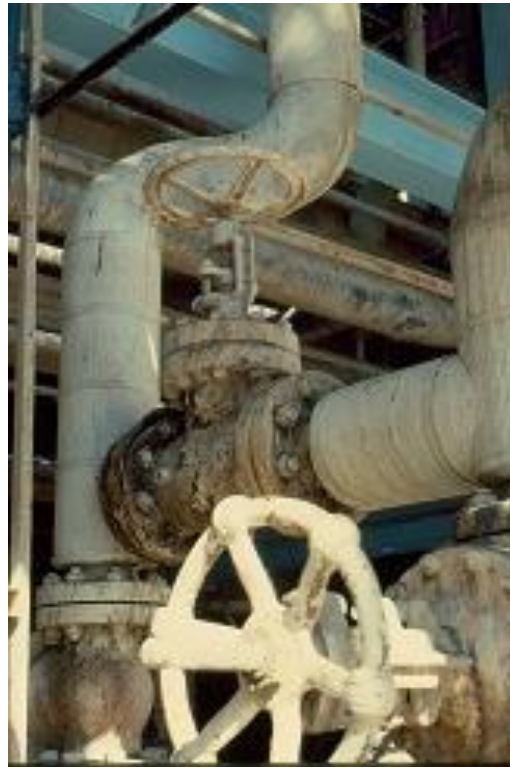
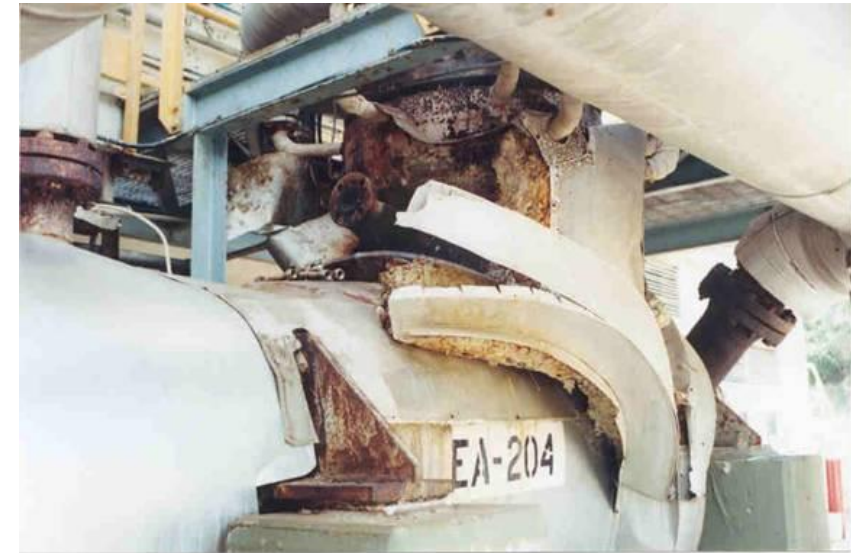
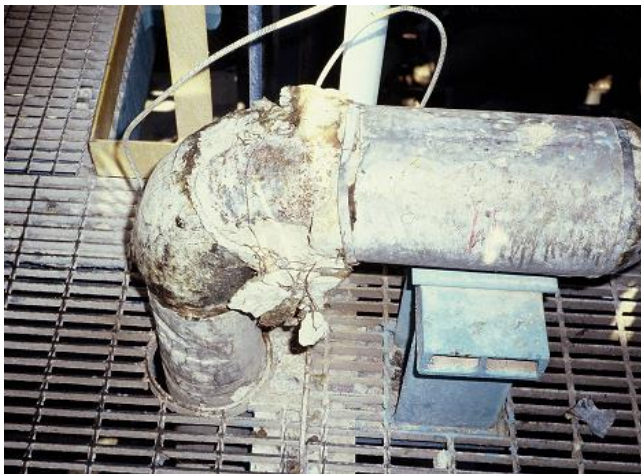
## Typical misuse of thermally insulated equipment and pipes

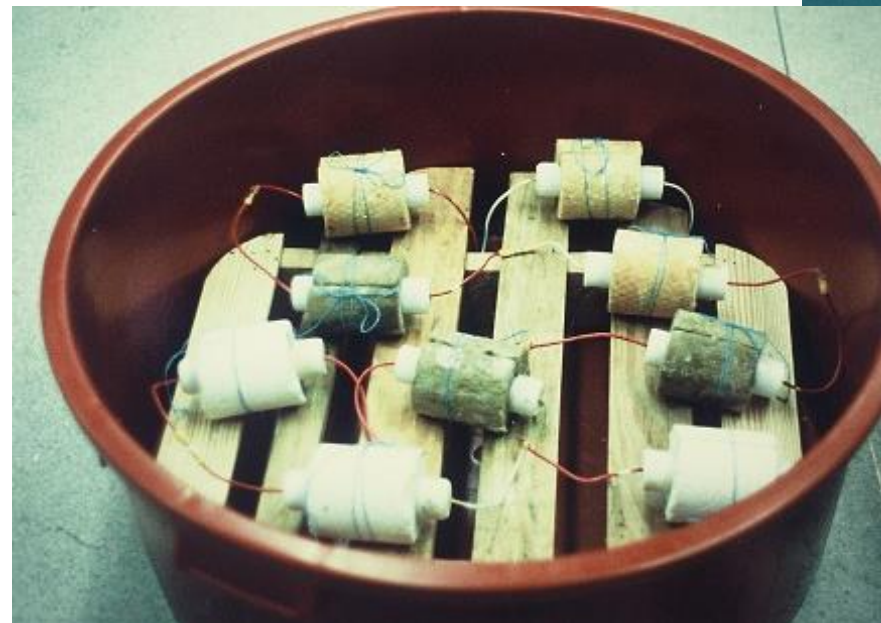
*To evaluate the various options of protective coatings, to be used under thermal insulation, the ASTM standards were searched and since a specific design was not found, a test tube was designed to achieve an evaluation with accelerated results*

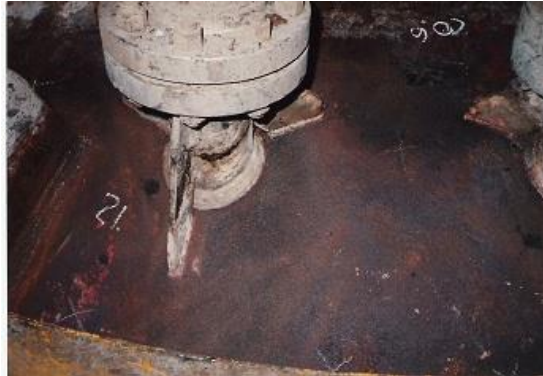
*Almost immediately the results were used in the painting of the heating jacket of a polymerization reactor (Polystyrene), making use of the combination: Inorganic Zinc and Fiberglass, with apparent good results after inspection done two years later.*

*It was necessary to implement protections against misuse by operators, who had to walk on the insulation to act some valves*

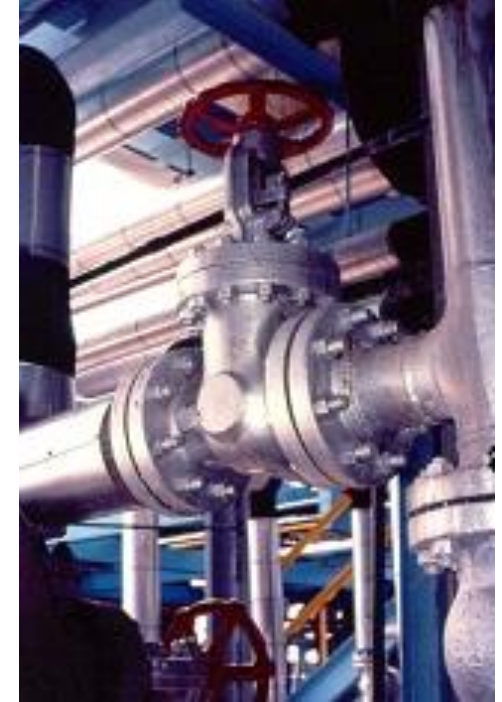
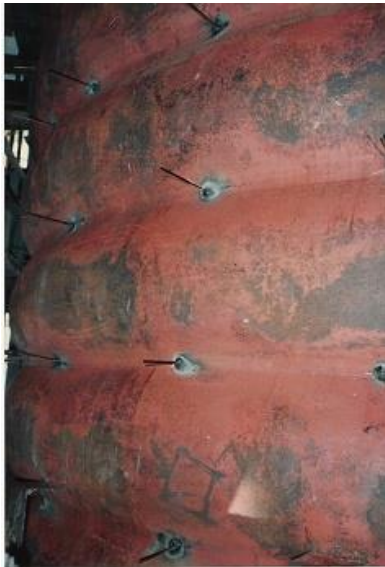
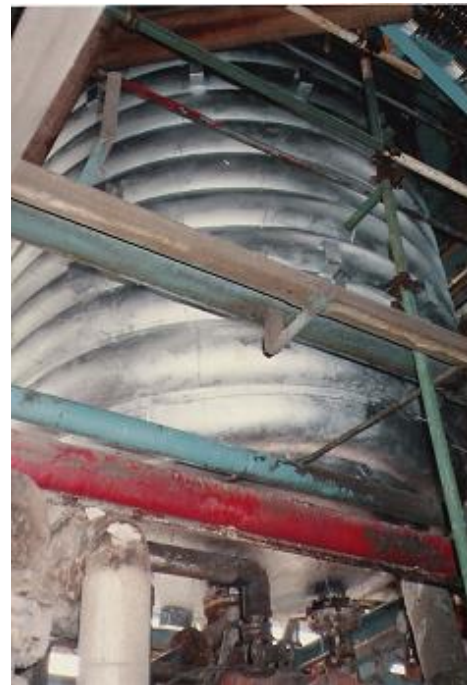
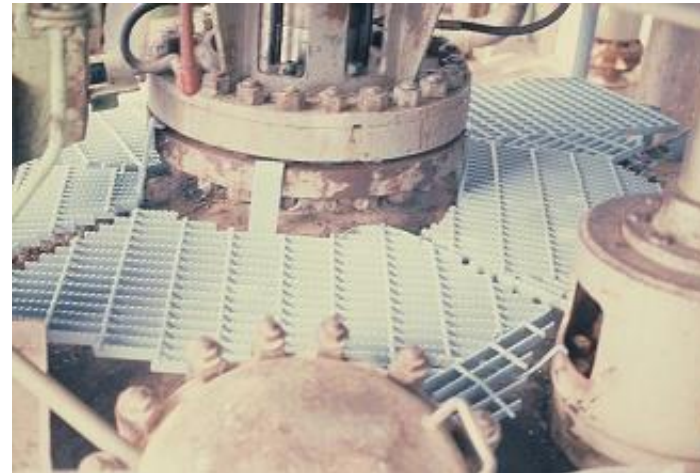
*The rehabilitation process continued with the insulated pipes, located in areas - very high humidity microenvironments*

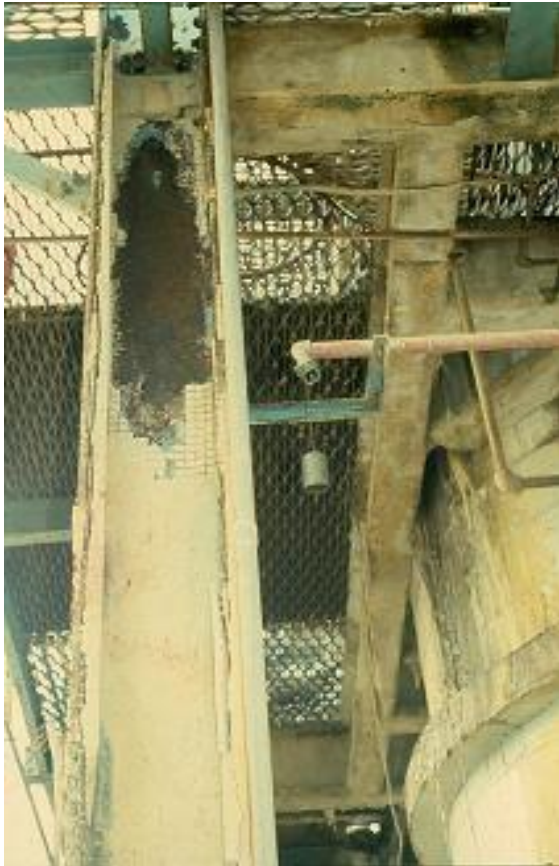
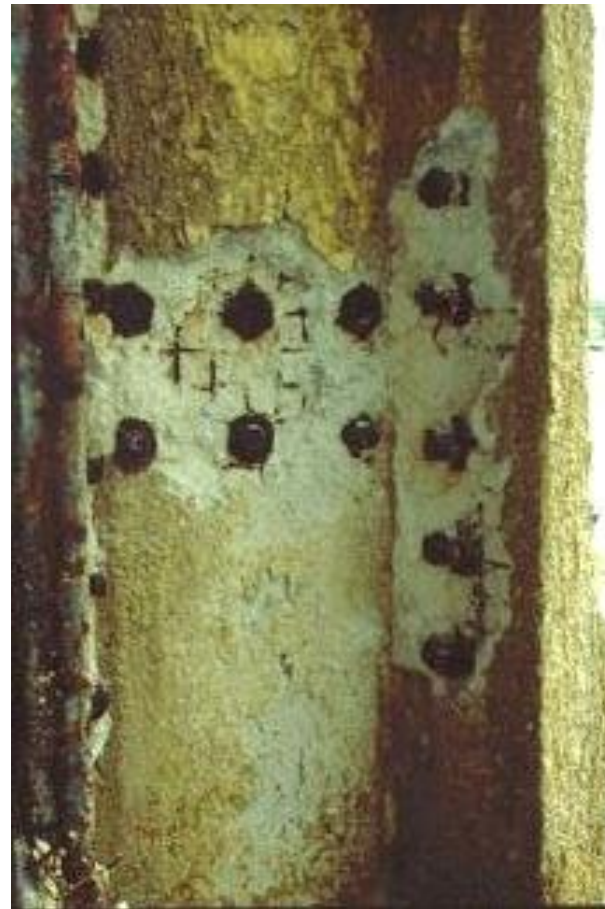
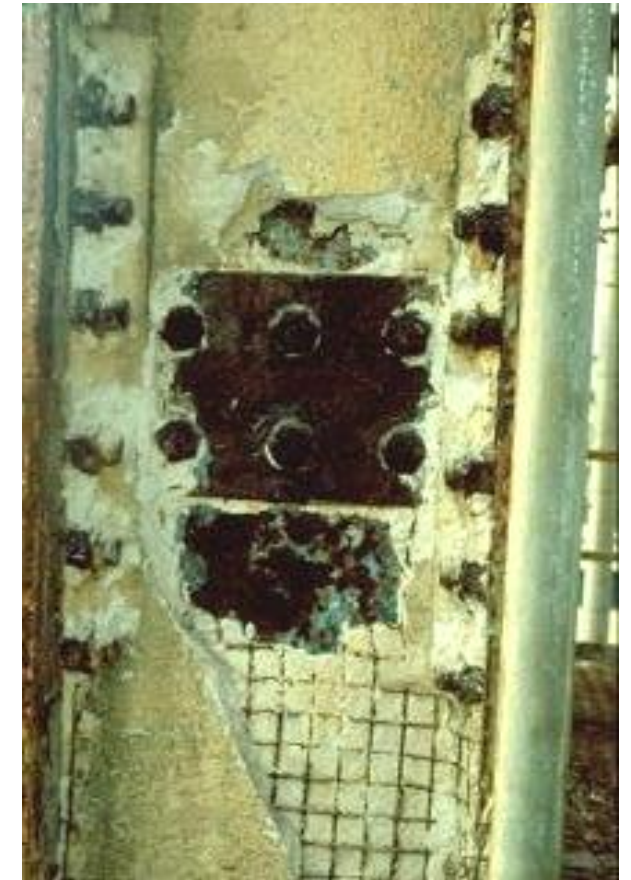
*The next protection system to be implemented was the one used in the structures covered with fire protection system*

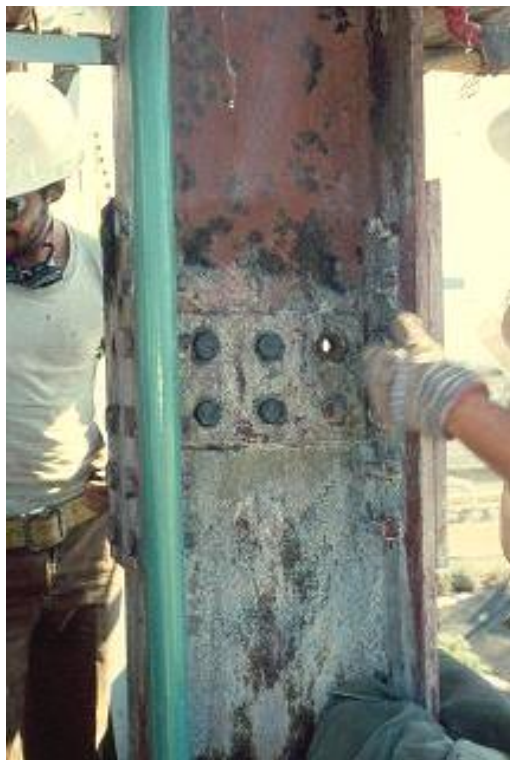
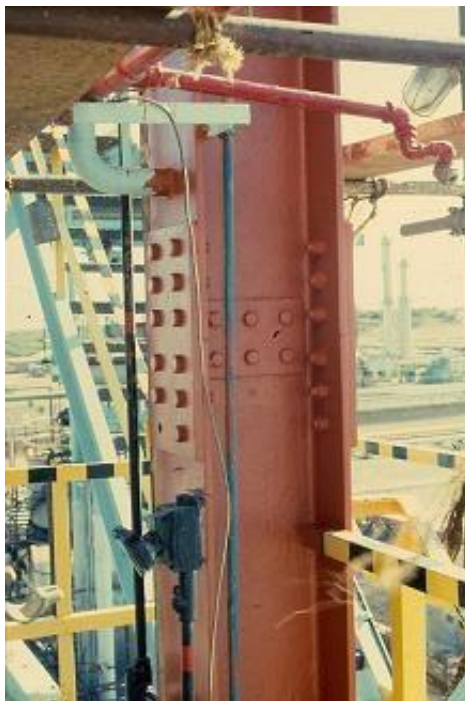
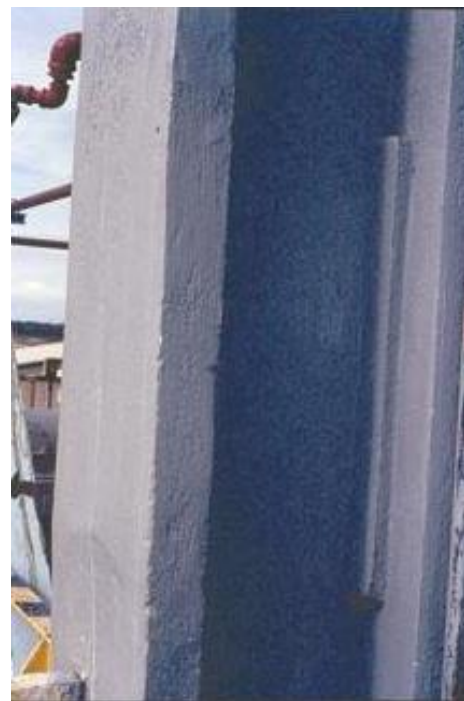
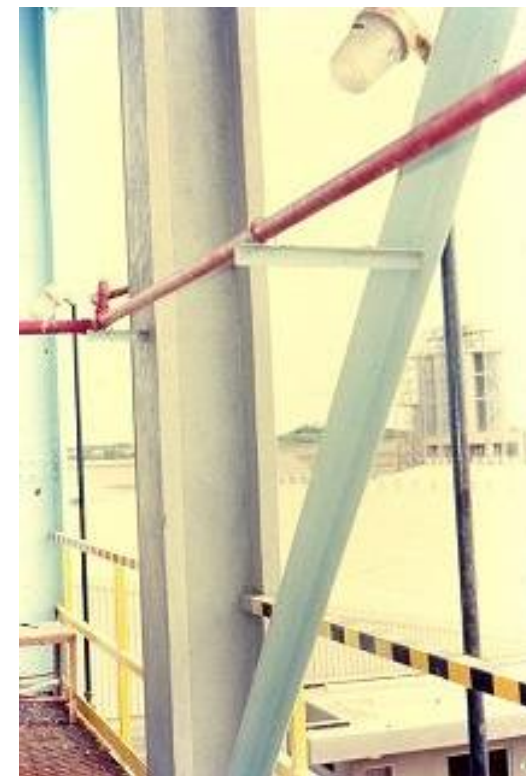
*Using Chlorinated Rubber paint for direct protection of steel structures and sealing of fire protection cement*

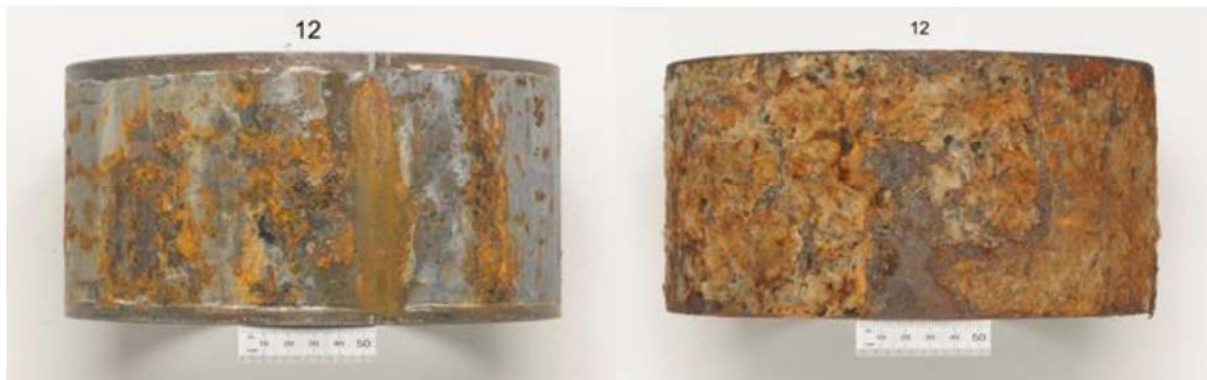
Uncoated pipe, 30 days,  $\sim 80^{\circ}\text{C}$ , 0.1wt% NaCl

Glass Foam

Mineral Fibre

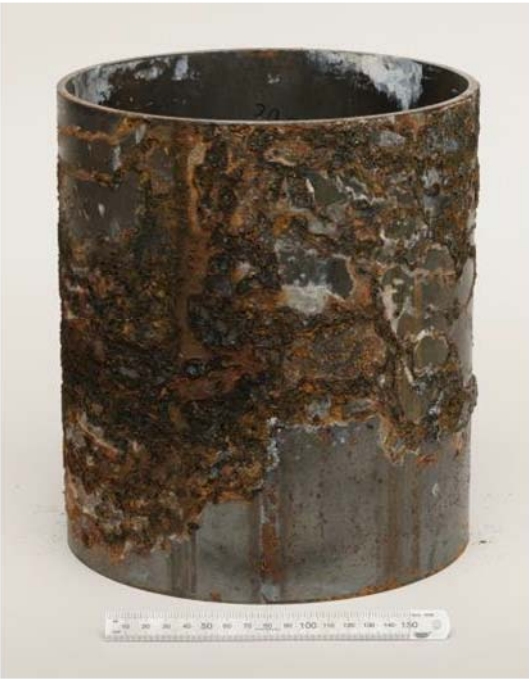
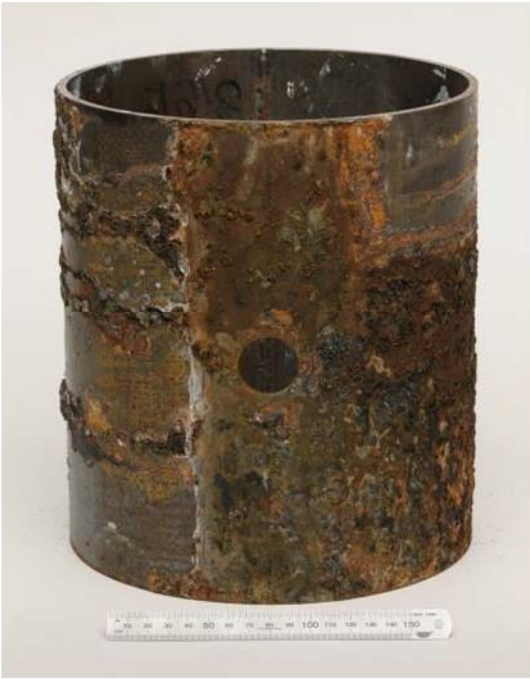
# Uncoated pipe, Mineral Fibre, 60 days, 80°C

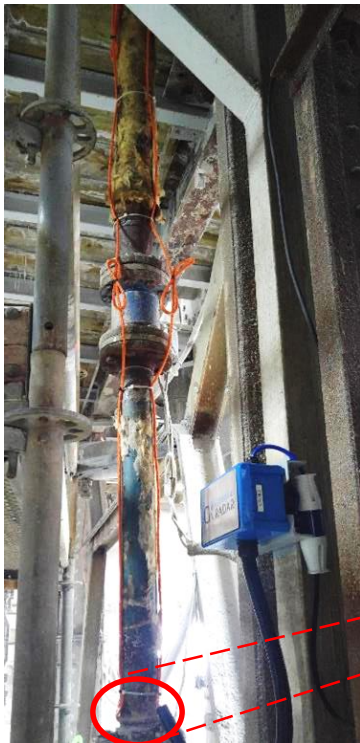
CRL002 – Vertical Pipeline

In a six month trial in a chemical plant in EU, CR system has successfully detected, located and continuously monitored a corrosion activity on a pipe, manholes and a vessel

Example of identified location by CR system where visual inspection confirmed the presence of corrosion on the asset and the CR Sensor. Having the ability to continuously monitor corrosion activity and having access to the data remotely can enhance and reduce maintenance budgets by conducting targeted inspections.

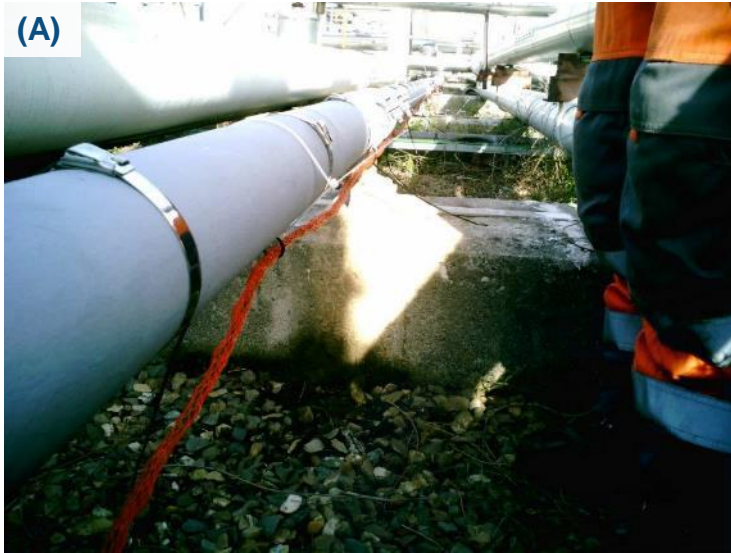
**Figure (A)**

Installation of CR corrosion sensors on a 3 inch pipe using cable ties

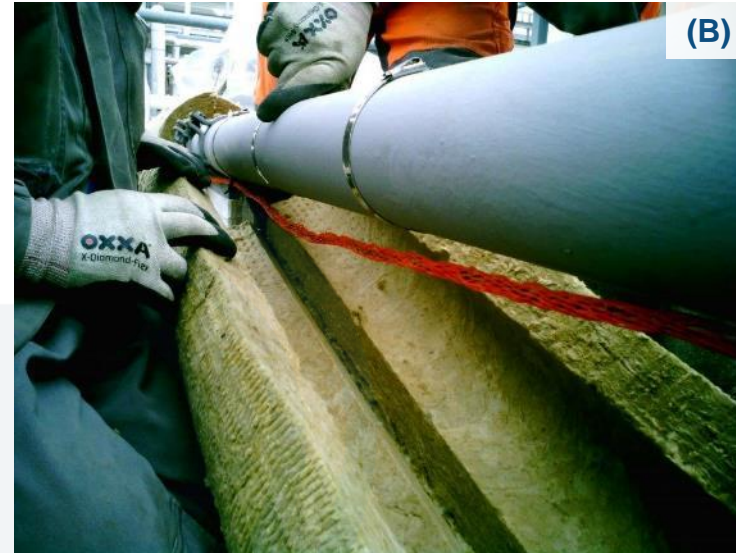
**Figure (B)**

Installation of the pre-fabricated insulation around the pipe and the corrosion sensor

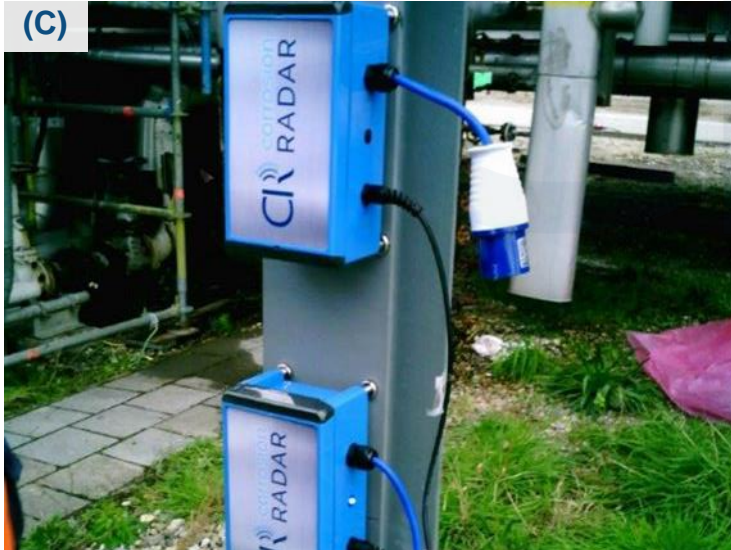
**Figure (C)**

Installed CR Nodes (electronic) driving CR Moisture and Corrosion sensors

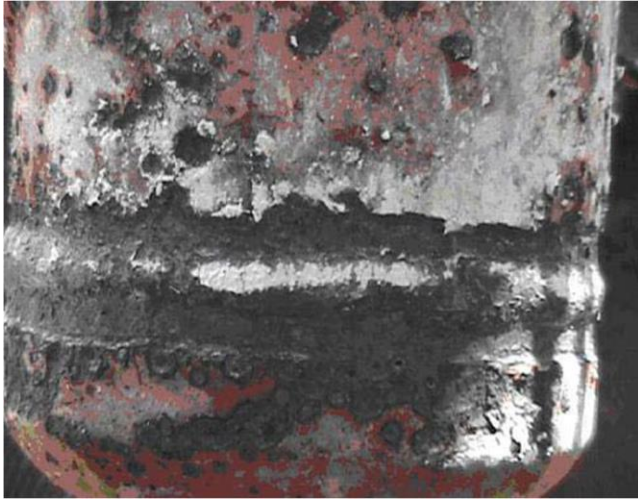
EXTERNAL PIPE SURFACE

- ✓ Oxidation

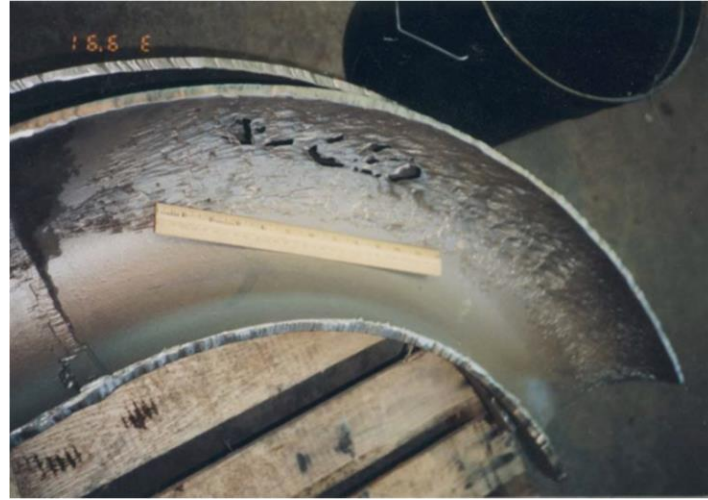
INTERNAL PIPE SURFACE

- ✓ Carburization: embrittlement, thermal insulation
- ✓ Mechanical cleaning / erosion
- ✓ HT Sulphidation (Sulphur compounds, NAC)

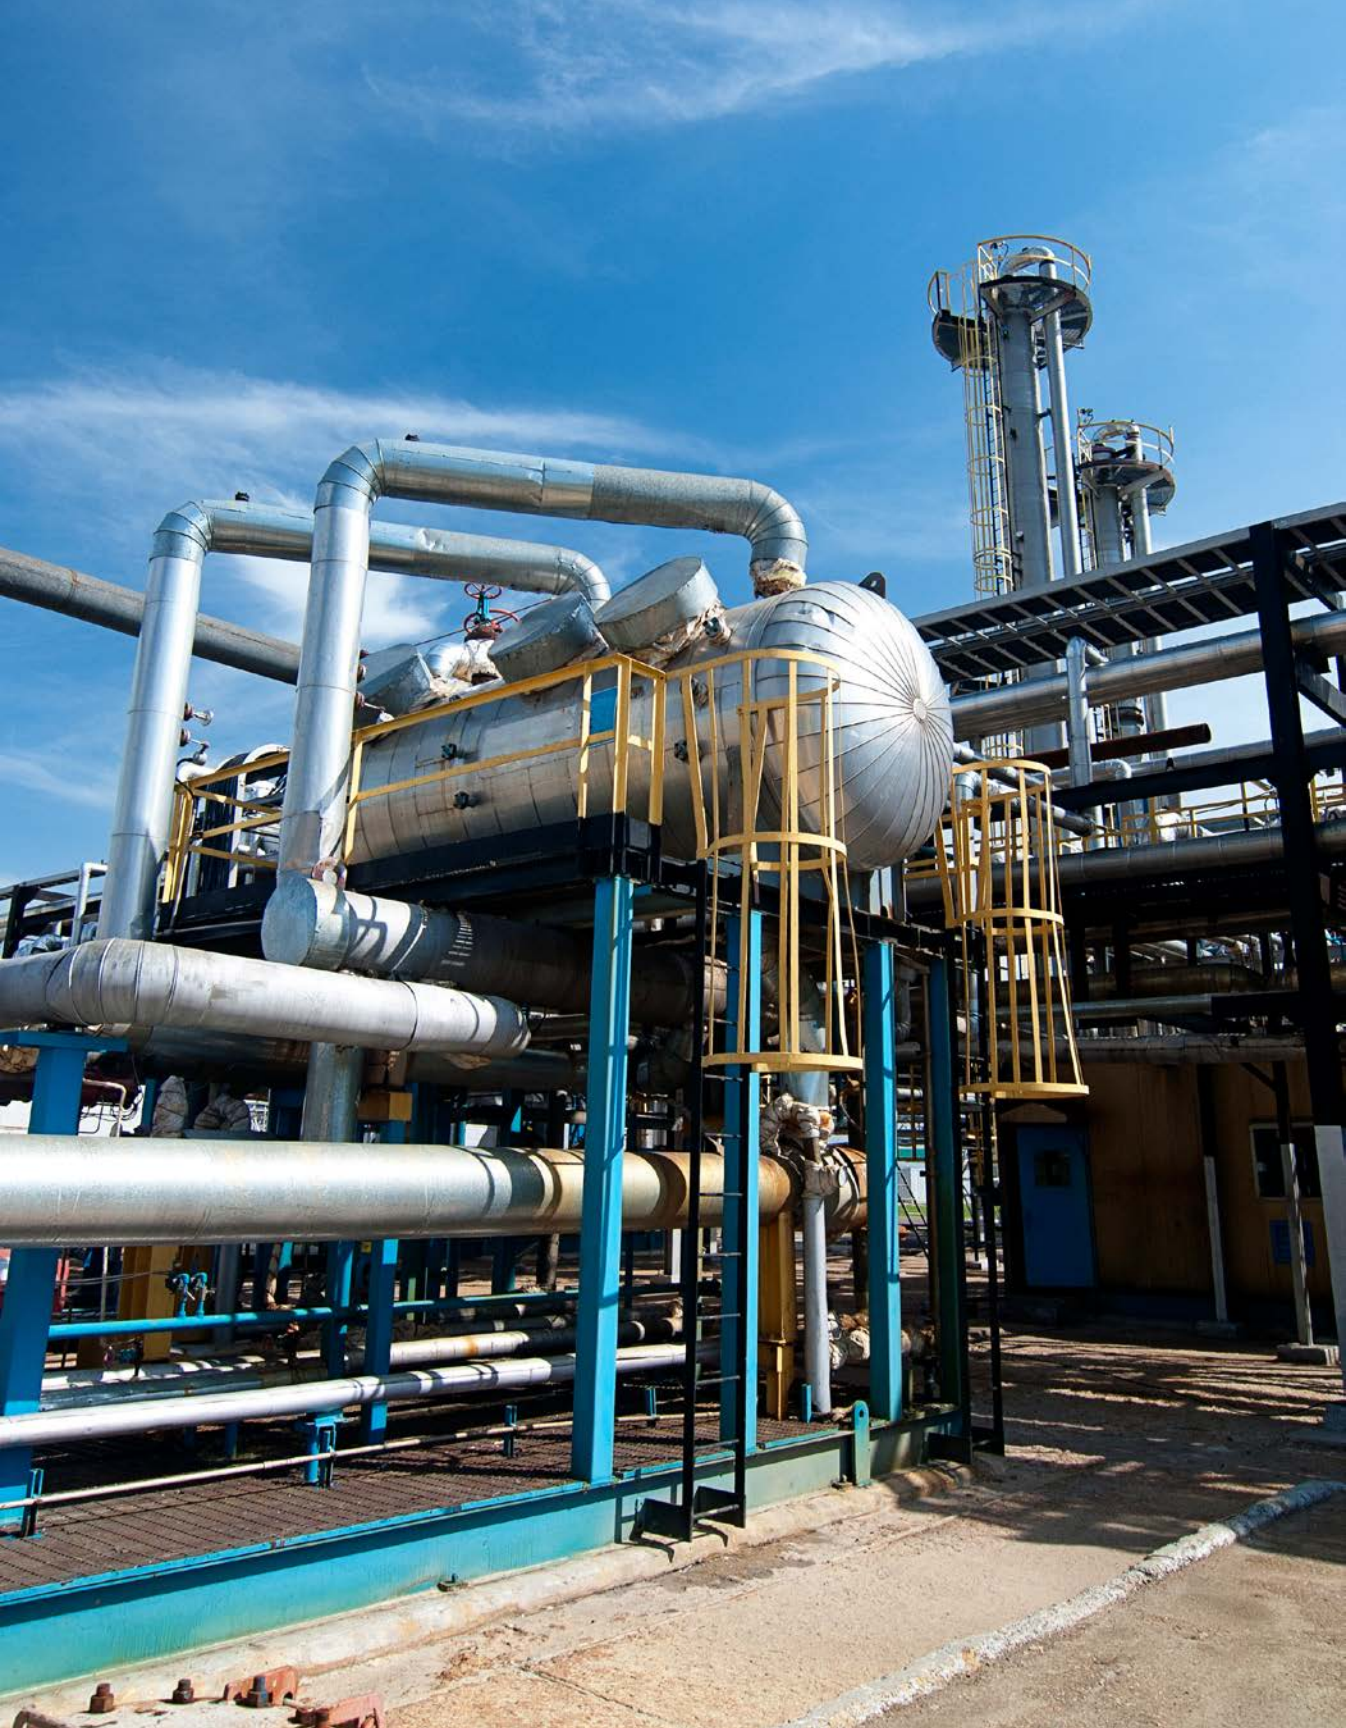
Figure above shows the predicted variation of corrosion rates for carbon steel with amine acid gas loading and velocity. This shows that, as would be expected, high rich amine H<sub>2</sub>S loading combined with high velocity results in higher corrosion rates.

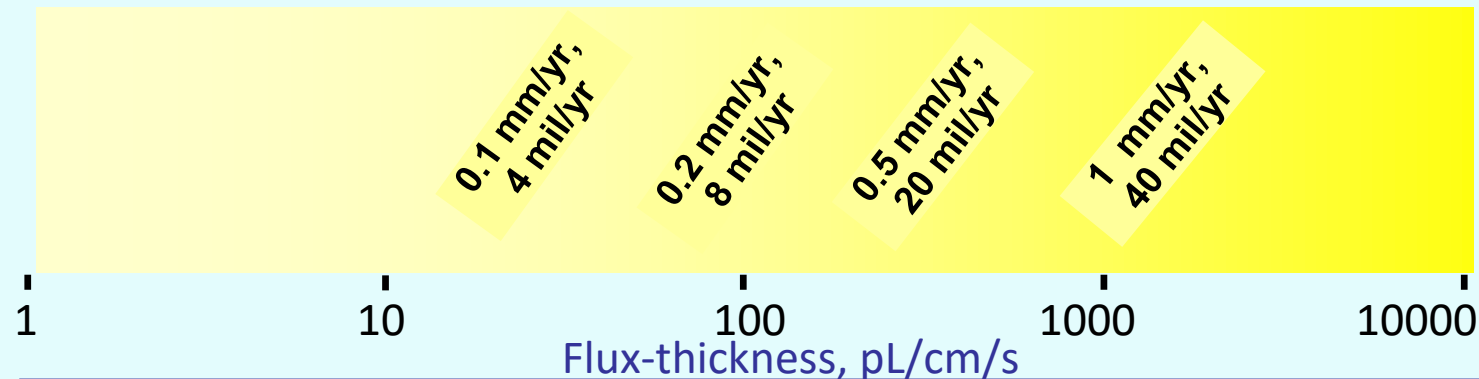
Instructions: Multiply flux in pL/cm<sup>2</sup>/s by test site thickness in cm, to obtain a flux-thickness in pL/cm/s. Look along bottom of chart for corrosion rate. Note corrosion flux correlation varies in a complex way with other corrosion variables, not least temperature. This makes the correlation very approximate.

5 pL/cm<sup>2</sup>/s indicates very low but definite HF corrosion. 300-500 pL/cm<sup>2</sup>/s is common,. HF is used to catalyse the formation of high octane gasoline – alkylate – from smaller olefins in HF alkylation units. The alternative catalyst – sulfuric acid – also causes corrosion but provides a much weaker flux signal. HF corrosion is very widespread and continuous. There is probably some temperature dependency for corrosion-flux correlation not shown on the chart.
