**Participants EFC WP15 meeting 11<sup>th</sup> September 2019 Seville (Spain)**

**EFC WP15 Activities**

## CUI, practical approach from a coating perspective

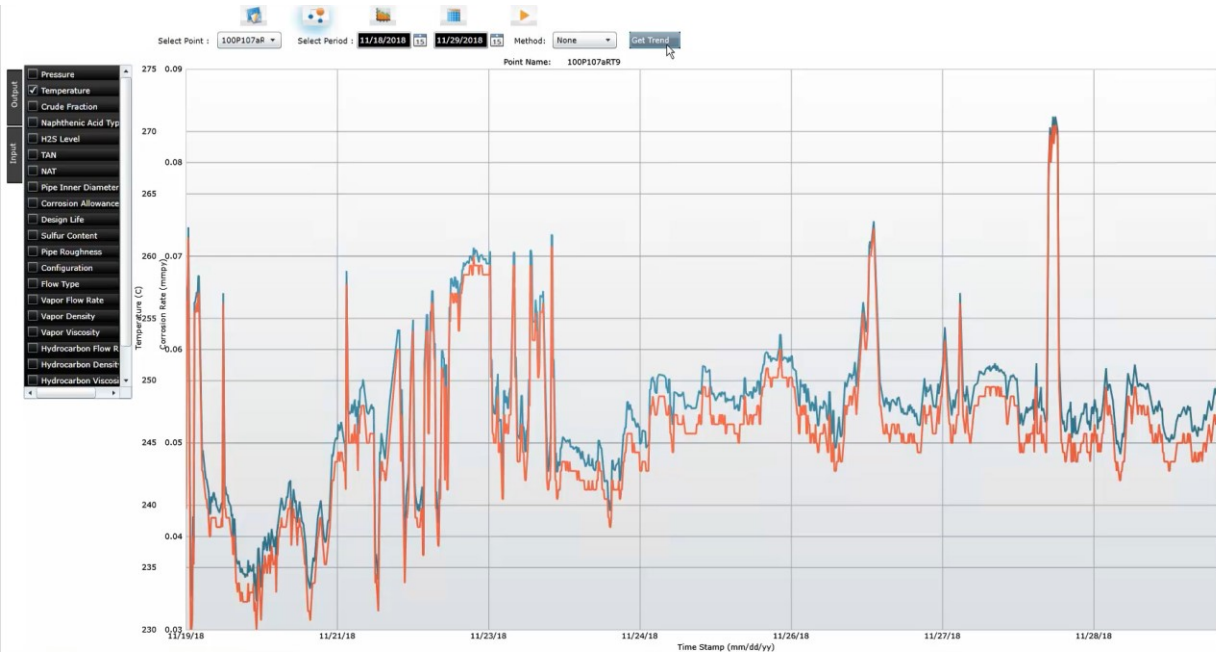
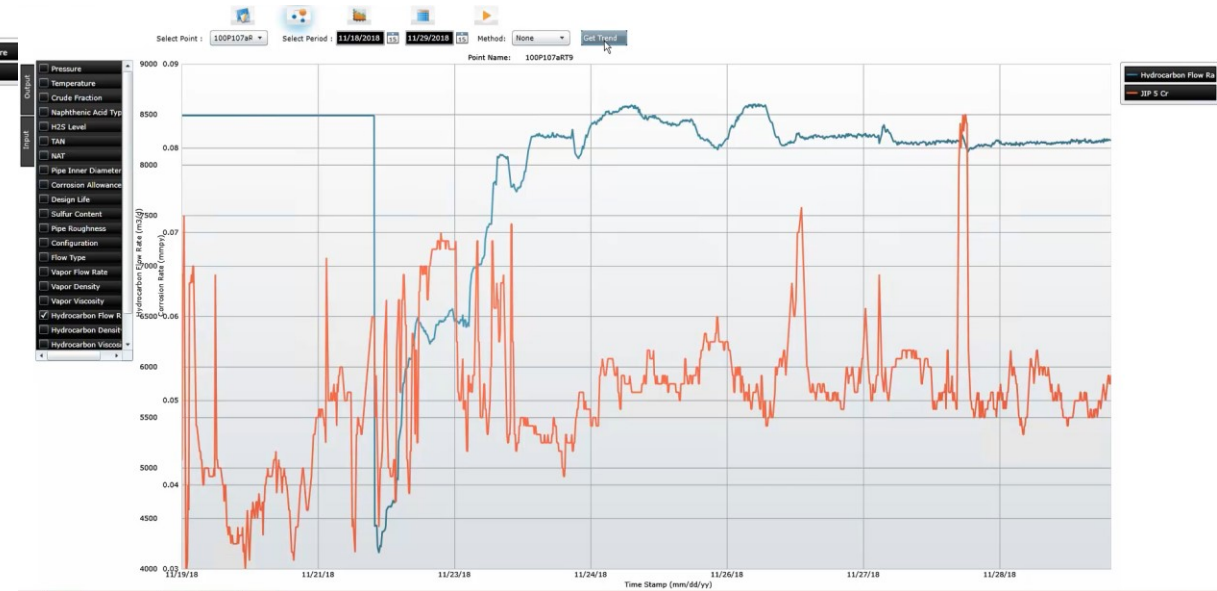
# LIVE TRENDING

- “Live” & historical trending from Real Time Framework level
- 10min update rate
- Process vs Corrosion Rate (predicted and measured – if any available)
