Participants EFC WP15 meeting 11th September 2018 Krakow (Poland)

EF WP15 Spring meeting 11 September 2018 Krakow - Poland

New developments on a new methodology to characterize Stress Relaxation Cracking

MTI Project 291 : Stress Relaxation Mitigation Strategy

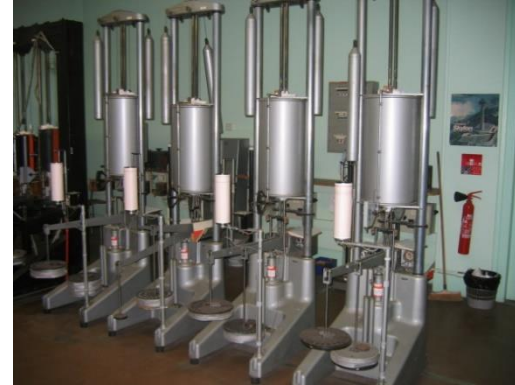
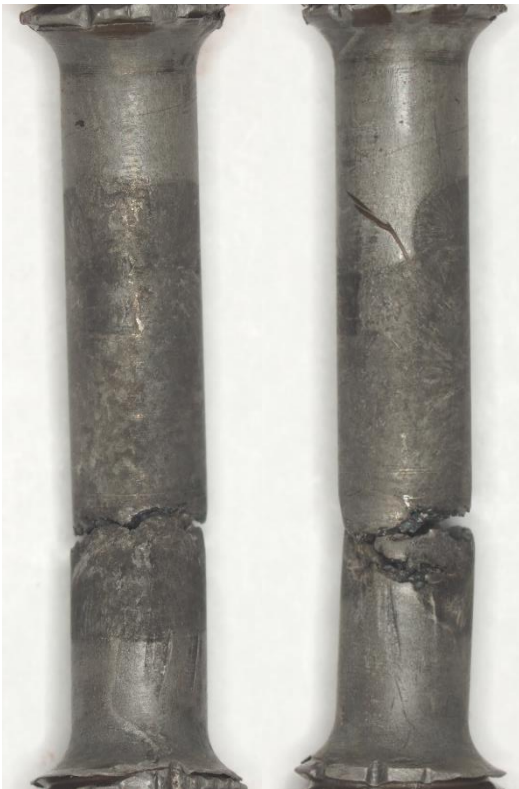
Loading in uniaxial direction

- The loading method could be one reason of difficulties to obtain SRC
- Dead weight is known to be more severe, but the load should not be too high to prevent creep failure

- ✓ Dead weight device : 180 MPa
- ✓ Specimen sampled from 15 mm thick weld plate
- ✓ Welding process : SAW and GMAW through all thickness
- ✓ Test duration of 720 hours
- Failure in deposited metal after around 300 hours
- Fracture surface is no SRC

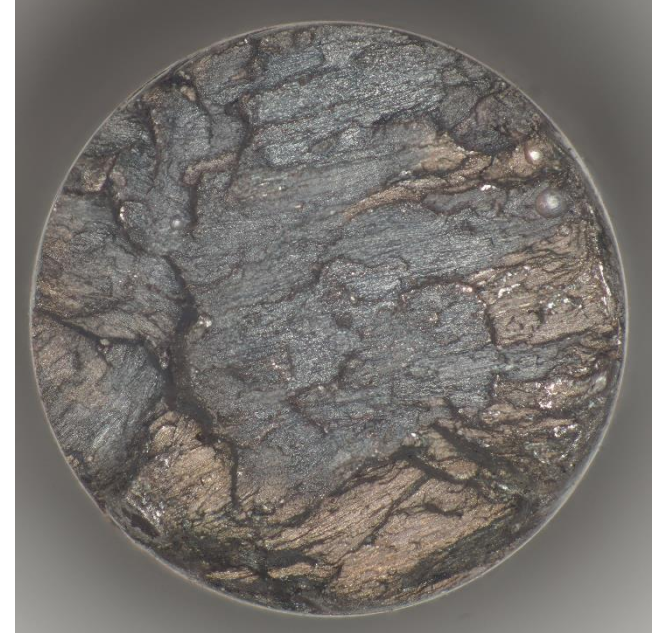
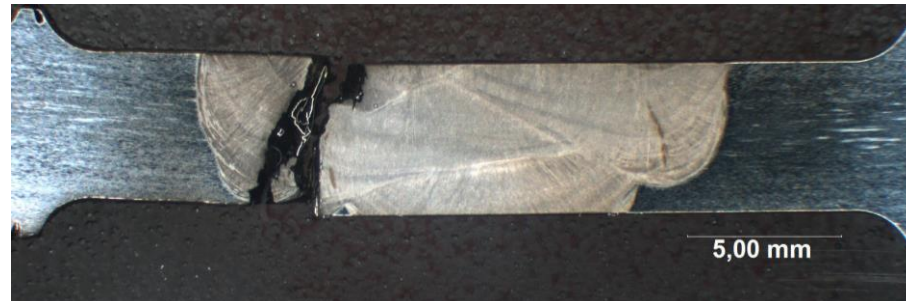
Loading in uniaxial direction

- The failure is in deposited metal, the failure mechanism is not SRC as expected

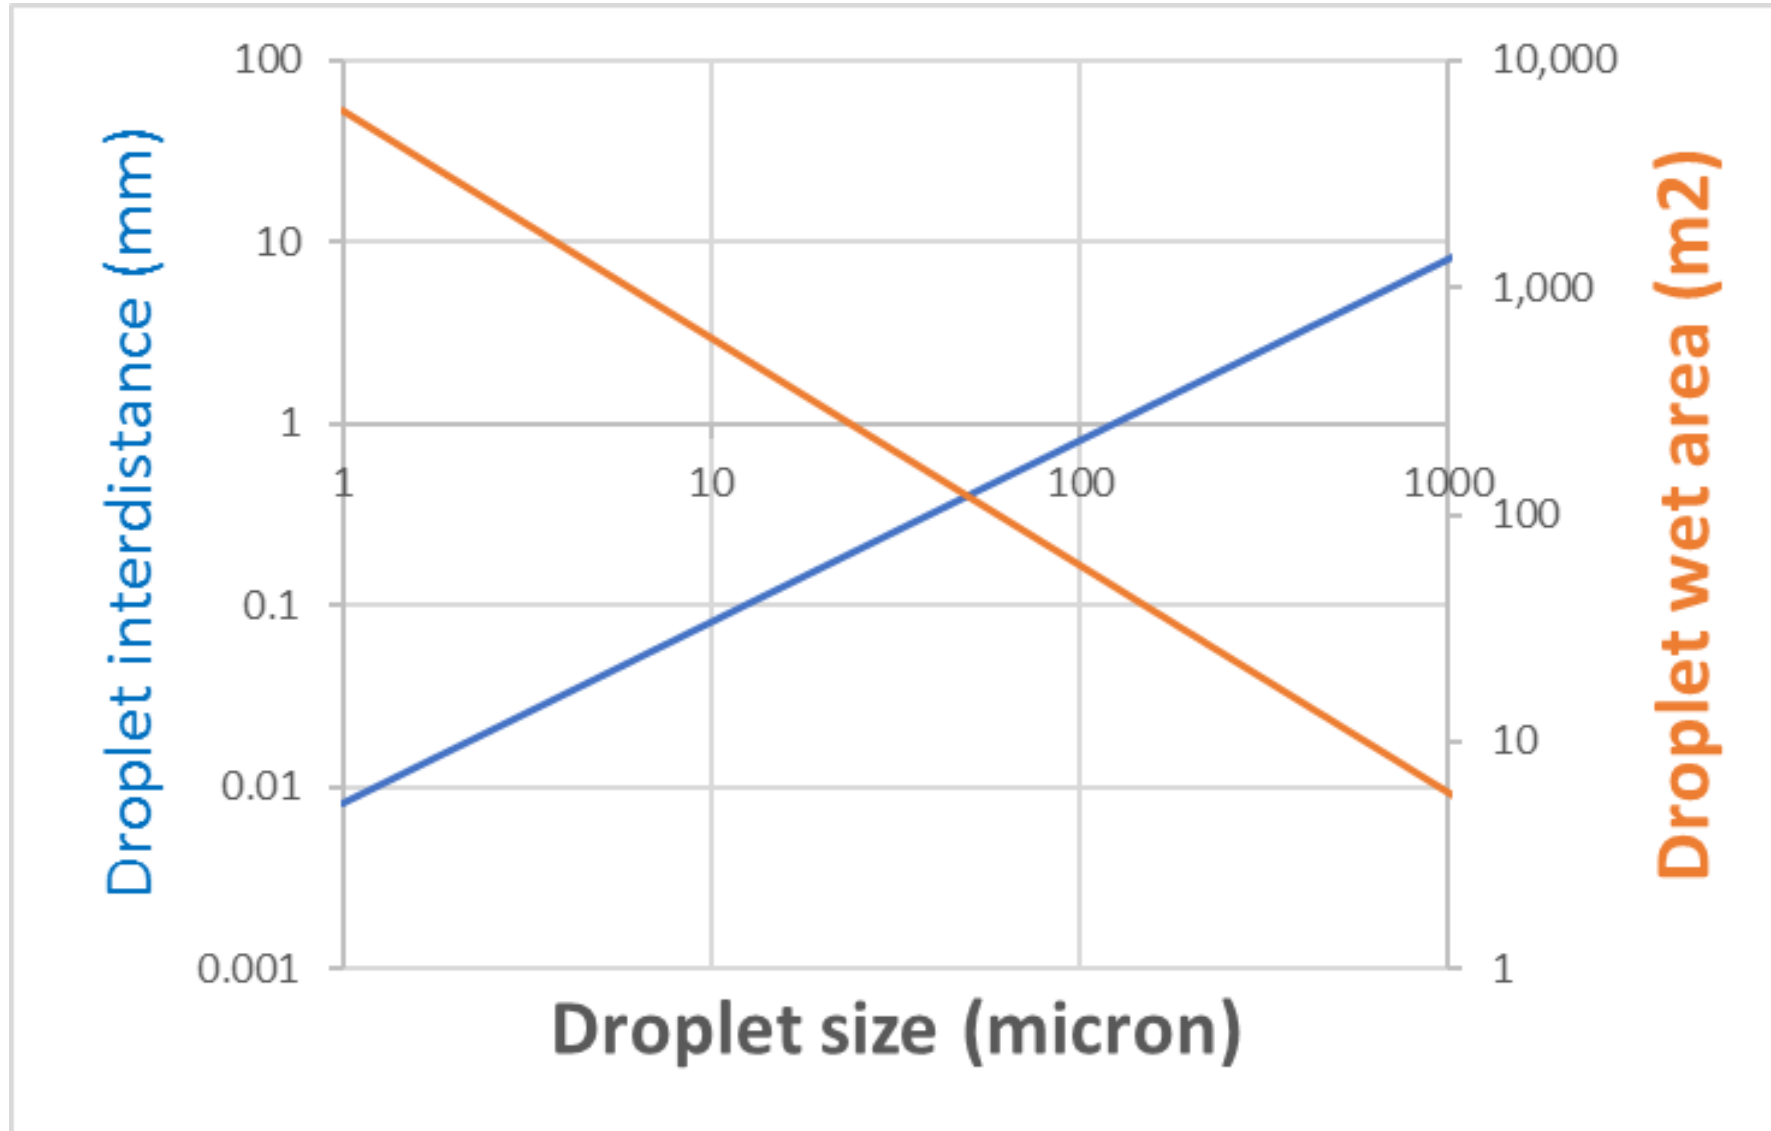
Spray characteristics at 1 l/m³

- 0.01 Mol HCl per m³ hydrocarbon vapor
- 1 liter injected water per m³ hydrocarbon vapor (15 w%)
- Uniform droplet size with Sauter diameters ranging from 1 μ to 1000 μ
- Residence time in overhead line is 1 second
- Diffusion coefficient HCl in HC-vapor: $4 \cdot 10^{-5}$ m²/s
- How fine a spray is needed ?
- What is the average distance between droplets ?
- What is the total wet area?
- What is the diffusion distance and what percentage of HCl will be absorbed?

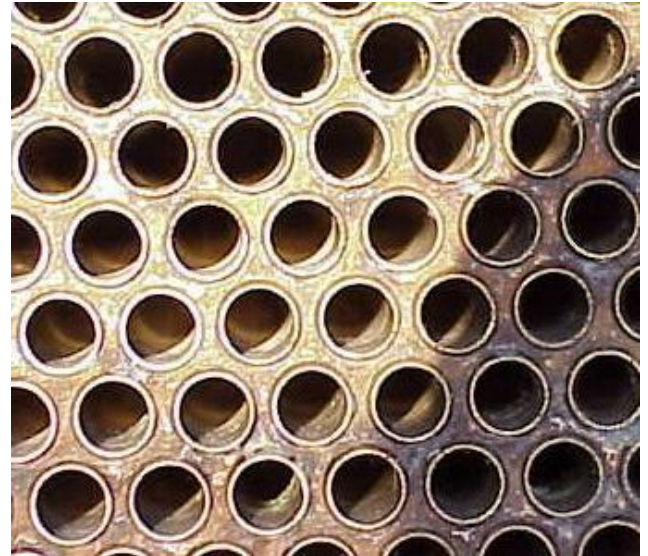
CUNI ALLOYS IN SEAWATER - ADVANTAGES

- Excellent corrosion resistance in seawater.
 - Forms a protective scale.
- Can withstand high seawater temperatures.
- Resistant to biofouling.
 - Chlorination usually still needed to protect other parts of the system from clogging.
- Excellent thermal conductivity.
- Good fatigue properties.
- Good ductility.
- Ease of fabrication.

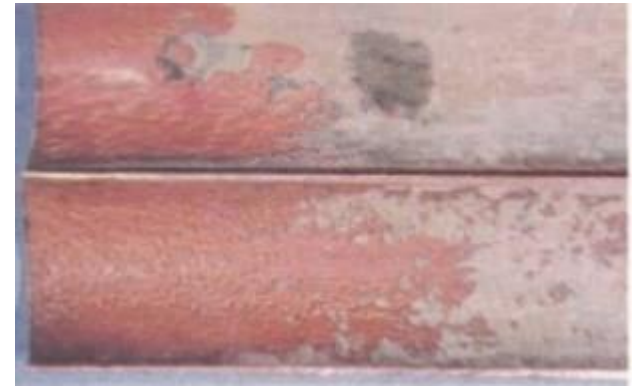
- Protective scale is soft and not strongly adherent to the metal surface.
 - Sensitive to erosion from solid particles.
- Shear stresses due to high flow rates can also cause erosion of the protective scale.
 - Limitations to flow rate depends on tube inner diameter.
 - Turbulence in tube inlet can be a problem area.
- The presence of sulphides gives a non-adherent, soft scale and rapid corrosion.
 - Sulphate reducing bacteria in stagnant or polluted seawater, such as ports.

Tube inlet erosion-corrosion
http://heatexchan.blogspot.com/2017/12/heat-exchangers-chemically-induced.html?_sm_au_=iPVQDQjWNrsPJJJs

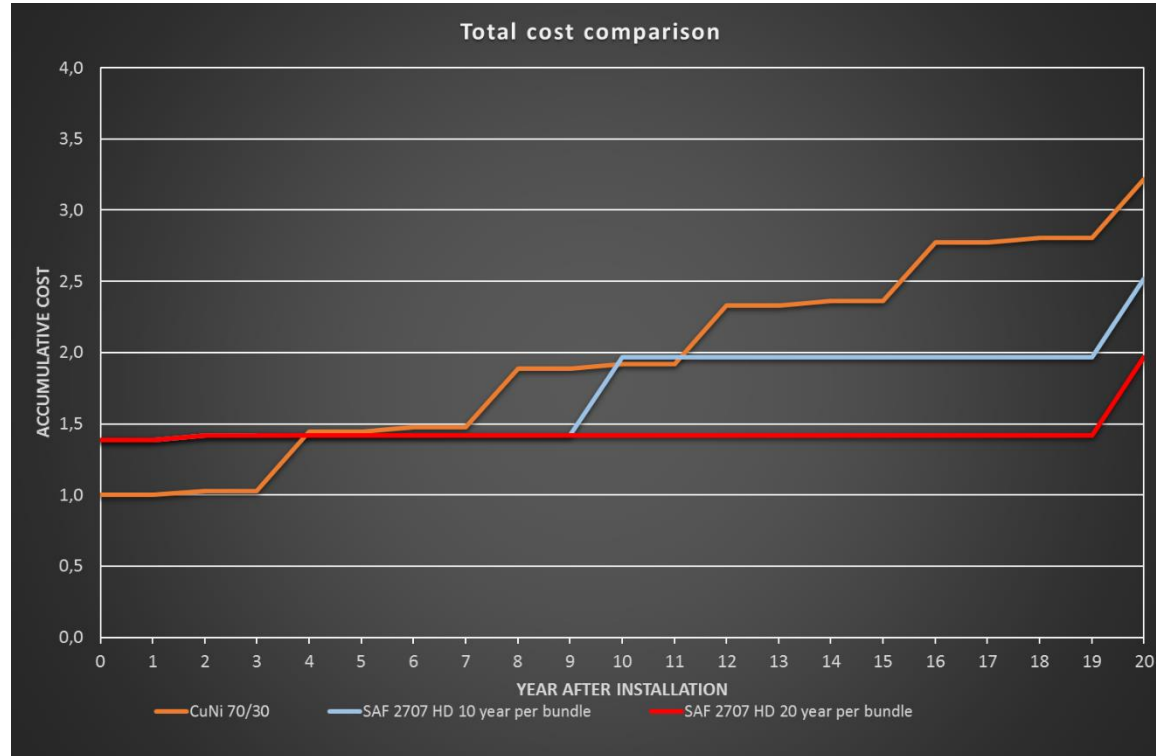
EXAMPLE COST ANALYSIS – TOTAL COST INDEXED

- Cost analysis shows that:
 - Initial equipment cost is higher for S32707 than for CuNi 70/30.
 - In case of 10 year lifetime for S32707, cost breakeven occurs after ~10 years.
 - In case of 20 year lifetime for S32707, cost breakeven occurs after 4 years.
- Production loss not included in calculations.
 - Customer did not want to share such information.
 - Calculations quickly become very complicated.
 - Calculations favourable for CuNi solutions.

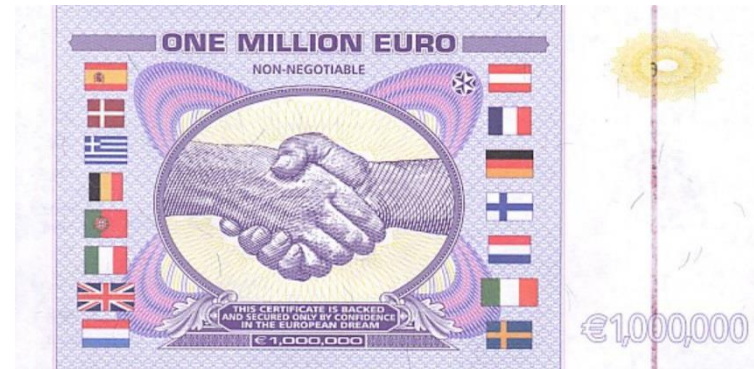
EXAMPLE COST ANALYSIS – CONCLUSIONS

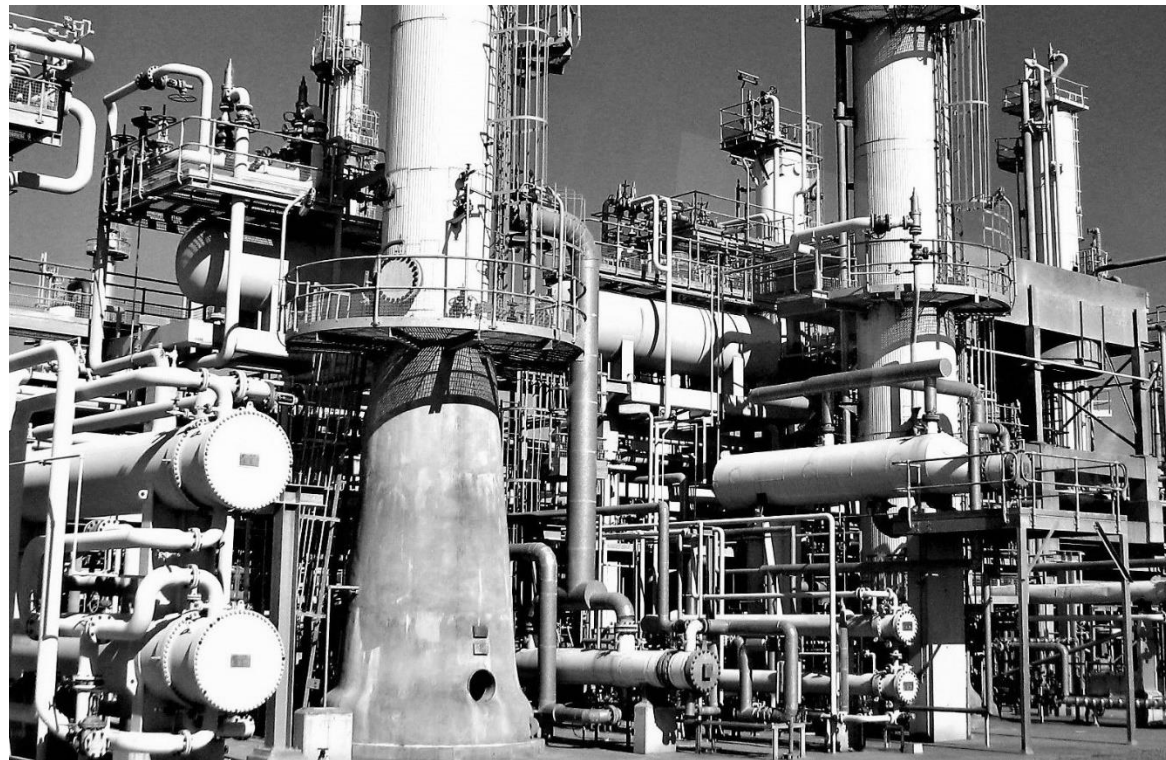
Crude Flexibility Strategy

- 15Mt/a refinery with high conversion capacity “independent” refinery
- Margin improvement project: Feeding higher TAN crudes to the refinery, taking profit from crude diversification

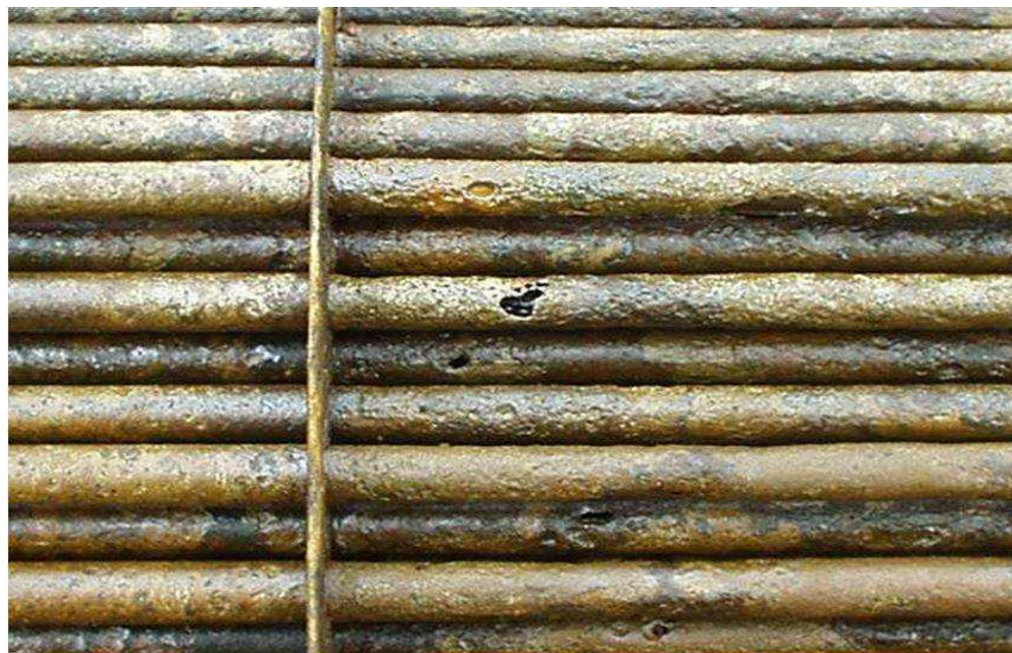
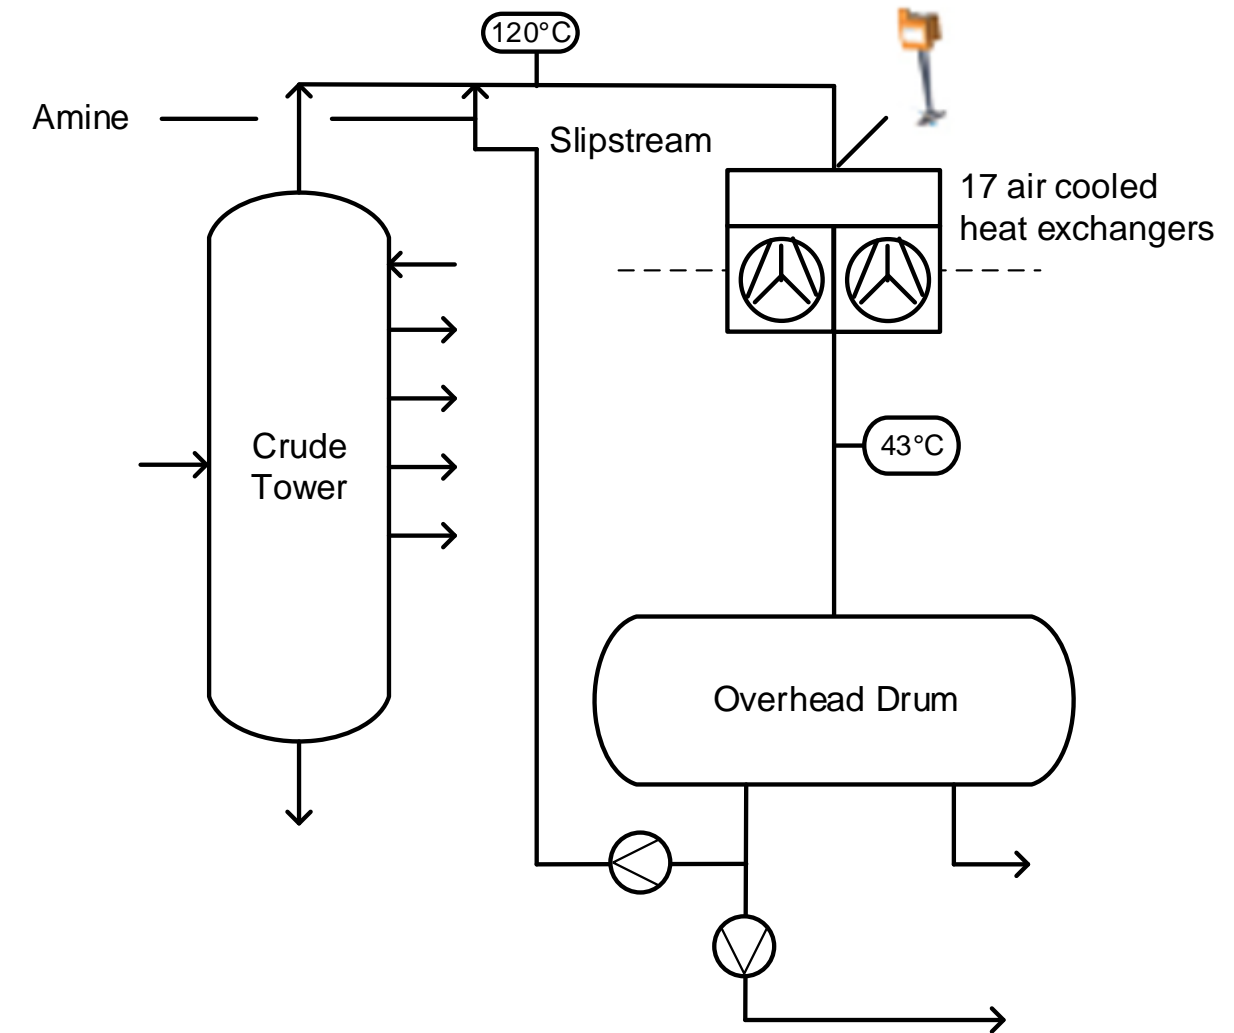
Crude Unit Overhead Corrosion Case Study

- CDU overhead system protected by chemical injection (filmmer and neutralising amine).
- Severe corrosion in the overhead piping system caused leaks.
- Expensive clamps had to be installed to secure operation.
- Risk of damaging the 17 air cooled heat exchangers.

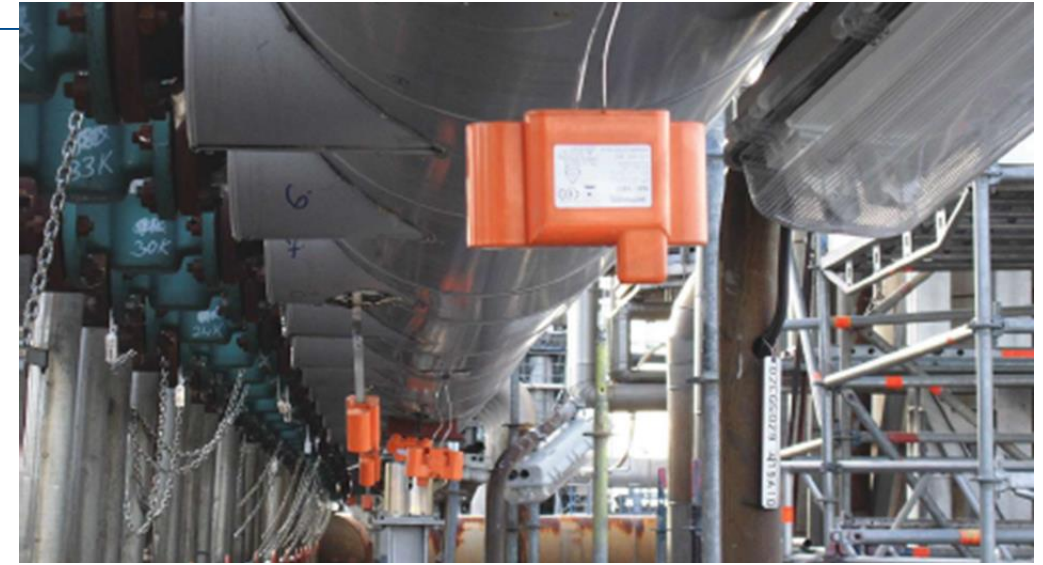
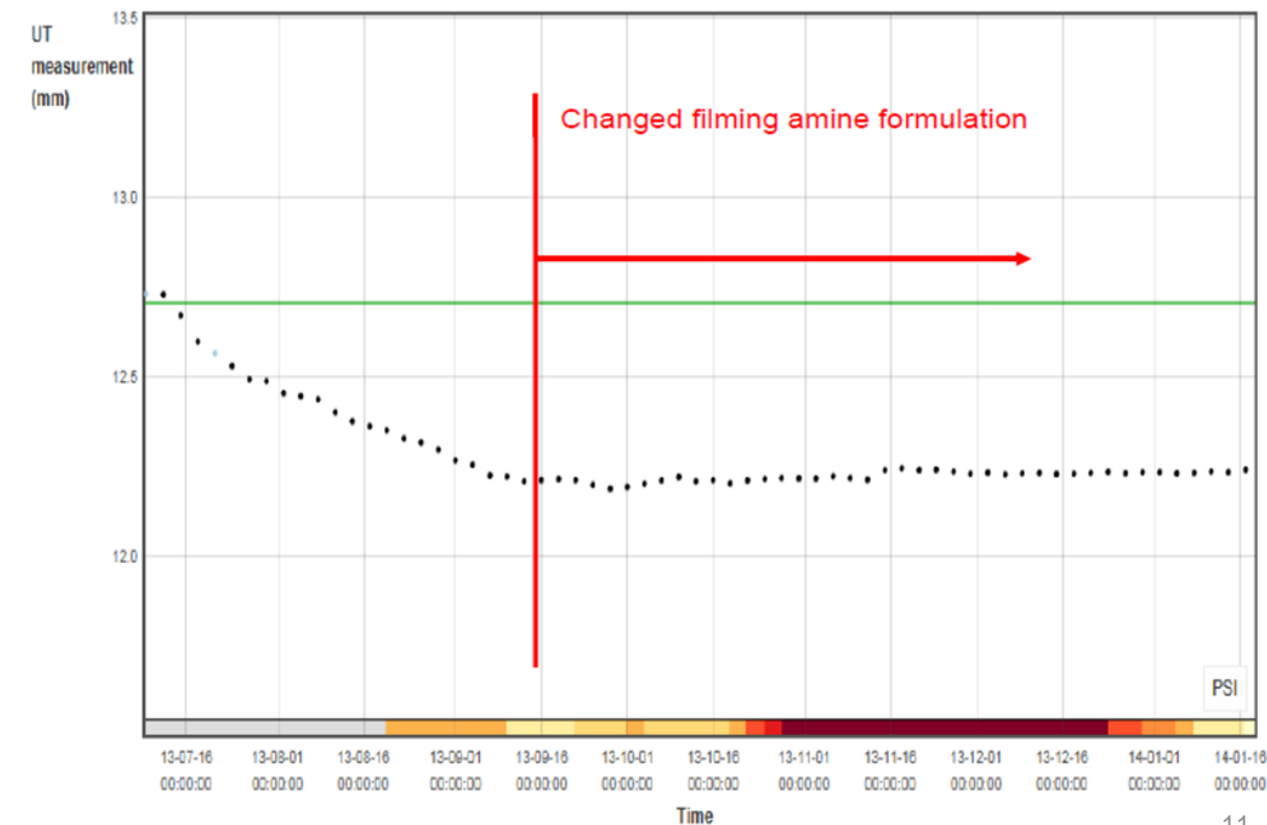
CDU Overhead: Corrosion Detection and Control

- 29 Permasense sensors were installed to continuously observe the system.
- Permasense system validated high corrosion rates.
- Trials were made to identify the cause of the corrosion:

- Reduce flow rate.
 - Insulate piping.
 - Change filming amine formulation.
- Effects could be immediately seen in the monitoring data.
- Chemical injection issue identified as the root cause:

- Filming amine injected with a naphtha slipstream taken from overhead drum.
 - Filming amine formulation caused emulsion formation in overhead drum.
 - Water was carried over with the slipstream causing the aggressive corrosion.

- Amine type changed, carry-over reduced, **corrosion stopped.**
 - Damage to the 17 air cooled heat exchangers prevented.

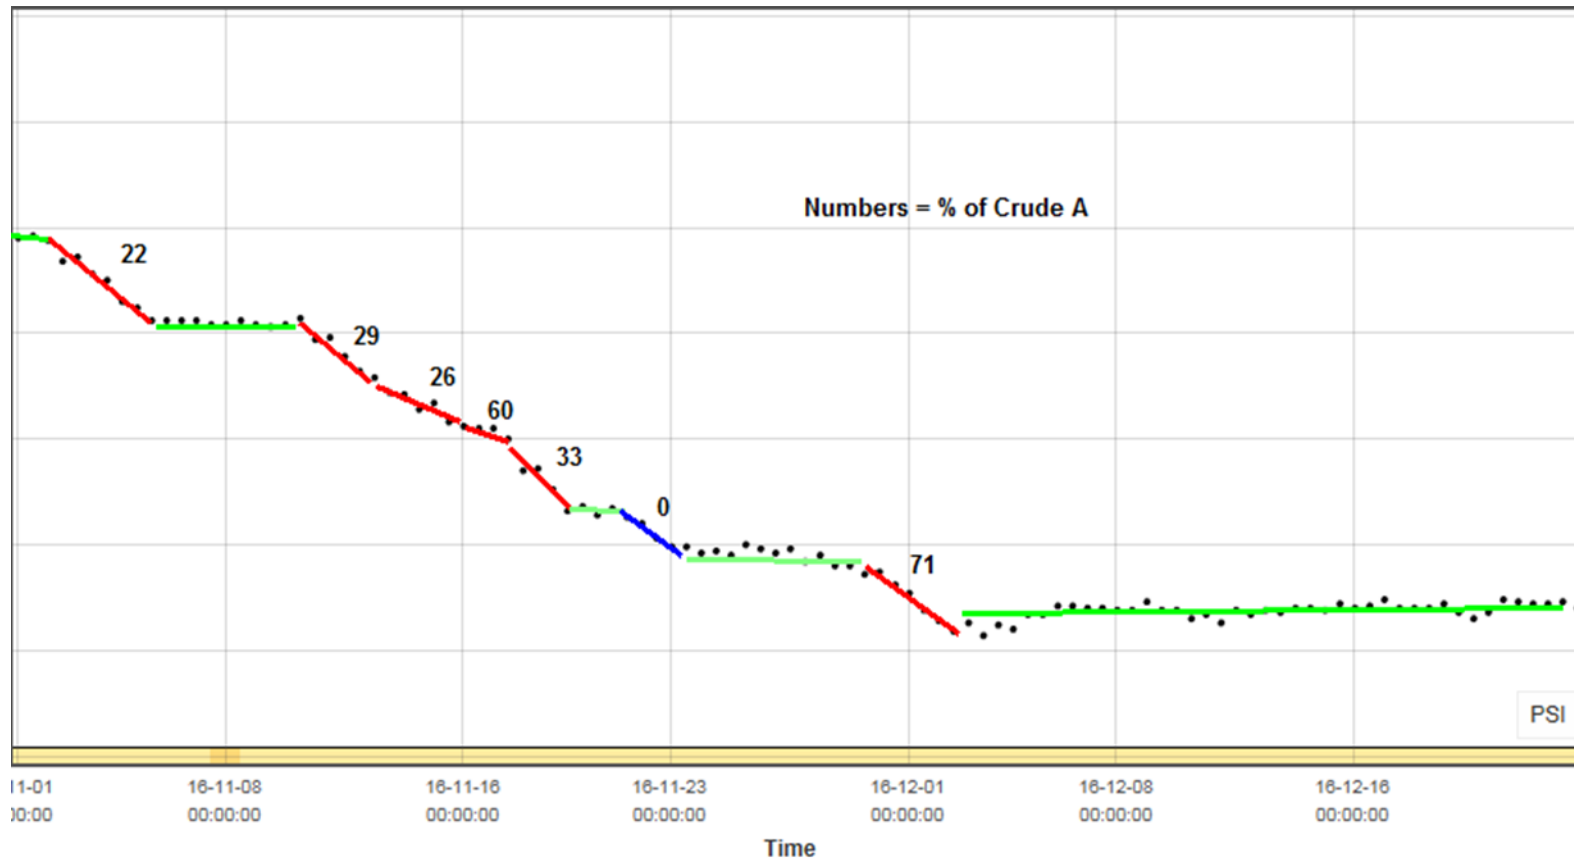
CDU OVHD: Corrosion Rate Correlation With Crude Blend

- A year after the corrosion rate was first stabilised, the corrosion rate increased again, immediately indicated by the monitoring sensors.
- Corrosion rate was varying with changes in the crude slate.
- Crude type “A“, high in chlorides, was identified as causing desalter issues.
- the sampling procedure in the desalter was improved to better monitor the risk.
- Other mitigations in place to control corrosion.

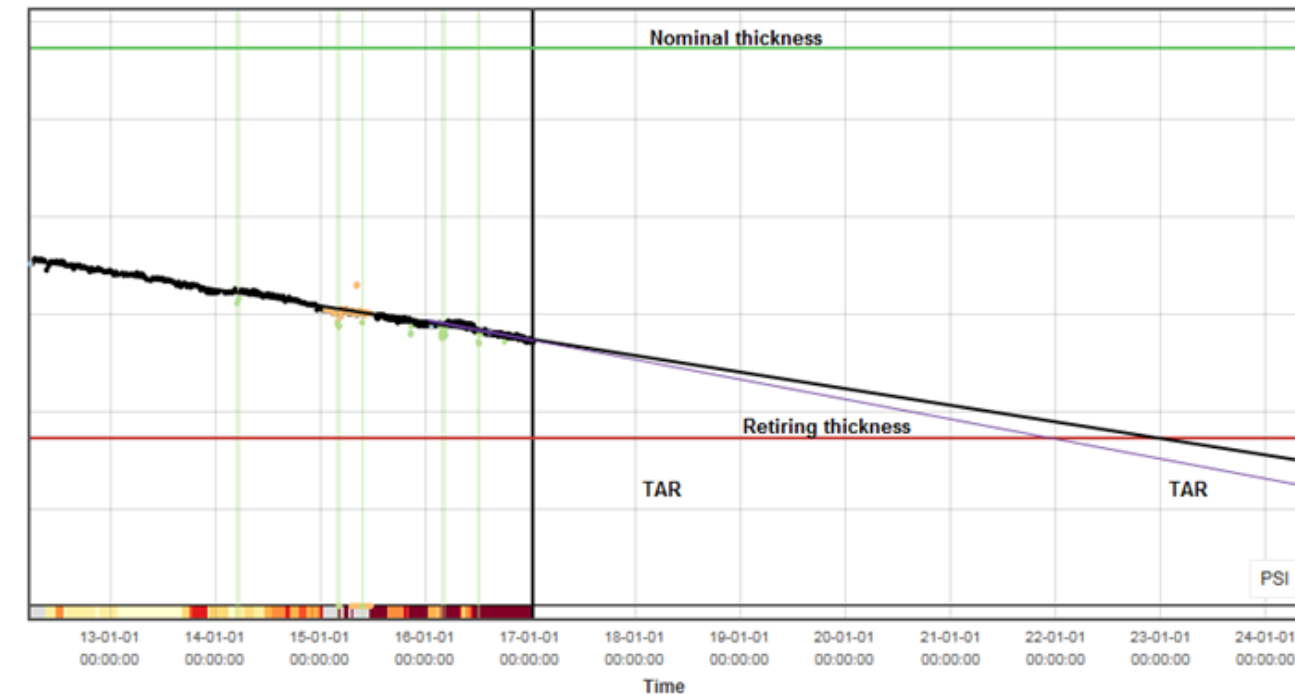
Reliable prediction through manual UT inspection was not possible because of low repeatability

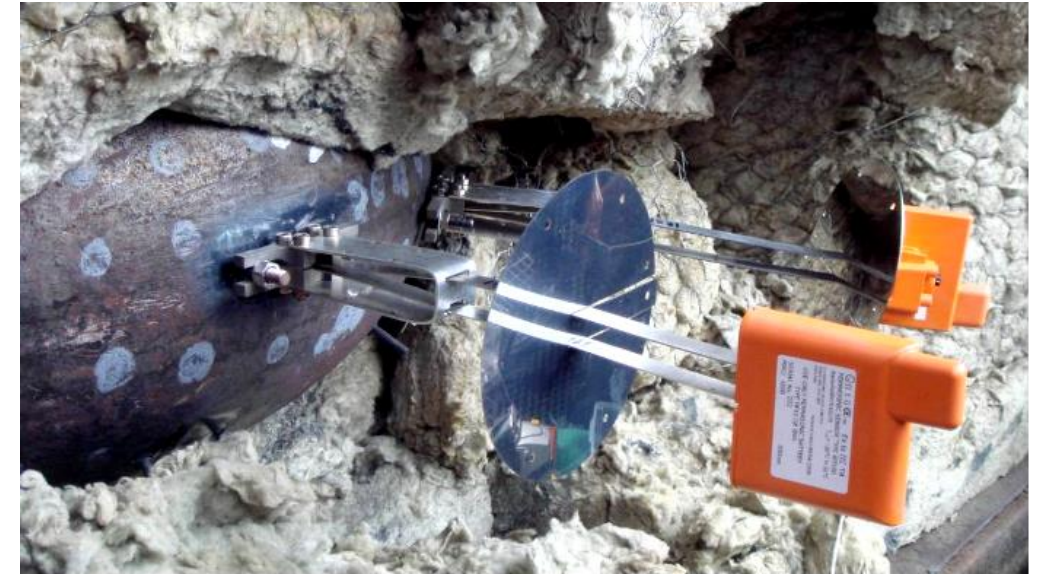
- Only cast carbon steel available for replacement. (No higher alloyed U-bends)
- Uncertainty about the actual corrosion rate. *Can we reach the next scheduled TAR with continued processing of high TAN crudes or do we have to stop this operation mode and lose margin?*
- Decision to add Permasense monitoring sensors. The most critical four U-bends close to the furnace outlet (i.e. at the highest temperatures) were selected for monitoring.
- Challenge to install four sensors on each bend at operating temperature 380°C successfully accomplished.
- Wall thickness curves provided a reliable prediction of the remaining life of the U-bends and that the next scheduled TAR two and a half years later could be reached without stopping the highly attractive high TAN crude processing.

Figure 1: Probes installed on cast carbon steel U-bend with M8 studs
