Participants NACE-EFC WP15 meeting 26th April 2007 in Paris La Défense

CUI, PCO T/A 2007 feedback, Inspection prioritization program for the future

**Thermal High Temp Technology on new
insulative and personal protective coating**

Experiences with relaxation cracking of 304H, 347 and alloy 800H in a ethylene cracker furnace

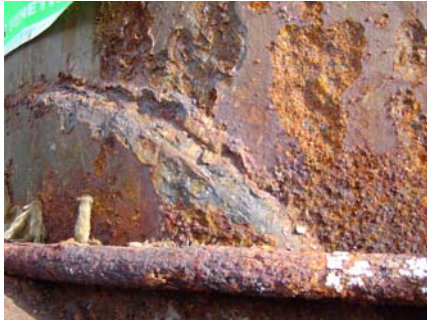
- Steam Separator (VBU),
larges crevices
 - Bottom only insulated
 - Location: Shell, near
manhole
 - Corrosion Deepness: 3 mm
 - Skin temperature: ~ 60°C
 - Painted (maintenance)
 - Service Life: 14 years
 - Root cause: Cladding
Condition, Rain hat
damaged

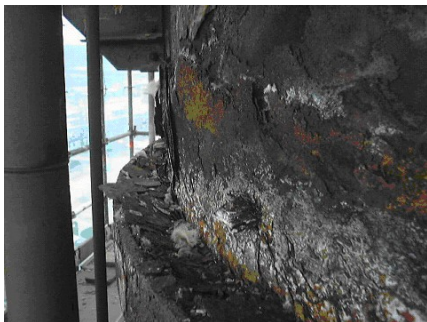
- Naphtha Splitter, 2004
 - Inspection follow RBI
study (2003)
 - Corrosion above stiffener
 - Corrosion deepness: 4-5
mm
 - Skin Temperature: ~70°C
 - No Paint
 - Service life: 30 years
 - Root cause: Water
ingress, stiffeners, clad
condition

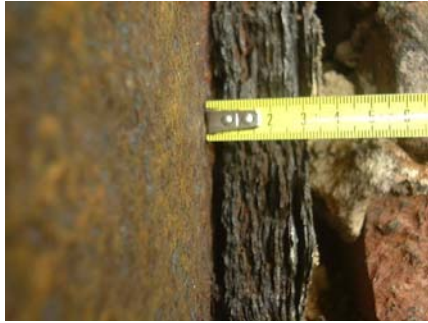
- Cor. Under Ignifuge Deisopentaniser
 - Under insulating bricks
 - Oxide thickness: 38 mm
 - Loss of thickness: > 6 mm, small hole in skirt
 - Skin Temperature: Ambient
 - No Paint
 - Service life: 33 years
 - Root Cause: Rain Hat Missing

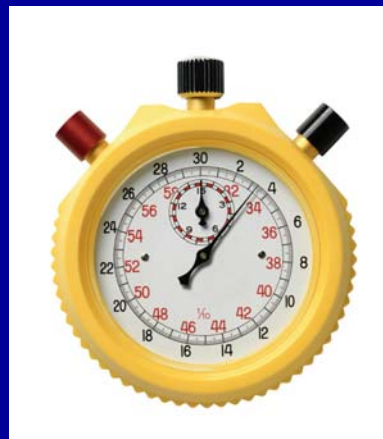
“Five
second
rule”

- 1.4 "..... contact time for industrial situations has been established at 5 seconds".
- 5.3 ".....exposure to which as average individual might be subjected".
- 5.7 "....metallic surfaces above 158°F, damage occurs almost instantaneously upon contact".

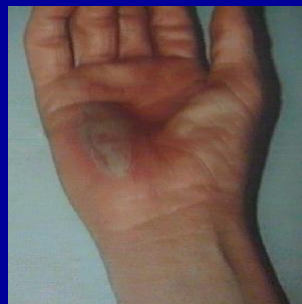
FIG.1 Approximately 58°- 60°C is the temperature at which an average person can have skin contact time for 5 seconds without cell death.

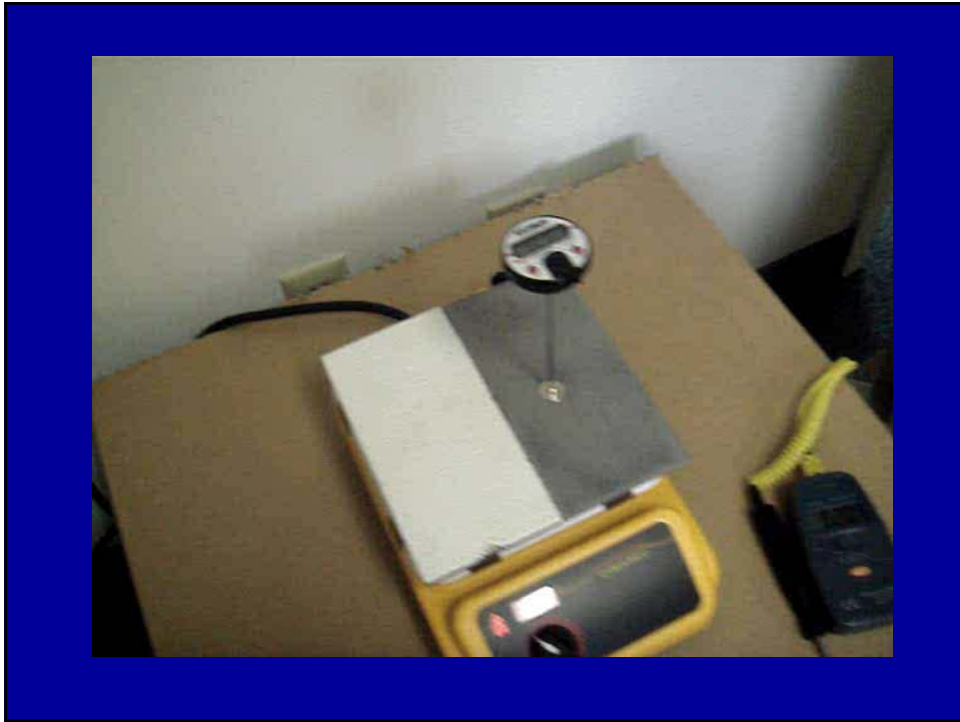
HTC 1027

- Ice Water
- 400 microns dft coating applied hot
- Test sample temperature

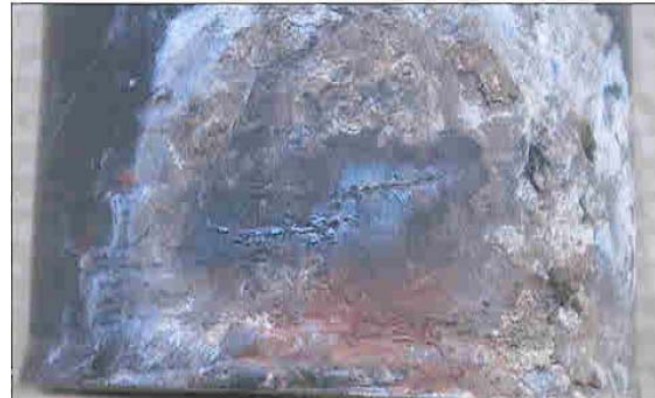
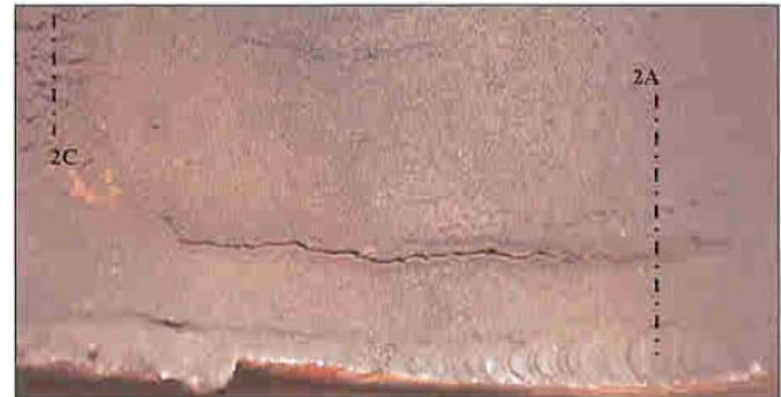
- January 2004
 - Cracking detected in 3 inch de-coke air lines
 - Material: austenitic stainless steel type 304H
 - Cracking transverse to tube axis
 - Close to welds, but not in HAZ

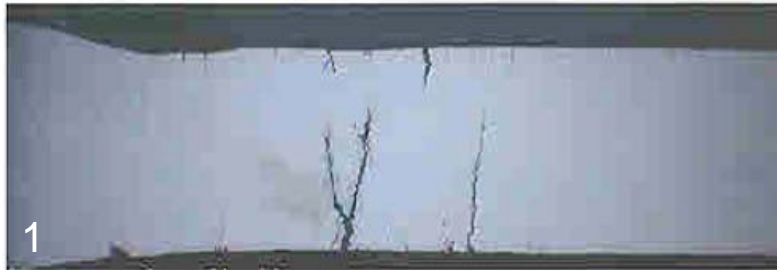
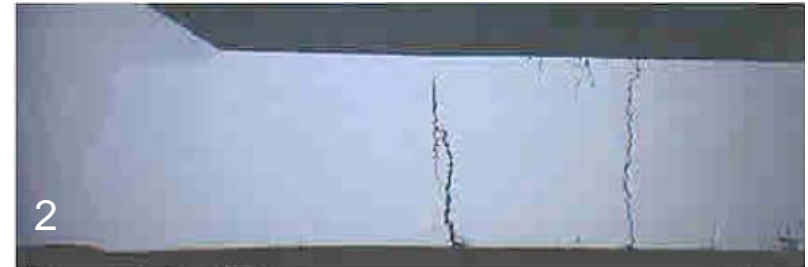
Macro

- Cracking initiated from the inside surface
- Some minor defects/cracks initiated from the outside

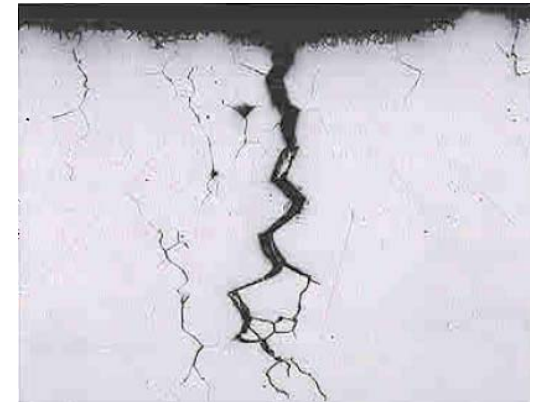
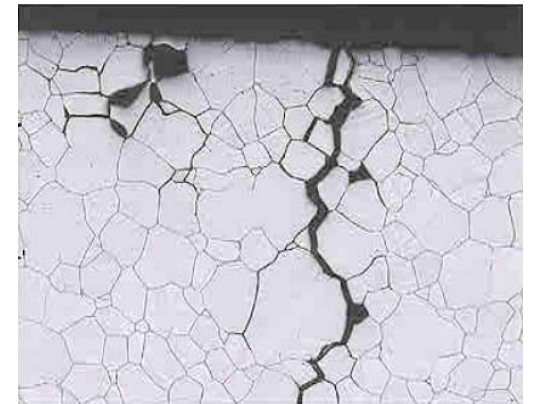
Outside

- Inter-crystalline
- Branching

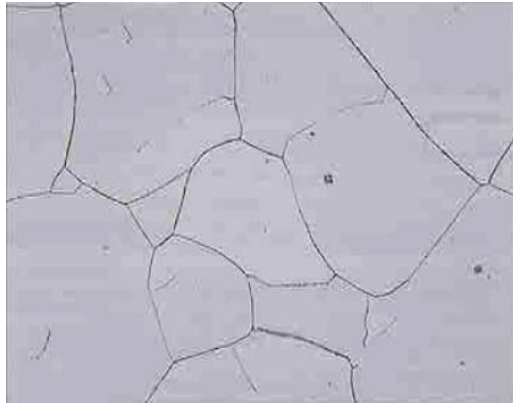
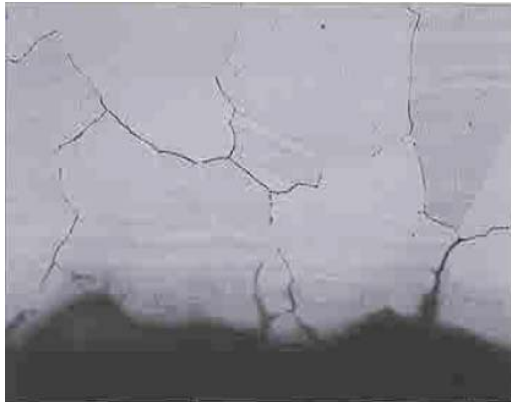
- Further observations
 - High level of sensitization (carbide precipitation at grain boundaries)
- Failure mechanisms considered
 - Thermal fatigue
 - Stress relaxation cracking
 - SCC during shutdown (polythionic acid)
- Conclusion
 - Most probably thermal fatigue due to cyclic de-coking operations
 - No evidence of Ni-filament (relaxation cracking), or evidence of voids ahead of the crack tip

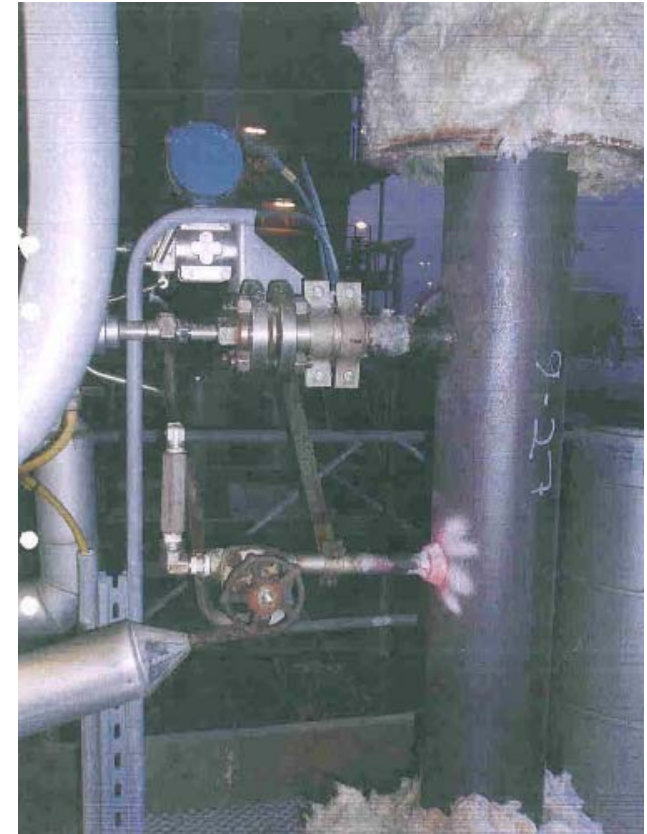
Experiences with cracking of 800HT PI-connection

- 1999
 - Leak detected
 - Assumed to be weld defect & repaired
- 2002
 - Leak detected on pass 4
 - Replacement of weldolet & $\frac{3}{4}$ " pipe on all 4 passes
 - 347H not available; substituted with Sanicro 31HT (alloy 800HT)
- 2005
 - Leak & fire on pass 1
 - Replace in 347H; other 3 OK

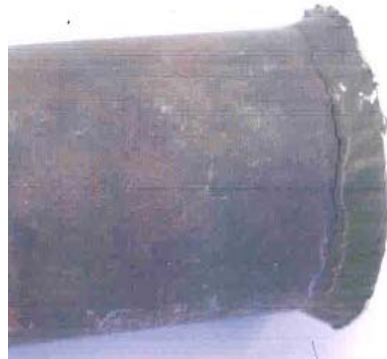
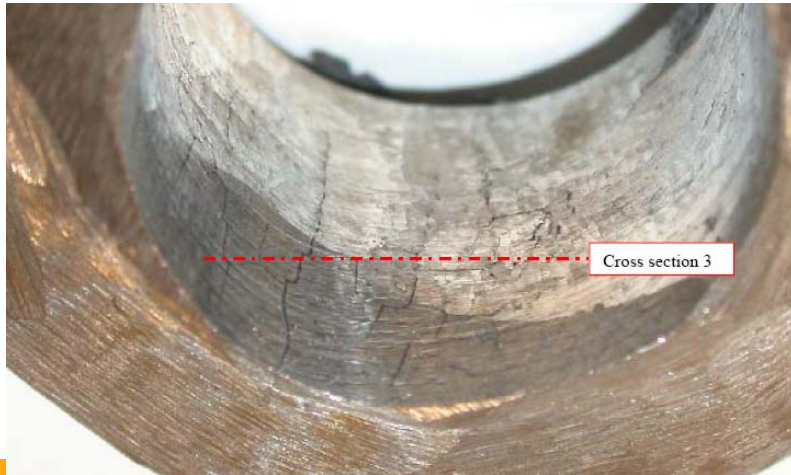
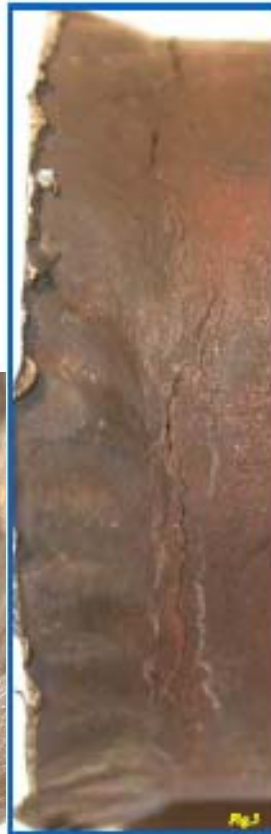
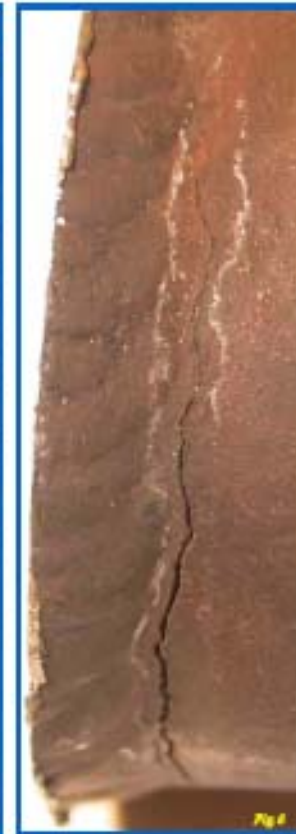
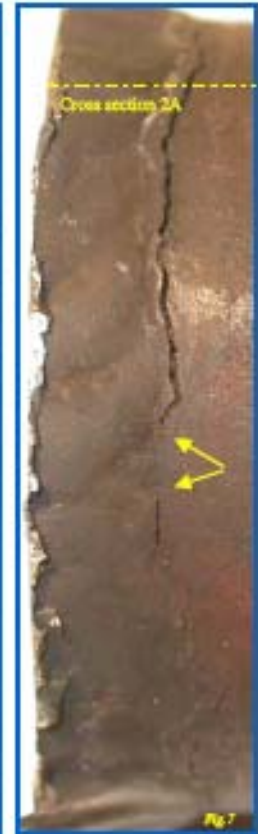
Visual

- Cracking in transverse & longitudinal directions
- Close to weld
