Minutes of EFC WP15 Corrosion in the Refinery Industry 14 April 2015

Unexpected cracking in SS316 piping in high temperature service.

Mitigation of Crude Unit Overhead Corrosion through Improved Monitoring & Online Control

New Technology developments enhance accuracy and responsiveness of permanently installed ultrasonic sensors

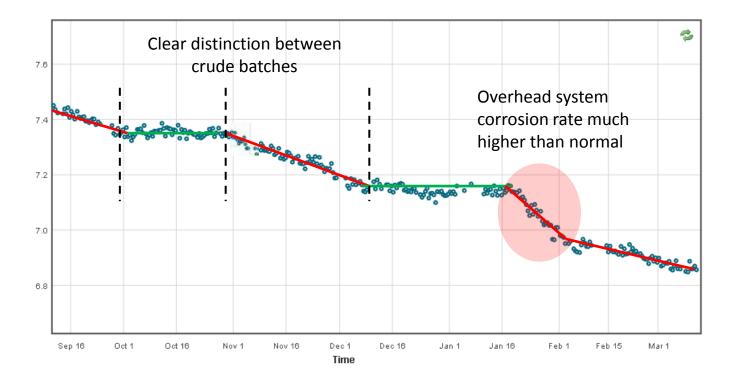
Applications Experts in remote m Case Study – CDU Overheads Organic Acid corrosion

- Continuous wall thickness monitoring enabled correlation of corrosion rate with crude slate
- Sensors in CDU overheads showed higher corrosion rate than expected for a particular batch of crude; no correlation with overhead inorganic chlorides
- Prompted refinery to investigate presence of organic acids from that crude batch, which was confirmed by detailed lab analysis
