Control of Relaxation Cracking in austenitic high temperature components

Control of Relaxation Cracking in Austenitic High Temperature Components

*Presentation for EFC, WP 15:
"Corrosion in Refinery"
April 26th, Paris*

*Hans van Wortel,
Eindhoven
The Netherlands*

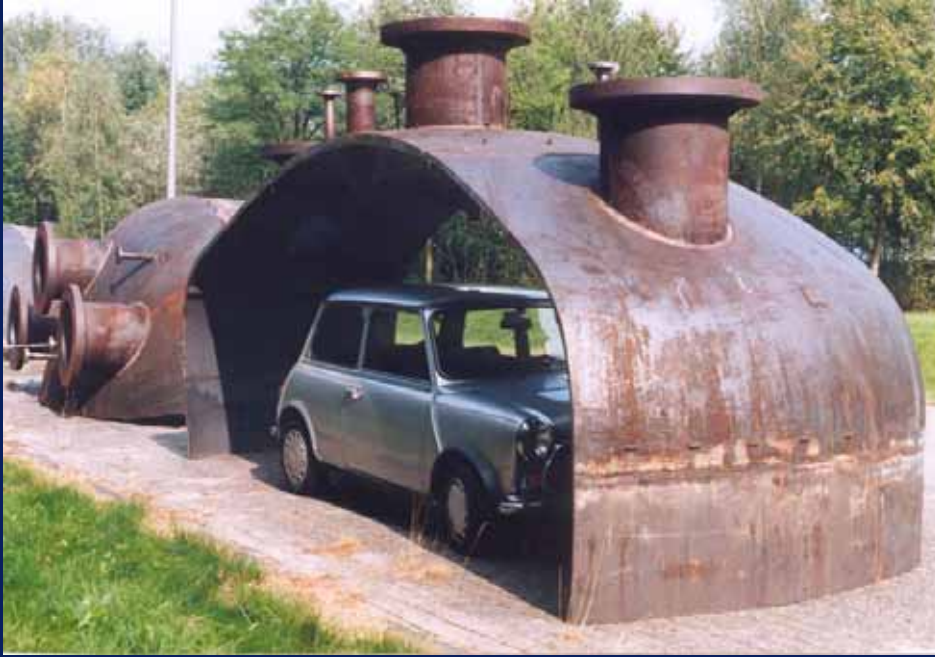
Failed Alloy 304H reactor vessel, wall thickness between 50 and 75 mm

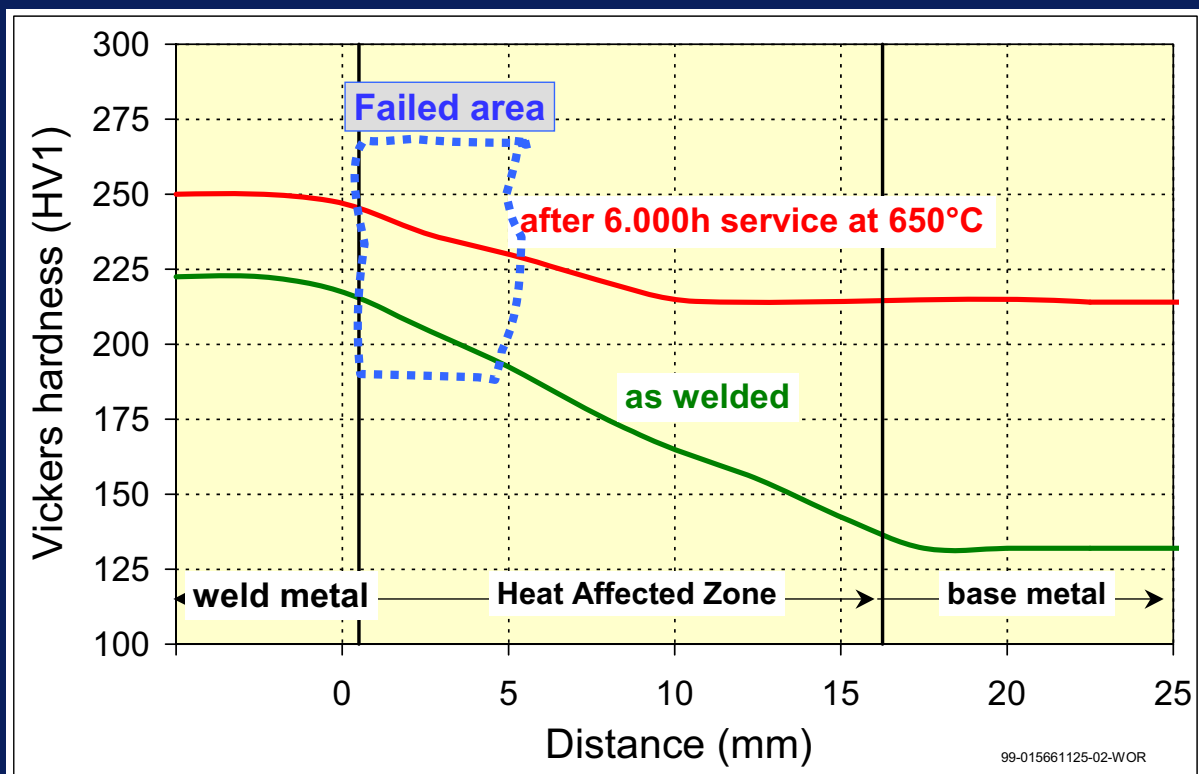
- *failure in a Alloy 800H reactor vessel after 6.000h service* -

- Diameter vessel : 2.800 mm
- Total height: 15 meter
- Wall thickness shell between 35 and 80 mm.
- Medium: hydro-carbons
- Metal temperature 600-650°C
- Leakage after 2.000h in the 80 mm material
- After 6.000h a catastrophic failure. Brittle fracture in HAZ of circumferential weld. Vessel broke in 2 parts resulting in a fire. However, no persons were killed

Hardness and failed area of a Alloy 800H welded joint

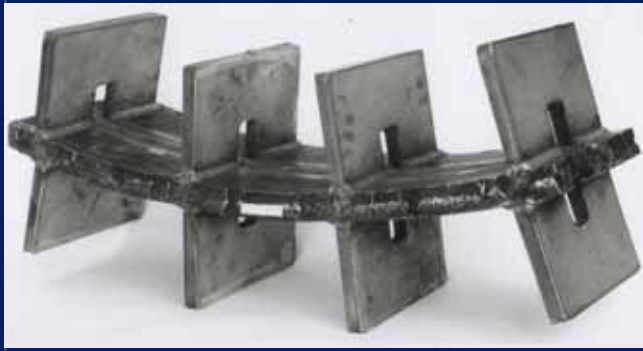
Result self restraint test of a Alloy 800H weld

Conditions heat cycle:

- heating rate 50°C/h
- aged 100h/650°C
- cooled down in furnace

Severe relaxation cracking due to welding stresses only!

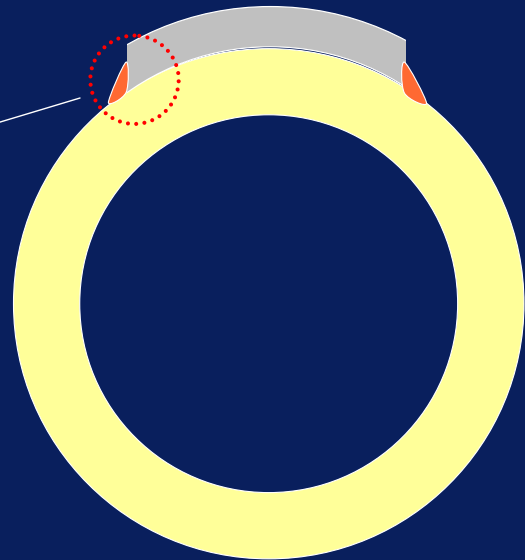
Header+ Support + weld metal: 347H

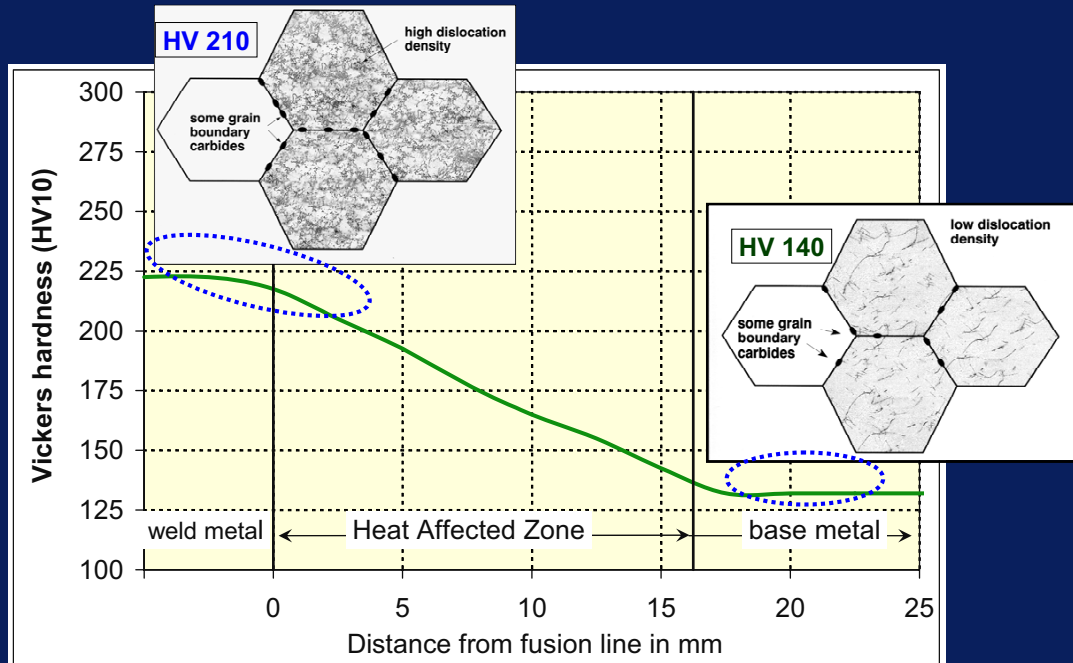
- Welding/cold deformation enhance dislocation density and results in hardness increase

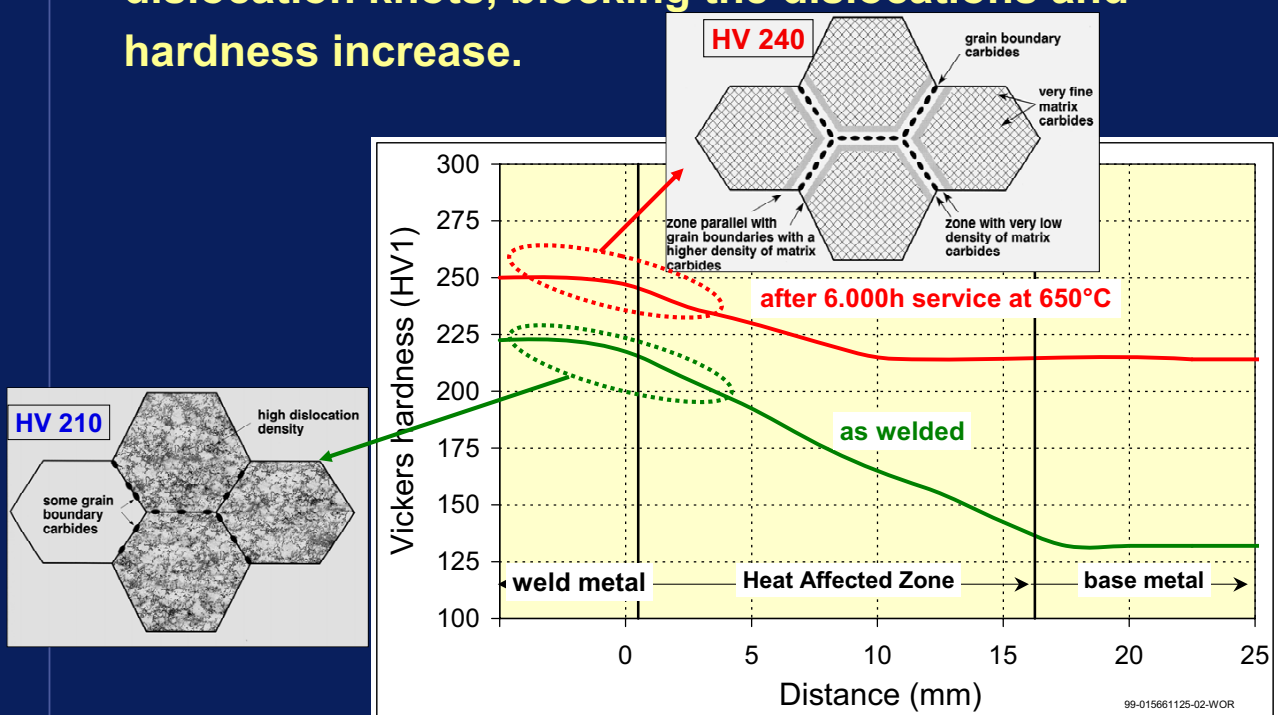
- During service this will result in:
 - Rapid precipitation of very fine matrix carbides on dislocation knots, blocking the dislocations and hardness increase.

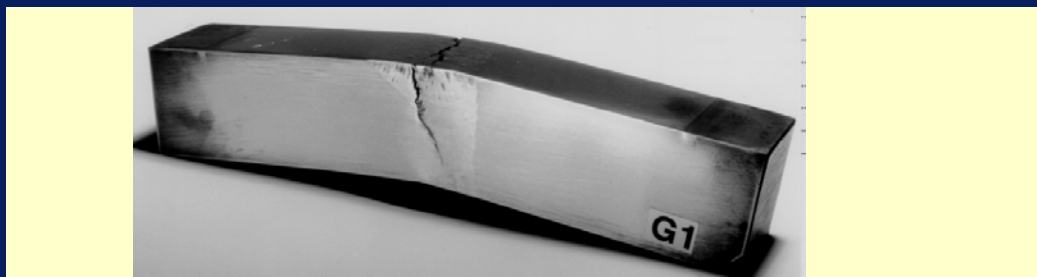
Relaxation Cracks can be simulated in the lab

- result of a relaxation test on a Alloy 800H welded joint -

Temperature: 600°C. Testing time: 150h.

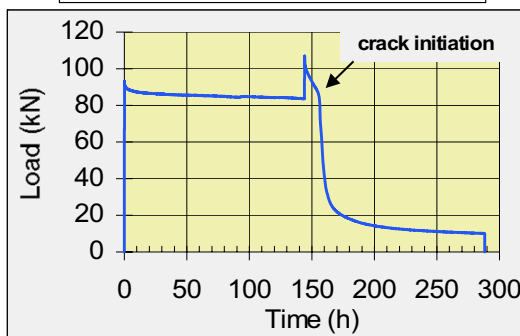
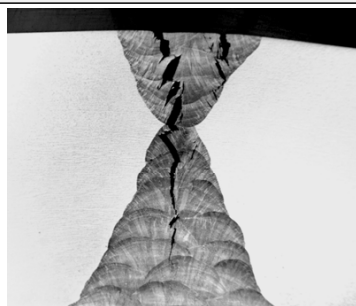
As welded condition, T=650°C

Severe cracking in weld metal

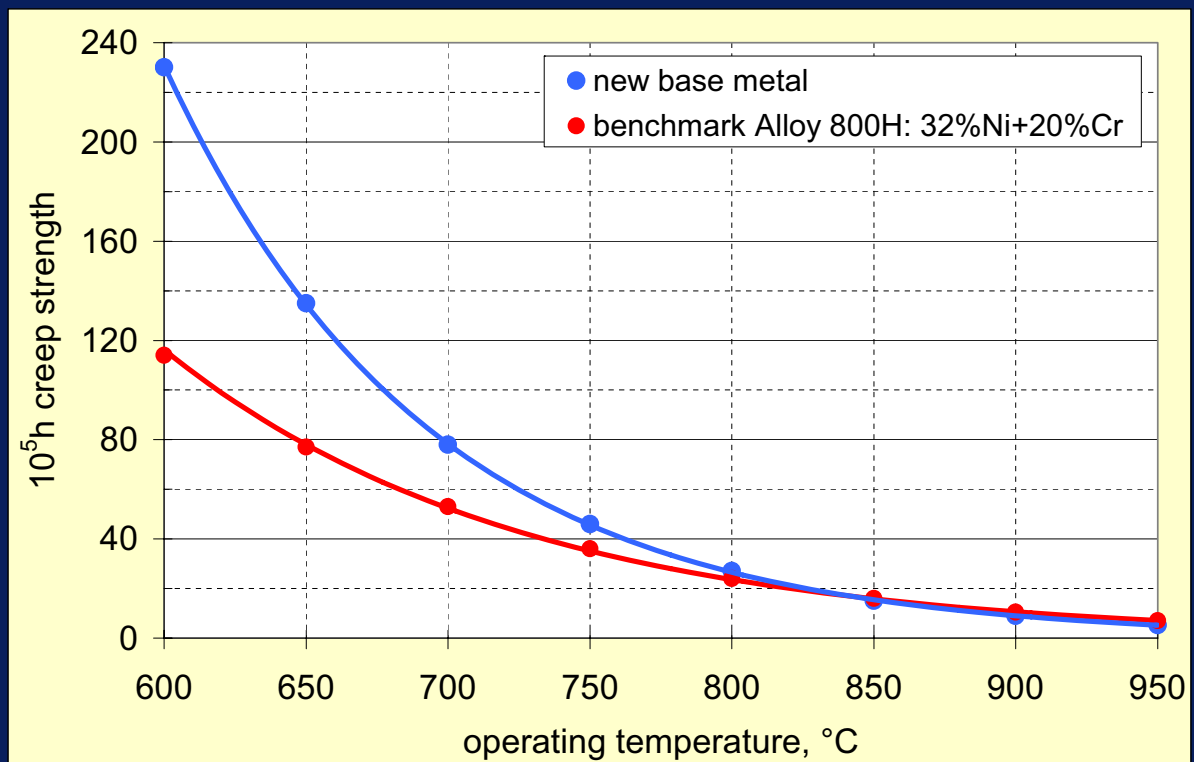
10⁵h creep rupture strength new developed base material, not susceptible for relaxation cracking compared to 800H
