Appendix 5

Advanced Weld Overlay Technology for

Pressure Vessels & Boilers with presentations of

history cases in Refineries

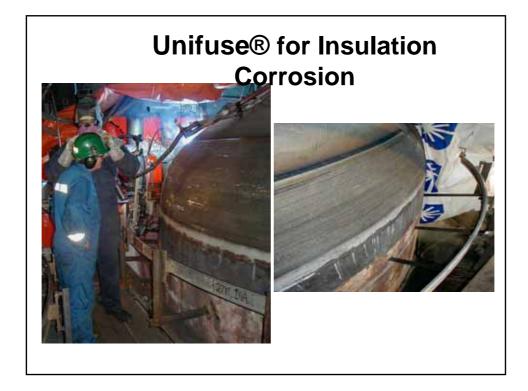
Unifuse® for Insulation Corrosion

- Facility : UK Refinery
- Plant Item : Coking Vessel
- Damage : Under Insulation Corrosion
- Location : Knuckle of top dome
- No. of Vessels : 2
- Vessel diameter : 6.2 mtrs
- Overlay Area : 20 m² per vessel
- Overlay thickness : Minimum 7.0 mm
- Material : Carbon Steel
- Program : 9 days utilising multiple automatic welding systems
