Welcome and

Presentation of Shell Technology Centre

EFC WP 15 Spring Meeting - 26 April 2012

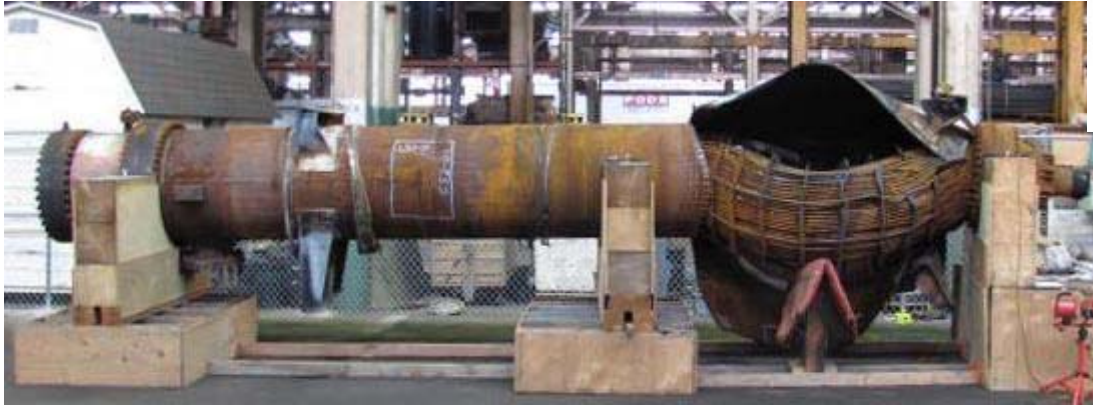
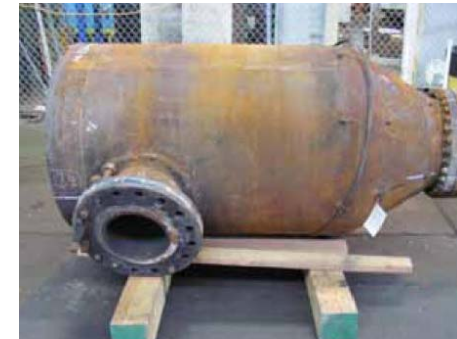
TESORO Anacortes

- ▶ Naphta hydrotreater
- ▶ Feed effluent heat exchanger (failure on the shell side – effluent)
- ▶ Seems to operate below the API curve (but lack of TC to know the temperature accurately)
- ▶ Equipment made of A 515 Gr 70 – No PWHT – put in service in 1971
- ▶ Accident happens the 2 April 2010 – 7 fatalities

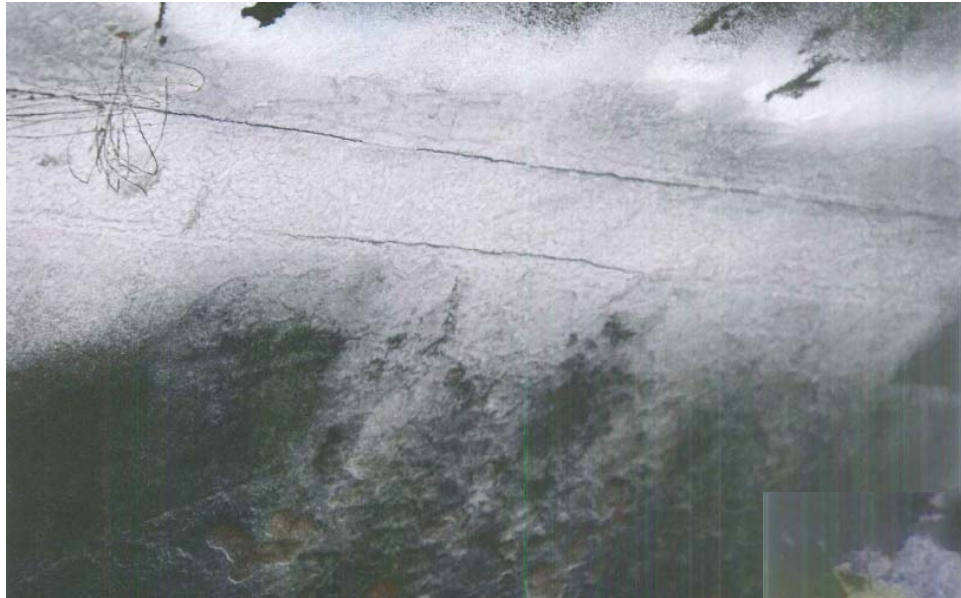
Illustration - 2008

- ▀ Unit : HDS built in 1979
- ▀ Feed effluent heat exchanger
- ▀ The feed is on the shell side
- ▀ Design : 800 PSI (54.8 bars), 500°F
- ▀ Seam coefficient 0.8 – design stress 123 MPa (17.8 KSI)
- ▀ External diameter : Ø 1216 mm Shell nominal thickness 36mm.
- ▀ Shell material A 48 CP (A 516 Gr 70), no PWHT
- ▀ Built in 1979 (origin of the unit)
- ▀ In 2008 during turnaround, inspection of the equipment : control of the main weld by UT TOFD and MT.
 - Cracks found in the longitudinal weld : length ≈ 4 feet,
 - Close to the hotter nozzle
- ▀ In April 2011 during a catalyst change, UT control of the weld. New cracks found
- ▀ The equipment has been removed from service.

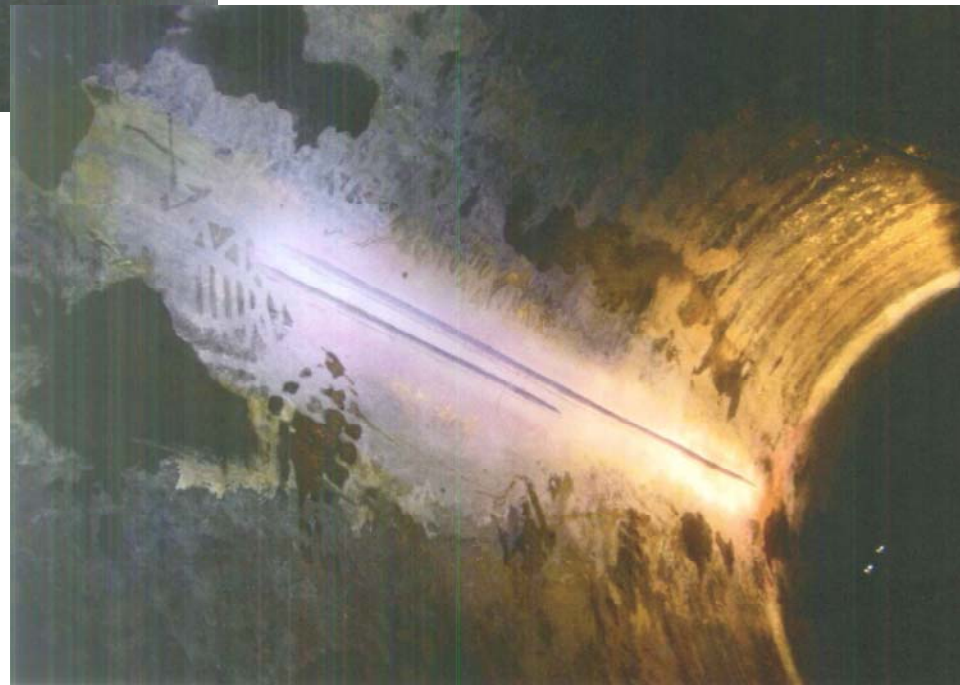
Cracks found

Cracks after grinding
Before repair

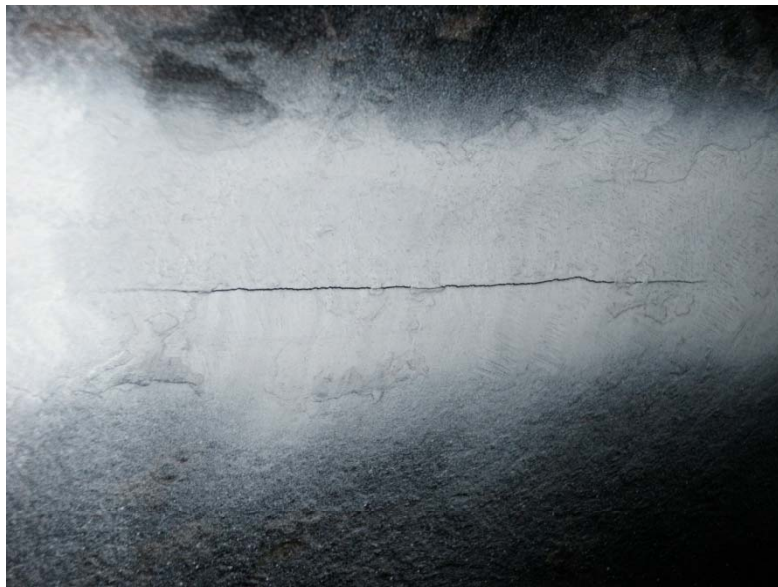
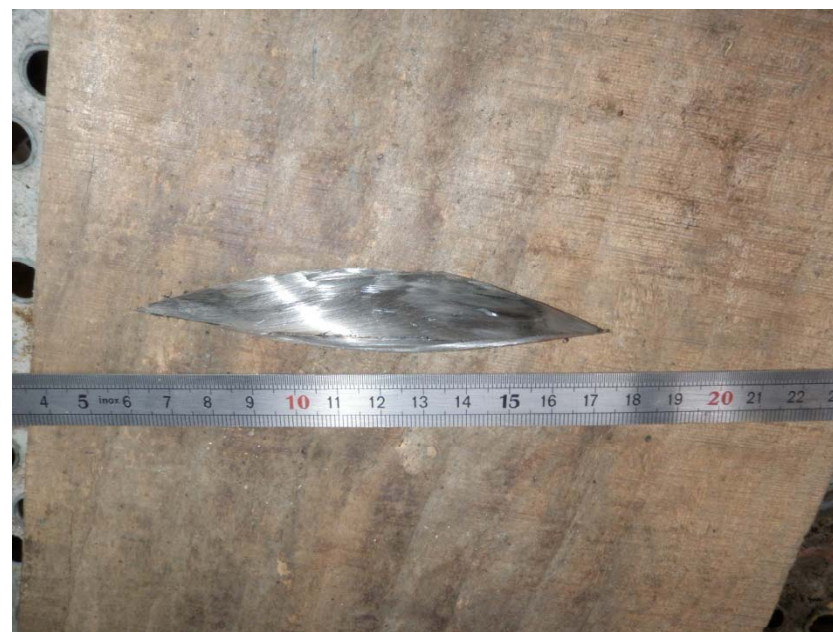
Cracks found in 2011

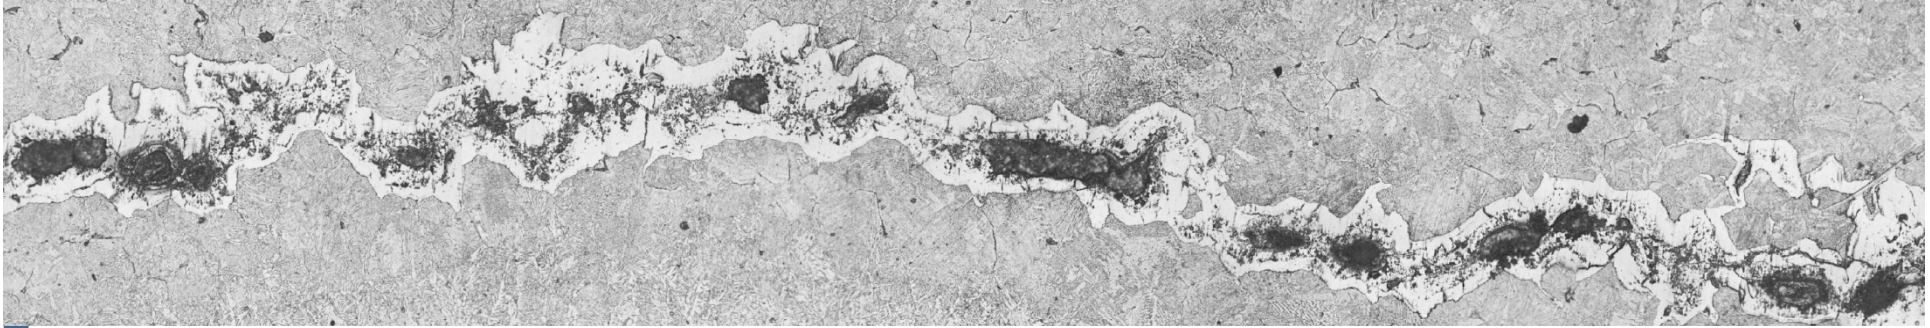
Crack assesment

- ▀ Main crack located just below the weld metal in the HAZ
- ▀ The main crack is strongly oxydized
- ▀ The main crack is intergranular
- ▀ Micro cracks are detected around the main crack in HAZ or the weld metal, without preferential orientation
- ▀ Localized decarburation is observed
- ▀ Micro cracks have been observed in area far from the main crack

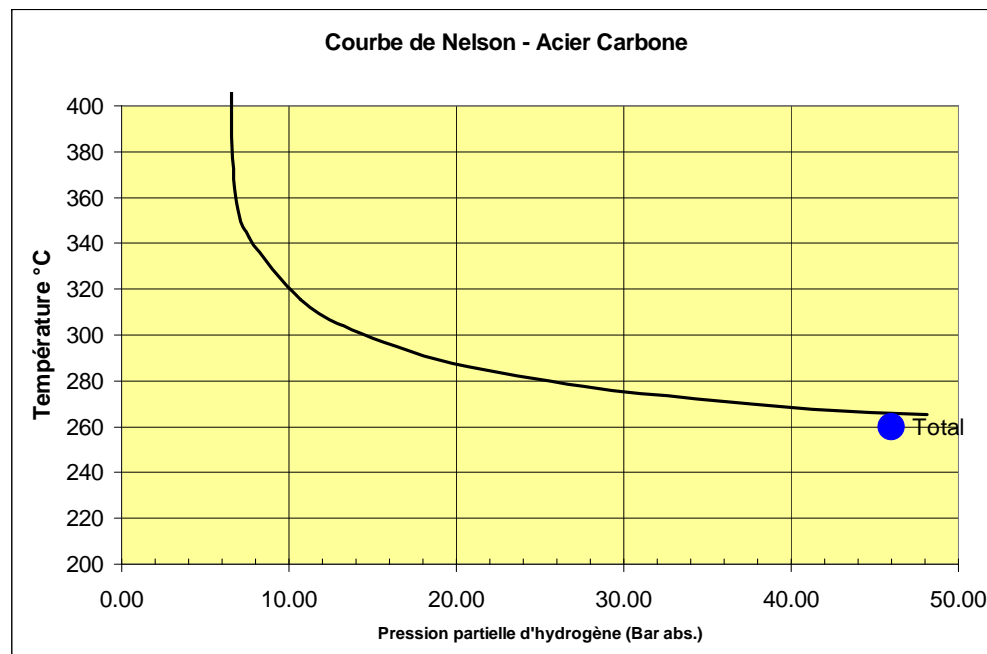
Operating conditions

- Exact operating condition have still to be confirmed.
- Hydrogen is purified by membranes.
- Maximum operating (EOR) 500°F (260°C) and PPH2 (46 bars)

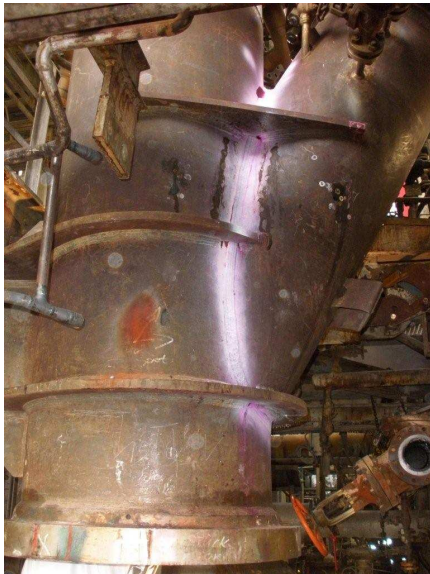
- Crack in crotch (Leaking area)

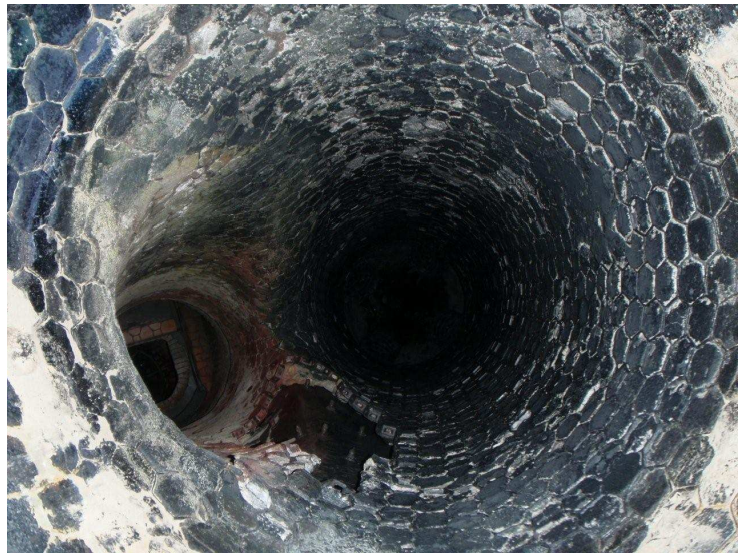
- Spalled refractory (Hotspot)

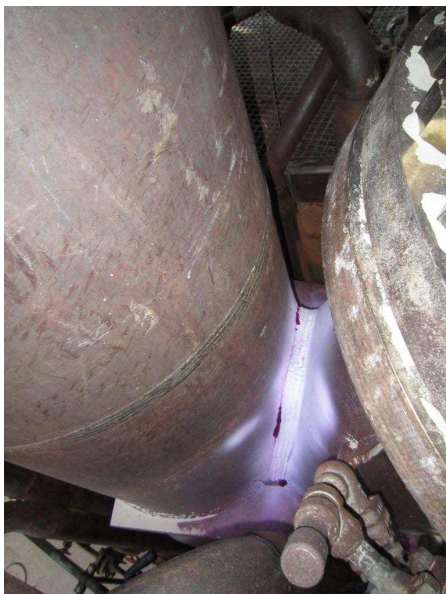
Penetrant test

- Crack with leak – long crack without leak

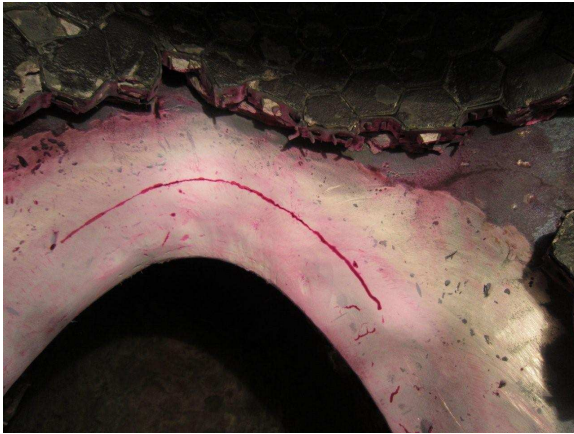
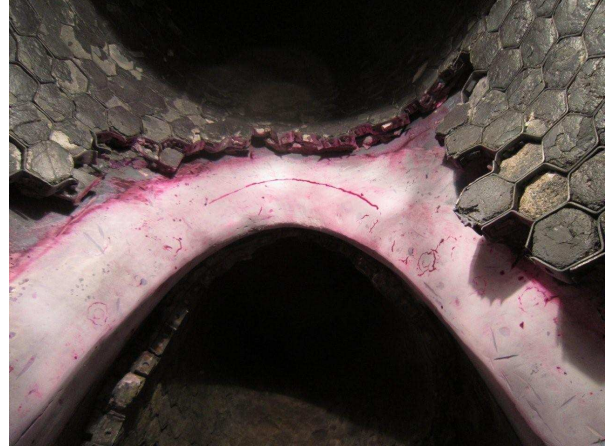
- Main crack at crotch area, additional cracks at former stud welding areas

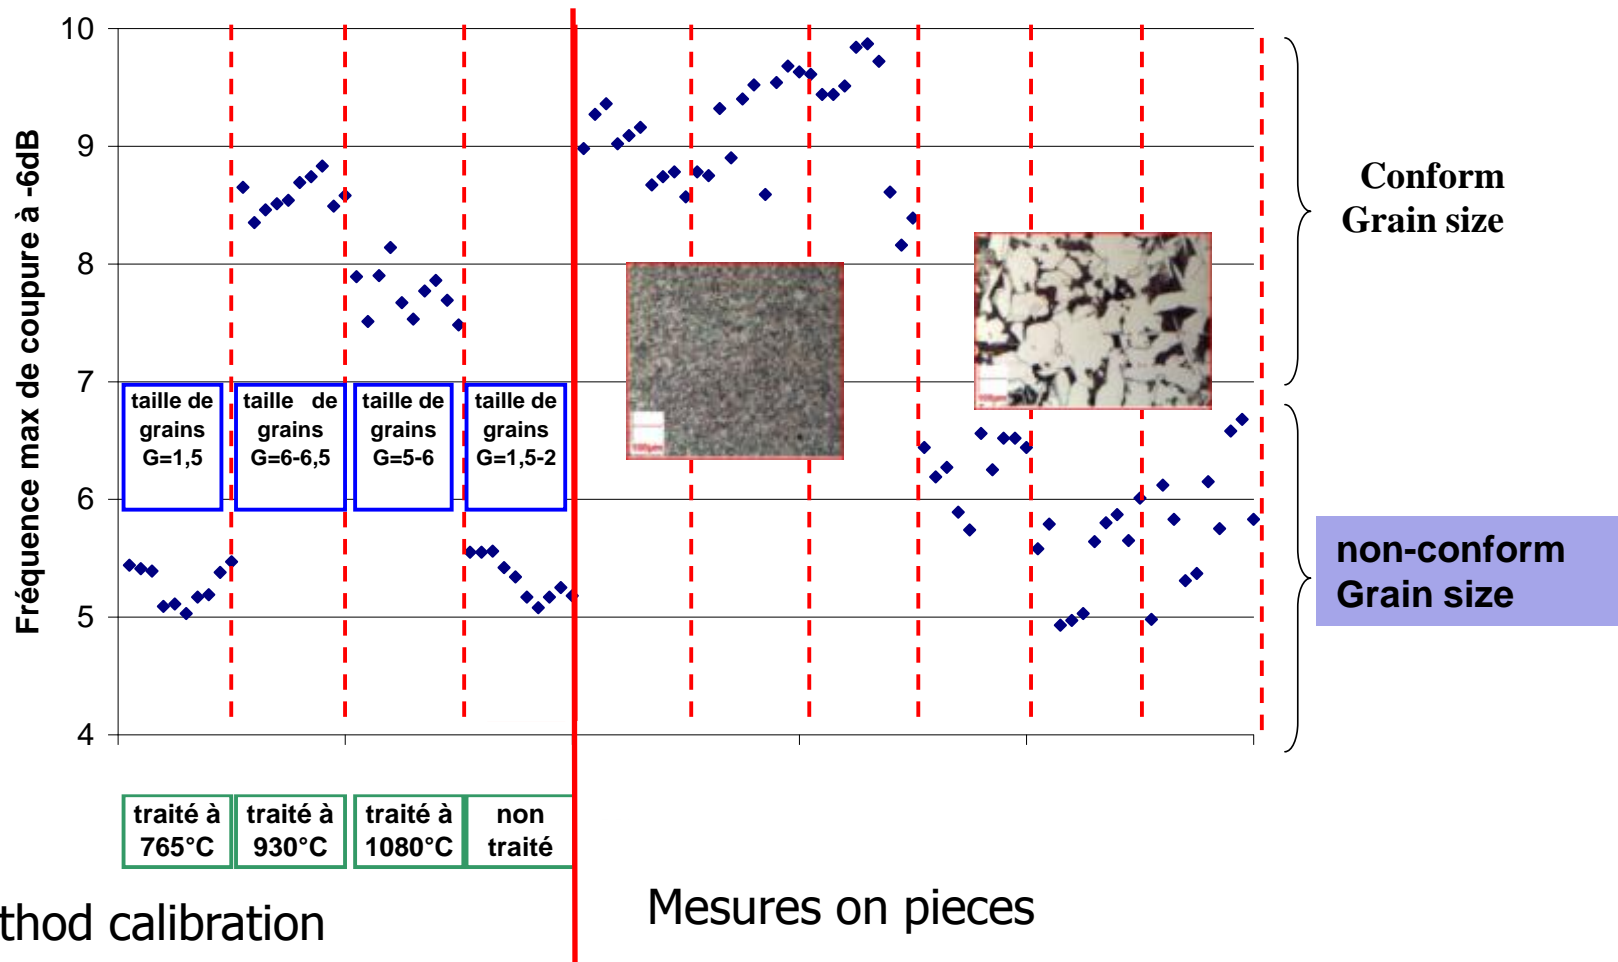
Normalized microstructure : Grain size checking Replica (long and costly)- UT Method

Mesures sur le spectre fréquentiel du 1er écho

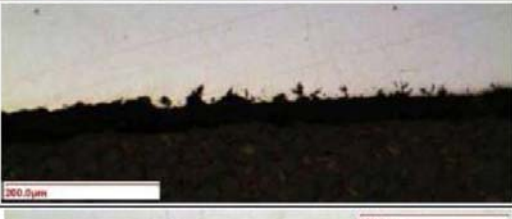
103 390	Cratères et fissure Longueur 81 µm	Cratères – Profondeur 26 µm

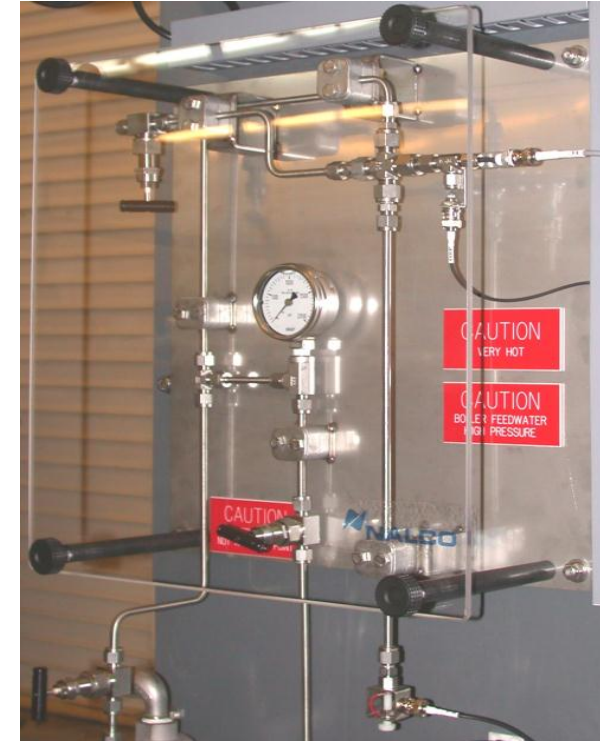
Nalco Corrosion Stress Monitoring

- It is a real time monitoring
- It a continuous ORP @ temp BFW measurement
- Oxygen scavenger control
- Proactiv tool
- Detect → Adjust → Deliver
