Participants EFC WP15 meeting 7th September 2011 Stockholm (Sweden)

Welcome to the EFC Working Party Meeting "Corrosion in Refinery" WP15

Stockholm 7 September 2011

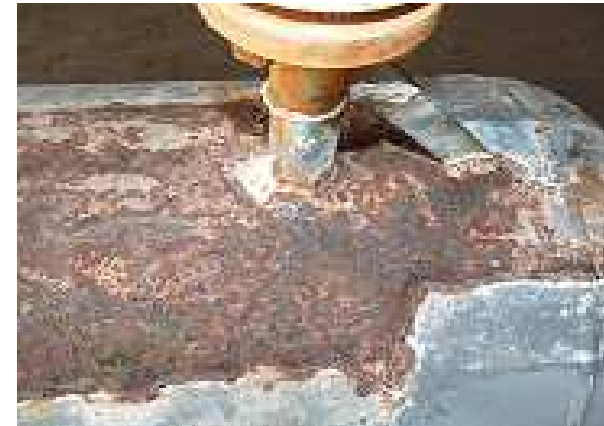
CUI after 8 years

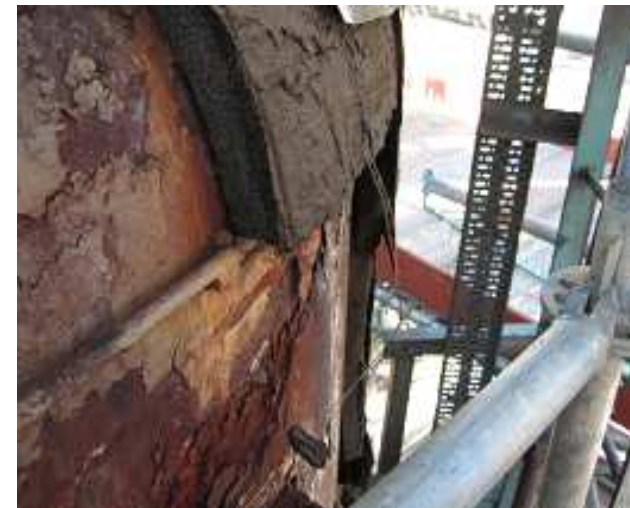
CUI with Foam-Glass after 15 years

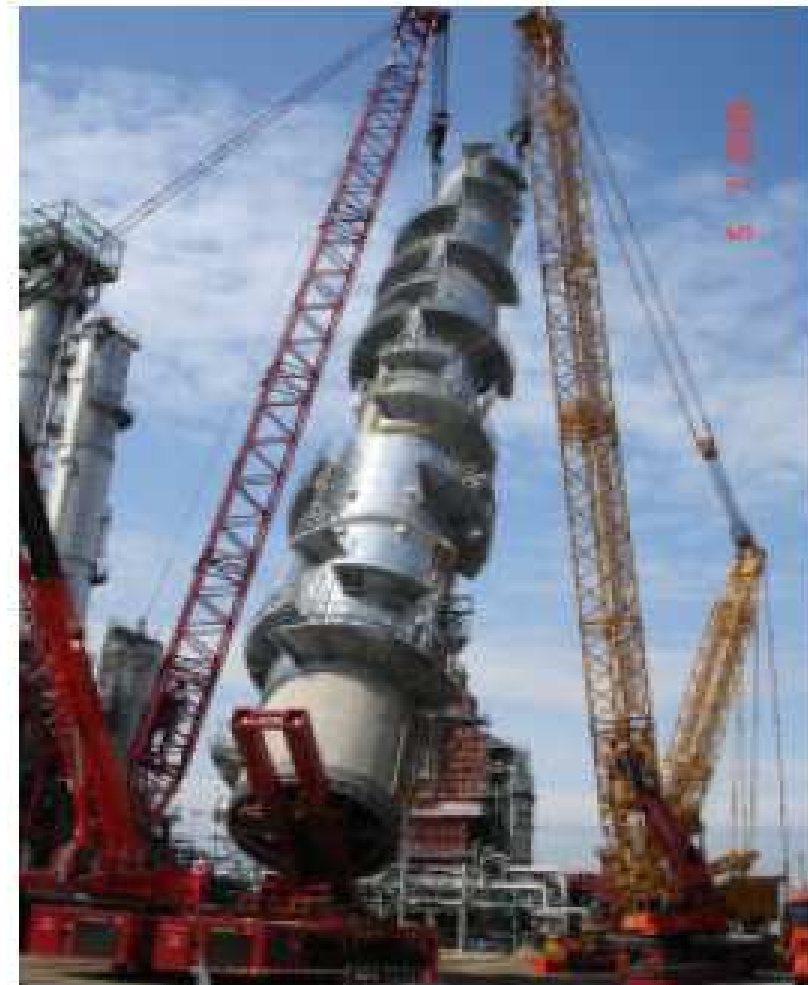
60m high by 5m OD tower - TSA coated

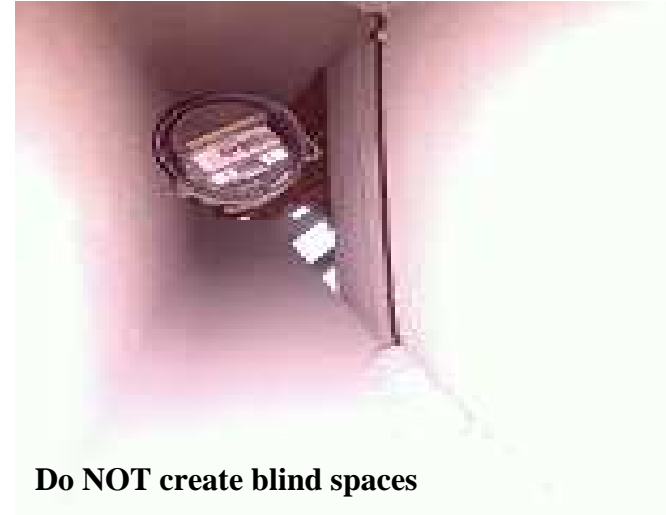
Do NOT create blind spaces

Do TSA complete vessel, supports, nozzles

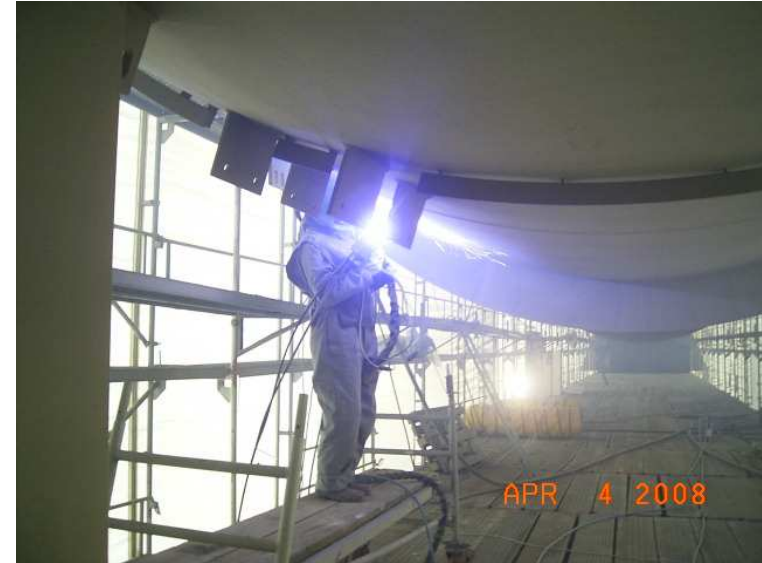
**Shop TSA of Tower:
60 m high x 5m OD.
Notice stand-off insulation
support rings - shell**

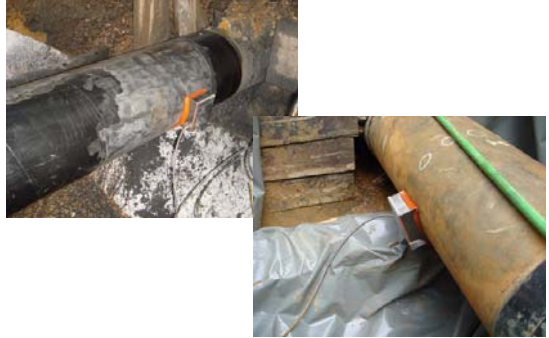
2 off Rightrax M2 Sensors were fitted at the locations as instructed on site located from the 3 O Clock to 9 O Clock position on both pipelines

Sensor Installed

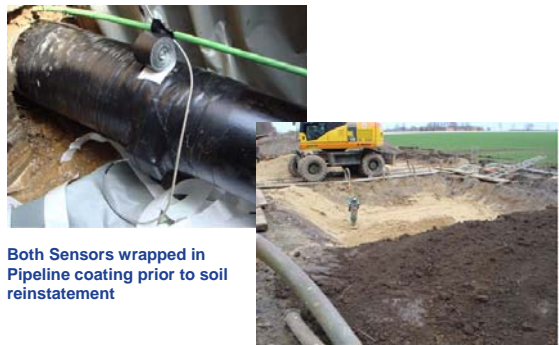
Both Sensors wrapped in Pipeline coating prior to soil reinstatement

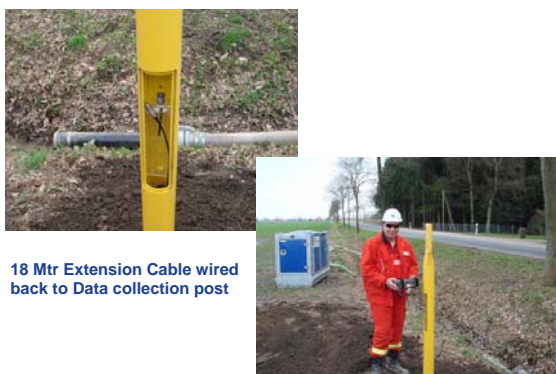
18 Mtr Extension Cable wired back to Data collection post

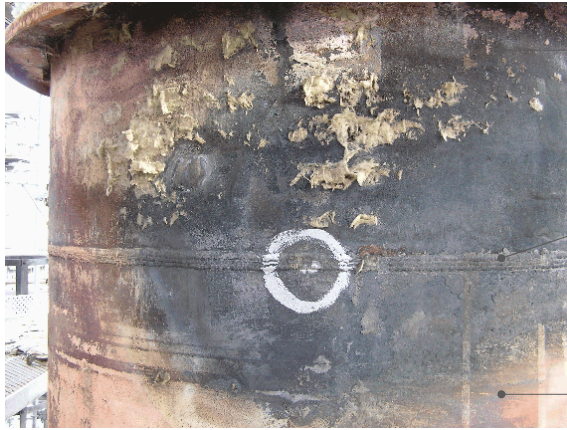
Field Inspection

ASTM A-387
Grade 12 Class 1
(1 Cr ½ Mo steel)

DMW / Closure weld
(carbon steel)

Small leak found at
fusion line between
DMW and carbon
steel base metal.

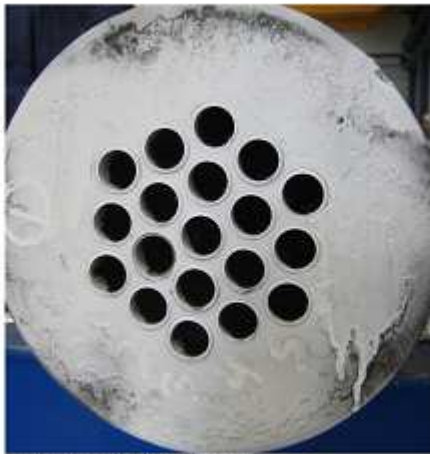
Tubesheet after rolling

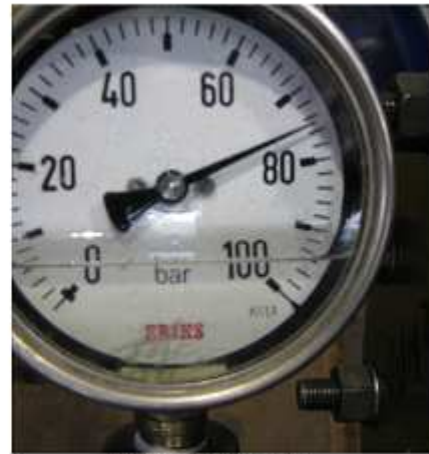
Manometer 75 bar

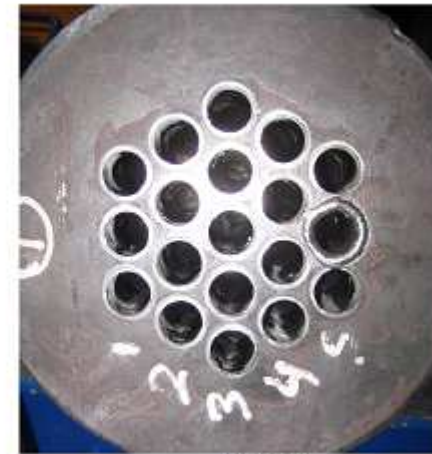
Sealweld
