Participants EFC WP15 meeting 8th September 2008 Edinburgh

EFC WP15 Activities

Corrosion of an ejector in a FCC

Poor service of Monel type alloys as distillation tower internals in refineries

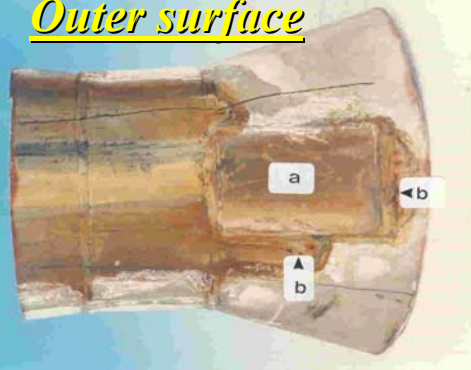
Outer surface

Outside: NaCl, NaOH, corrosion products of Ni, Mo, Fe.

*a – welded plate
b – locations of leakage*

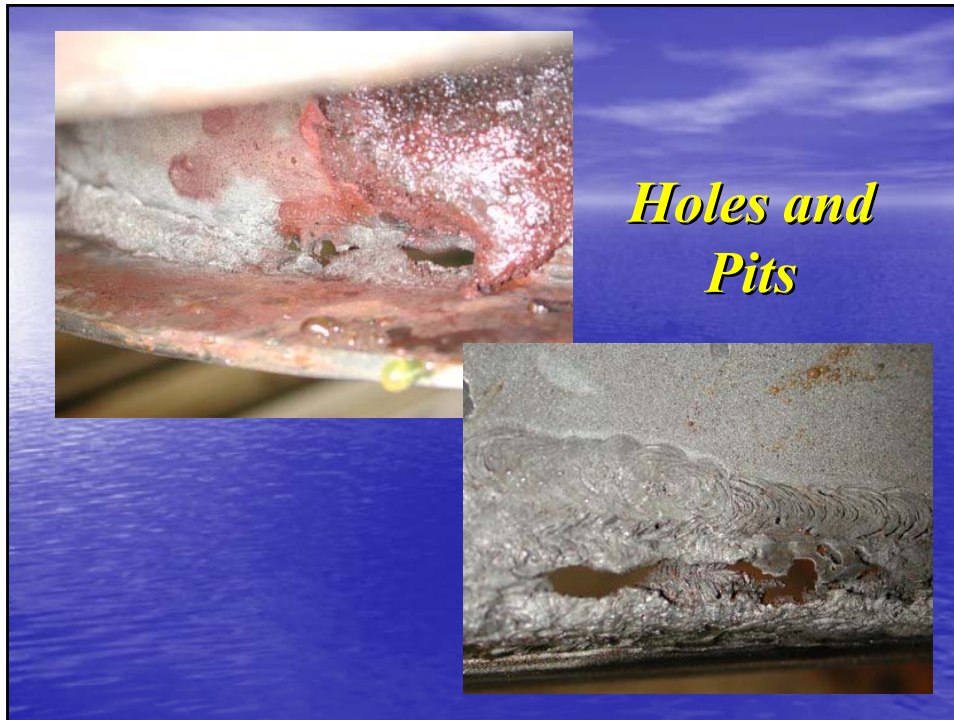
Cause: Dew point acid corrosion.

Remedies:

- 1. Keep the temperature above the dew point ($\geq 130^{\circ}\text{C}$).*
- 2. Change of geometry.*
- 3. Apply inner ceramic flexible protective coatings ?*
- 4. Utilize high temperature inhibitors ?*

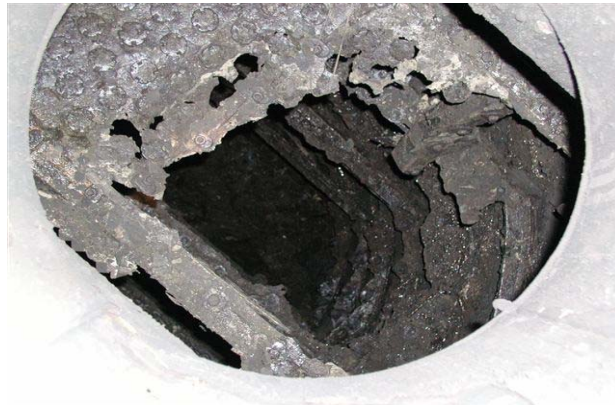
View of the completely corroded tray section

- Selective leaching of copper from Ni:Cu matrix of Monel 400 alloy – De-alloying
- Proved by X-Ray microanalyses of metal surface and
- X-Ray diffractometric analysis of corrosion products
- Cause of corrosion:
 - Attack of complex forming species (ammonia and cyanide ions) under heavy ammonium bisulfide/chloride deposits

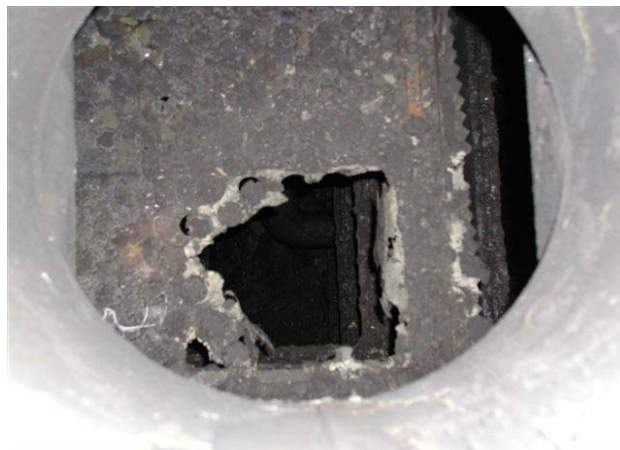
View of a less heavily damaged tray

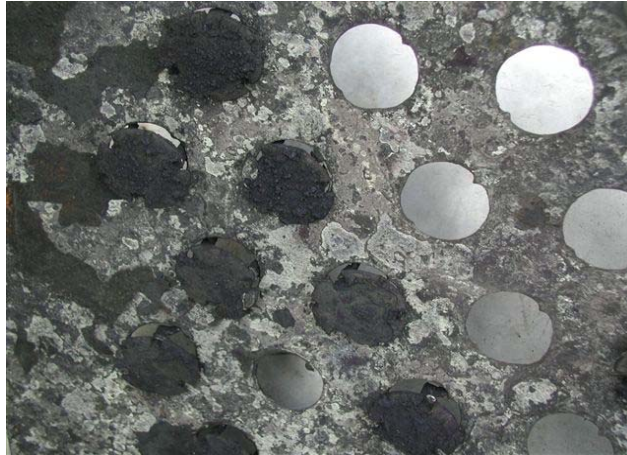
Corroded valve tray

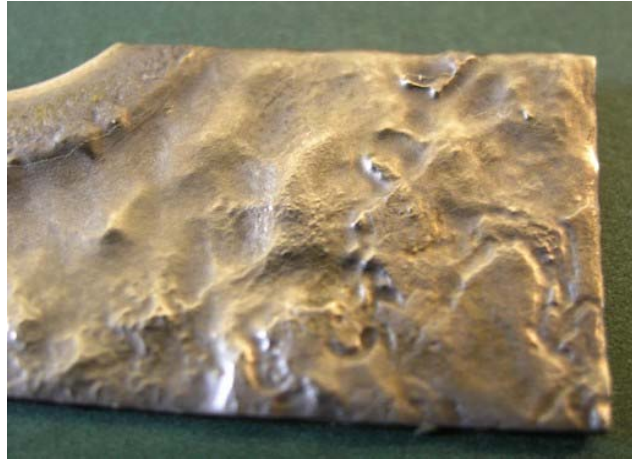
Specimen of tray material after removal of deposits

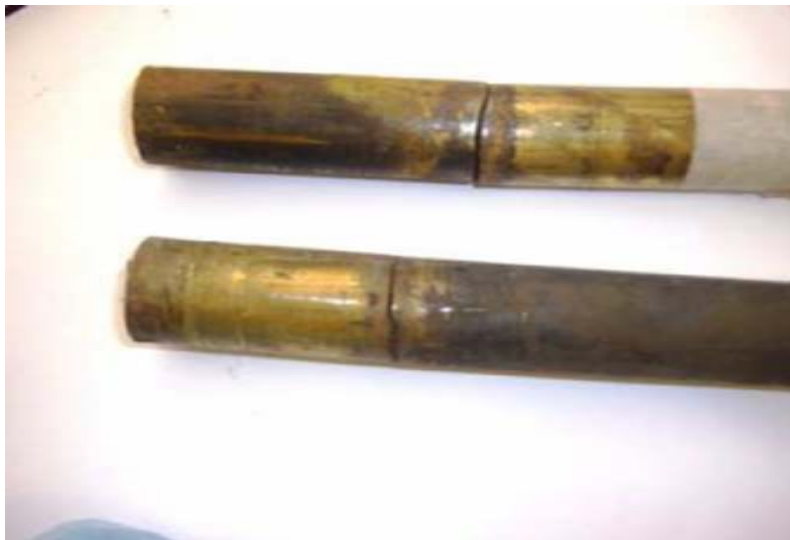
Tube cracking at expanding end area by over-stress

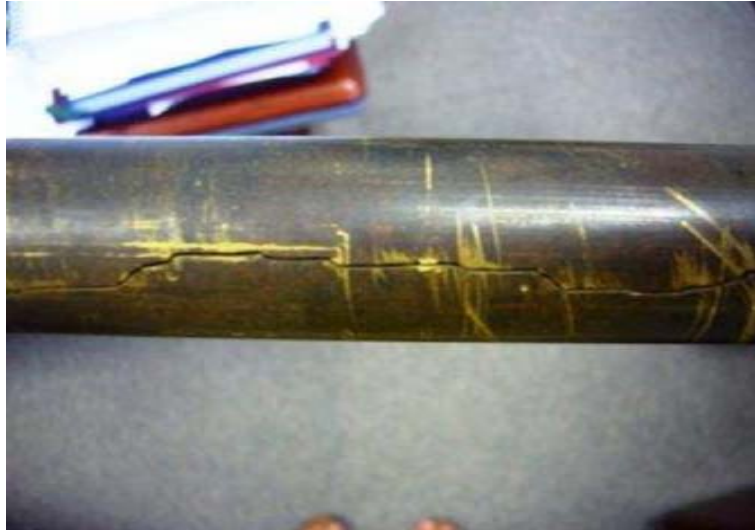
Tube cracking at middle area by ammonia SCC

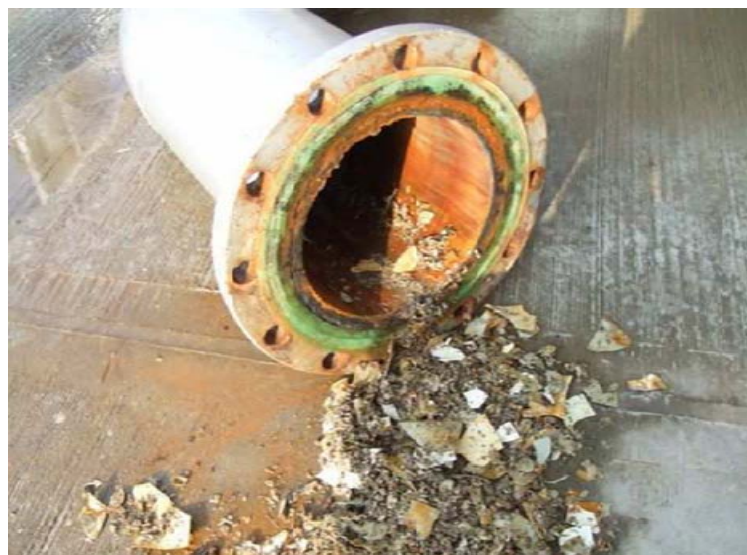
Debris from thre sea water

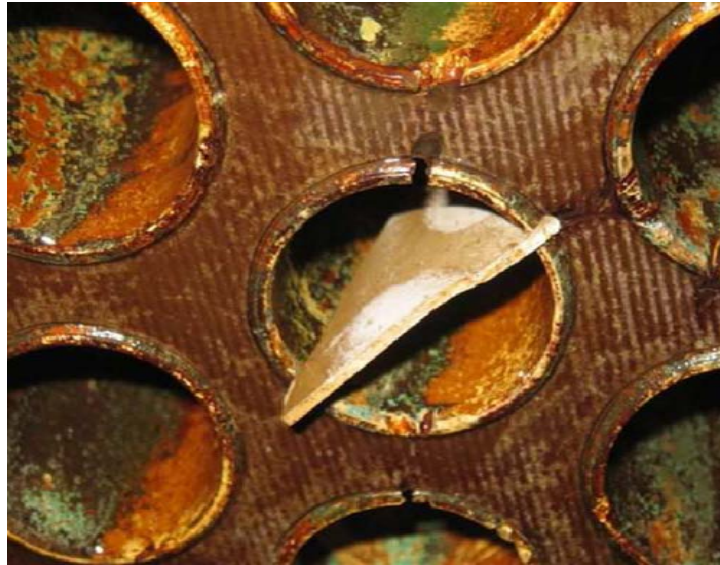
Debris from thre sea water

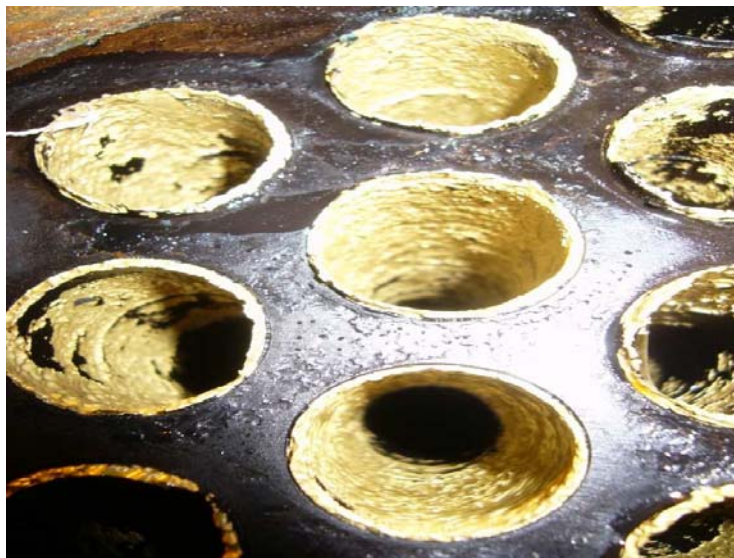
Tube end erosion by high velocity sea water

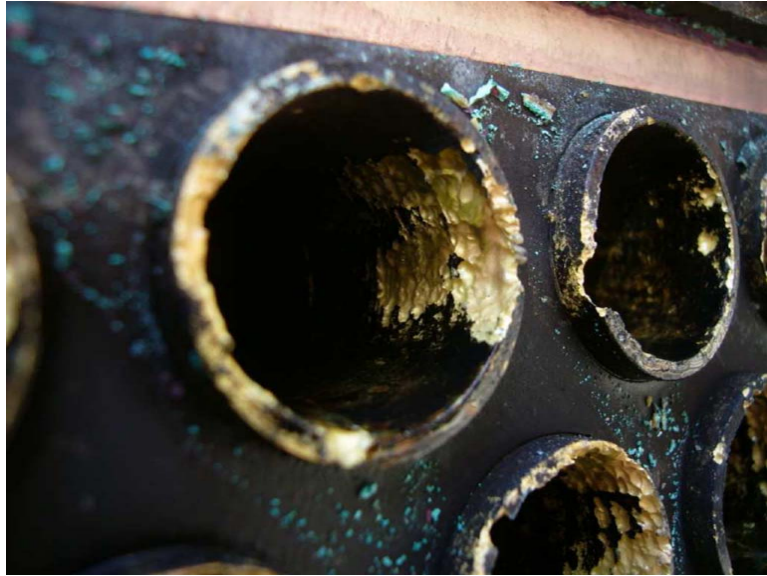
Tube end erosion by high velocity sea water
