Participants EFC WP15 meeting 22th June 2010 Budapest (Hungary)

Anti – Corrosion Management in MOL Refining

EFC WP 15 meeting

Budapest, 22.06.2010

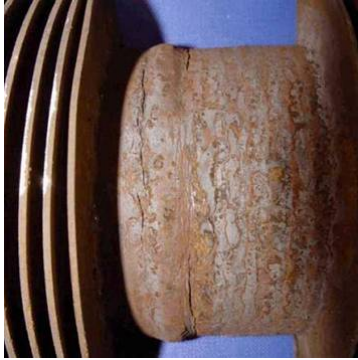
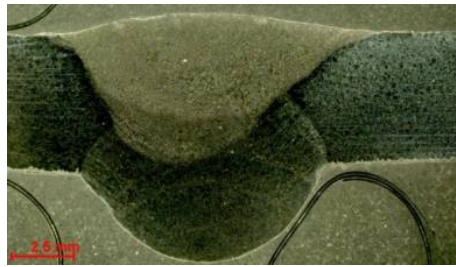
Location : primarily in heat affected zone but not only !

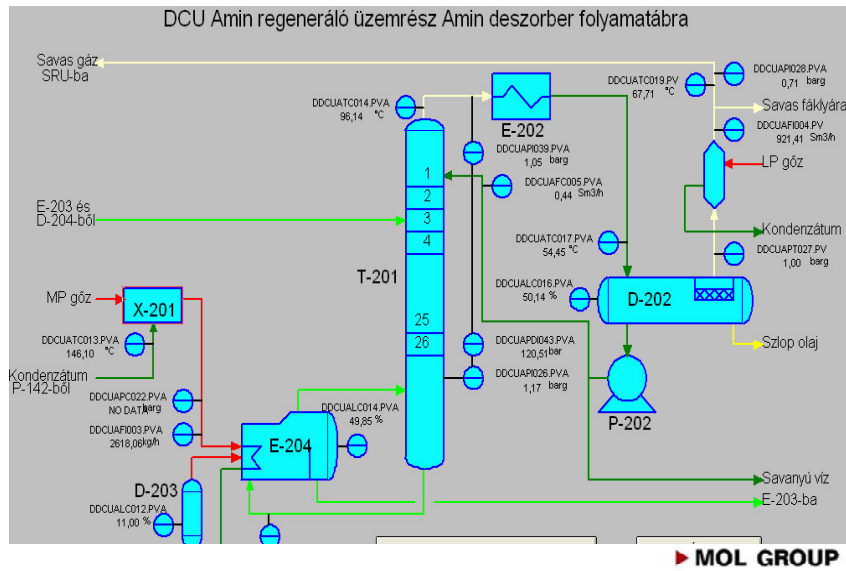
The failed T 201 Amine regenerator column with connecting units

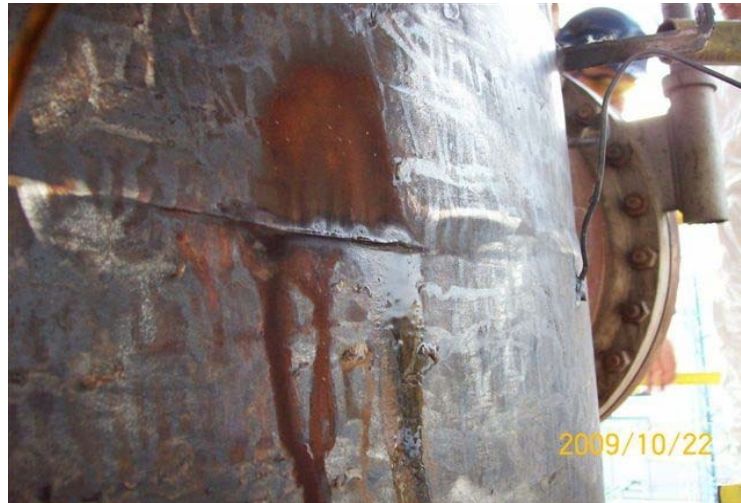
View of corroded section from outside

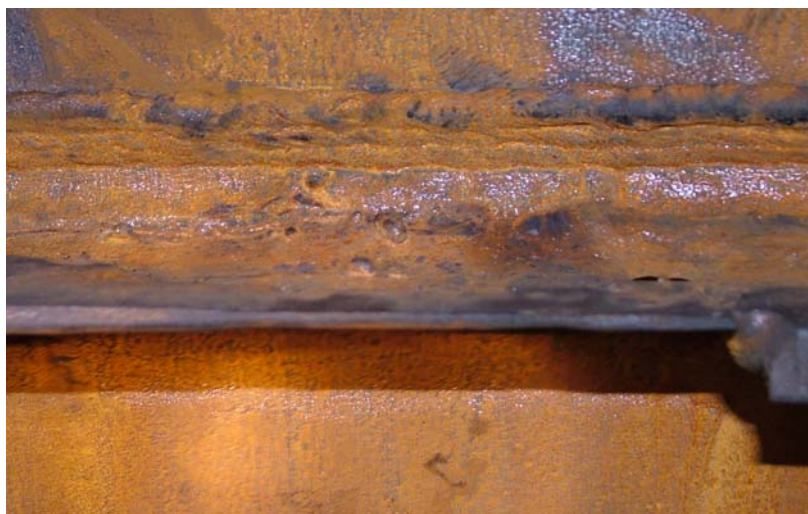
Thinning of tray holding ring and damaged weld

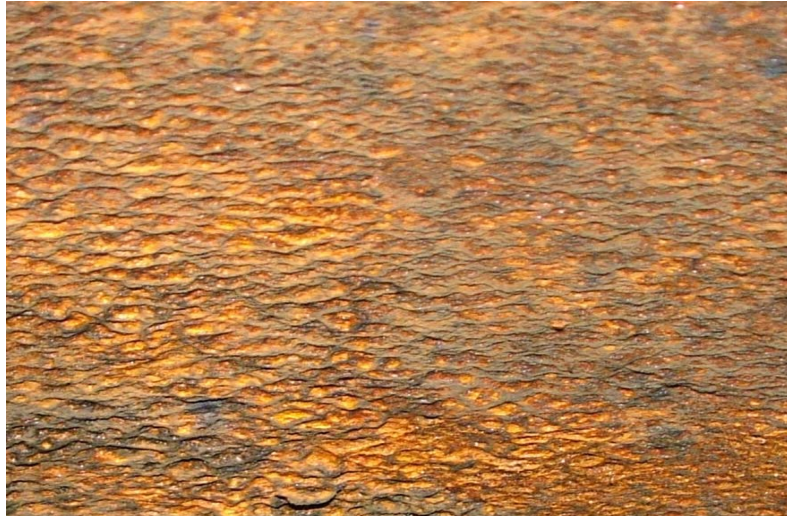
Corroded internal wall showing erosion-corrosion pattern

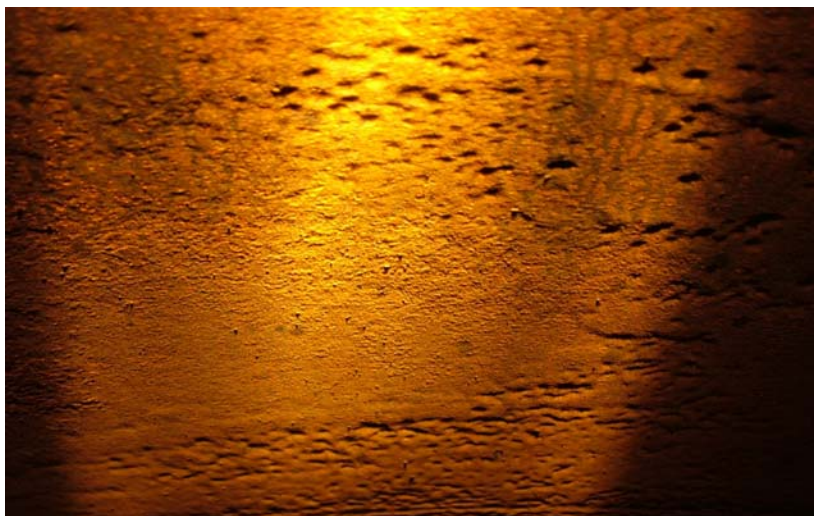
Serious pitting caused by free carbon - dioxide

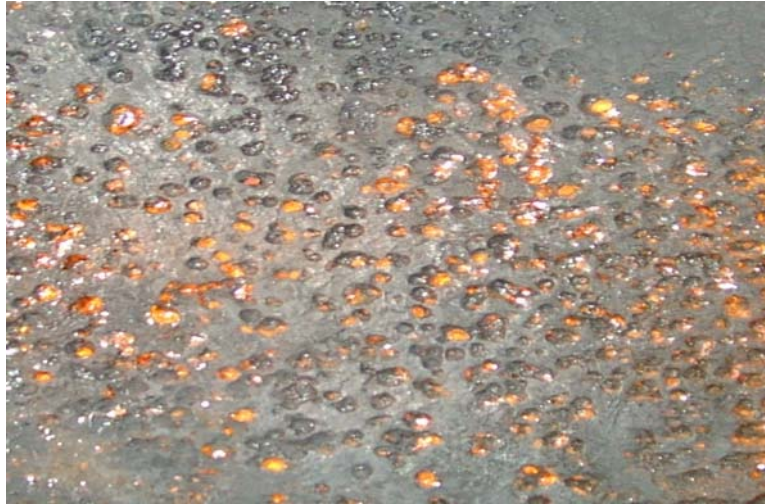
Serious pitting caused by free carbon - dioxide

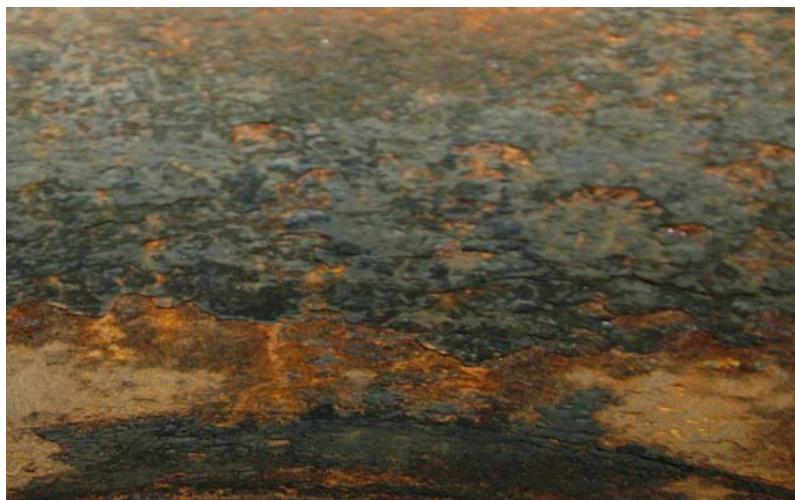
Heavy deposits of corrosion products and heat stable salts

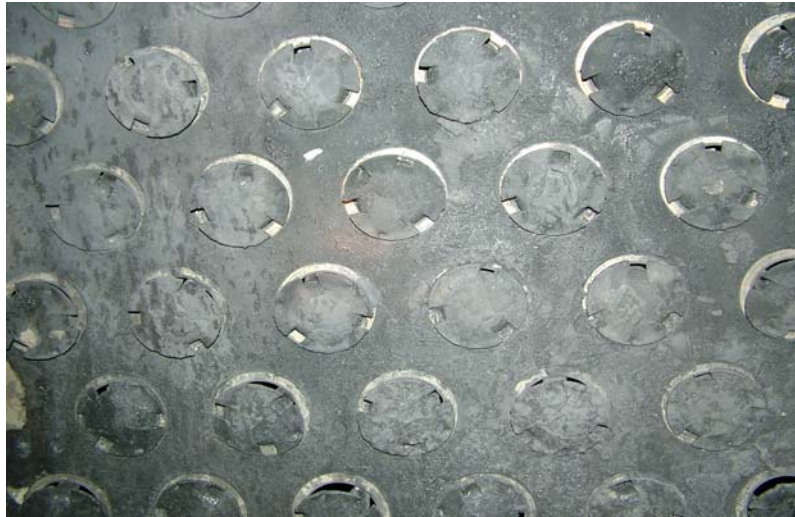
304SS valve trays in good condition

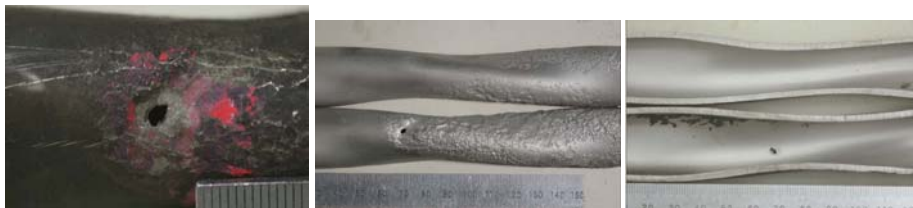
- **Corrosion damage on the tubes**
 - ✓ Hole in the tube wall
 - ✓ Corrosion isolated to shell side
 - ✓ Corrosion problems limited to the bottom row of tubes

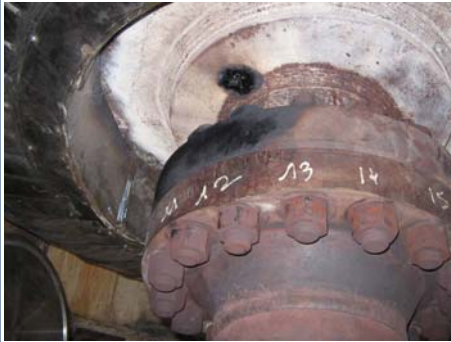
► Product leak on the vent hole of the reinforcing pad.

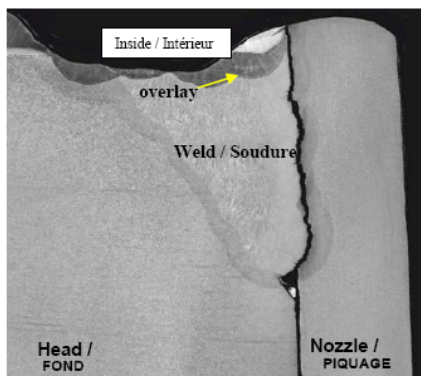
Fissure dans soudure côté piquage
Crack in the weld on nozzle side

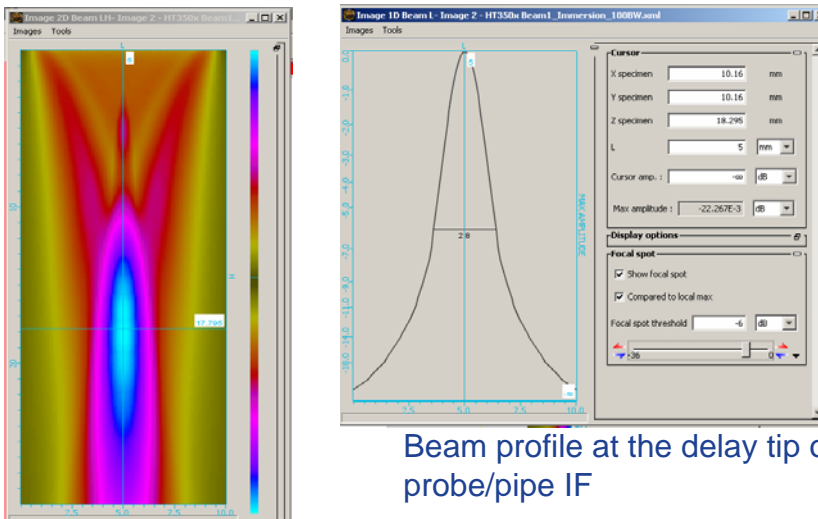
Acoustic beam in the delay

Beam profile at the delay tip or
probe/pipe IF

3 dB width = 1.9 mm

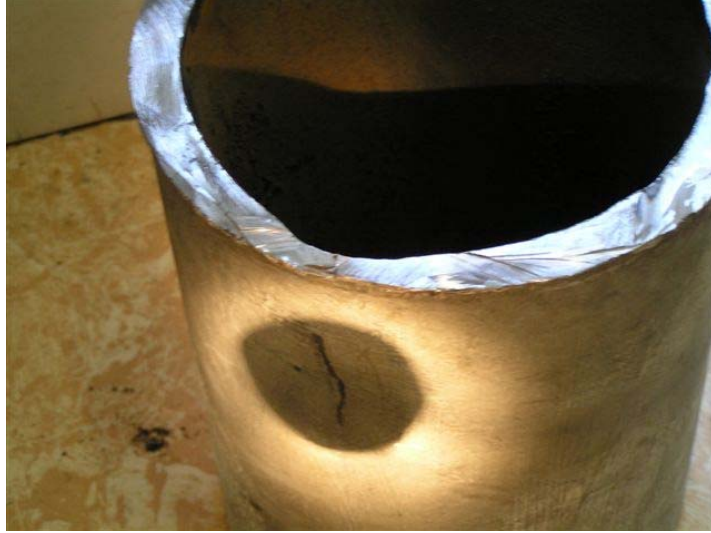
Example 1: VGH piping defect 1

- The scope of defect 1 was local: approx 30 cm long damaged area
- UT thinning monitoring point was approx. 1 m from place of defect - measurements didn't indicate any thinning.
- The scope of defect 2 was local too, no UT monitoring specified before.

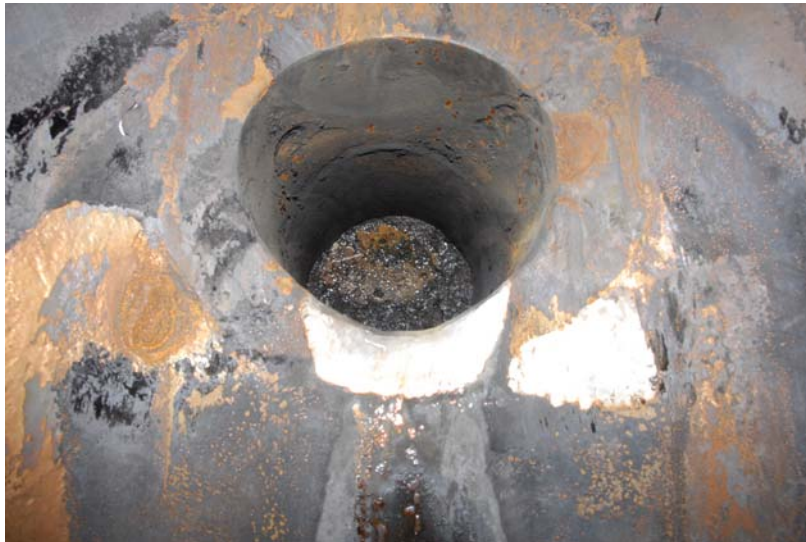
Example 1: VGH piping defect 2

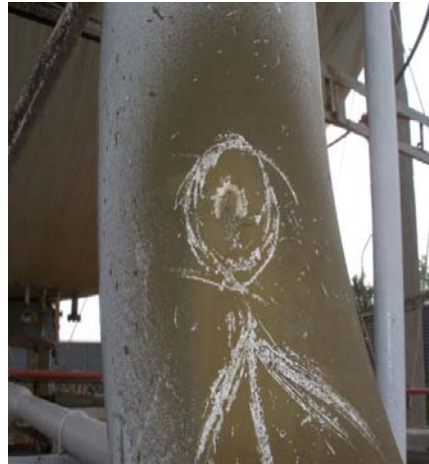
- Leakage on the propane pipes into spherical tank
- Localized thinning of elbow-pipe
- The pipes were not regularly checked in the past because no defect measuring was still indicated
