**EFC Working Party 15 « Corrosion in Refinery » Activities**
EUROPEAN FEDERATION OF CORROSION <http://www.efcweb.org/Working+Parties-p-104085/WP%2B15-p-104111.html>

**EFC Working Party 15 « Corrosion in Refinery »**
EUROPEAN FEDERATION OF CORROSION

**EFC WP15 Corrosion Refinery Industry
10th April 2019 Meeting**

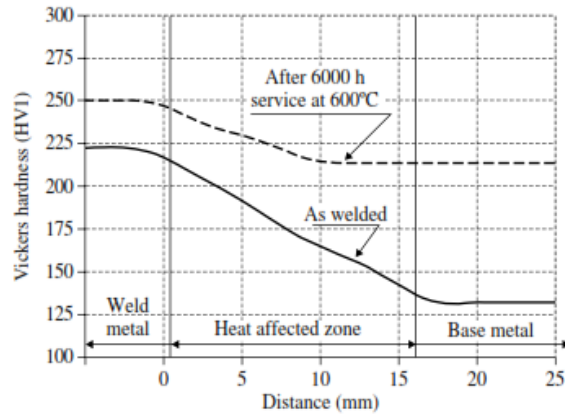
Alloy 800H after service @ 600 °C

"Age hardening" effect can induce hardness level greater than the one typically found in annealed austenitic materials

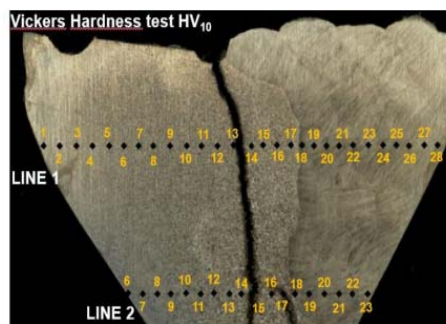
Real Case

- Parent Material AISI 321H, consumable E347
- Piping system 70 mm thick butt weld failure
- Crack in HAZ
- 650 °C , 2000 hrs

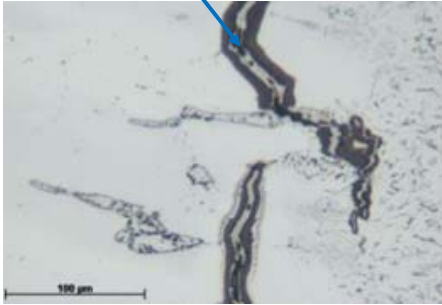
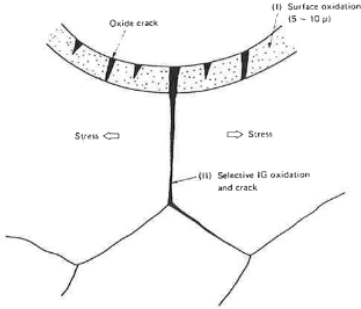
Real Case

AISI 321H failed at 650 °C
Metallic filament (iron rich)

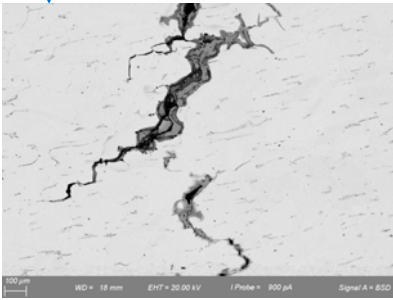
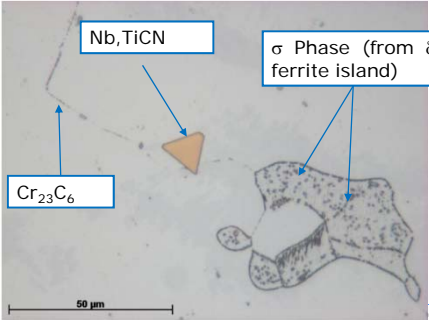
- SRC is **grain boundary related mechanism**
- Presence of sigma phase can promote the phenomenon?
- Real case on 321H heavy pipe weld (1200 hrs @ 600 °C)
 - Some step wise propagation at crack tip
 - Presence of scattered sigma phase at grain boundaries
 - Secondary influence?
 - Further reduction in HT ductility?

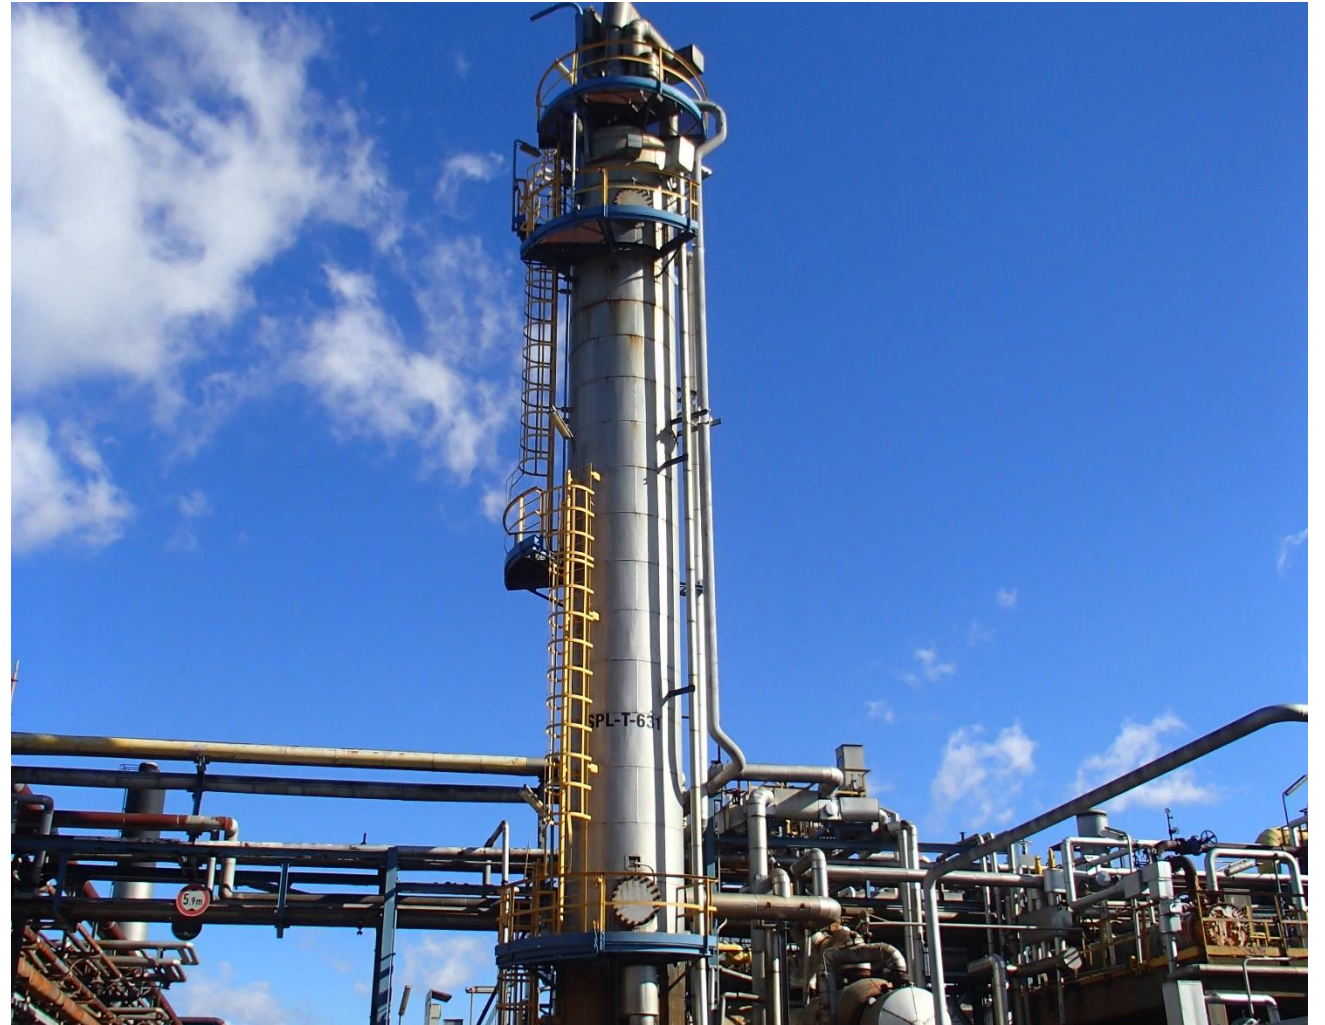
MEA-Regenerator with removed insulation

If you have old insulated stainless steel equipment, take care of it!

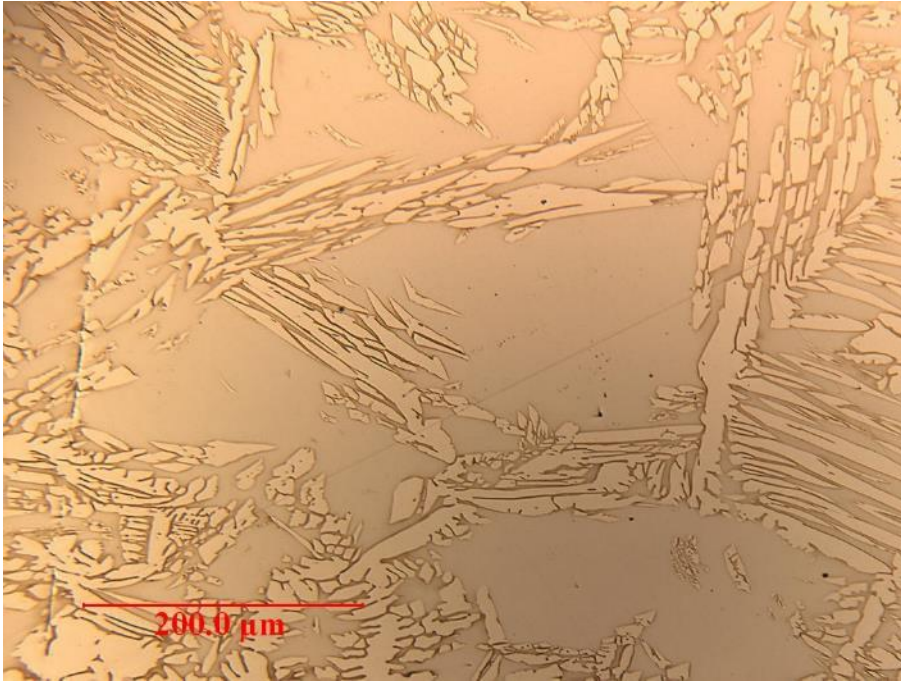
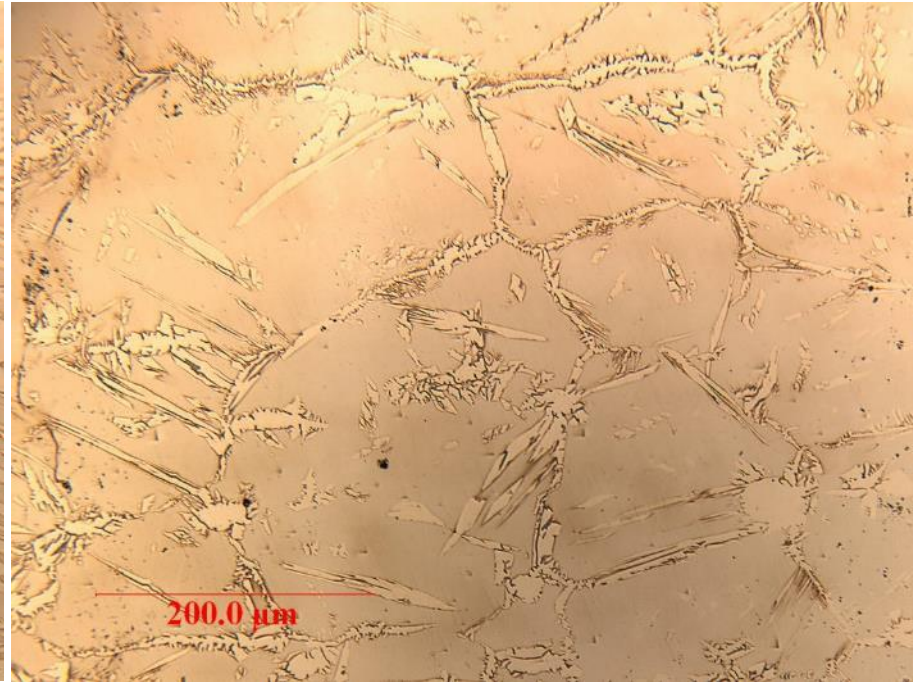
Microstructure of Gleeble specimen : slow cooling (left), fast cooling (right)

Microstructure morphology is similar to the microstructure observed on real welds

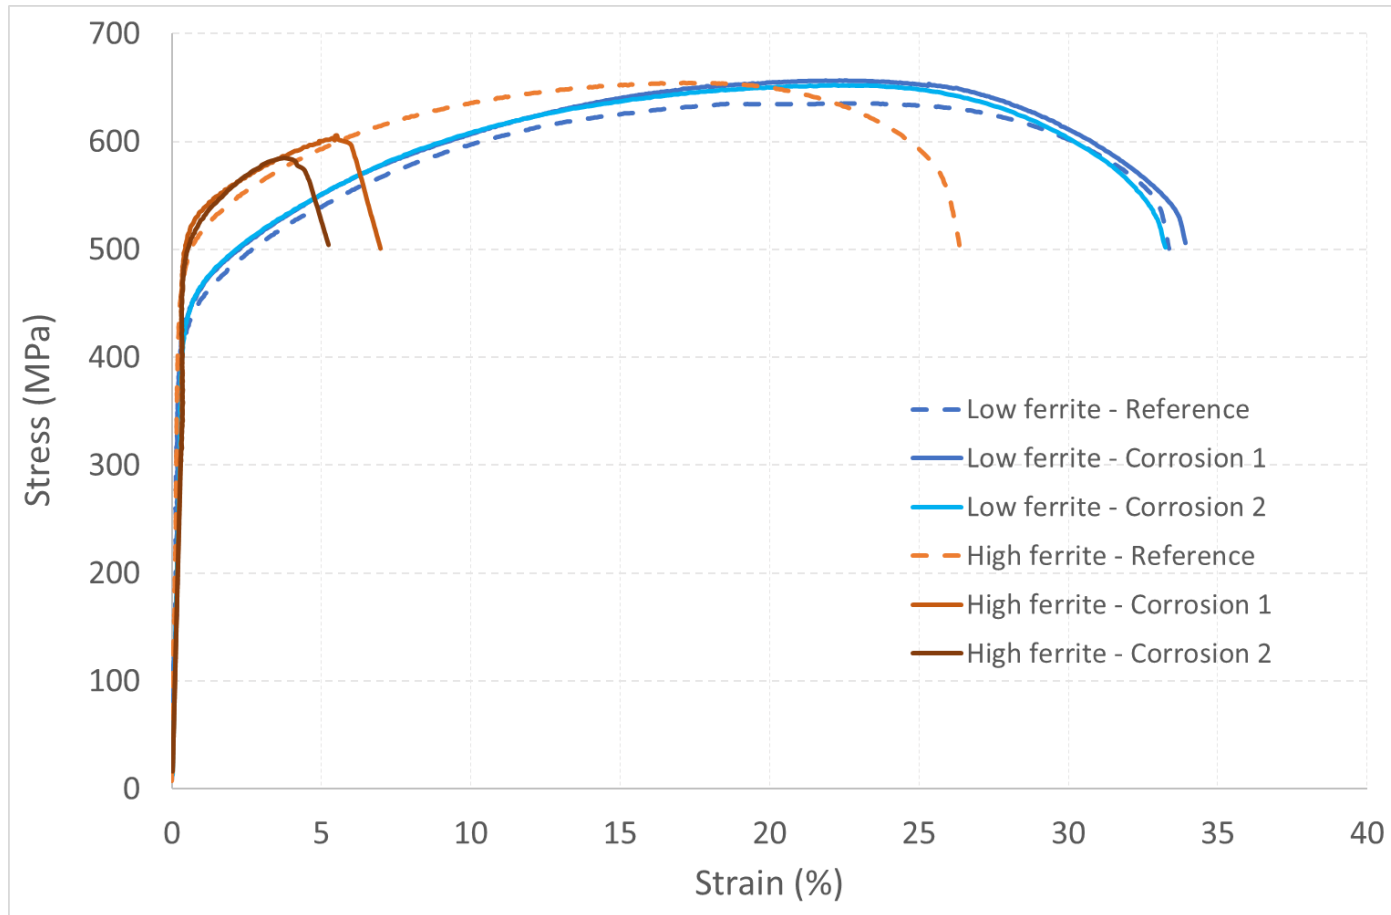
SSRT curves in $100 \text{ g L}^{-1} \text{ NaCl}$, $0.5 \text{ bar H}_2\text{S}$, $\text{pH}=4.5$, 90°C

- No stress corrosion susceptibility for ferrite content around 58%
- High stress corrosion susceptibility for ferrite content around 75%

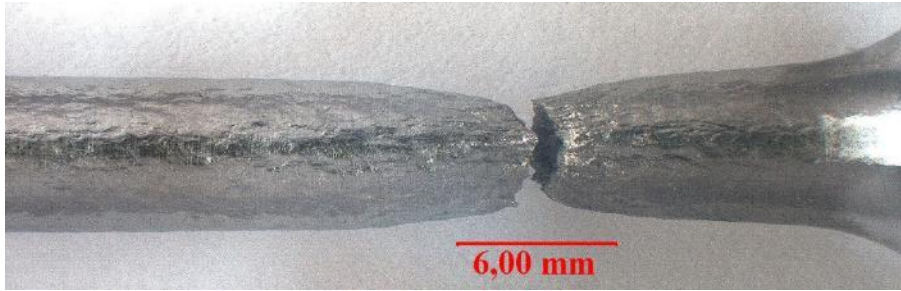
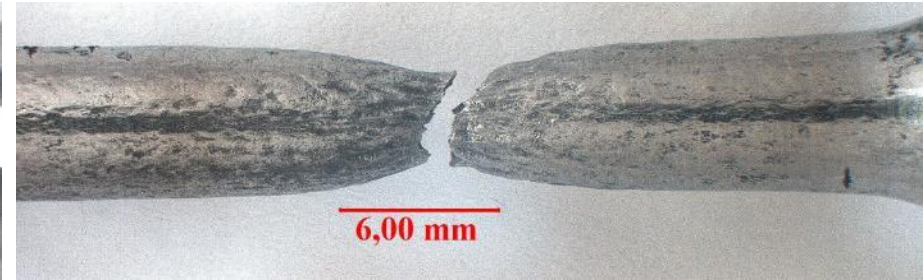
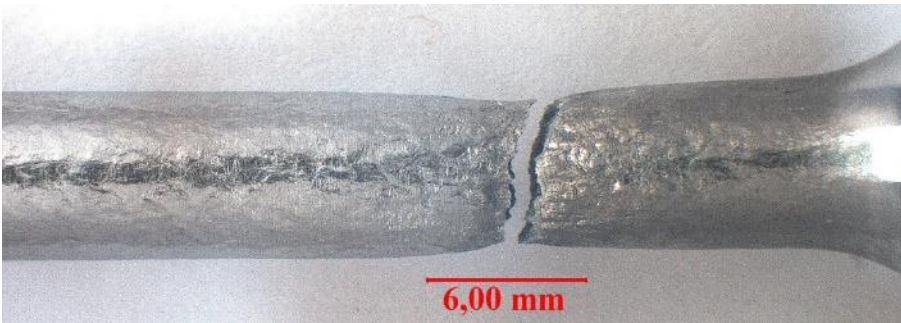
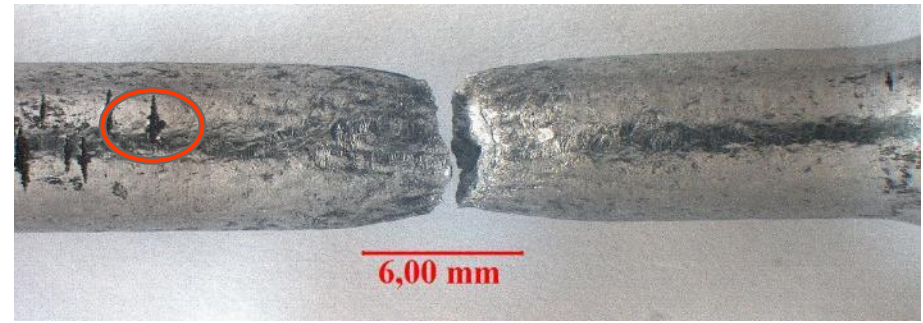
SSRT specimen in glycerin

SSRT specimen in corrosive environment

- Failure is anisotropic
- Small corrosion sites
- No loss of mechanical properties

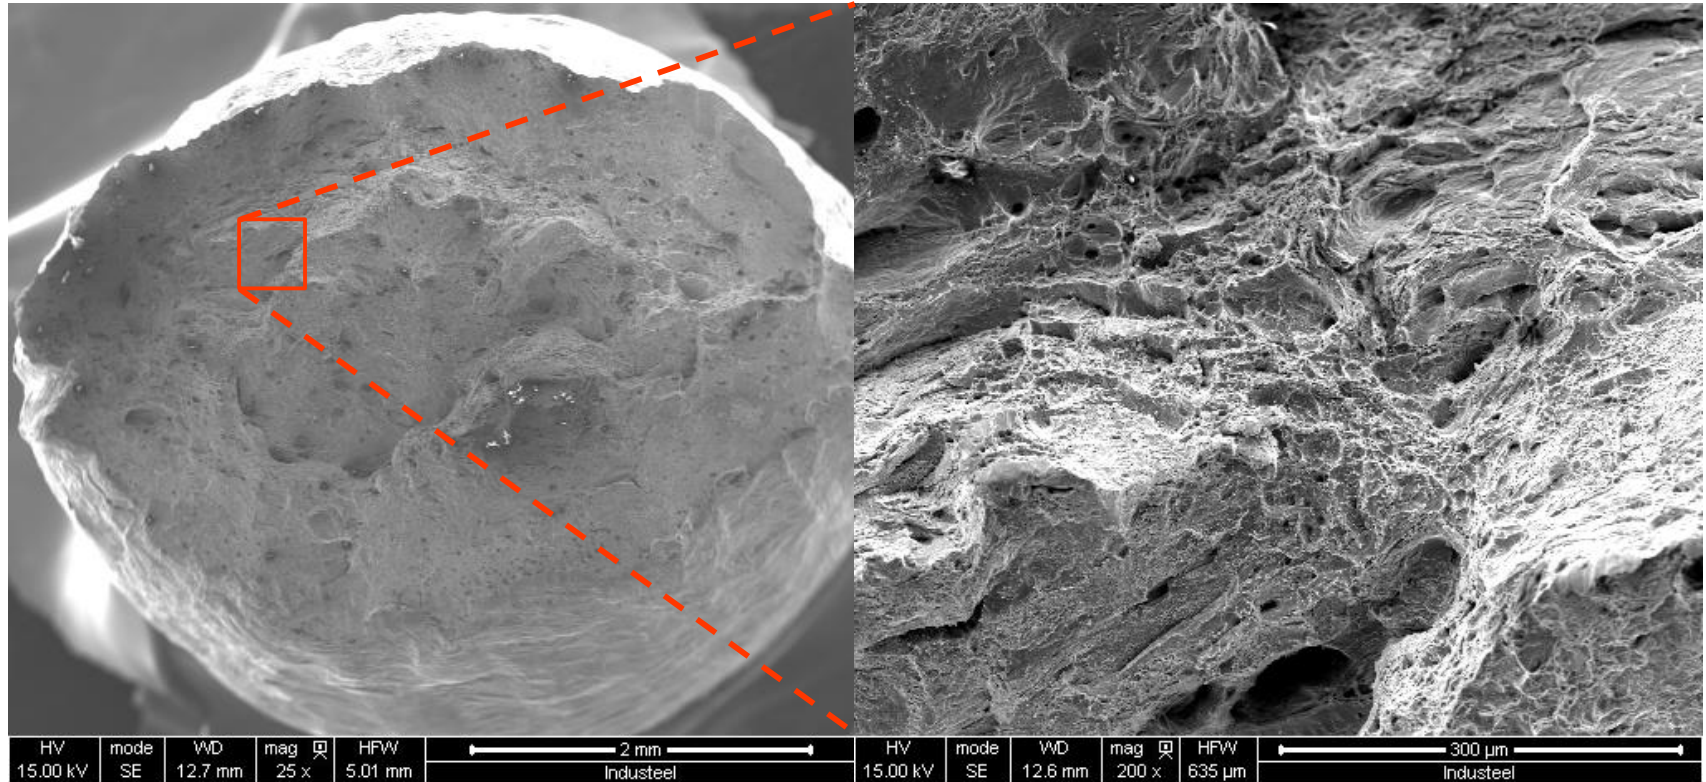
- Fracture surface is anisotropic due to the microstructure (rolling direction)
- Fracture surface is fully ductile

No sensitivity to stress corrosion have been observed though macroscopic and microscopic characterizations

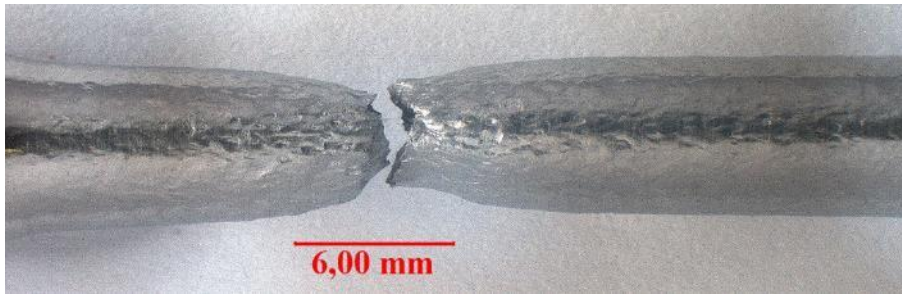
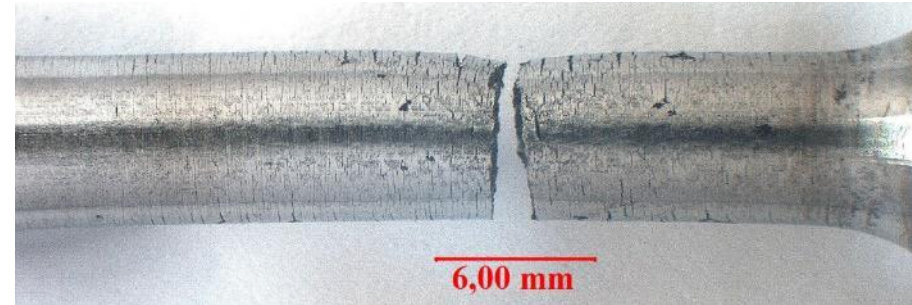
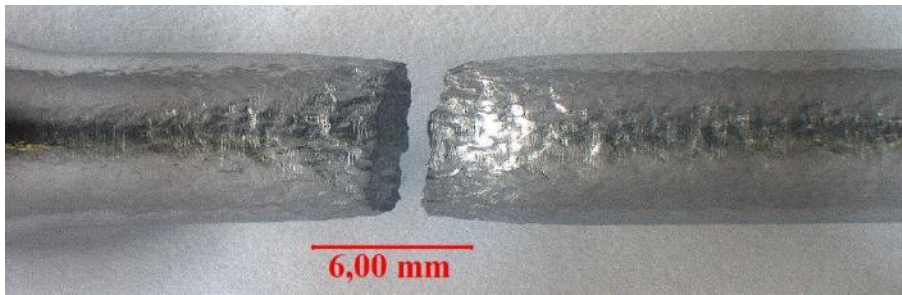
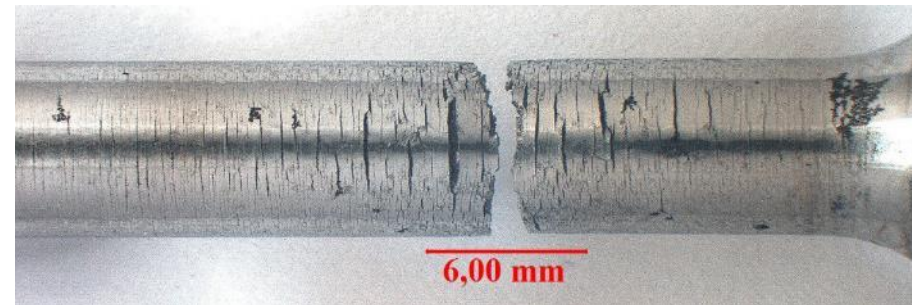
SSRT specimen in glycerin

SSRT specimen in corrosive environment

- Failure is anisotropic
- Multiple secondary cracks
- High loss of mechanical properties

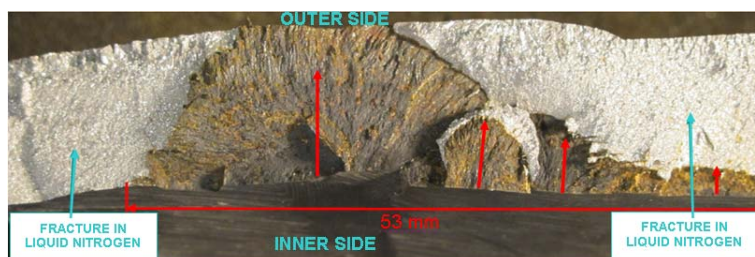
Crack initiation zone on the shell inner side and presence of a layer of adherent and compact deposits, black - brown colored, on the whole surface of the fracture

Elliptical and irregular morphology ("terraces"), characterized by multiple propagation fronts, not homogeneous, on different planes

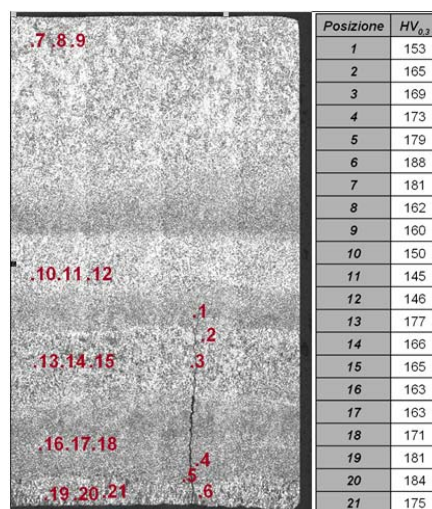
Microhardness HV_{0,3}

No anomalies revealed as high hardness zone close to the crack (typical critical max value can be 248 HV)

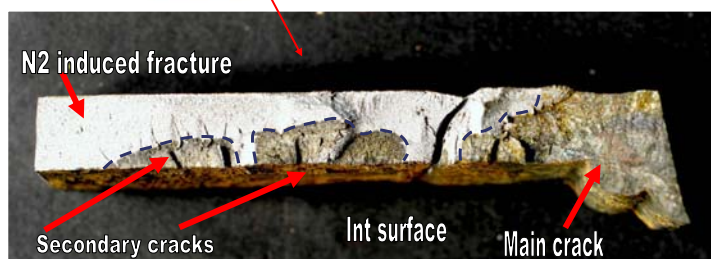
SEM + EDS examination

- Irregular "terrace like" fracture surface with dark deposits
- Pseudo-elliptical shape

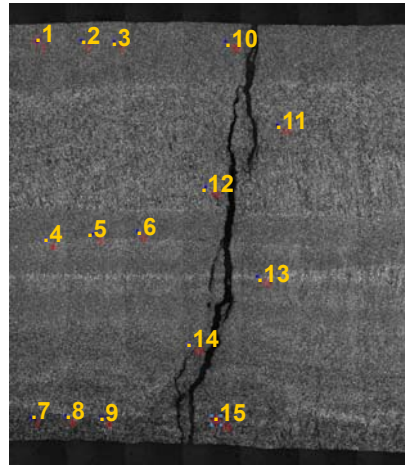
Microhardness HV_{0,3}

No anomalies revealed as high hardness zone (typical critical max value can be 248 HV)

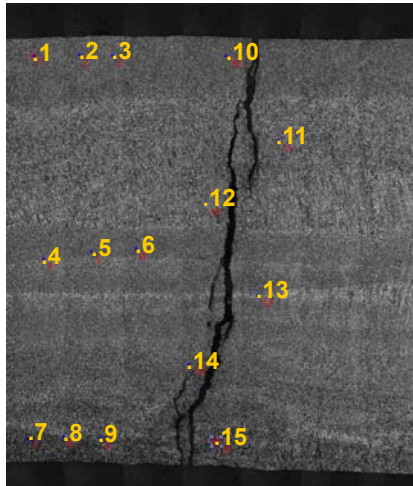
Microhardness HV_{0,3}

No anomalies revealed as high hardness zone (typical critical max value can be 248 HV)

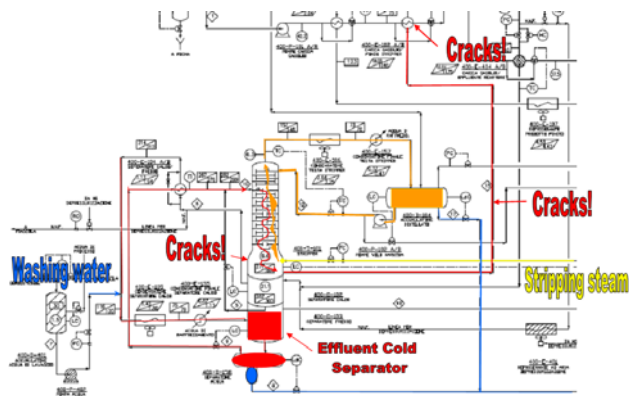
- Discontinuous, non steady-state service of the circuit can cause water separation and accumulation.
- Alkaline water with high pH, ammonia, H₂S, chlorides, carbonates, (Na-alkalinity?), (Oxygen??) – EAC Active!
- Start up and transient service cycle can cause fast heating, water evaporation, concentration of aggressive ions and thermal-transient stress/strain (slow strain rate) acting together with residual welding stresses

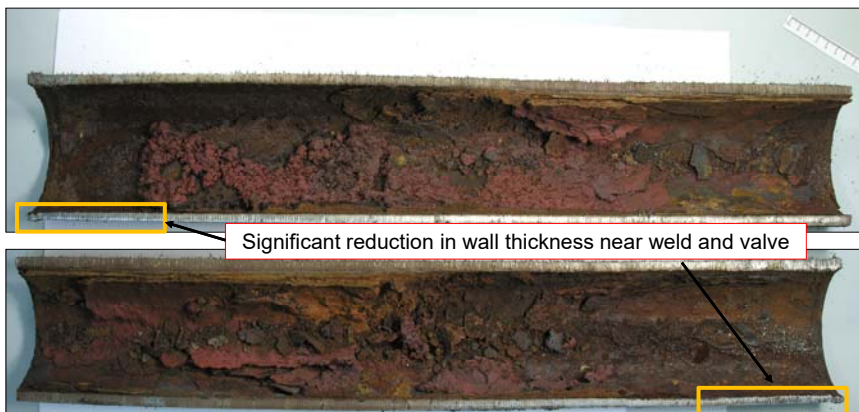
Visual inspection of dead-leg

- Inner surface shows thick deposits up around 10 mm thick.
- Deposits appear mostly red-brown.
- Wall thickness reduced the most near weld (squares).

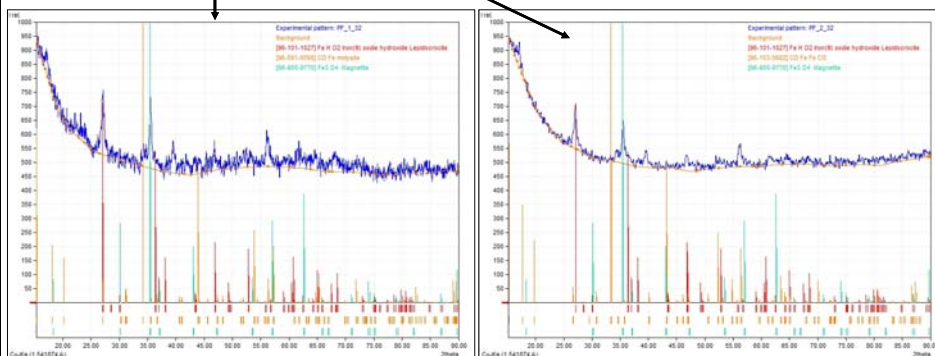
Analysis of deposits by X-ray Diffraction

- Deposit in zones A and B are chemically similar:
- Zone P: FeO (OH) = 50wt%, Fe3O4 = 35wt%, FeCl3 = 15%.
- Zone Q: FeO (OH) = 57wt%, Fe3O4 = 35wt%, FeCl3 = 8%.

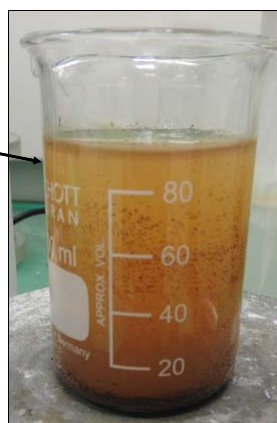
Analysis of deposit properties in tap-water

pH of tap water = 7.57.
pH of deposit in tap water
after 1 hour = 3.01.

- Deposit appears to partially dissolve in tap water giving acidic pH.
- Low pH suggests hydrolysis of FeCl3 (formation of hydroxide and H+).

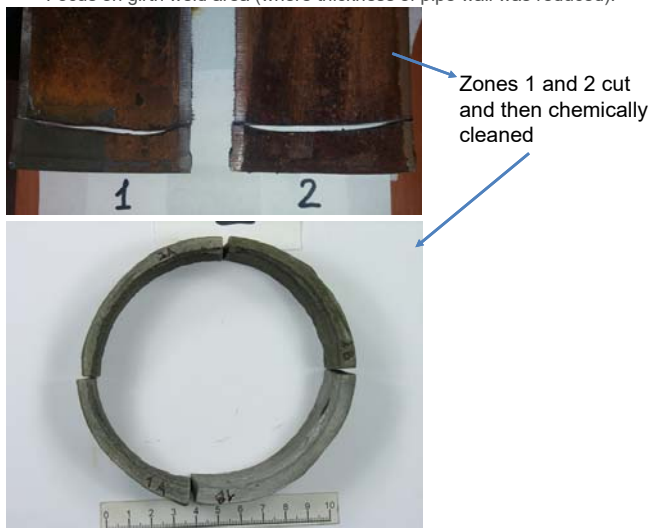
- Focus on girth weld area (where thickness of pipe wall was reduced):

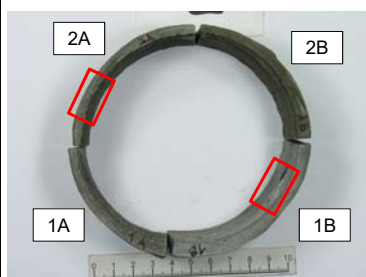
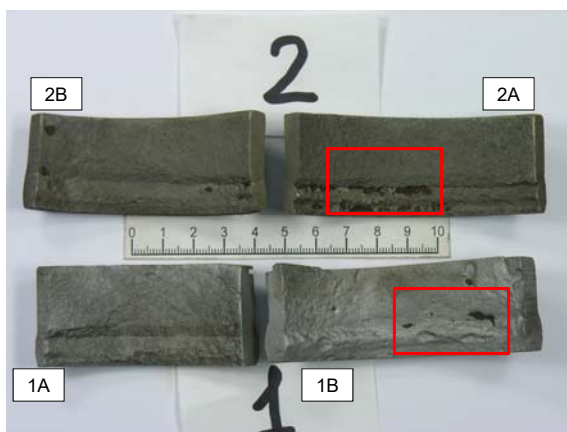
Selection of zones for SEM-EDS and Metallography (2)

Zone 2A => area with minimum wall thickness (HEAVY DAMAGE).

Zone 1B => area at 180° to zone 2A (LIGHT DAMAGE).

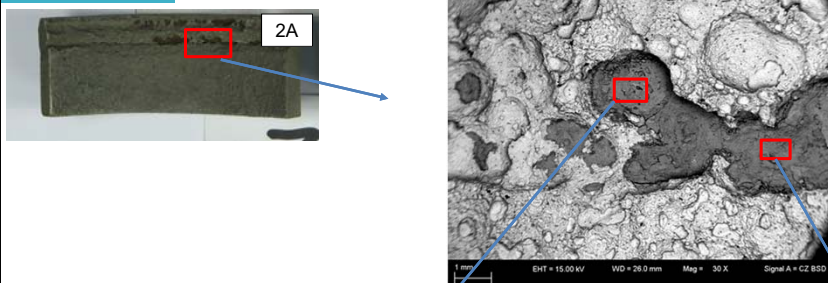
SEM-EDS on surface of heavy damage zone

- Zone 2A reveals round corrosion sites of several mm in diameter in base and weld.
- SEM-EDS shows main elements as O, Fe, Cl.

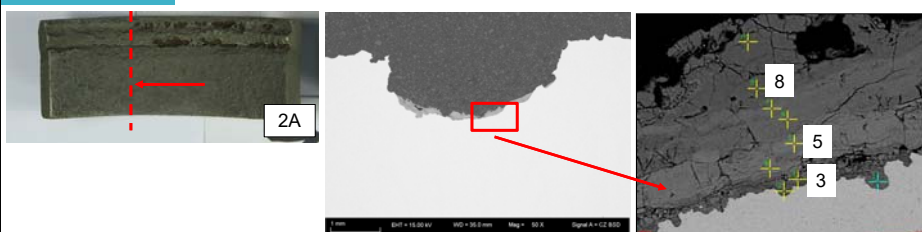
SEM-EDS after sectioning at heavy damage zone

- Corrosion products in cross section contain O, Fe and Cl.
