Participants EFC WP15 meeting 13th September 2007 Freiburg

EFC WP15 Activities

External corrosion control program at the Humber Refinery

CORROSION IN REFINERY INDUSTRY FAILURE ATLAS

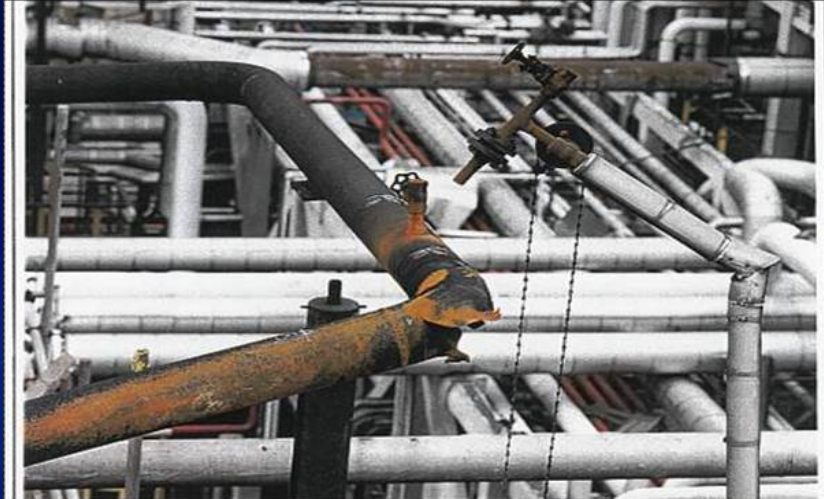
- On 16th April 2001, an explosion and fire occurred at the ConocoPhillips Humber Refinery.
- A 6" pipe carrying flammable gases failed just after an intermittent water wash location on the De-Ethimizer Overhead system.

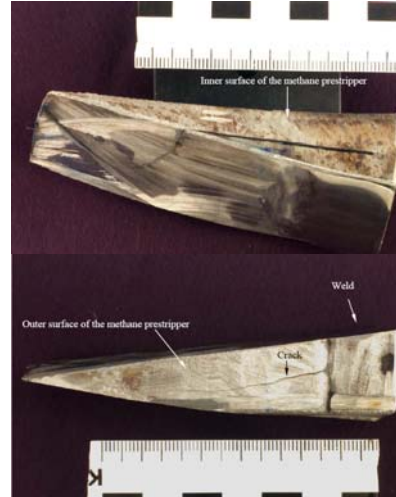
- Removed crack for investigation
- Visual examination
- Hardness measurements
- δ -ferrite measurements
- Fractographic examination
- Metallographic examination
- Chemical analyses

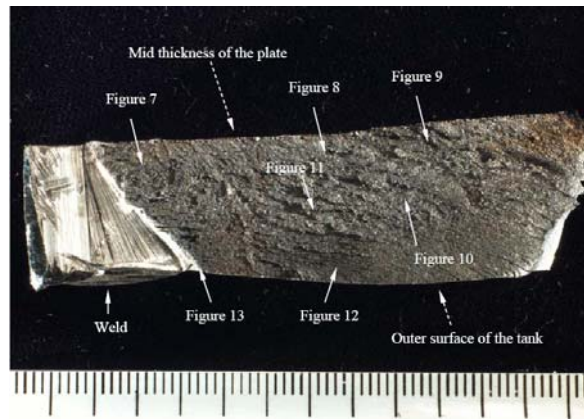
- Cracking in mixed-mode
- Intergranular & transgranular cleavage
- Positions 7, 8, 9,10,11,& 12

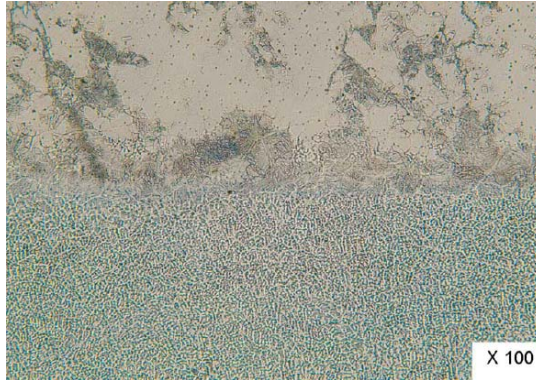
- Bottom - weld metal
- Middle - heat affected zone
- Top -base material

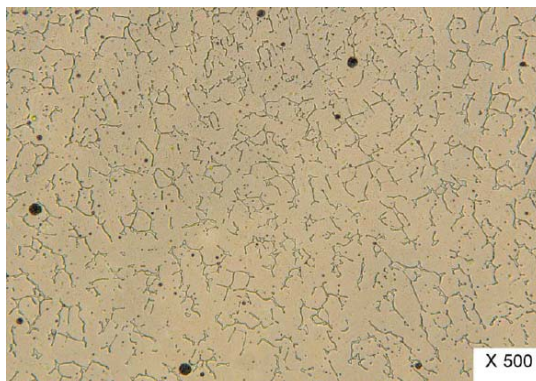
- Microstructure of the weld metal
- 5 – 10% δ -ferrite

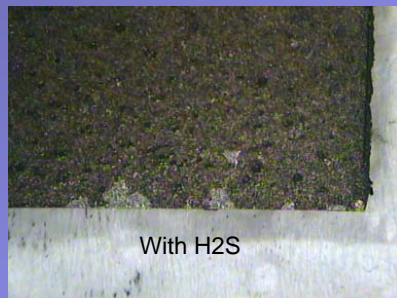
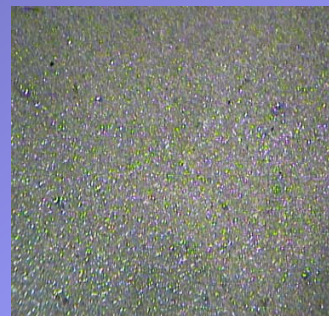
- We never observed the *mesa attack* morphology (as expected)
- Corrosion morphology was generalized.
- Sulfur produces a black, compact and protective film on the surface
