Participants EFC WP15 meeting 8th April 2014 Mechelen (Belgium)

EFC WP15 Activities

Presentation of the activities of WP15

EFC Working Party 15 « Corrosion in Refinery » Activities

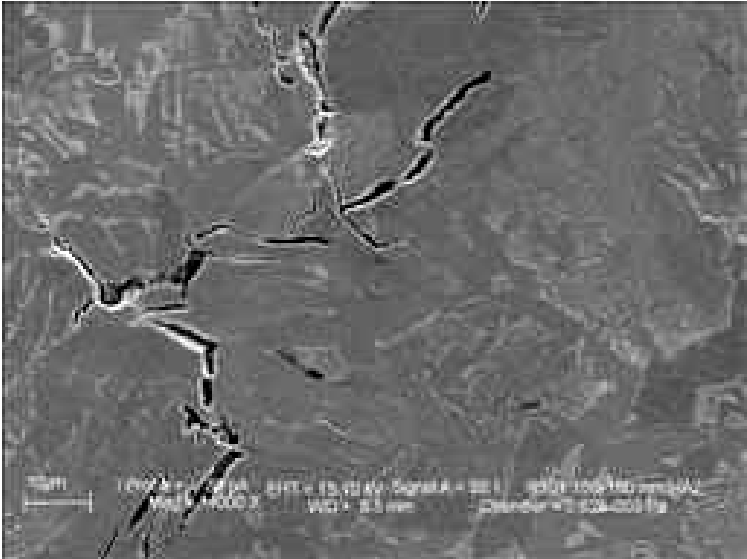
Figure 6: At higher magnification intergranular fissures next to pearlite colonies were observed.

2500x

5000x

displayed intergranular fissures that were associated with pearlite colonies. This is illustrated in the scanning electron microscope photos shown in Figure 6. It also appears that the cementite (Fe_3C) carbide has experienced some degradation which is typically associated with fissuring caused by high temperature hydrogen attack (HTHA).

The general appearance of the fissuring associated with Stage 1 cracking as illustrated in Figure 6 suggests that this cracking may be generated in part by the same methane pressures that drives HTHA. However, the general appearance of the fissures shown in Figure 6 suggests that Stage 1 cracking is not associated with the same time dependent creep mechanism generally associated with HTHA. A comparison between the fissures characteristic for Stage 1 cracking with the methane bubbles associated with the initial stages of "typical" HTHA suggest that Stage 1 cracking may share a common driving force in methane pressure, but not the same time dependent creep mechanism. Figure 7 compares the grain boundary fissuring characteristic for

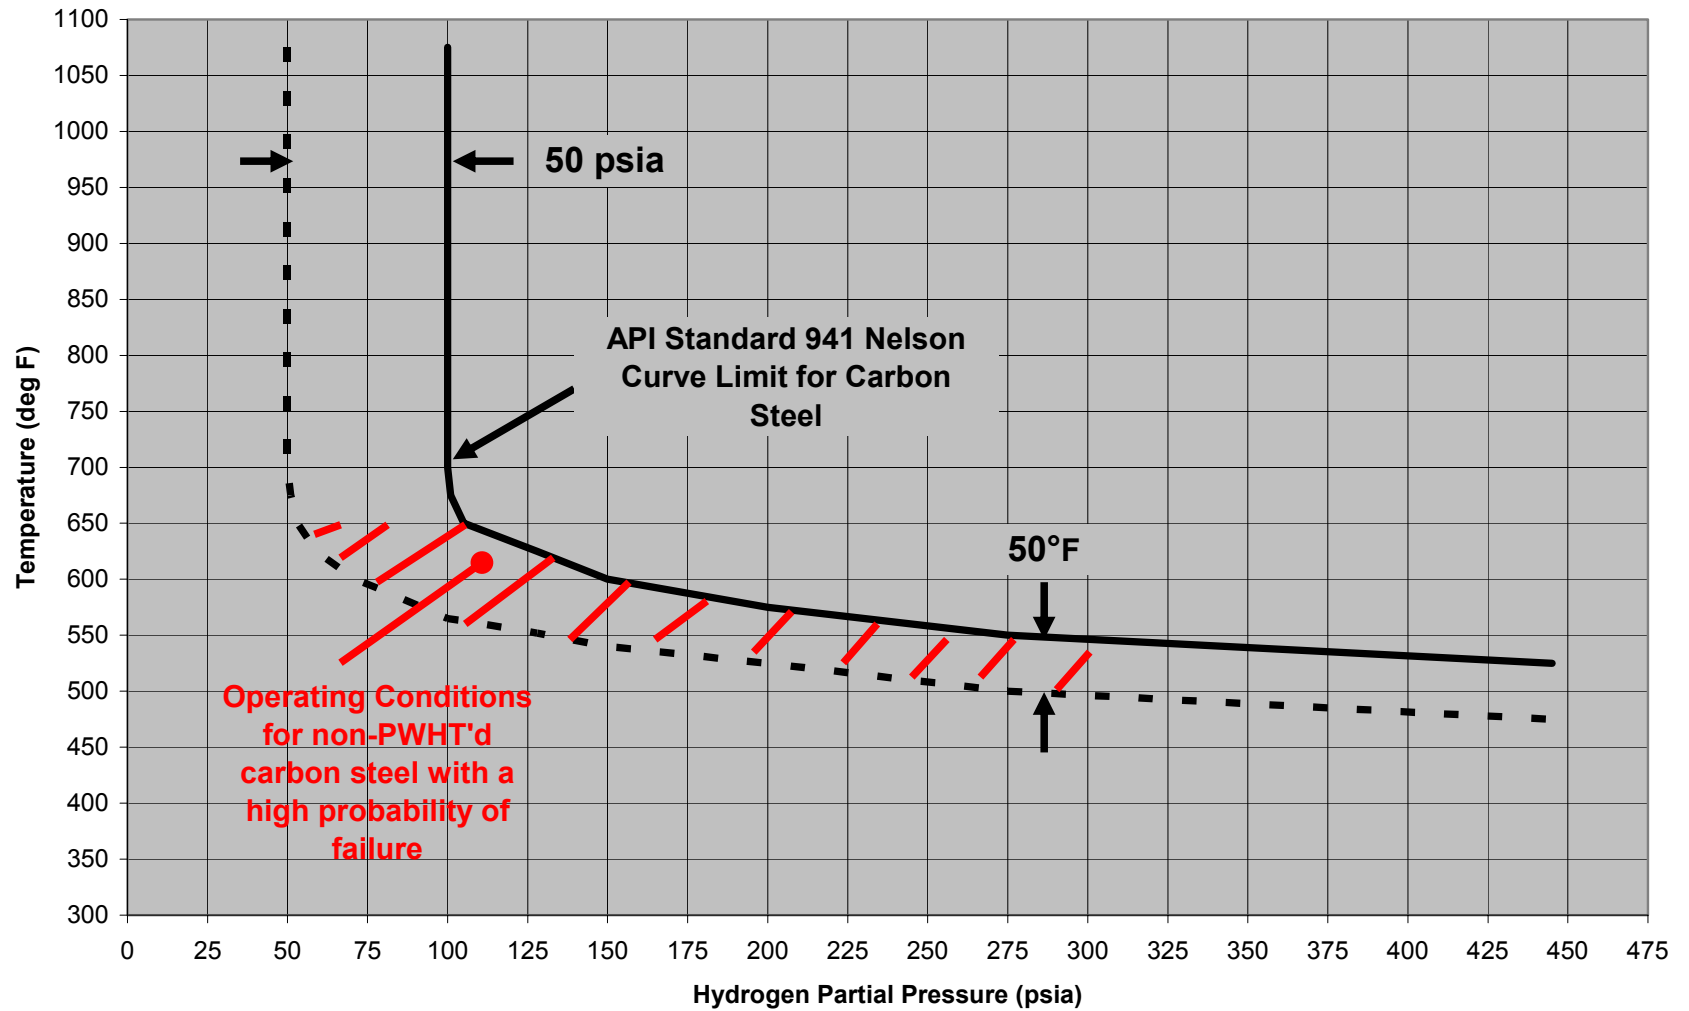
Figure 9: Inspection for cracks is recommended for non-PWHT'd carbon steel vessels that operate at conditions illustrated by the area highlighted in red.

Inspection Guidance for Non-PWHT'd Carbon Steel

We also provide suggested guidance on when to re-inspect equipment that operates at the conditions illustrated in Figure 9. Since our investigation into this cracking mechanism indicates that it is primarily dependent on hydrogen partial pressure, we believe that if an inspection indicates that the equipment is crack-free, and if we can demonstrate through processing monitoring that the equipment does not operate at more severe

5. Inspection guidance was developed for all non-stress relieved carbon steel equipment in the operating range reflected in Figure 9. We also provide guidance on how to determine if a re-inspection is needed once an inspection has been performed and no cracking is found.

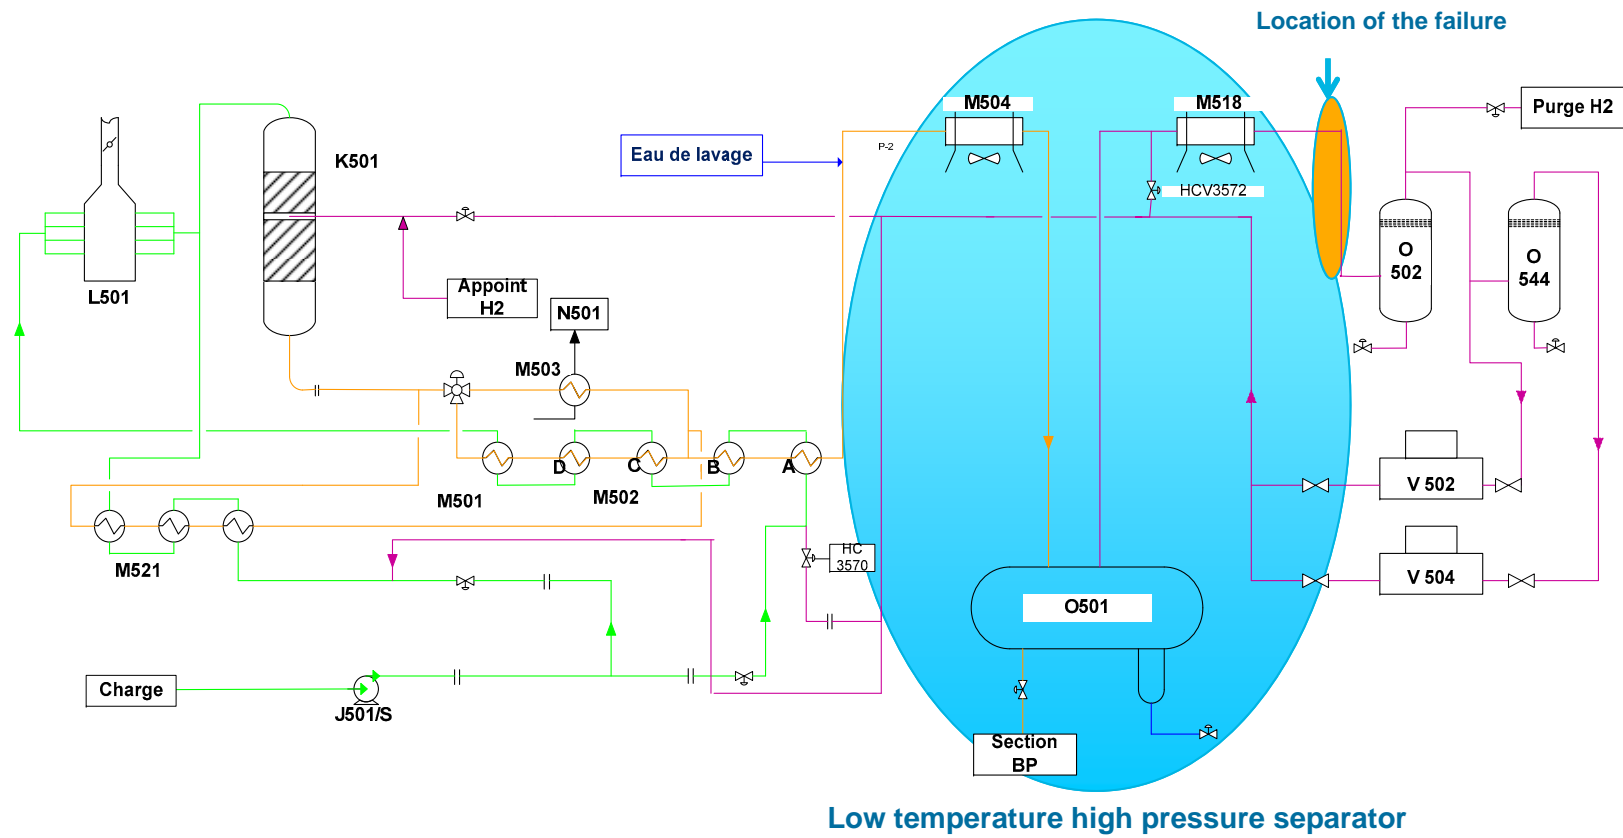
SIMPLIFIED SCHEME OF THE UNIT

Cold scheme with 2 steps of cooling

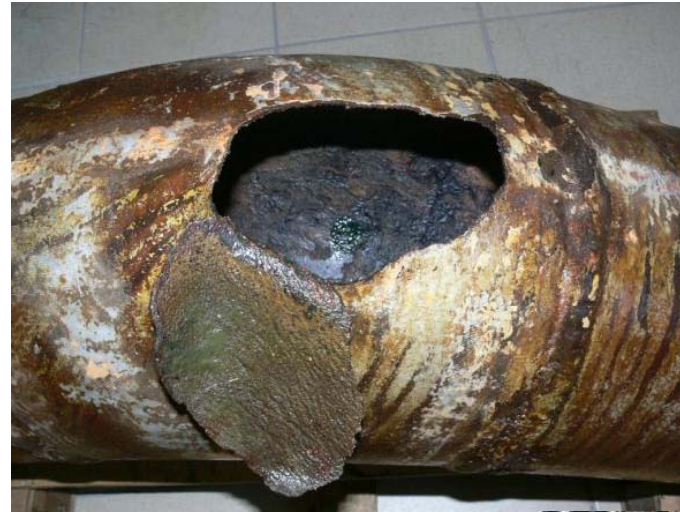
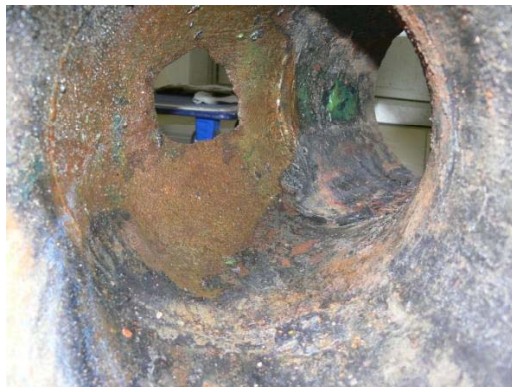
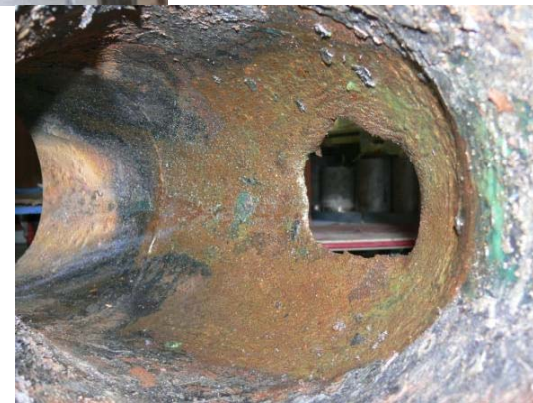
PICTURE OF THE RUPTURE ELBOW

Inside of tube (from the left)

inside of tube (from the right)

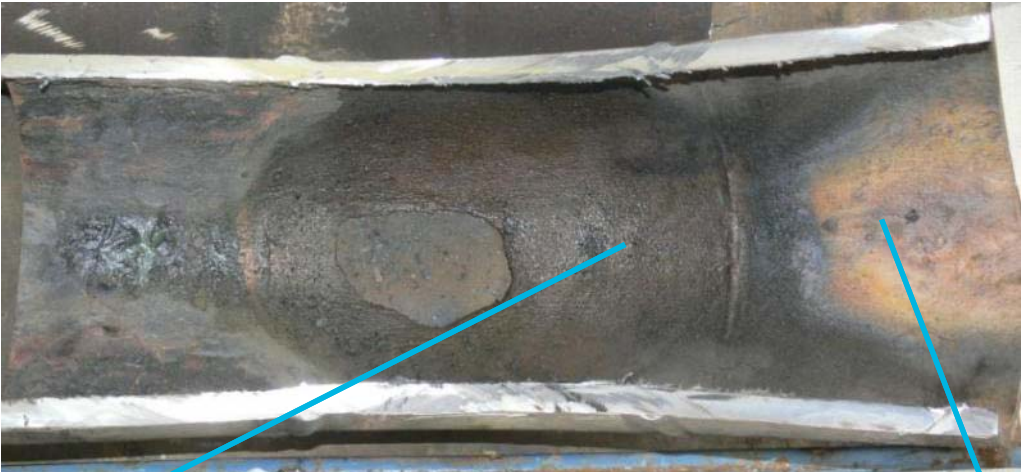
EXAMENS MÉTALLOGRAPHIQUES DU COUDE (1/3)

Sens du fluide

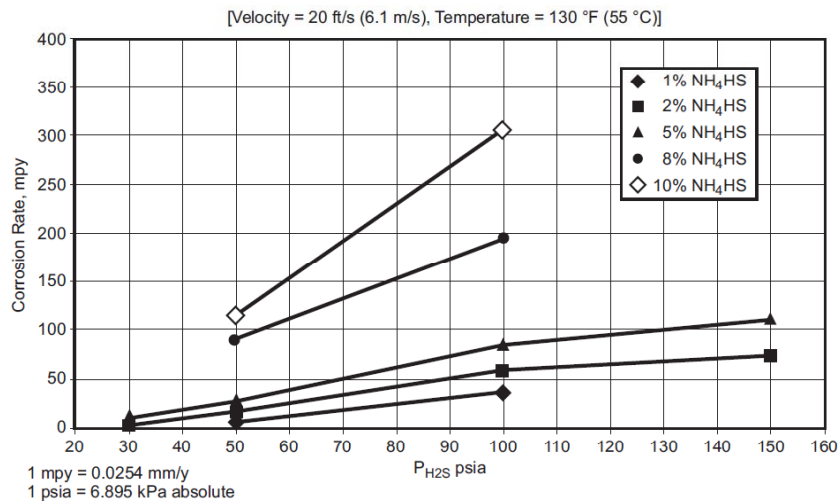
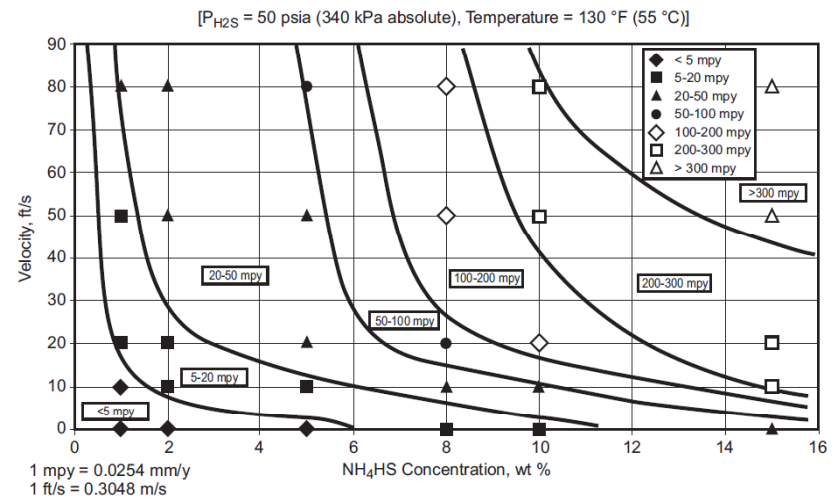
API 932-B

Figure 8—Curves Showing Effect of H_2S Partial Pressure on Corrosion of Carbon Steel

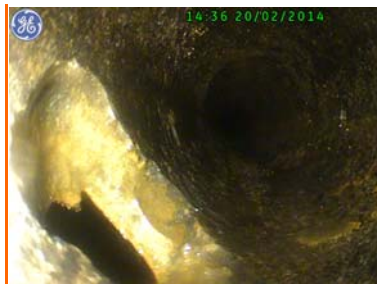
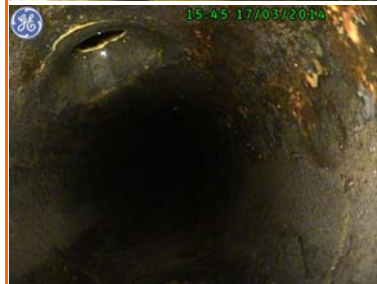
Downstream Showcase: Heat exchanger

Heat exchanger
diameter: 19.05 mm
Thickness: 11mm
length: 8m
Presents serious problems including corrosion and perforations

RVI Inspection using the Video probe XLGo+ 8.4mm 8m
RVI can provide internal condition,

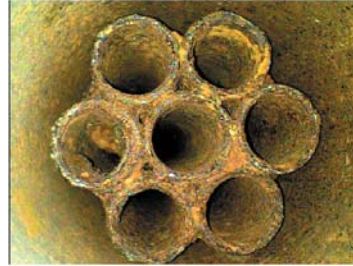
Tank and Vessel Remote Visual Inspection

Scope view of straightening vanes. Observe the fouling on vane at the 9 o'clock position

Measurement errors can result if debris is trapped upstream of straightening vanes.

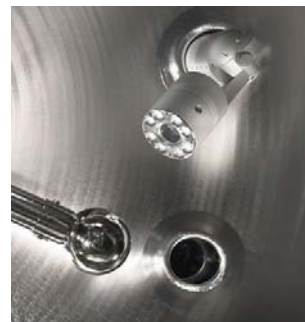
Distillation Towers Remote Visual Inspection: Refinery in USA

PTZ cameras for remote viewing in large Areas:
Tanks and Vessels Inspections, Weld Inspections, Corrosion Evaluation, Coke Drum Lining Inspection, Floating Roof Inspection, Fractionation Tower

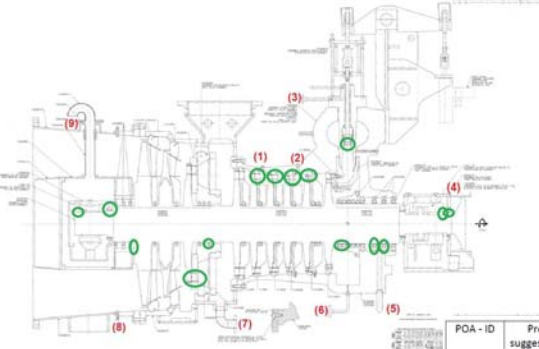
Steam Turbine Remote Visual Inspection

List of point of access for Boroscope inspection (in service) STEAM TURBINE (DEM. THERMODYN)

POA - ID	Probe suggest to be used + (F or S) view	Parts	Indication they normally found of ST
1	5mm F	BLADE	Erosion on leading edge from Steam
2	5 mm F	BLADE	Erosion on leading edge from Steam
3	6 mm S	REG. VALVE	Erosion on VALVE on contact point between BASE/VALVE
4	3,9 mm S	SEALS	Indication of # color is an indication of High Temp on the seal, evaluation of clearance ? presence of leakage ?
5	5 mm S	SEALS	Indication of # color is an indication of High Temp on the seal, evaluation of clearance ? presence of leakage ?
6	3,9 mm S	SEALS	Indication of # color is an indication of High Temp on the seal, evaluation of clearance ? presence of leakage ?
7	3,9 mm S	SEAL/BLADE?	Indication of # color is an indication of High Temp on the seal, evaluation of clearance ? presence of leakage ?
8	3,9 mm S	SEAL	Indication of # color is an indication of High Temp on the seal, evaluation of clearance ? presence of leakage ?
