Participants EFC WP15 meeting 3th May 2018 Dalmine (Italy)

EFC WP15 Activities

EFC Working Party 15 « Corrosion in Refinery » Activities

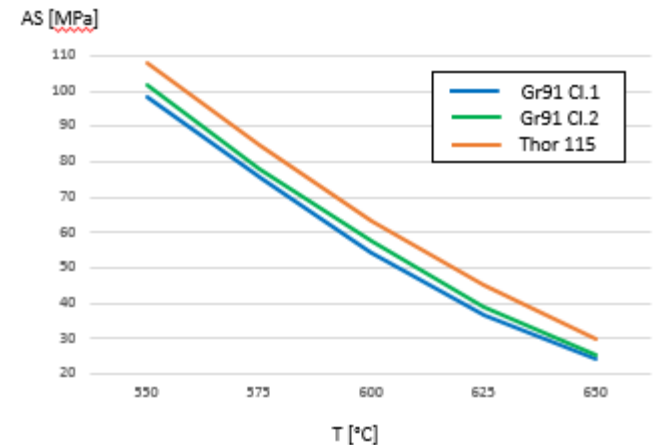
(MPa) \ (°C)	550	575	600	625	650
New Gr.91 Cl. 1	98.5	75.5	54.3	36.8	24.0
New Gr.91 Cl. 2	102	78.2	57.6	39.2	25.1
Thor 115	108	85.0	63.3	45.3	29.8

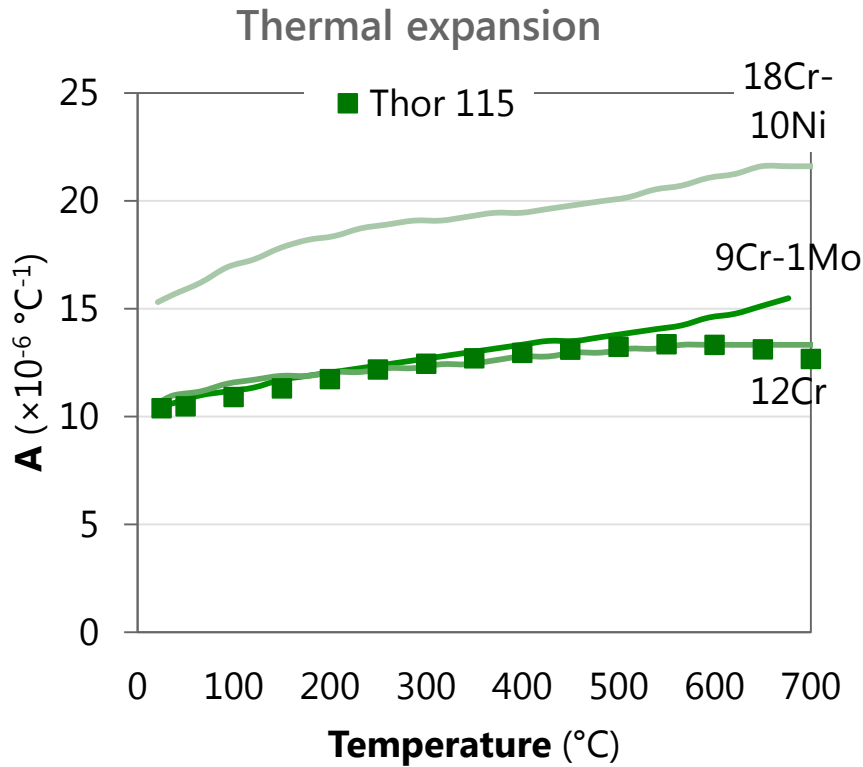
Physical properties

As a ferritic steel, Thor presents smaller thermal expansion and better thermal conductivity with respect to austenitic grades.

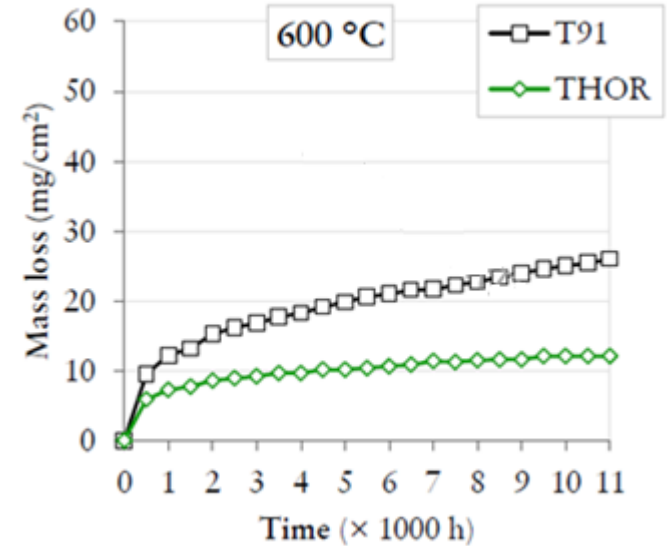
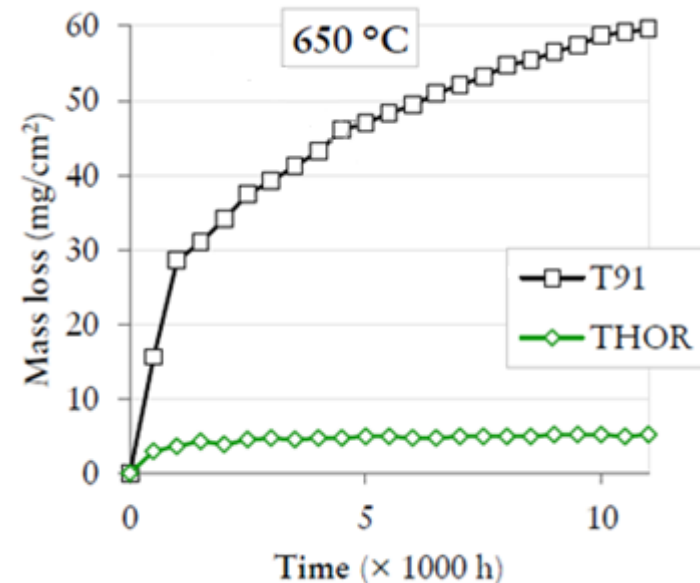
- Steam oxidation testing performed by **Oak Ridge National Laboratory**
- Furnaces holding specimens (600, 625, 650 °C) fluxed with steam from ultra-high purity water.
- Testing duration 11,000 h (about 460 days)
- Specimens removed from furnaces every 500 h for the measurement of mass loss as a function of time.

Rate of oxidation in Thor is similar between 600 and 650 °C, thanks to the higher amount of available Cr for diffusion to the surface, forming a compact protective oxide (spinel) layer at higher temperature.

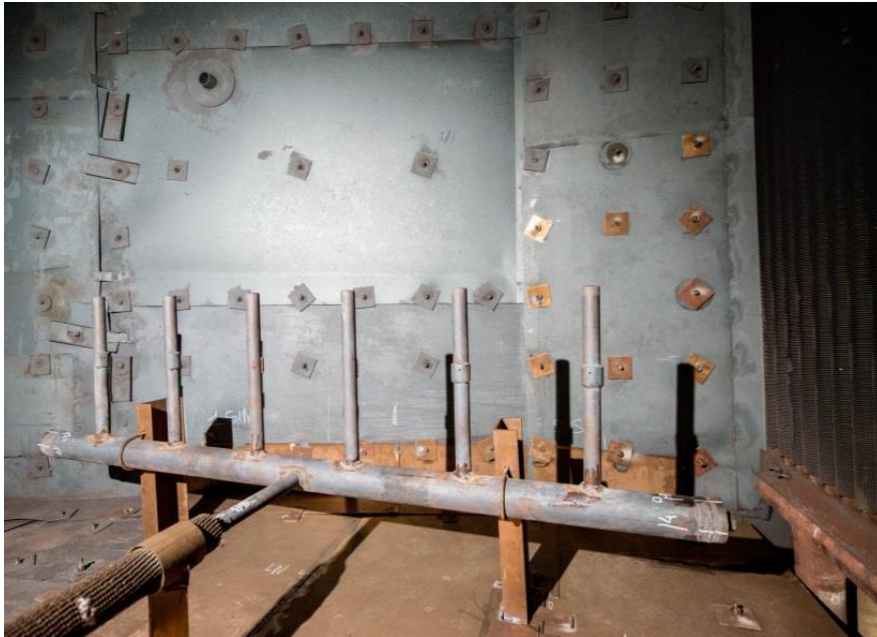
HRSG test loop

Installed and running since May 2015.

Superheater steam is extracted from an existing vent and reheated inside a Thor circuit up to 615 °C.

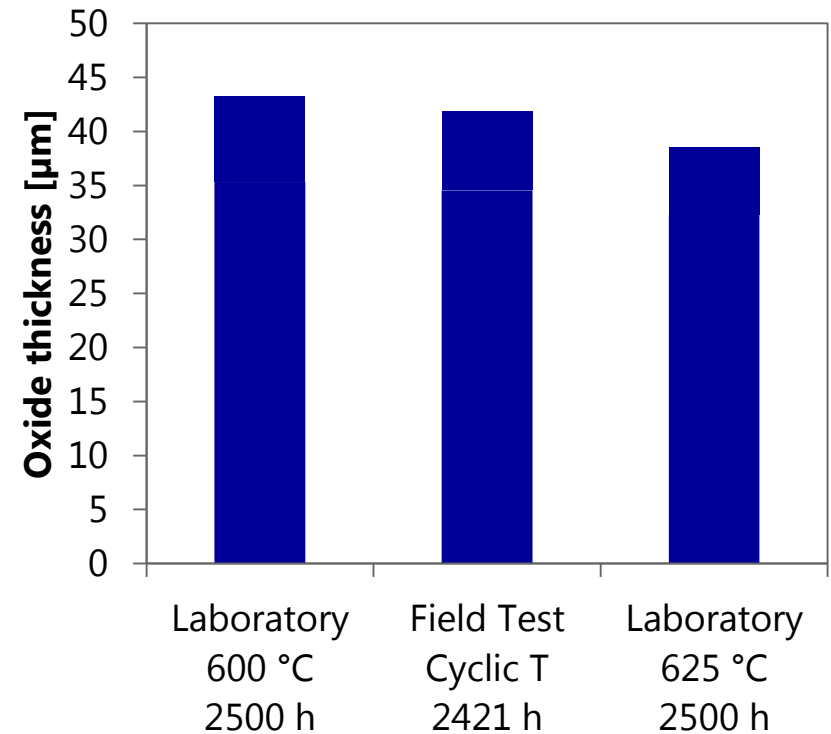
Scale thickness at the inner tube surface after **2,421 h**.

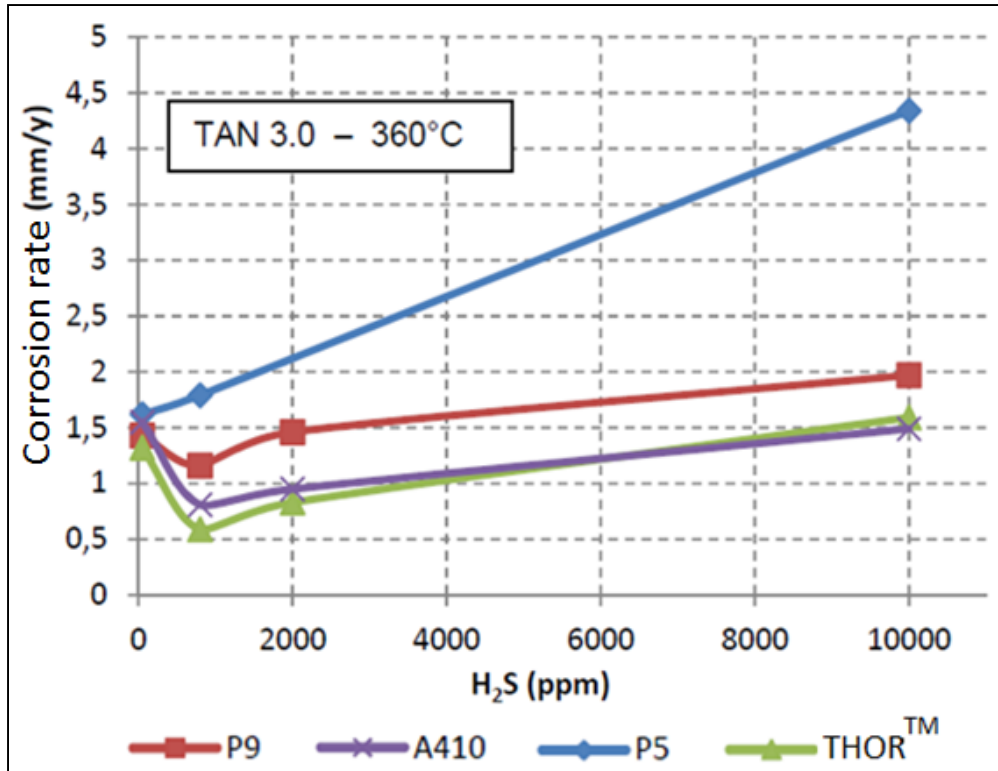
Special tests: Sulfidation and NAC

- Pilot Plant in VeneziaTecnologie
- No TAN decrease for degradation
- Comparative tests
- Tests in naphthenic and sulphidic environment
- Expected trends confirmed after weight loss analysis at different H₂S contents

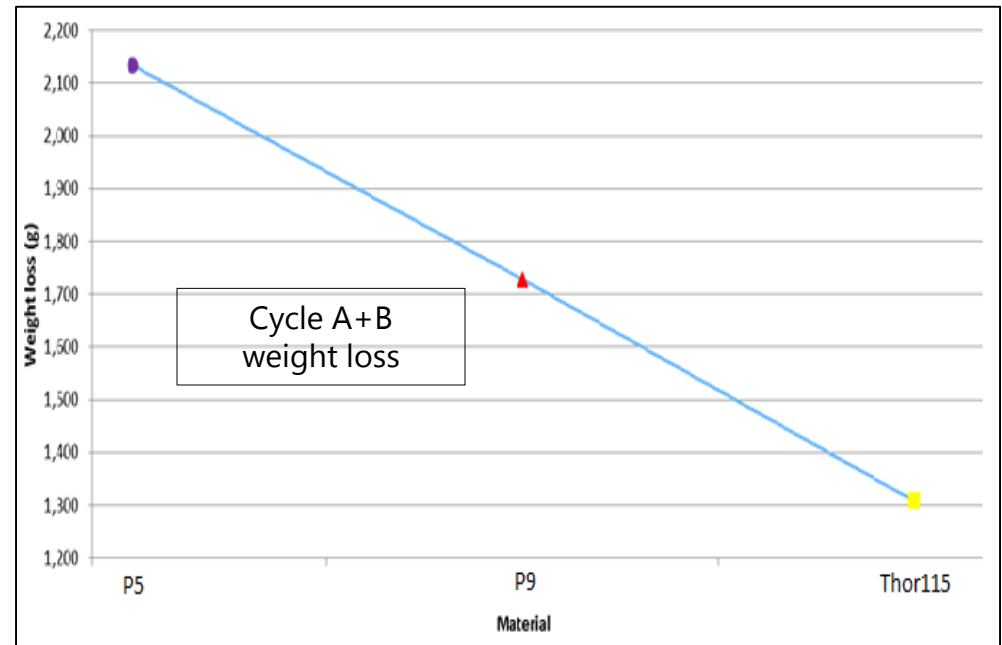
Special tests: HGO hydrotreating pilot plant

- Tests performed at ARRC in Abu Dhabi
- HGO Hydrotreating
- 2 cycles, 1 month each
 - cycle A at 390°C
 - cycle B at 420°C
- Comparative tests and temperatures to stress corrosion kinetics:
 - First cycle stimulating FeS layer formation
 - Second cycle boosting T
- Lower weight loss of Thor 115

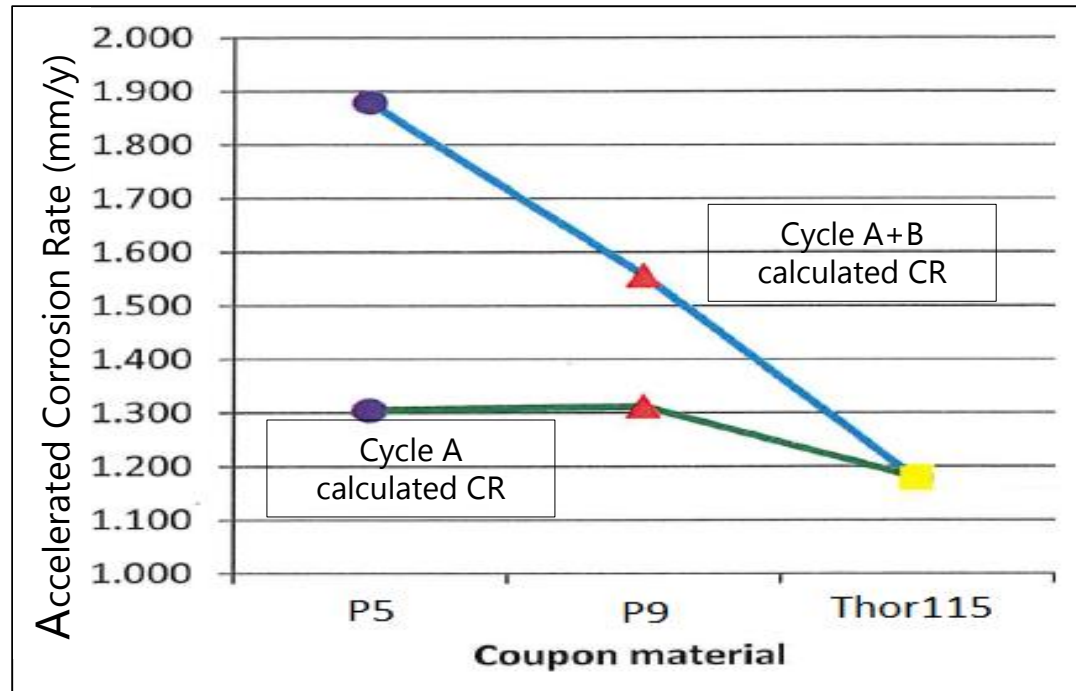
Special tests: HGO hydrotreating pilot plant

- Calculated corrosion rate unchanged between first cycle and after the 2 cycles
- Higher stability of protective layer

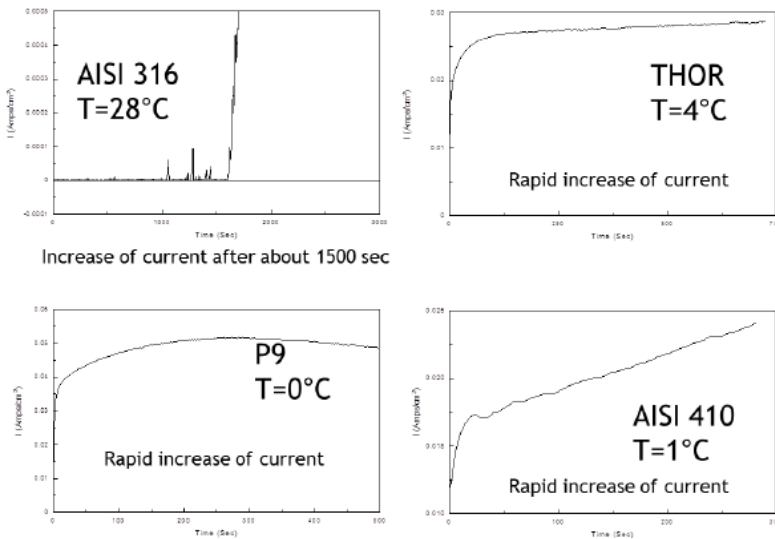
Special Tests: Chlorides

- Test Parameters as per ASTM G150

Tests carried out in CSM laboratories.

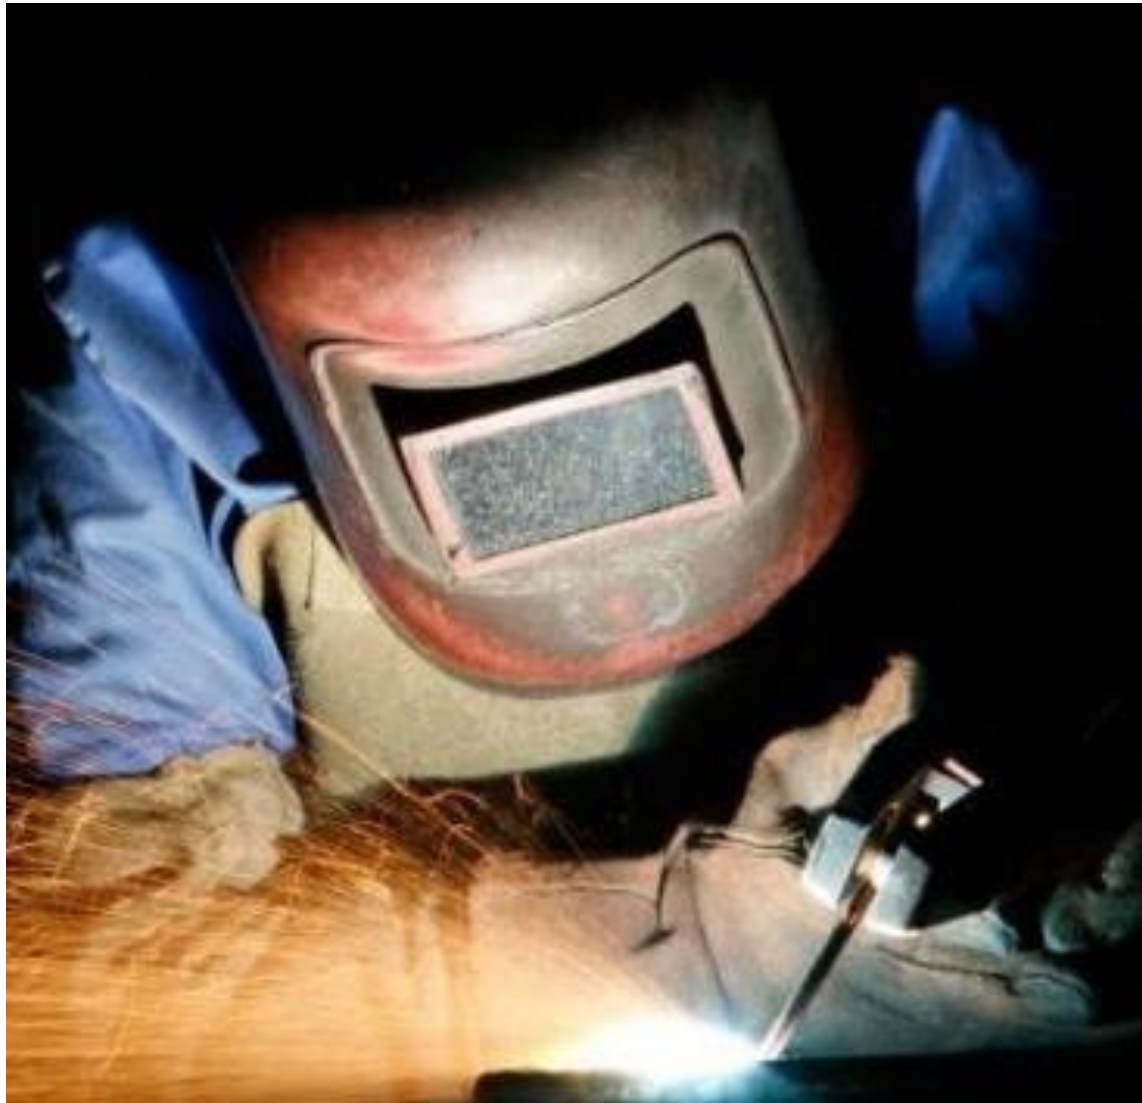
- Process parameters equal to the ones used for grade 91
- Full mechanical characterization, with satisfactory results

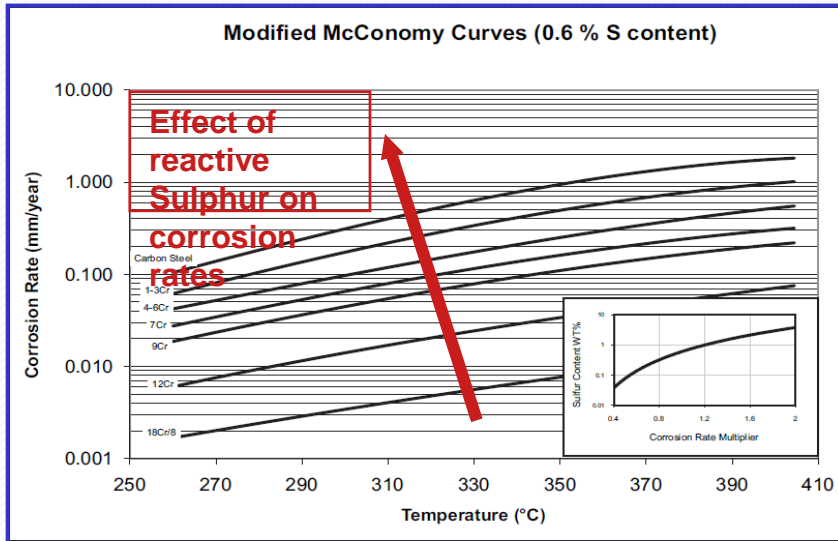
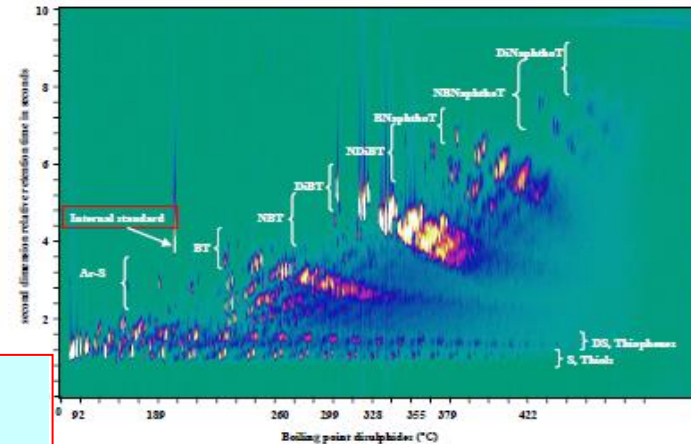
ACTIVE SULPHUR

(1200 ppm) is less corrosive than the one having (590 ppm) due to the Presence of active Sulphur in several

S,Th	Sulphides, Thiols
DS, T	DS, Thiophenes
Ar-S	Aryl-sulphides
BT	Benzothiophenes
NBT	Naphtenic-Benzothiophenes
DiBT	Di-Benzothiophenes
NDiBT	Naphtenic-di-Benzothiophenes
Bnaph	Benzo-Naphthothiophenes
NBNaph	Naphtenic-Benzo-Naphthothiophenes
DiNaph	DiNaphthothiophenes

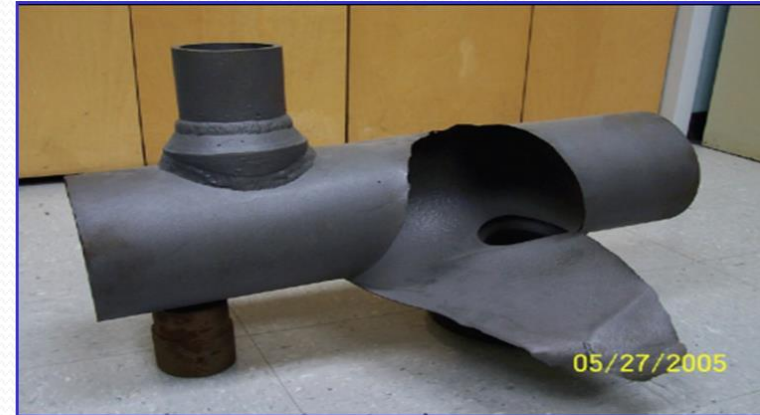
Sulfidation corrosion

- ❑ **Wastage of the wall**
- ❑ **1800**
- ❑ **With the advent of FCC , coking, and Hydroprocessing**
- ❑ **A function of temperature, the total sulfur the types of sulfur, the type of stream,**
- ❑ **above (230 °C).**
- ❑ **Set of curves**
- ❑ **Prediction is an elusive technical challenge.**

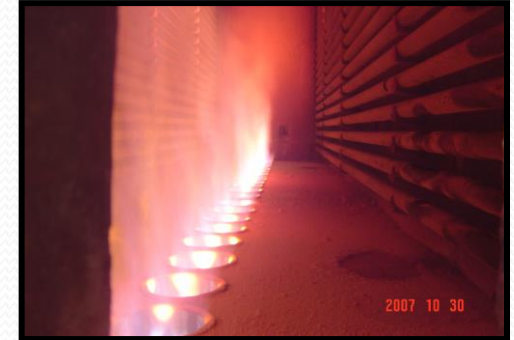
H₂-free Services

- Carbon steel for temperatures up to (275 °C). Use fully killed steels to assure silicon content > 0.10 wt %.
- 5Cr-0.5Mo for temperatures between (275 °C and 325 °C).
- 9Cr-1Mo above (325 °C).
- 300 Series SS can also be used to virtually eliminate sulfidation corrosion.

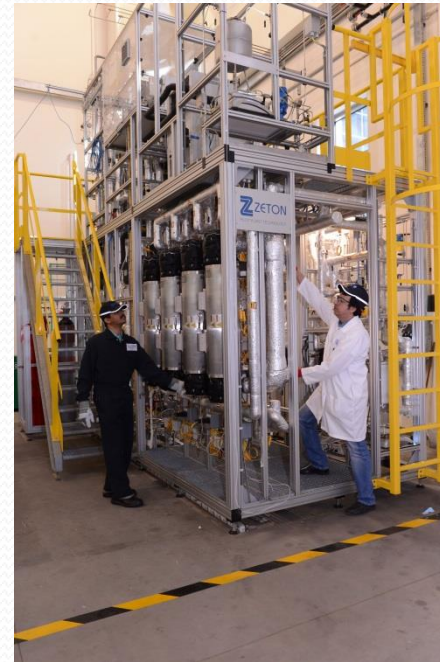
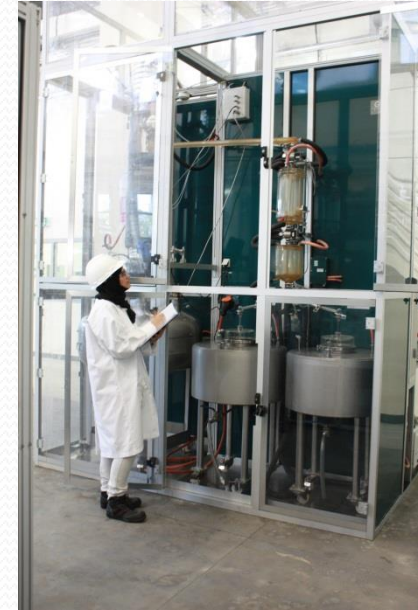
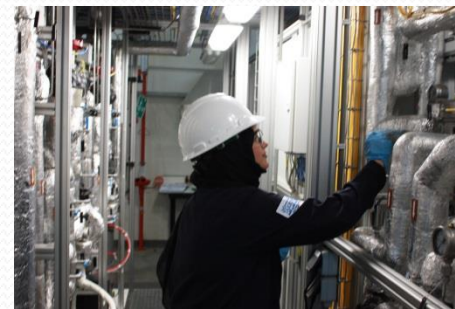
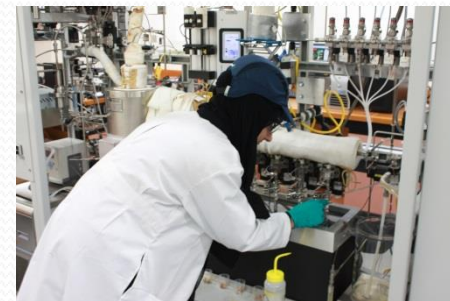
Material Corrosivity Evaluation

- ❑ ARRC was requested test a new alloy was developed by M/s Tenaris namely Thor™115 in comparison to P5 and P9.
- ❑ ARRC simulated real refinery conditions in a pilot plant unit that was specially modified
- ❑ Actual feedstock and operating conditions used in refineries

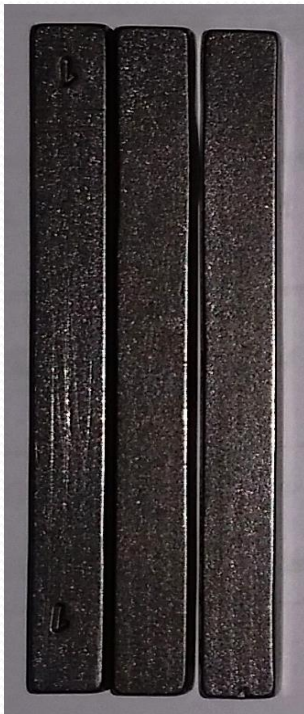
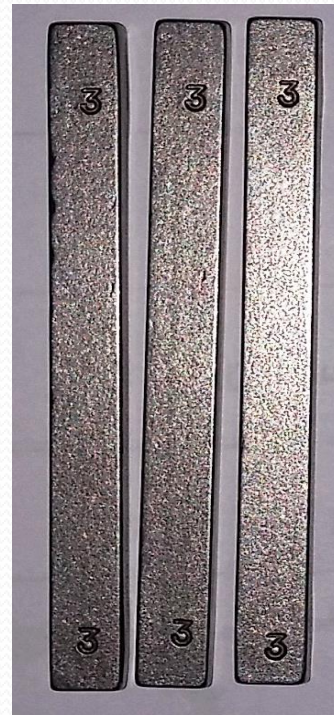
Surface Prepared And Cleaned New Coupons Before Exposure

Coupon naming terminology		
Test 1	Middle holder	
	Coupon Tag number	Naming
	1C 2C 3B	Test 1 (390°C) coupons
Test 1&2	Top holder	
	Coupon Tag number	Naming
	1A 2A 3A	Test 1&2 coupon, or Full run coupons (Top holder)
Test 2	Middle holder	
	Coupon Tag number	Naming
	1D 2D 3D	Test 2 (420°C) coupons
Test 1&2	Bottom holder	
	Coupon Tag number	Naming
	1B 2B 3C	Test 1&2 coupon, or Full run coupons (Bottom holder)

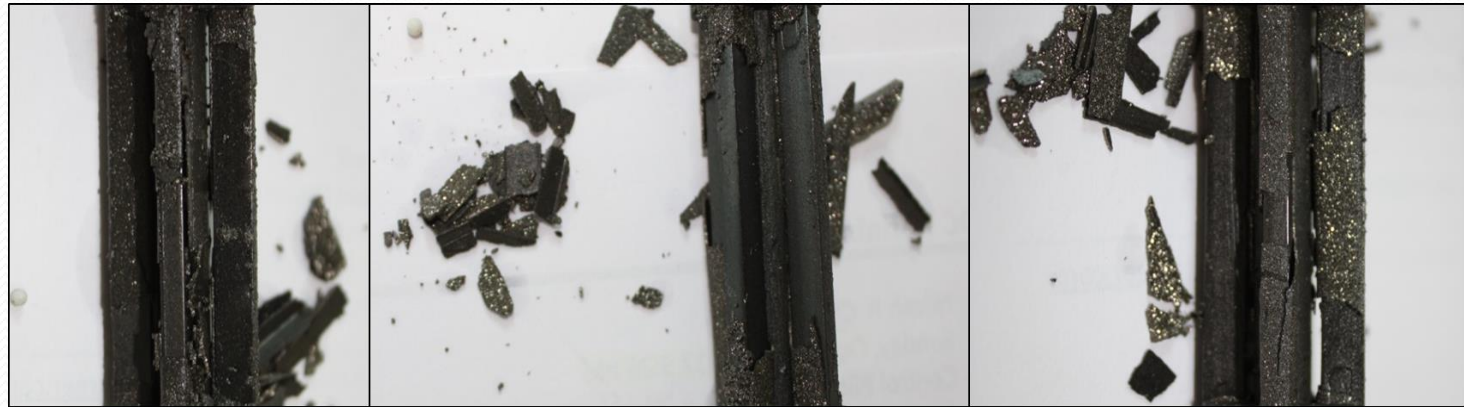
Coupons after Test 2 upon retrieval. From L to R: Top holder; Middle holder and Bottom holder.

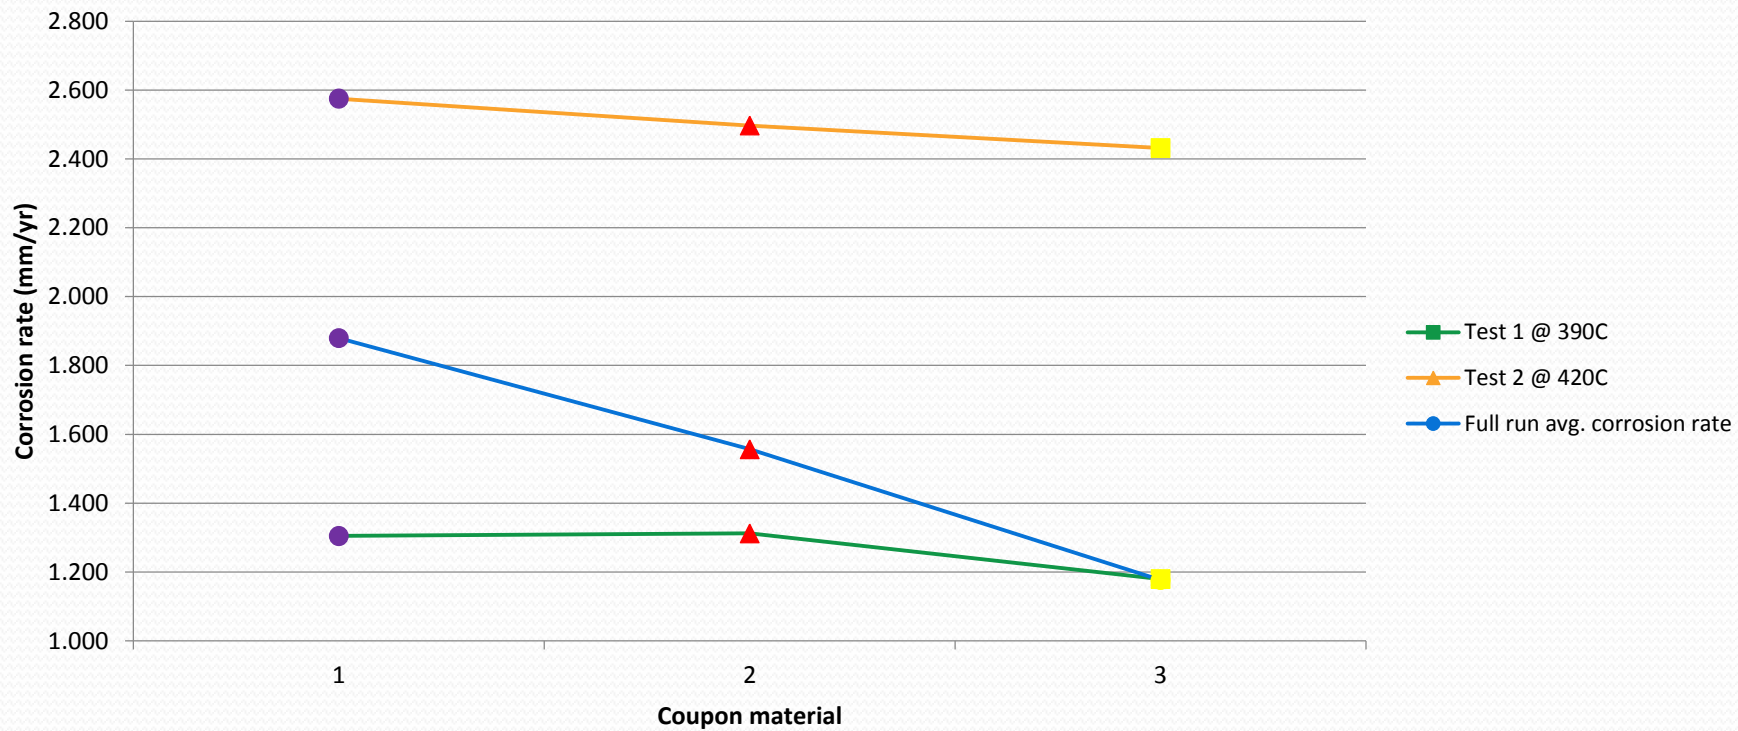
Material	Material number	Marker
P5	1	
P9	2	
Thor™ 115	3

Comparing corr. rates of Test 1, Test 2, and Full run (Test 1 & 2) coupons

- Tested materials not anticipated to be used for these exposure conditions
 - Merely to obtain a comparative results in a short time period
 - The actual corrosion rate values are relevant to the specific test conditions *only*
 - The desired objective of the tests is to rank material performances
- Materials 3 have better resistance to sulfidic environments compared to materials 1 and 2.

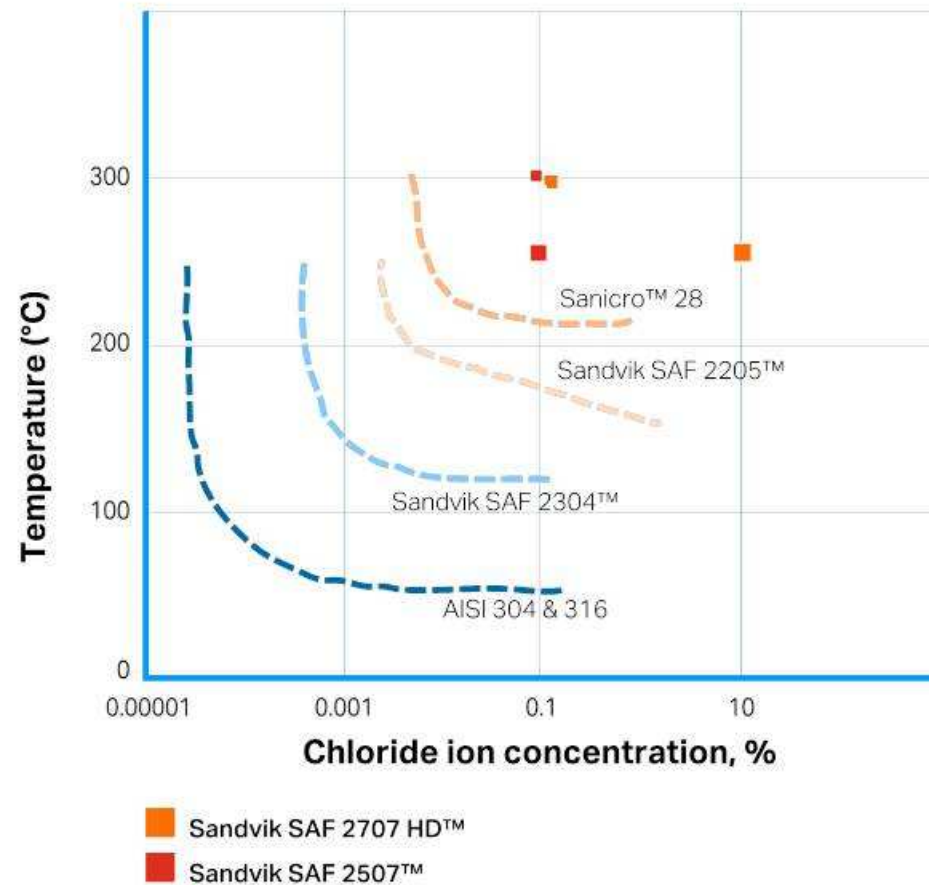
- Autoclave
- 100 bar
- 8 ppm O₂
- Load = proof strength
- NaCl-solution
- 1000h (6 weeks)

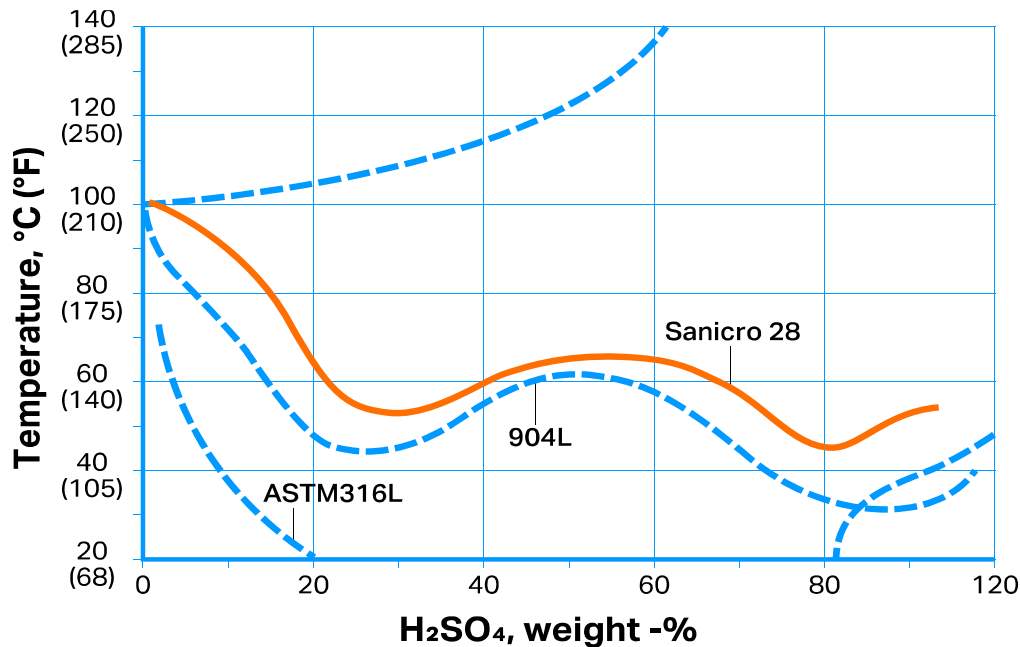
- Isocorrosion diagram for Sanicro™ 28, 904L and ASTM 316L, in deaerated sulphuric acid
- The curves represent a corrosion rate of 0.1 mm/year (4 mpy)

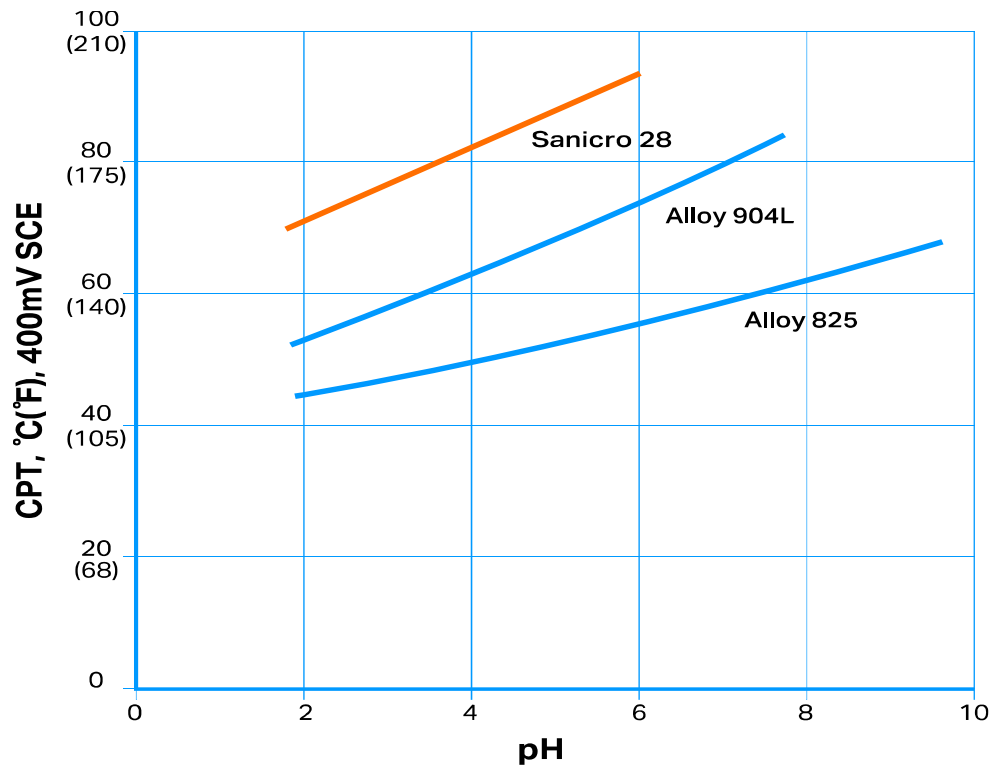
- Critical pitting temperature (CPT) at +400 mV SCE for different alloys in synthetic seawater (3% NaCl), at different pH values

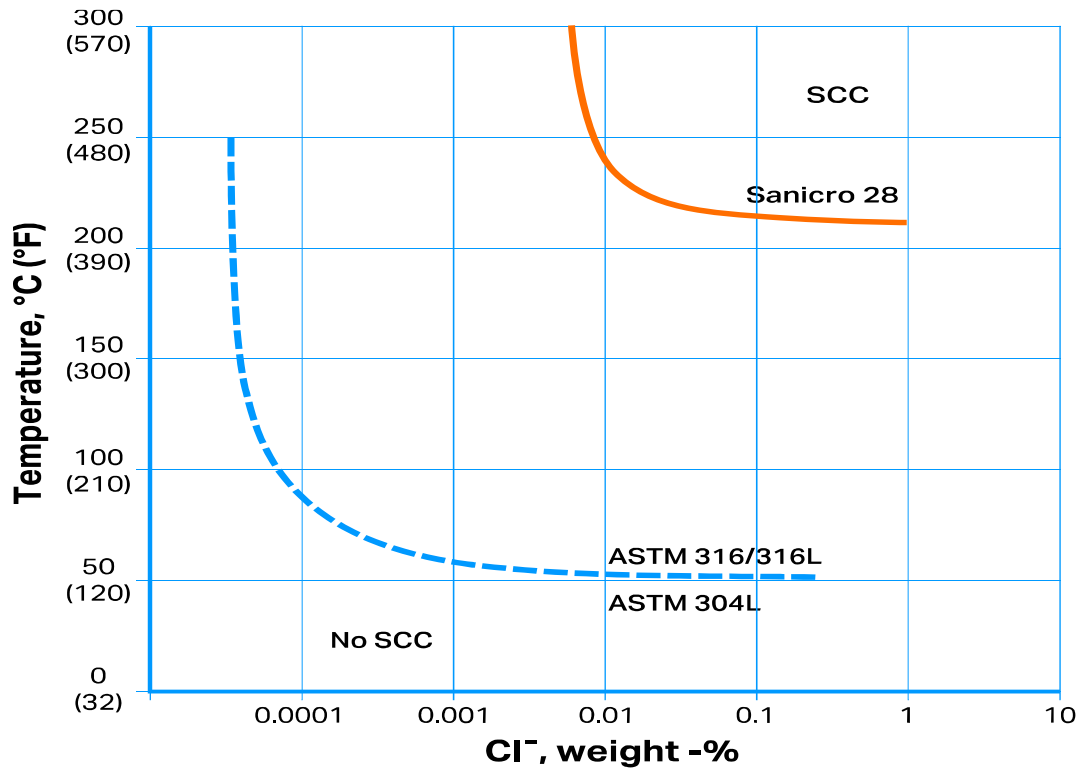
- Results of stress corrosion cracking tests on different steel grades in 40% CaCl₂, at 100 °C (210 °F), pH = 6,5

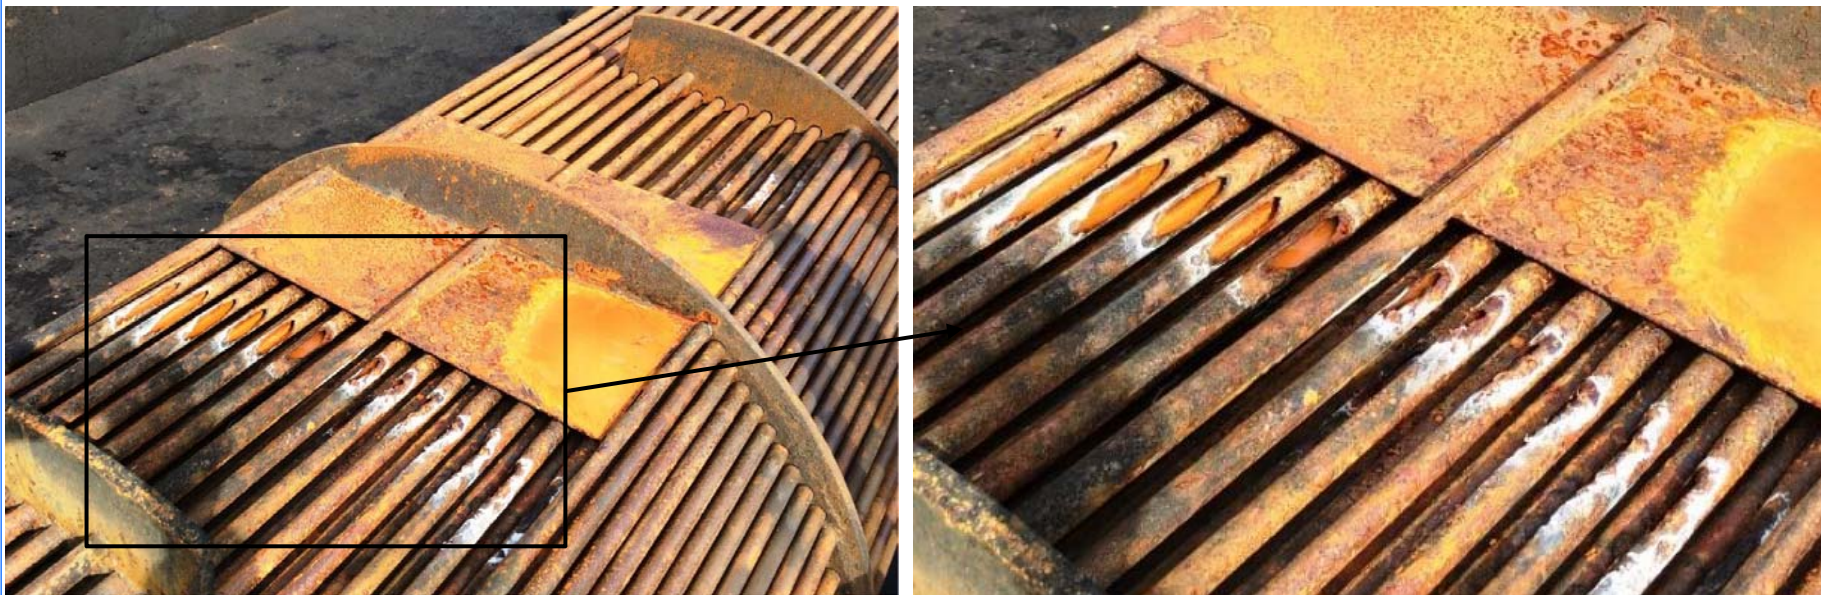
- Overhead condenser CDU unit
- Corrosion phenomena of tubes close to inlet nozzle
- Corrosion close to impingement plate
- Water washing implemented on the vapour line ahead since last 2 years
- Water used -> water from SWS
- Corrosion increased in the last 2 years (bundle installed in 2016)
- Injection of neutralizer and inhibitor on the vapour line

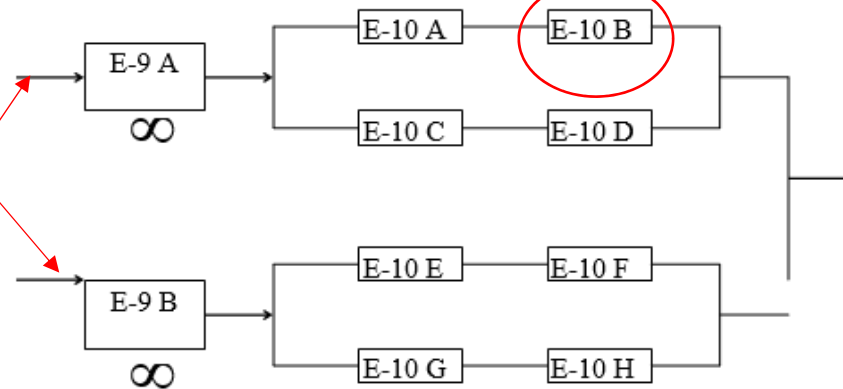
Water washing

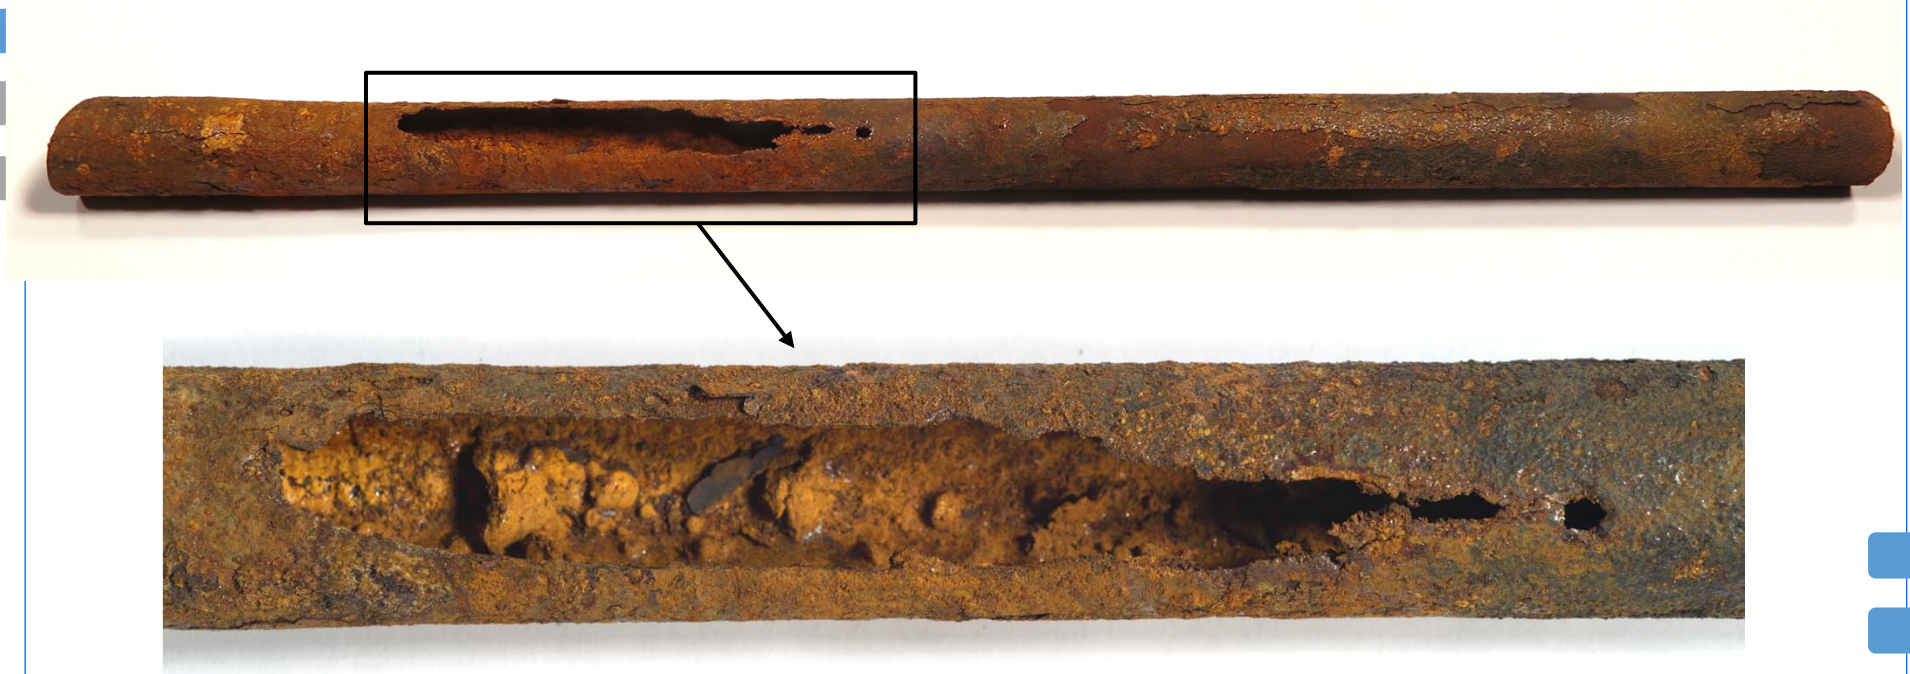
Detail of corrosion

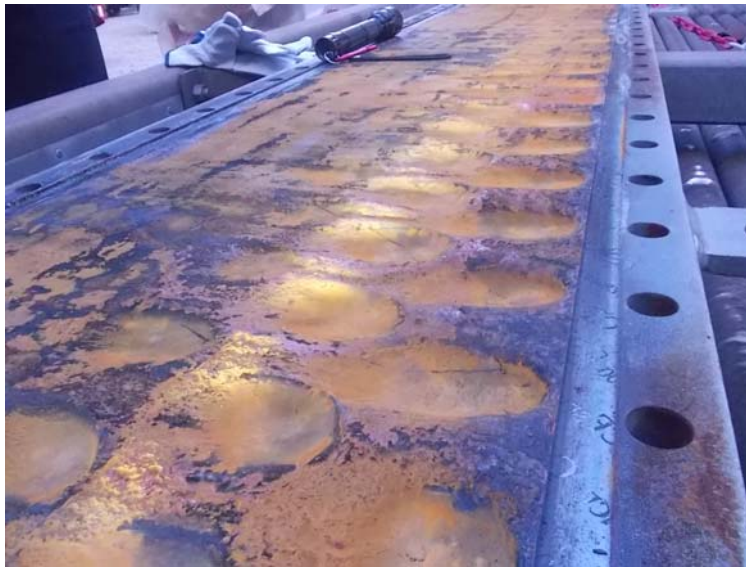
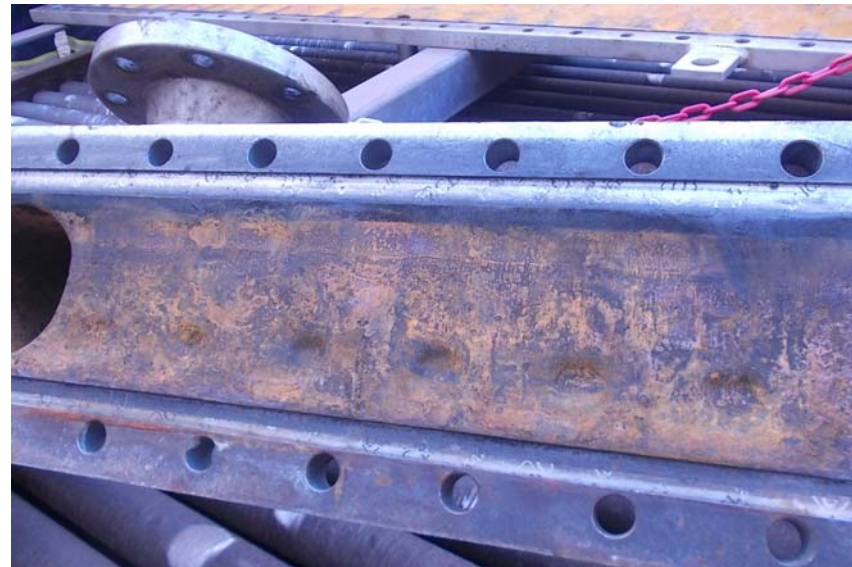
- Overhead condenser CDU unit (AIR COOLER)
- Corrosion phenomena of Plate at outlet section (flow discharge of relevant tubes)
- Water washing implemented on the vapour line at each AC bank
- Water used -> demineralized BFW (not deaerated)
- Mixed metallurgy for tubes in different banks (duplex + CS)
- Injection of neutralizer (MEA + MOPA) and inhibitor on the vapour line

- Heavy impingement corrosion of plate.
- Organic fouling plug some tubes -> increased velocity in plug free tubes
- WW -> BFW with 5 ppm O₂ -> not deaerated
- ***CONTROL INJECTION RATE, INJECTION POINT AND QUALITY OF WASHING WATER, ALSO CONSIDERING HEAVY ORGANIC FOULING (PLUGGUNG OF SOME TUBES)***

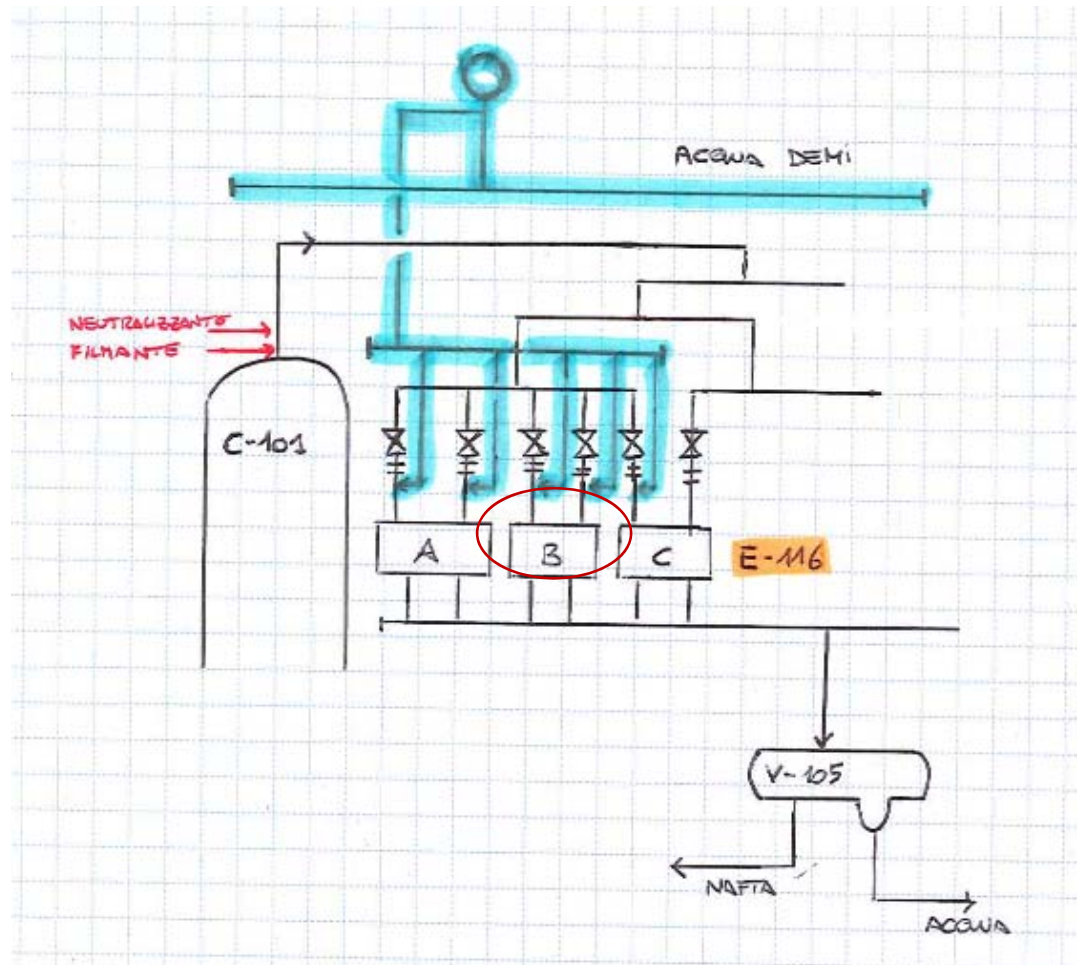
Scheme of injection point

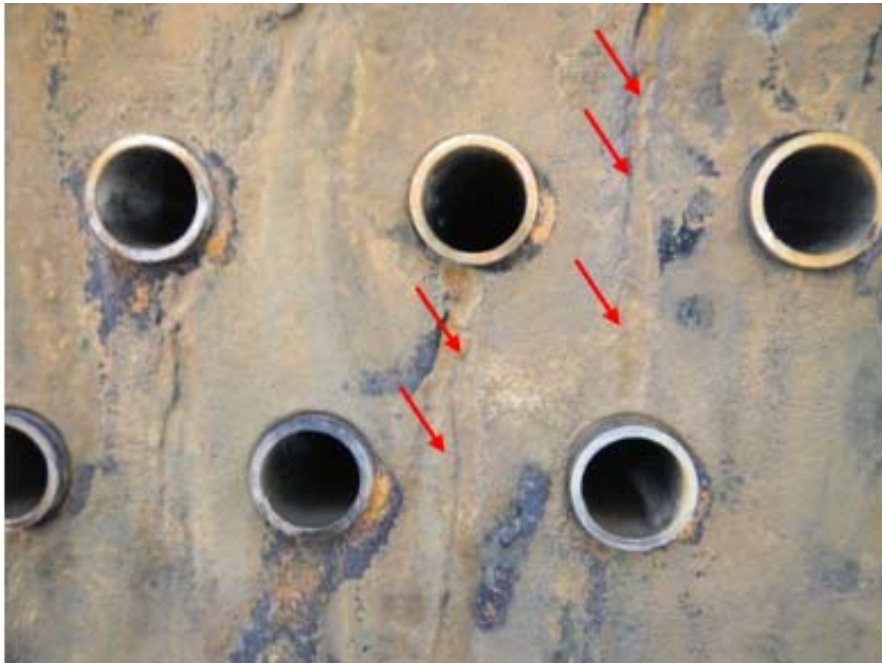
Grooving corrosion on the tube-sheet at outlet of tubes (only with SS tubes, no with CS tubes)

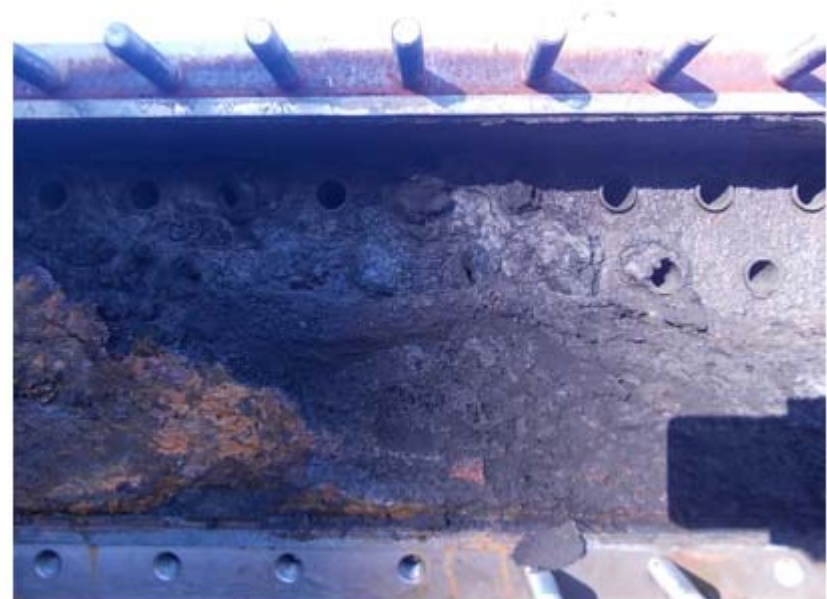
Organic fouling at AC inlet Box (asphaltenes rich)

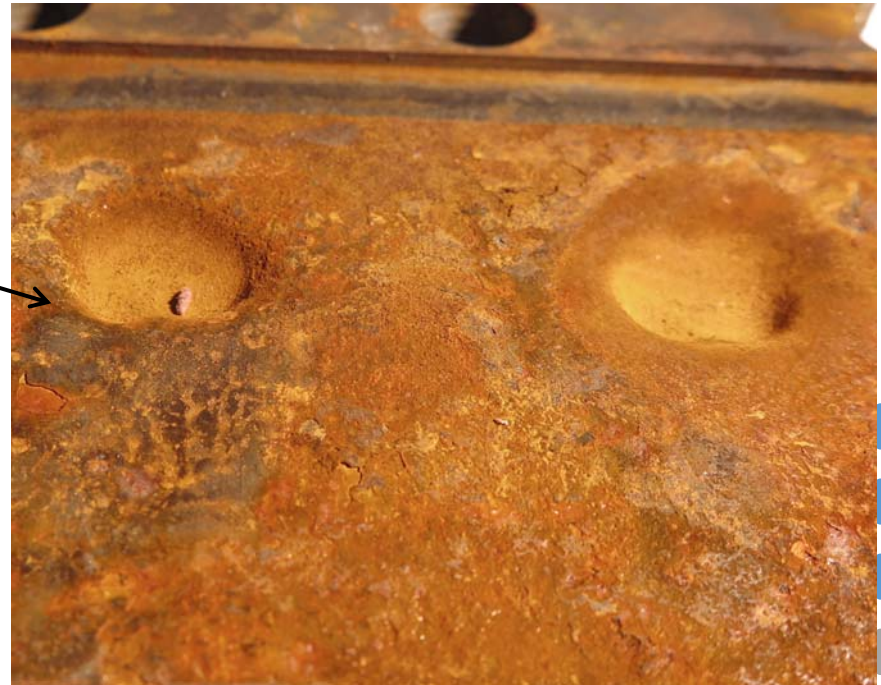
Detail of corrosion

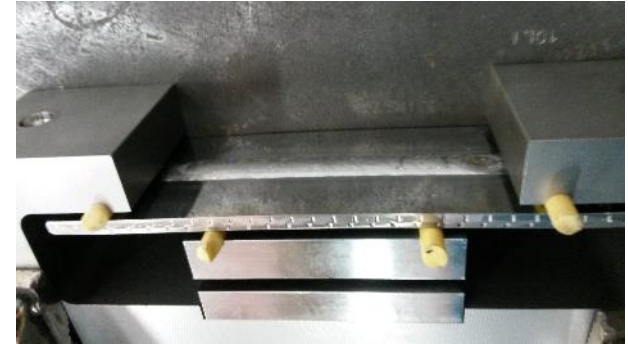
- 4 points bending test:
 - Welded samples (HAZ) with seam
 - Dimensions: 140 x 40 x 4 mm

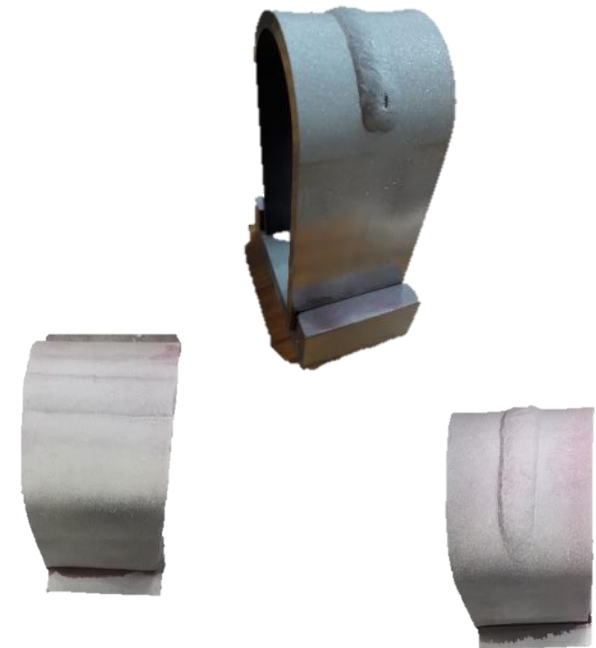
- U-bend test:
 - Welded samples (HAZ) with seam
 - Dimensions: 140 x 40 x 4 mm

Weld in transverse direction

Weld in longitudinal direction
