Participants EFC WP15 meeting 3th May 2018 Dalmine (Italy)

EFC WP15 Activities

EFC Working Party 15 « Corrosion in Refinery » Activities

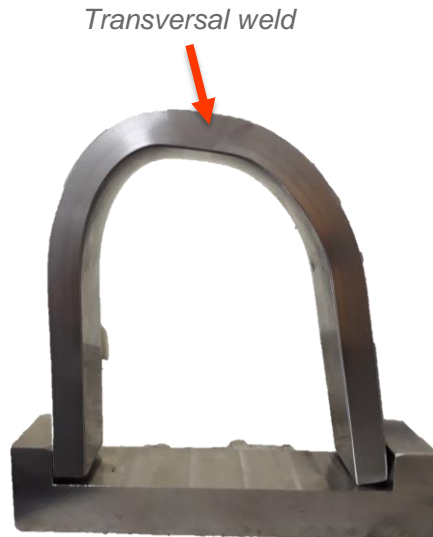
- No cracks on previous set-up, probably because of :
 - Thickness of plates: 4 mm is too thin
 - Welding process: weld seam induced HAZ too small
 - Precipitation and stress relaxation kinetics mismatch

- ✓ U-bend set-up : strain around 10%
- ✓ Specimen 15 mm thick
- ✓ Welding process : GMAW through all thickness
- ✓ Sensitization before straining

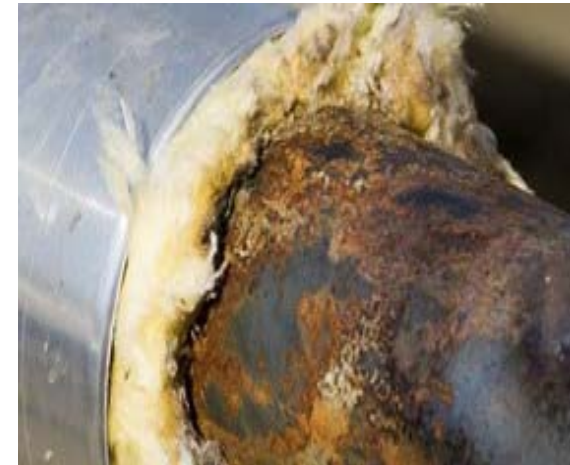
How CUI is caused

- > In order to have CUI, you **must have an insulation system** installed on a pipeline or vessel
- > Water penetration allows oxygen corrosion to occur.
This can happen due to:
 - Rain water
 - Deluge systems
 - Process liquid spillages
 - Condensation
- > Further contamination, primarily **chlorides and sulfates** from the environment or insulation can speed up the process dramatically

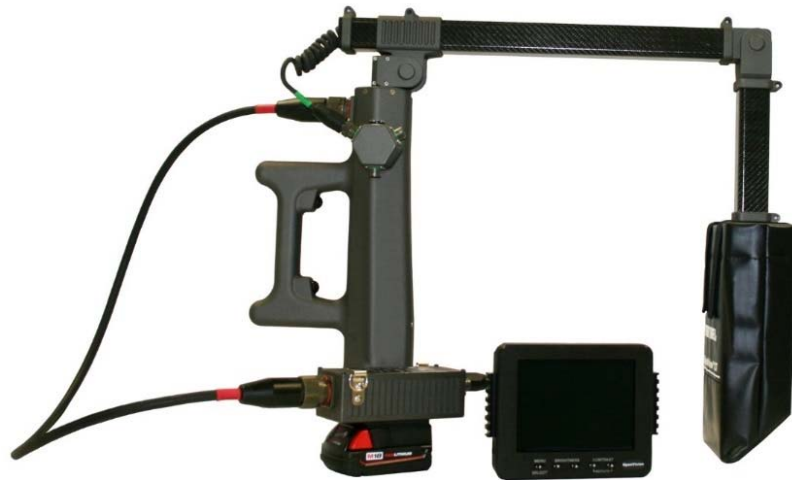
OpenVision

> Handheld or mounted low voltage X-ray scanning device

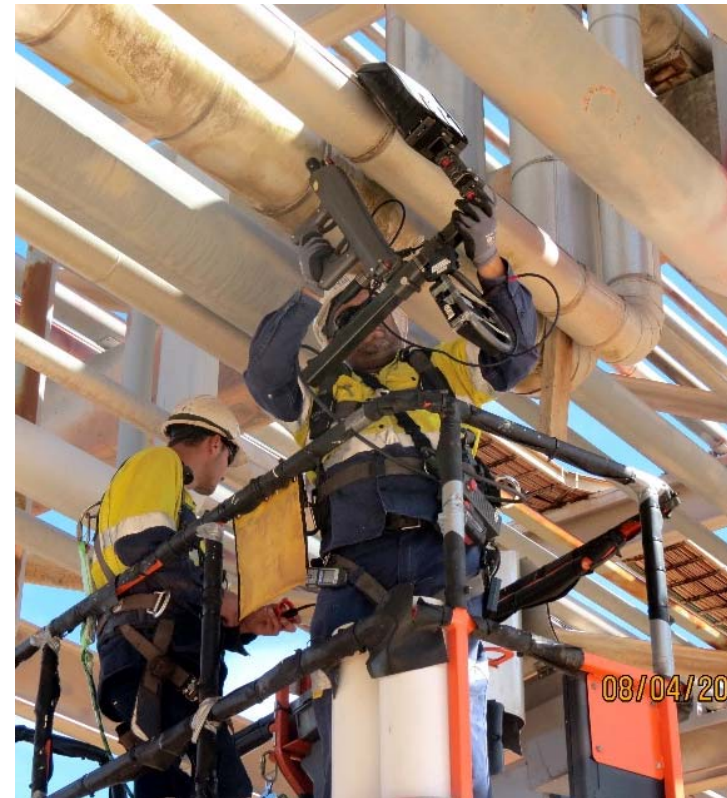
Main Benefits

- > Real time data acquisition
- > Capable of inspecting through most insulation and cladding
- > Also capable of locating welds
- > Fairly low radiation intensity
- > No isotope (can be turned off)
- > Performed in a two man team
- > Roaming safety barriers reduce exclusion site zone

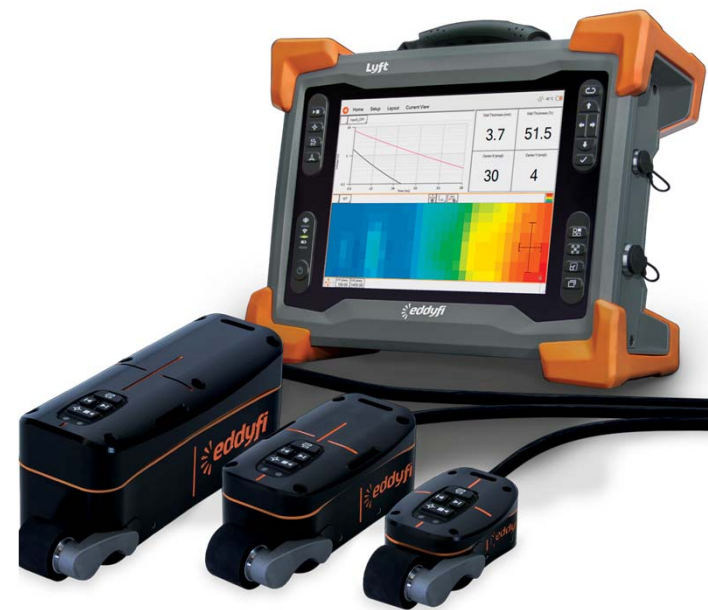
Eddyfi Lyft

> Pulse Eddy Current (PEC) System

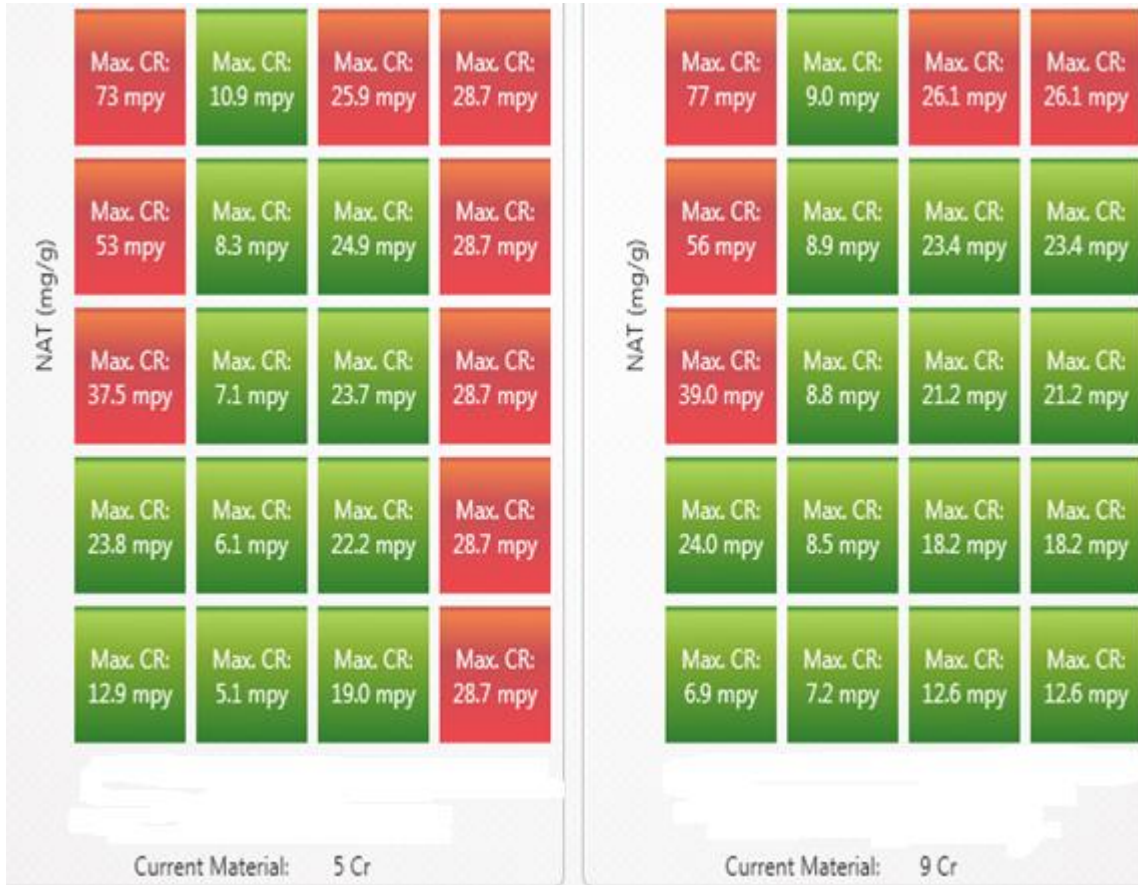
Crude corrosivity mapping

Side-cut corrosivity mapping

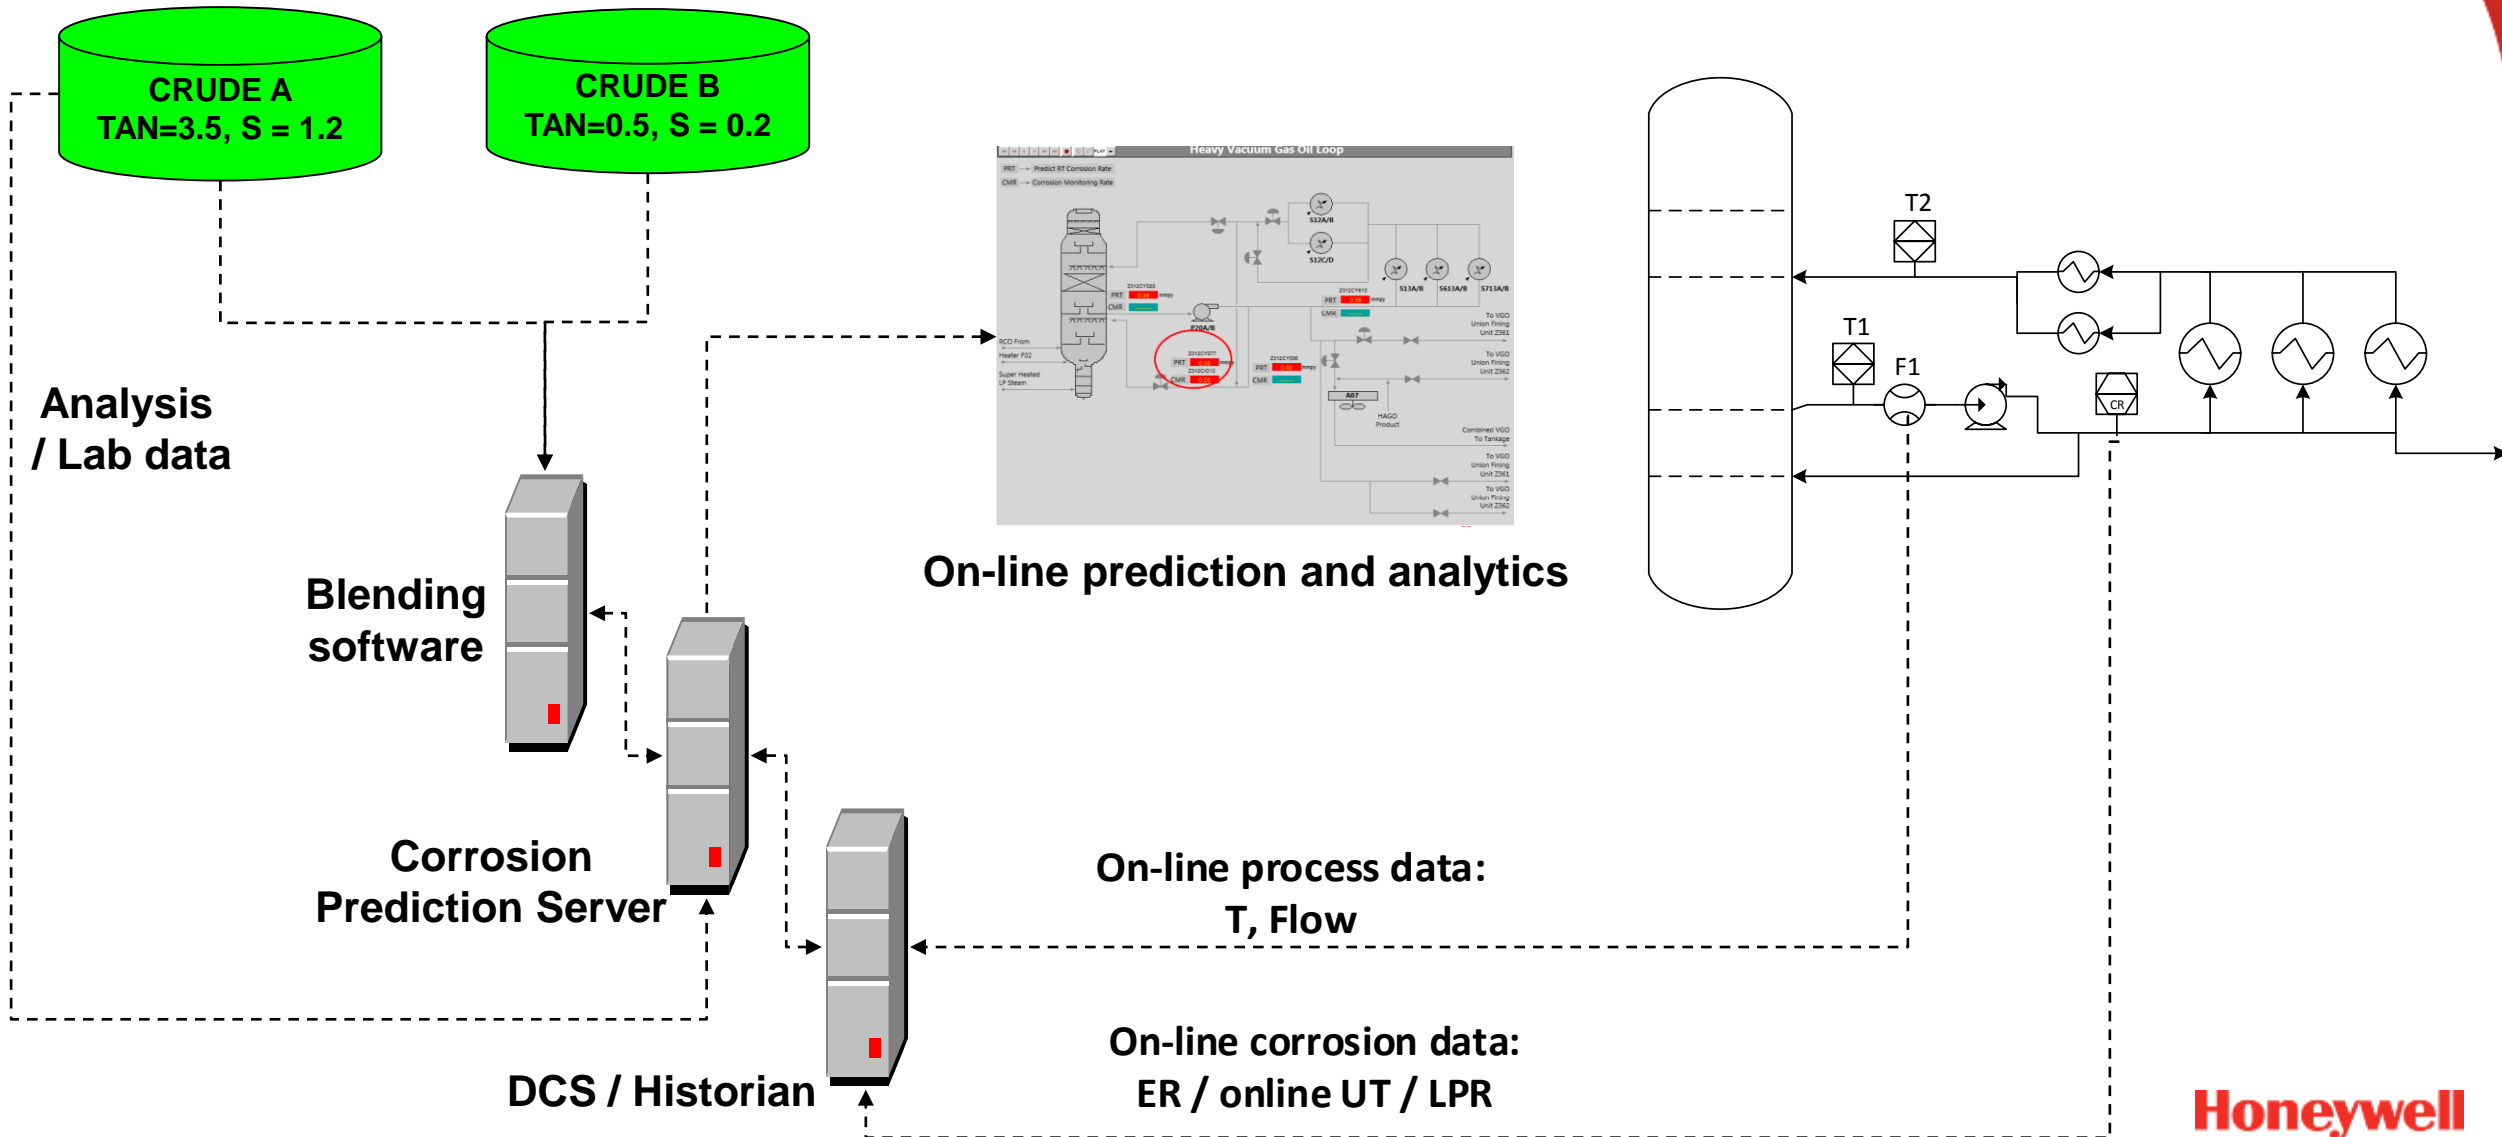
Corrosion prediction of blended crude – real time approach

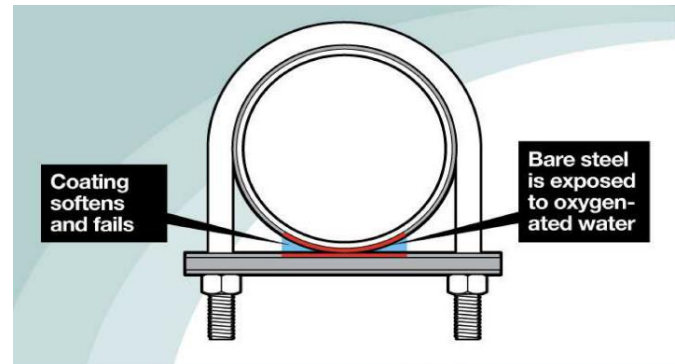
CUPS – Damage & Degradation Mechanism

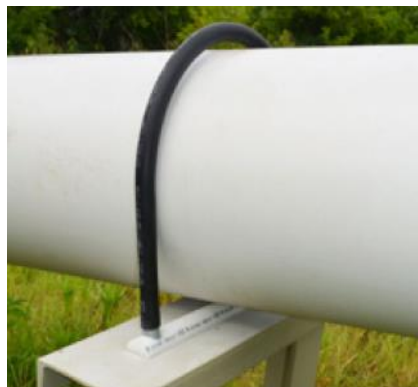
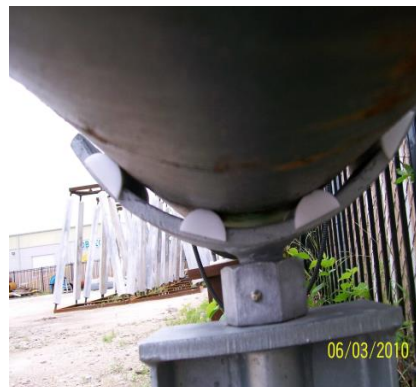
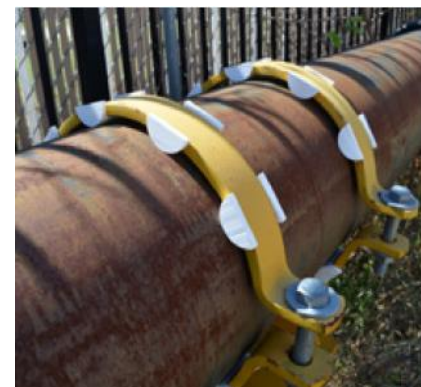
→ Prevention of CUPS:

- Use of pipe shoe shall be mandatory in new design and evaluated in retrofits.
- The crevices at the pipe surface and their ability to trap water must be eliminated.
- As a secondary concern, metal-to-metal contact should be eliminated if possible.
- The solution should allow easy maintenance and inspection of the pipe at the support point.
- The system must provide complete support to the piping system.
- It must be applicable to new construction and retrofits

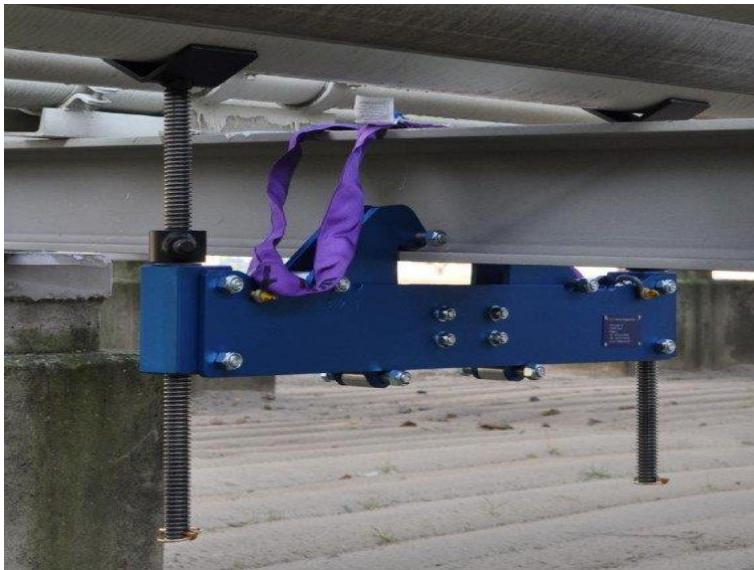
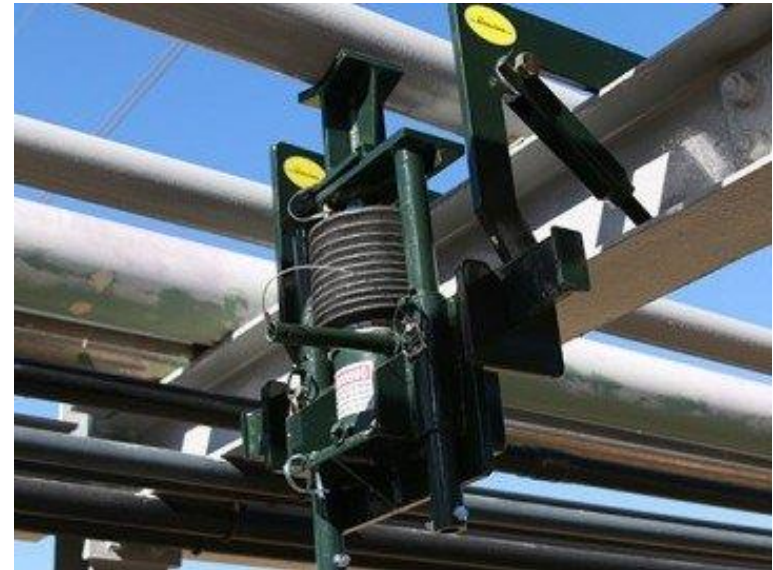
→ Lifting Tools:

- Cranes
- Fixed Lifting Beams
- Special Tools
 - Pipe Rack Jack
 - Hydraulic Pipe Lifting

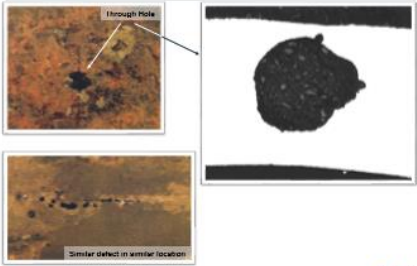
Case 1	Case 2	Case 3
Defect	<p>Defect analysis – Case 1 (U-tube)</p>

Position	Intrados	Intrados	Extrados
Type	Through hole	Deep occluded pit	Through hole
Morphology	Occluded cavern pit, needle shaped walls, small starting hole ($\varnothing \sim 0.5$ mm)		
Notes	Most corr. indication on the 6h lines	Traces of stagnant water (elbow full of water)	Traces of stagnant water (water pool)

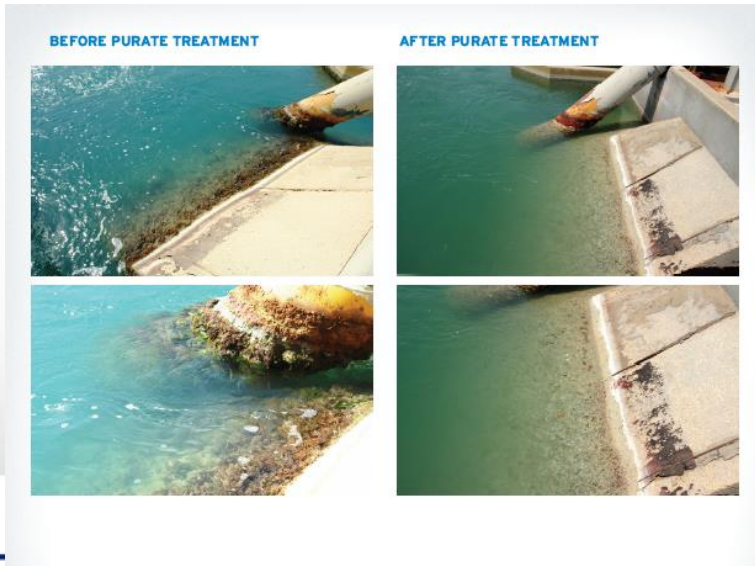
Figure 2: Microbial and fungal counts in seawater system
