Participants EFC WP15 virtual meeting 9th September 2020

**EFC guide line 55 « Corrosion Under
Insulation » Flyer**

Corrosion
under
Insulation

Digitalisation with corrosion monitoring: uses cases for CUI, coatings, RBI

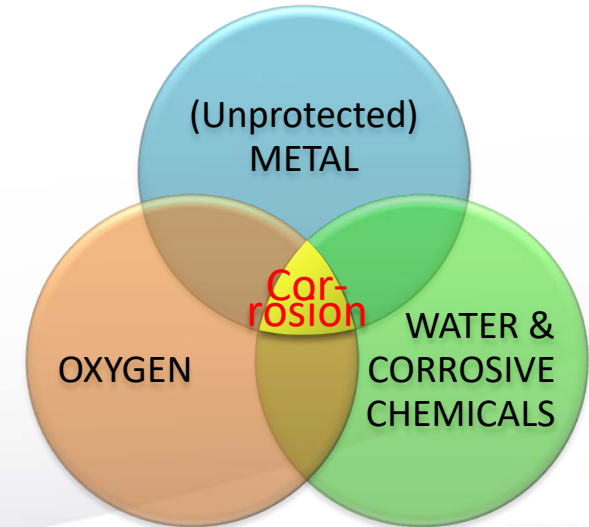
CUI: Effectivity of inspection techniques

Effective and efficient NDT plan:

- Risk determines required effectiveness of the inspection plan
 - API 581 basic (effectiveness class A to E)
 - With follow-up, this leads to risk reduction
- Costs of access to the property are dominant
 - Life cycle calculation for inspection and maintenance regime (reference numbers)
- Many construction, access and damage details only become apparent in the field
 - Pre-inspection in preparation for NDT or Selection of NDT technique in the field
- % Area coverage more important than accurate measurement
 - Potential locations based on design and damaged insulation
 - Then still considerable risk not covered
- Eligibility filter helps with initial selection of technique
 - Work out together with NDO Specialist

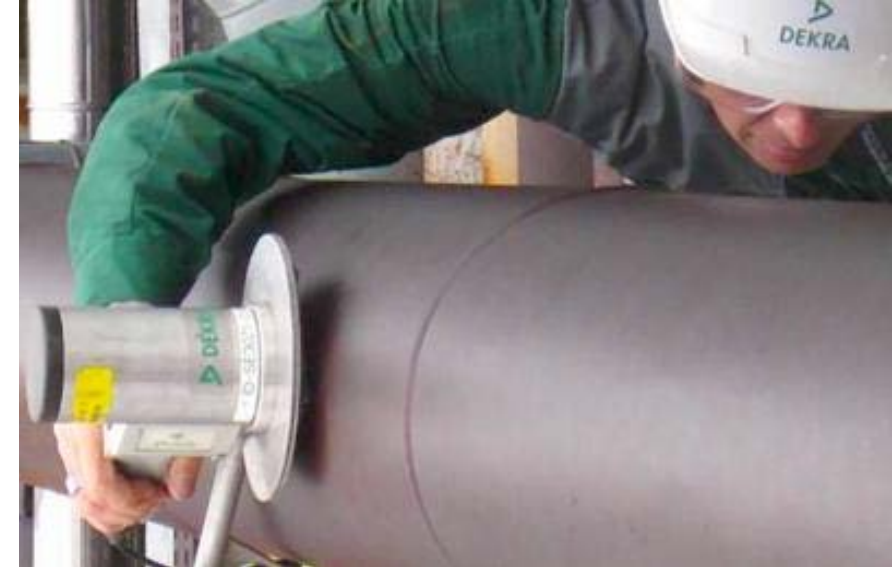
CUI: Effectivity inspection techniques

Geschiktheidsfilter NDO technieken		Corrosie onder Isolatie
Object type	Aftakkingen op leidingen > DN250 en op vatwanden	
Beoogd doel	Corrosie detectie	
Vereiste inspectie-effectiviteit	B= Usually Effective	
Vereiste dekking	65%	
Diameter (mm)	250	
Nom. Wanddikte (mm)	6	
Toegankelijkheid	Vanaf grond of bordes toegankelijk Vanaf grond of bordes toegankelijk Vanaf steiger werken Hoogwerker, rope access Ondergronds	
Geschikte NDO technieken	Opmerkingen	
On stream RT (film)	Beperkt toepasbaar voor wanddiktemeting (HOIS Recommended Practice 1 v3.1)	
On stream RT (digitaal)	Beperkt toepasbaar voor wanddiktemeting (HOIS Recommended Practice 1 v3.1)	
Profile radiografie	Beperkt toepasbaar voor vochtdetectie (HOIS Recommended Practice 1 v3.1)	
In-line inspection (intelligent pigging)	0	
Visuele inspectie met uitpakken	0

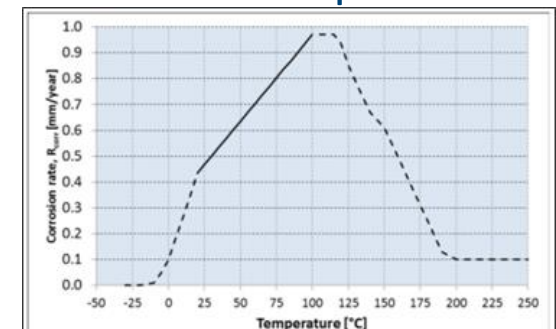
Figure A-3: Corrosion rate (R_{corr}) vs. temperature

Suitable temperature

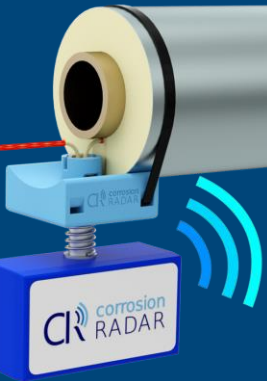
CR Moisture

CR Corrosion

CR Coating**

Other Sensor**

- Distributed Corrosion & Moisture Sensors
- Long Range Coverage
- Cost Effective Installation
- Covering Complex Pipe works

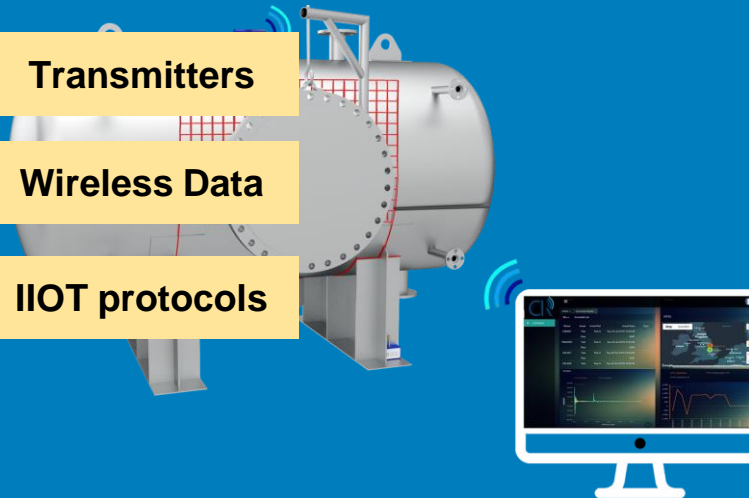
Wireless Data

IIOT protocols

- Long-Life Battery Powered
- Remote Wireless Communications
- Continuous Monitoring
- Dashboard for Actionable Intelligence

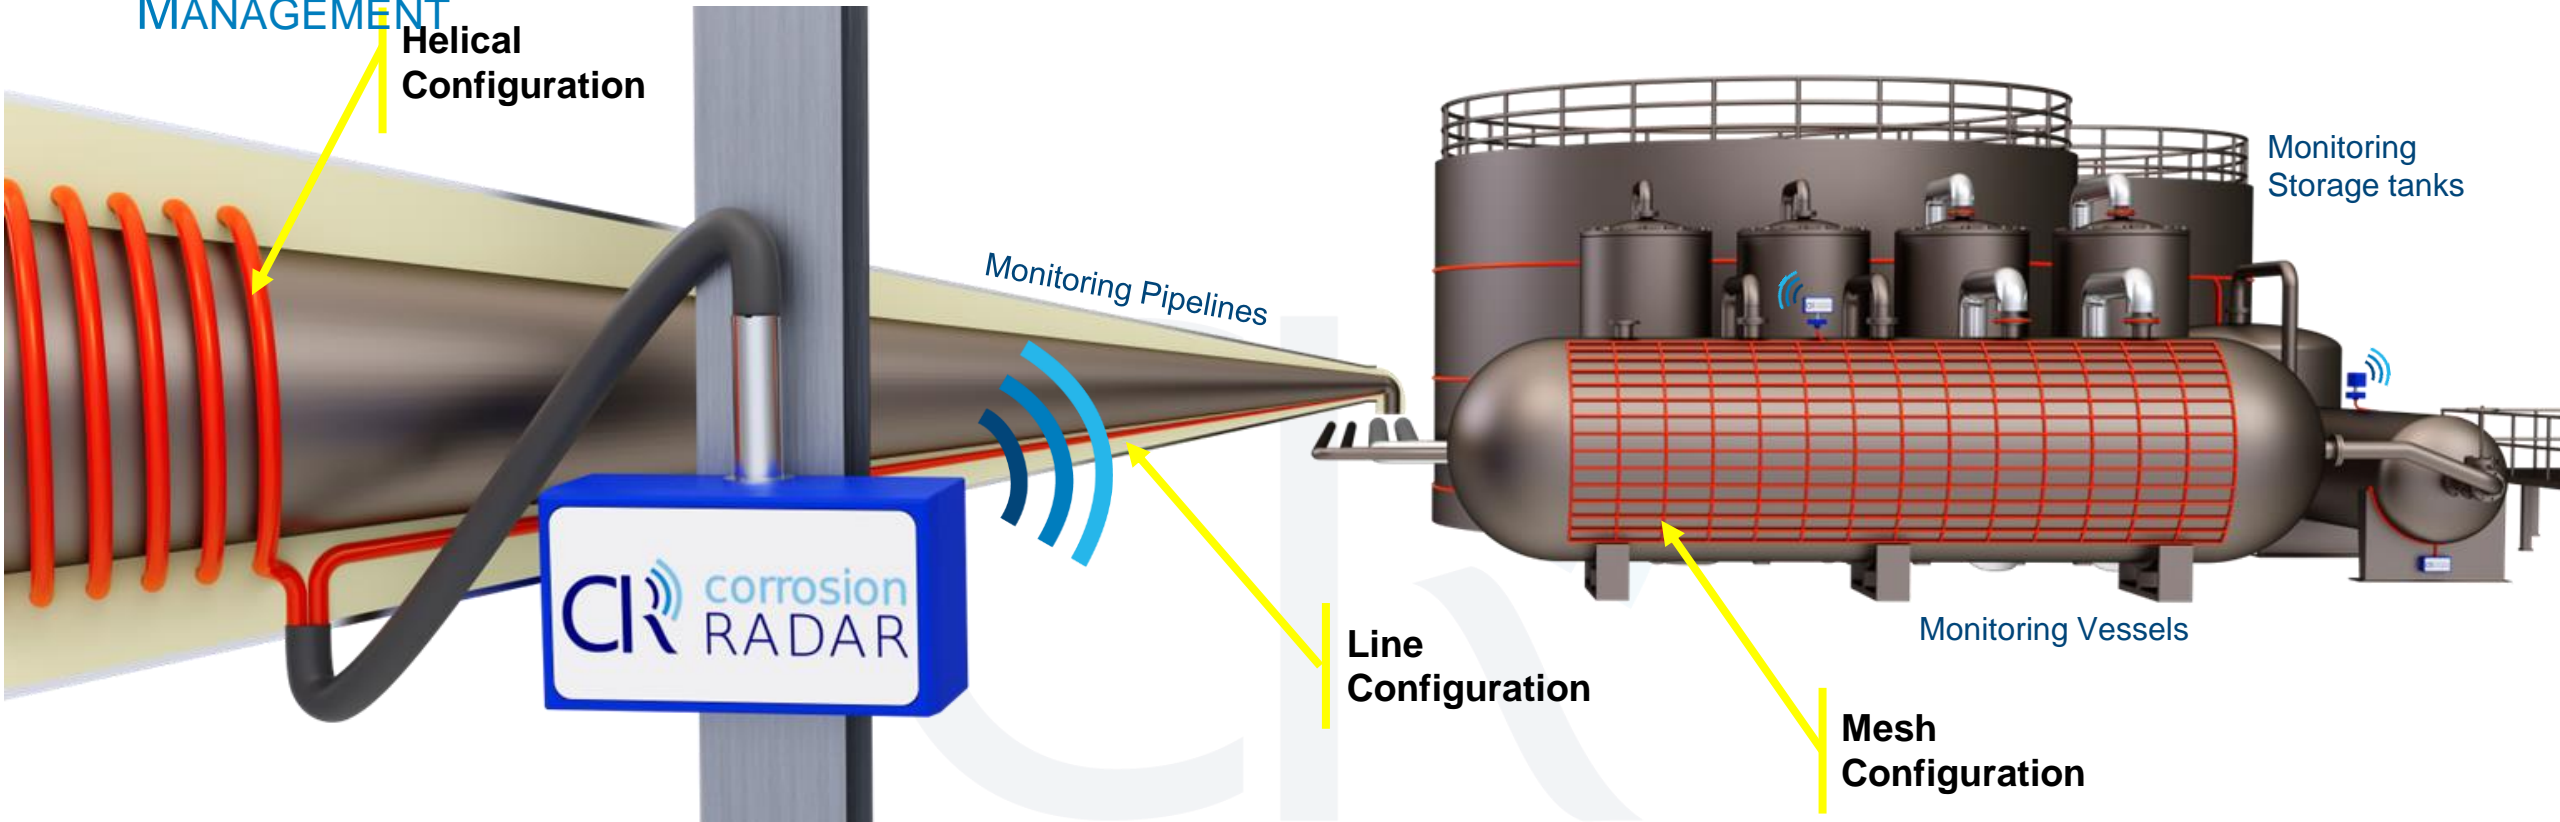
CORROSION AND MOISTURE SENSORS FOR PREDICTIVE CUI MANAGEMENT

Sensors

Sensors Type	1) Corrosion 2) Moisture
Sensor Length	1) Up to 100m 2) 50m
Temperature Range	-50 to 1) +300 °C 2) +200 °C

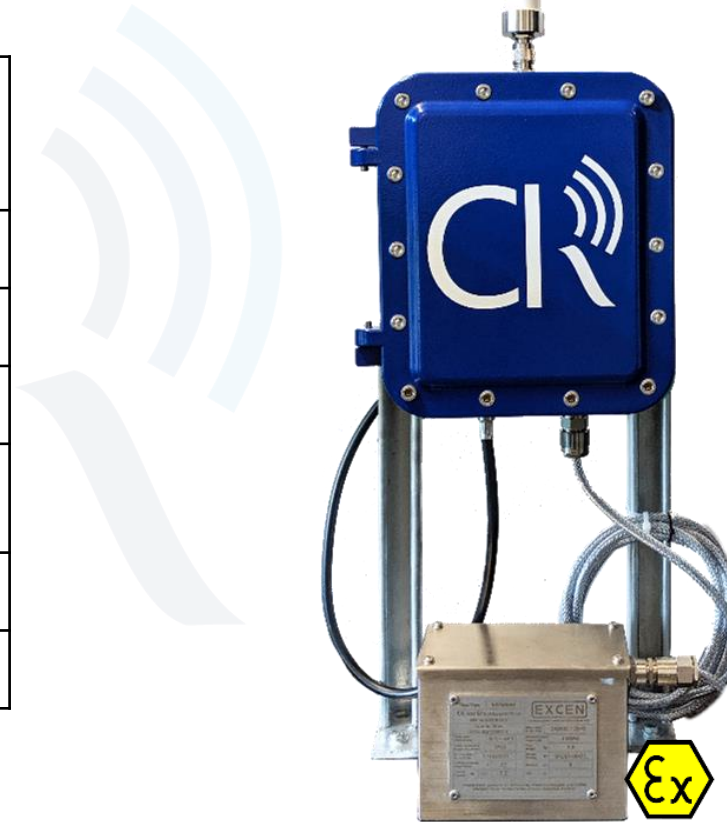
Corrosion & Moisture Monitoring System - Electronics

ATEX/IECEX Certification	II 2 GD Ex db IIB+H2 T3-T6 Gb Ex tb IIIC T85°C - T150°C Db
Ingress Protection	IP66
Power Source	Mains
Temperature Range (°C)	- 20 to +60
Communications	Wireless: Wifi/Cellular/WirelessHART/LoRa Other options: USB
Approx. Dimensions (mm):	284H X 245W X 169D (Without Antenna)
Approx. Weight	11.2 Kg

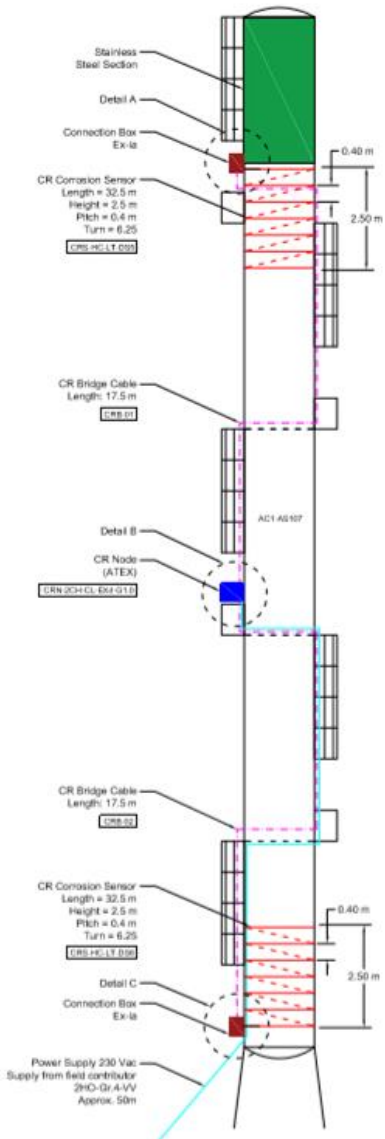
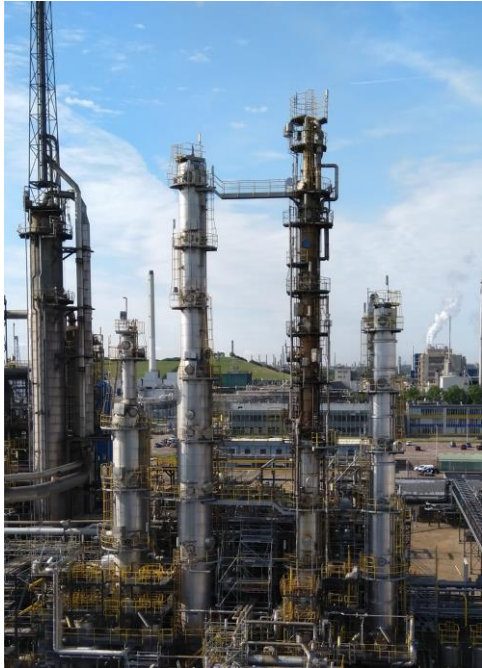
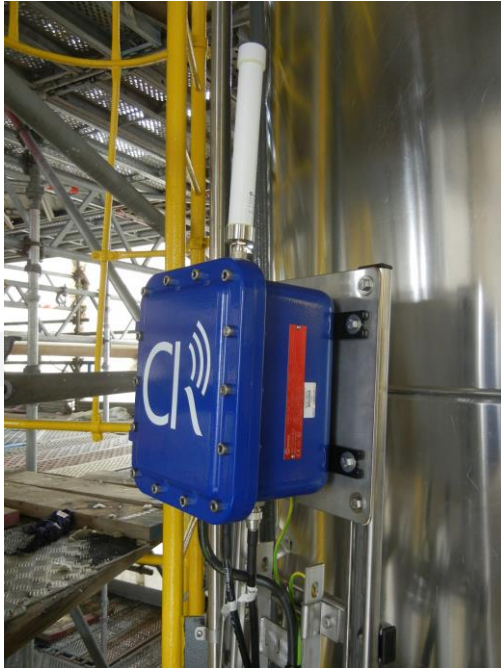
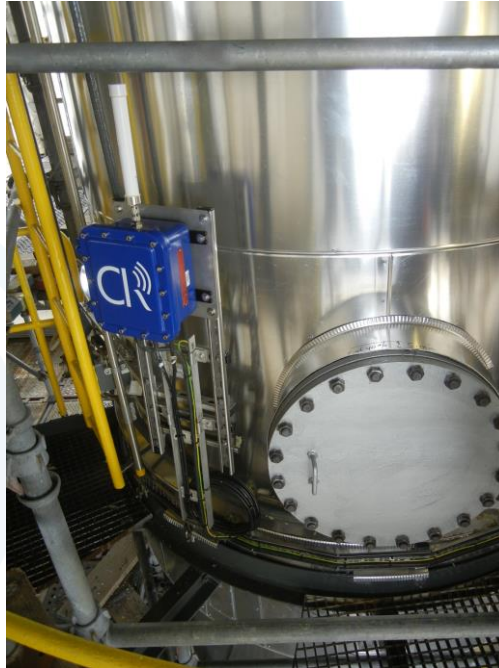
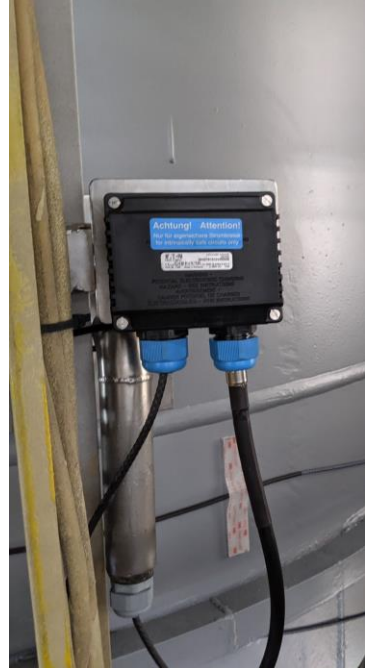
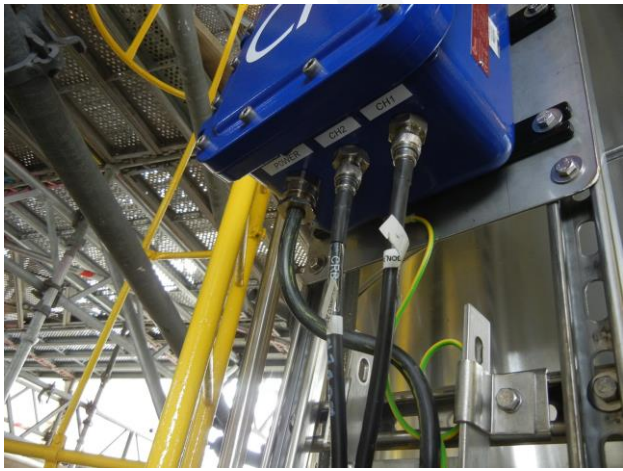
Case Study A

PRODUCTION COLUMN CORROSION MONITORING (ATEX)

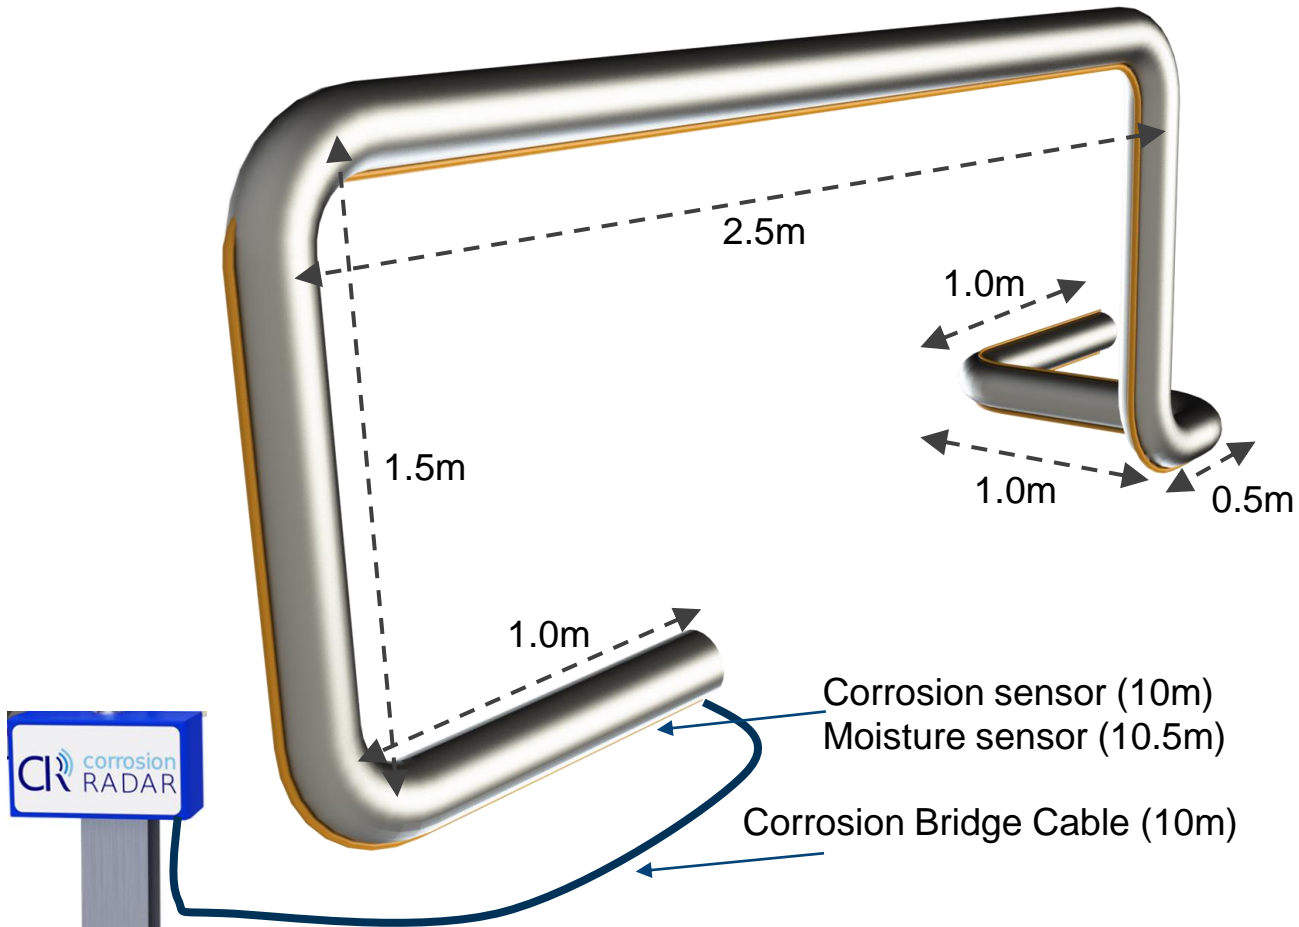
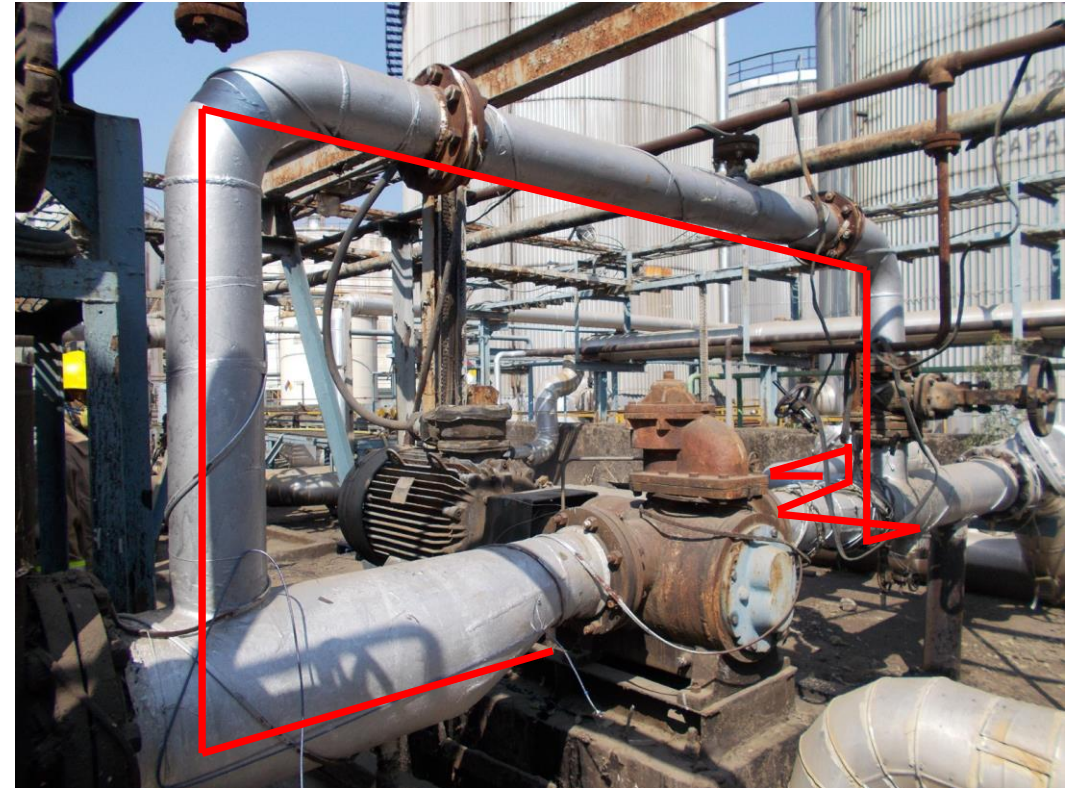
INSTALLATION OF CR SYSTEMS

Installed layout of both CR Corrosion and Moisture monitoring systems

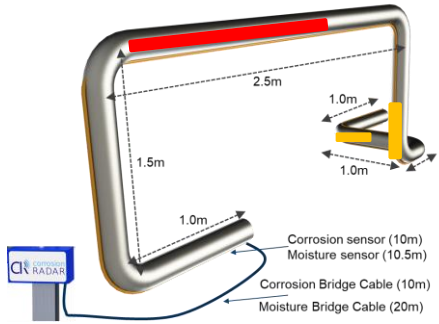
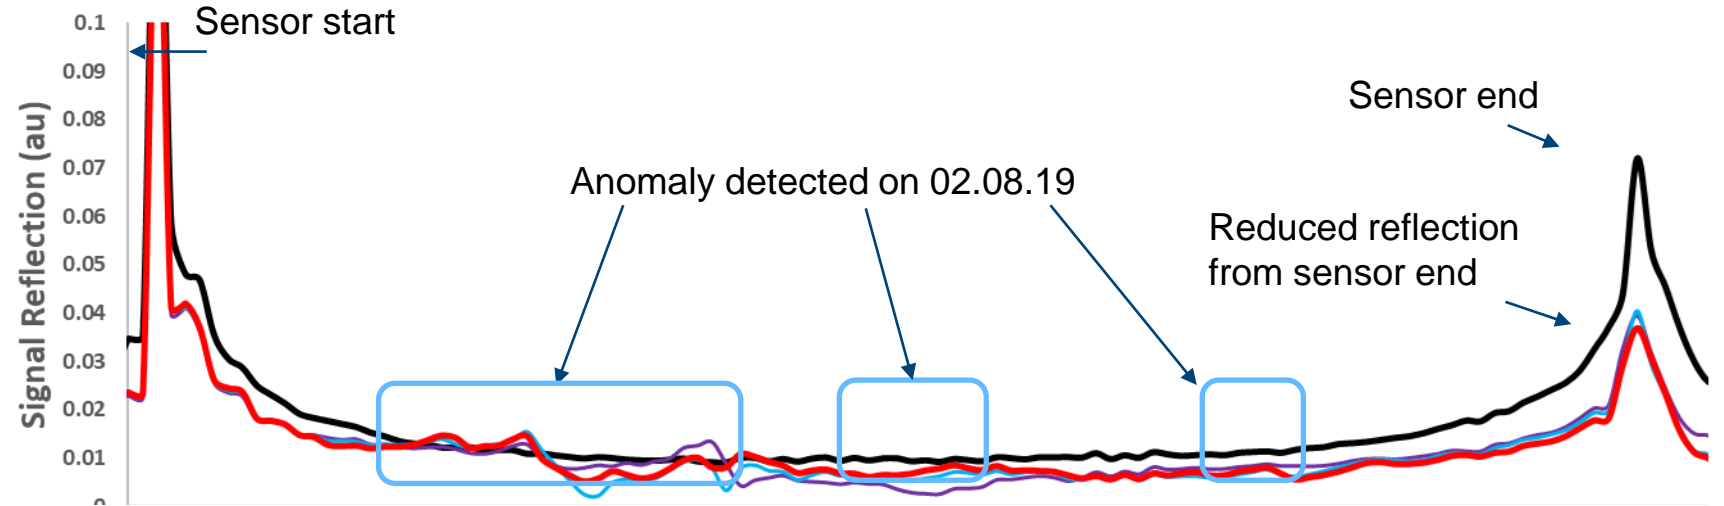
Corrosion Sensor

Data after 9 months

CORROSION AND MOISTURE MONITORING SYSTEMS

— 01.02.19 07:00 — 02.08.19 11:35 — 18.08.19 14:50 — 07.09.19 06:03

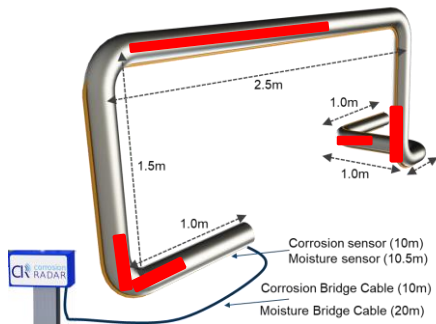
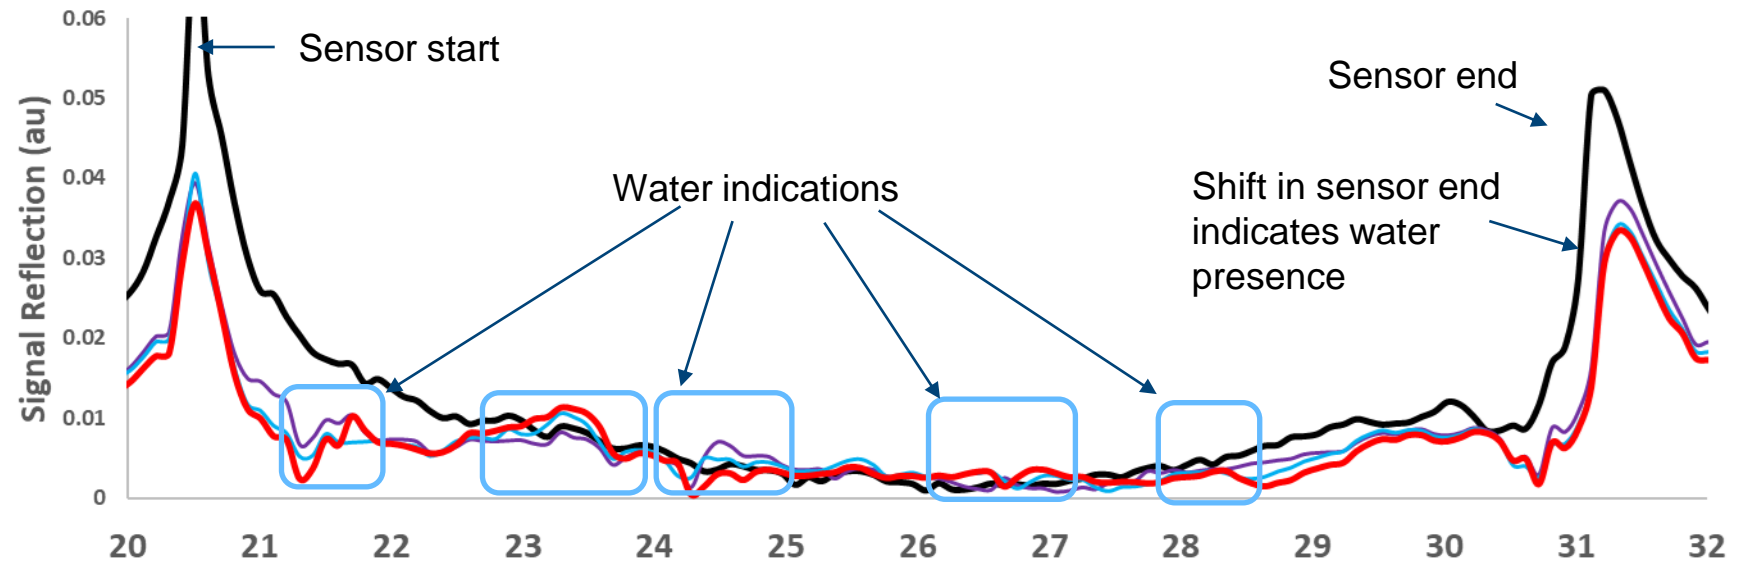
Moisture Sensor

— 01.02.19 07:00 — 02.08.19 11:35 — 18.08.19 14:50 — 07.09.19 06:03

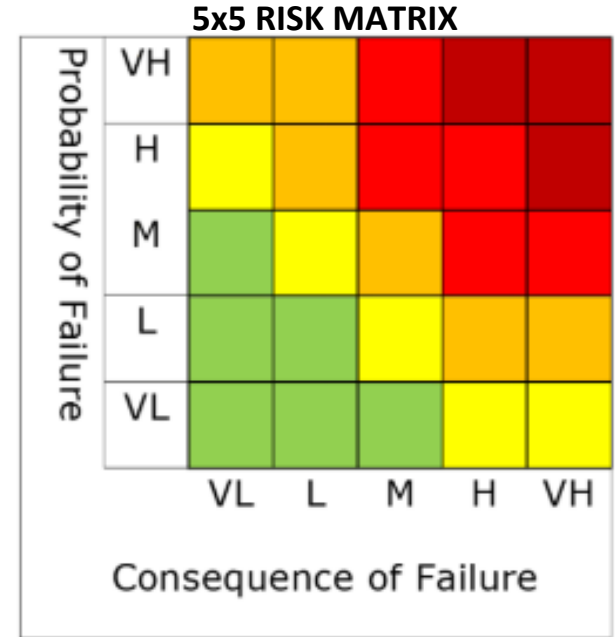
Dynamic PoF
Probability of failure
for CUI

From CR sensor signal readings and inputs coming from the characteristics of the asset

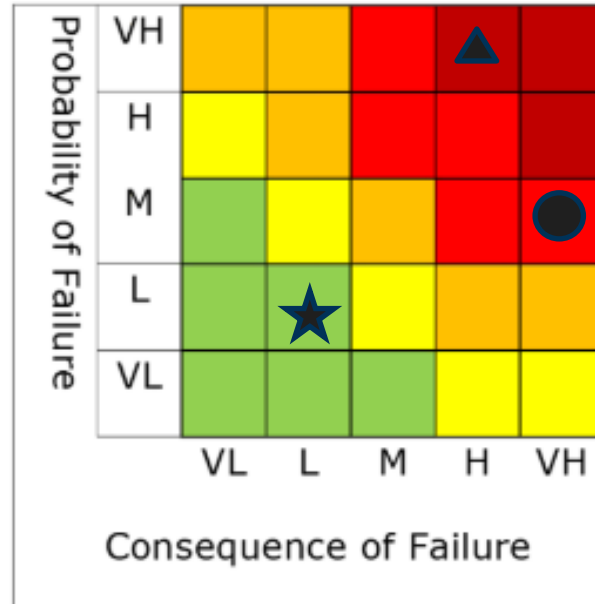
Static RBI

Year 1 ~ Year 5

- Is not periodically updated
- Does not reflect field conditions
- Scope for optimisation

- ▲ Asset 1
- ★ Asset 2
- Asset 3

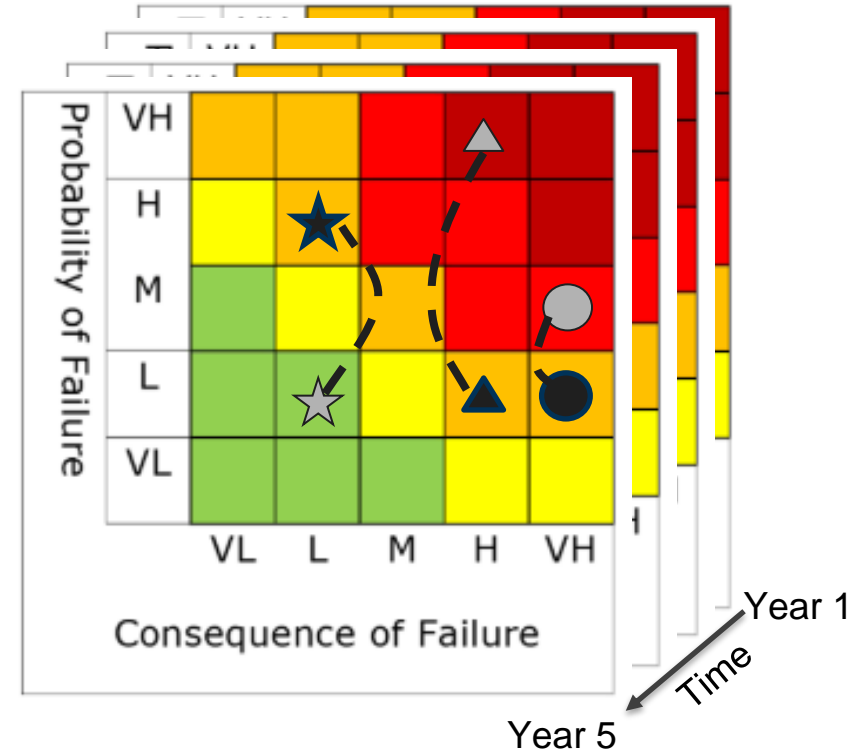
Dynamic RBI

Year 1
Time
Year 5

Enabled by
CorrosionRADAR
monitoring
system

- Periodic updates (manual or automated)
- Incorporates field conditions (moisture)
- Optimised inspection cycles

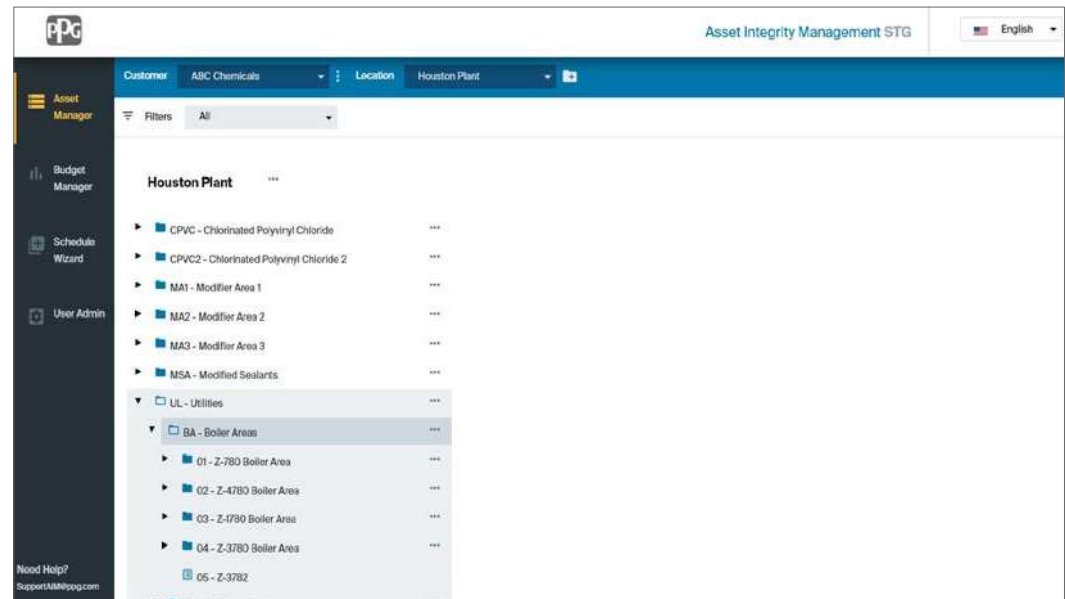
Asset Manager

- Master catalog of all assets within your facility grouped by location, unit, and section detail.
- Assets mapped by defined boundaries using your naming conventions.
- Single interface to view all details concerning the assets including; plots, pictures, condition analysis, inspection reports, etc.

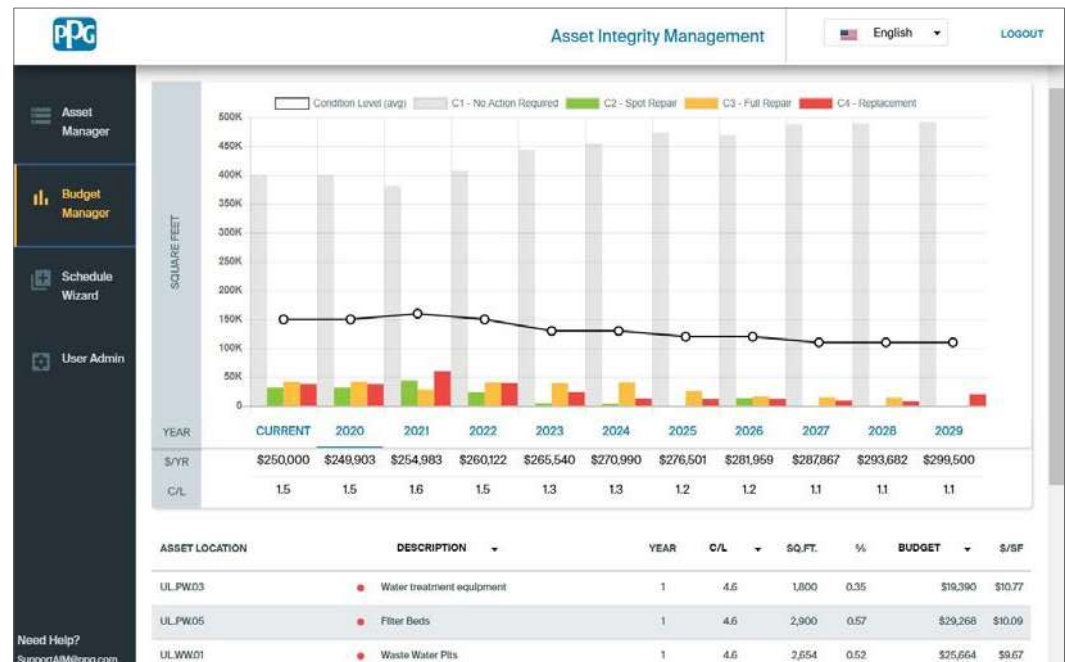
Budget Manager

- Provides a graphical display of the current condition and a forecast of the condition for each year of the maintenance program.
- Asset location details are listed for each year of the maintenance program.

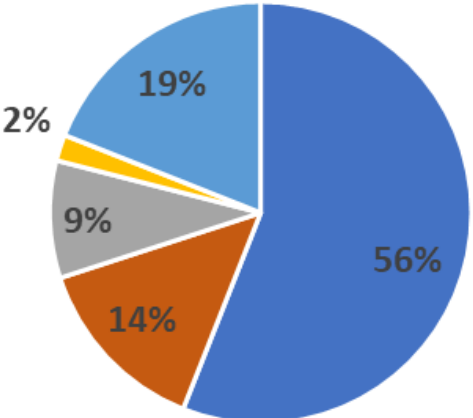
Mechanical Integrity Failure Location

- Piping Internal Corrosion
- Piping External Corrosion
- Equipment Internal Corrosion
- Equipment External Corrosion
- Bolted Joint/Seal Failure

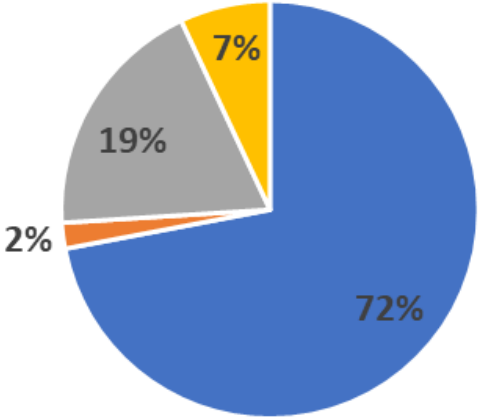
Mechanical Integrity Failure Reason

- Normal
- Maintenance
- Non-Routine or Infrequent
- Abnormal or Unplanned

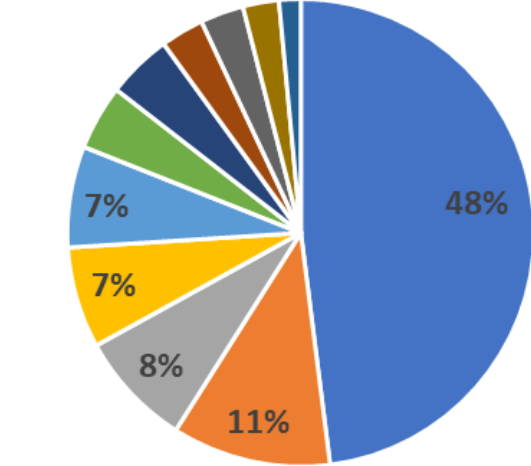
API 754: Tier 1 & Tier 2 Events - Point of Release

- Piping System
- Pump
- Fired Heater
- Pressure Vessel
- Compressor
- Atmospheric Tank
- Other
- Heat Exchanger
- Instrumentation
- Flare/Relief System

Source: LMA; Common Causes of Major Losses in the Onshore Oil, Gas & Petrochemical Industries; September 2016

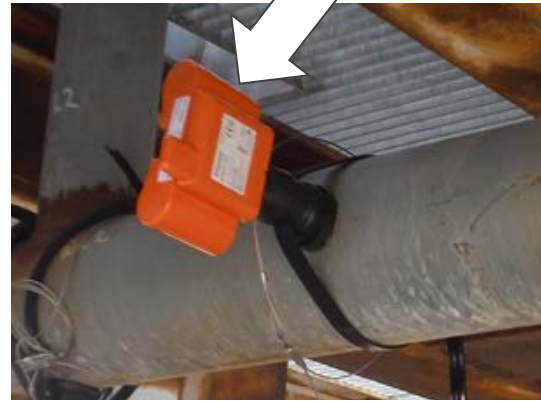
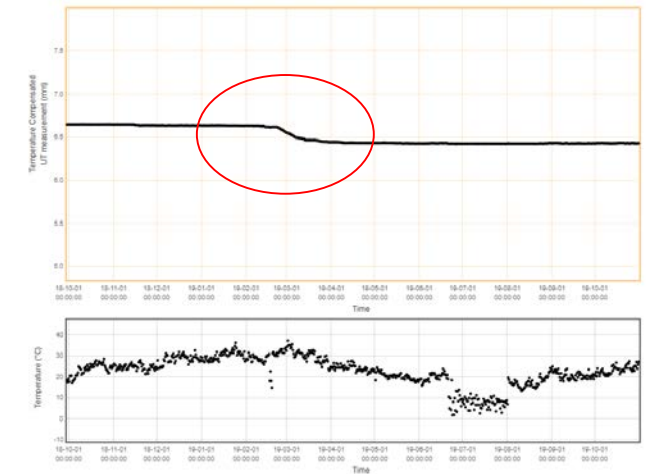
HF Alkylation – Case Study 1: Increased corrosion rates due to acid carry over

- No corrosion expected at this location
- Carbon steel selected as no HF should be present
- Corrosion monitoring used to confirm health of unit/ normal operation & turnaround planning
- High corrosion rates observed, alerting team to corrosion due to acid carry over
- Data from multiple sensors used to assess severity and spread of the corrosion caused
- Team were able to identify root cause and take corrective action before metal loss reached critical level
- Continued to monitor corrosion rate after the event to ensure that stable operation had been restored

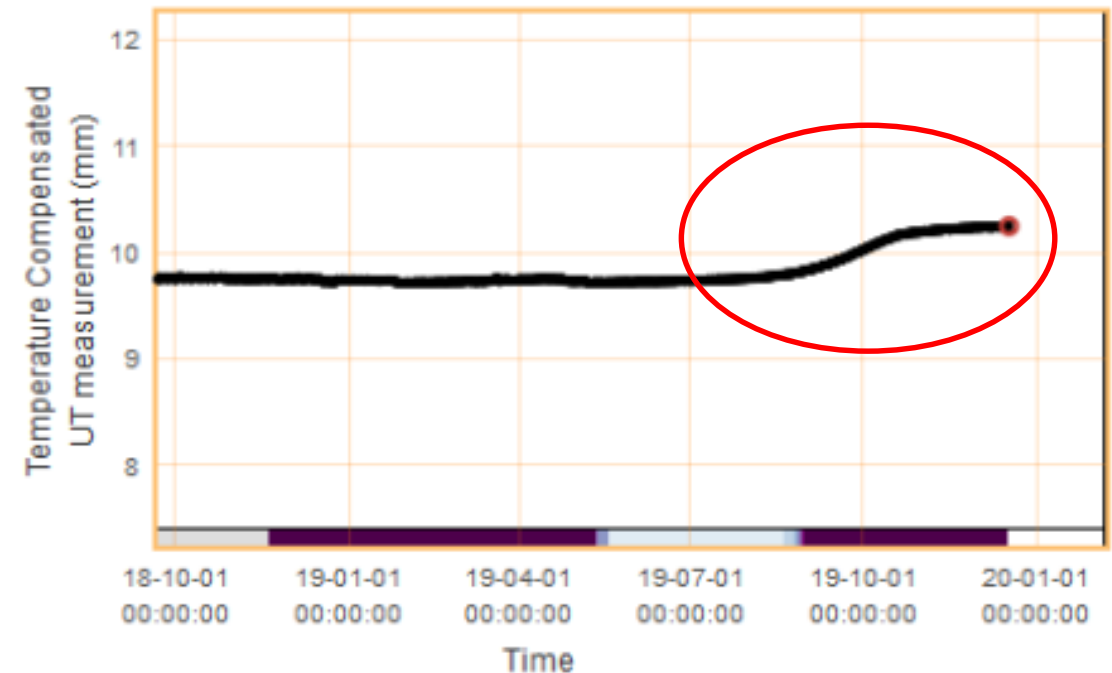
Thicknesses with associated waveforms

- Permasense is used to identify the presence of iron fluoride scale inside the piping system
- Scale build-up inside in the piping distorts the ultrasonic reflection. Approximately 30% of sensors installed at HF Alkylation units are affected by this and therefore it can be also detected by ultrasonic sensors. Iron fluoride scale build-up identified by an increased wall thickness over time.

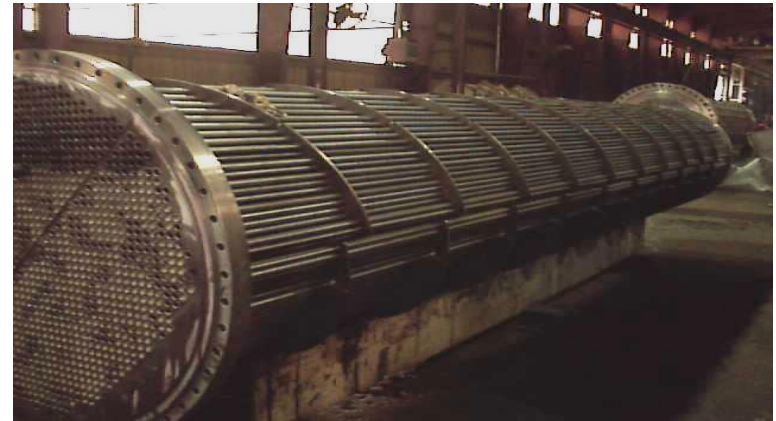
Overhead condenser refinery – Debottleneck / Retrofit

- Operational conditions of the bundle:
 - Shellside : HC Vapor Condensing
 - Tubeside: Cooling water
- Tube bundle material: CuNi 90/10
- Issues:
 - Corrosion existing on CuNi tubes
 - Limited run time (cleaning every 4 months)
- Additional challenges:
 - Need to increase the duty by 40%
 - No space to add new shells
- Solution:
 - Material: Titanium Gr 2 to address crevice corrosion
 - Technology: helix exchanger to reduce fouling
 - Technology: low finned tubes to increase the duty
- Results:
 - **No corrosion issue**
 - **Run time: 3 years**
 - **Duty increased by 40%**

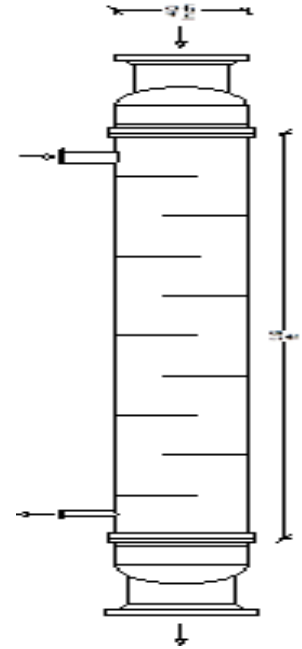
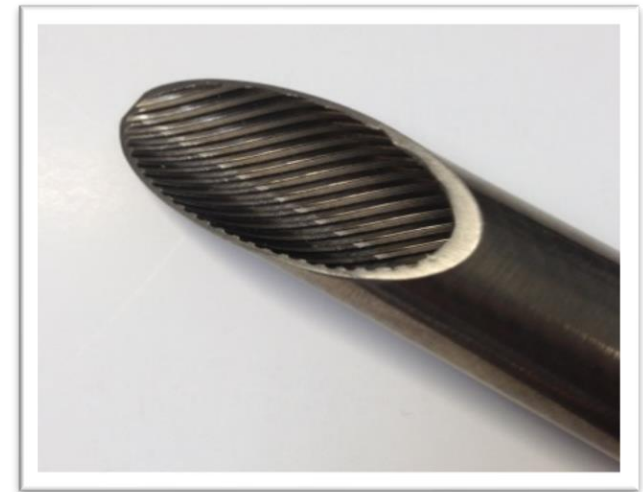
Methanol vaporizer – Debottleneck

- Operational conditions of the bundle:
 - Shellside : Condensing steam
 - Tubeside: Methane droplet + Methanol Liquid
 - Vertical flow down
- Tube bundle material: Carbon Steel
- Issues:
 - Corrosion existing on the Carbon Steel tubes
- Additional challenge:
 - 100% vaporization mandatory
- Solution:
 - Material: stainless steel to address corrosion
 - Technology: inner ribs to compensate the loss of performance in the material choice
- Results:
 - **No corrosion issue**
 - **100% vaporization**

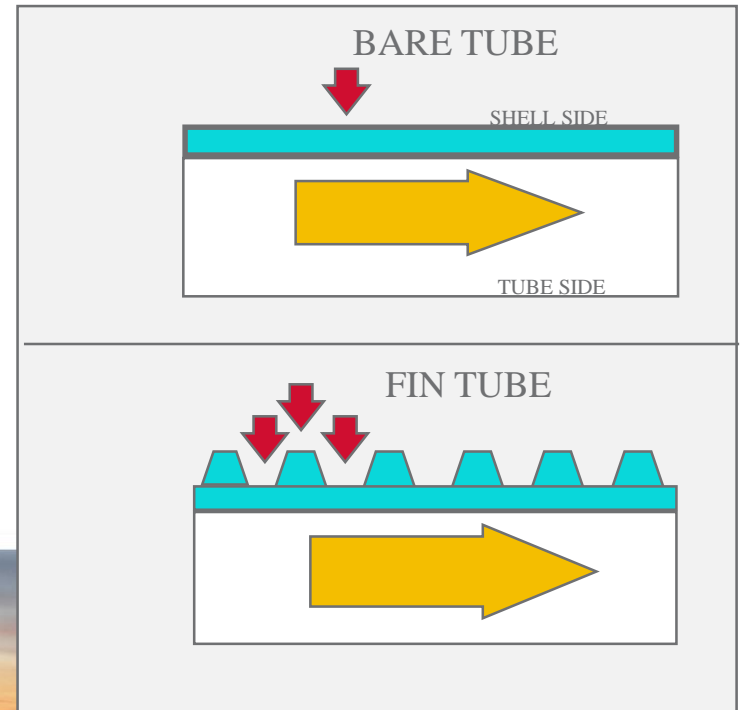
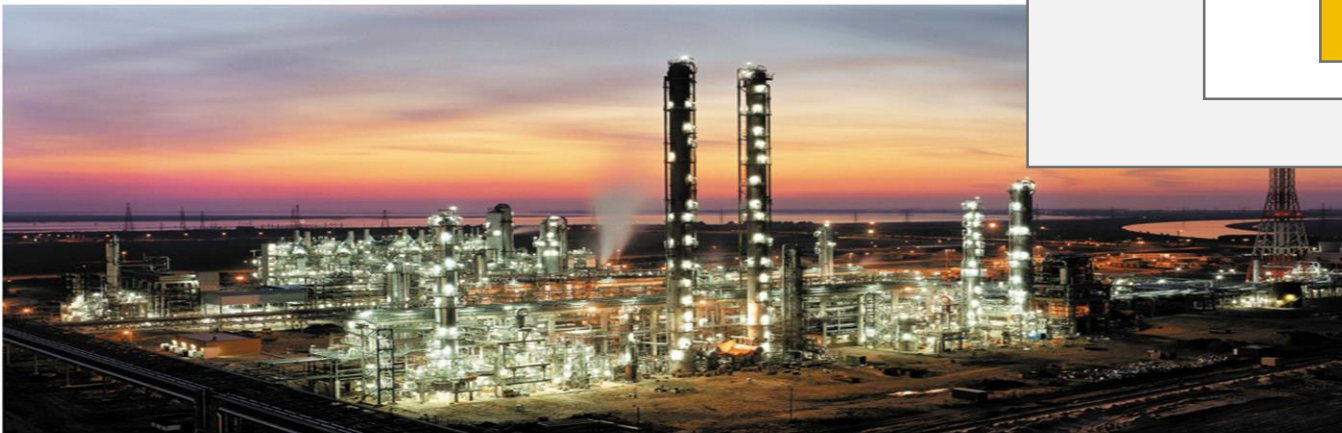
FINNED TUBE: A TOOL FOR PROCESS INTENSIFICATION

- Shell side controlling heat transfer
- Space is limiting
- Debottlenecking
- Close temperature approach

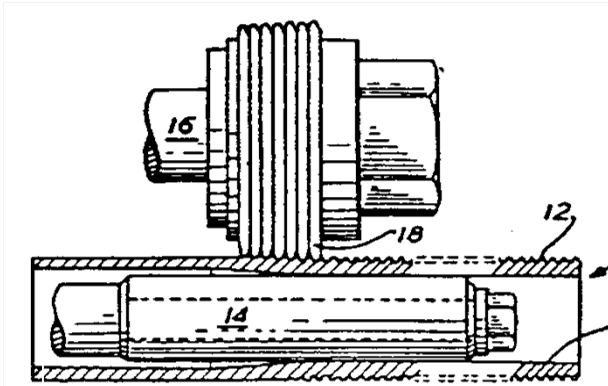
OUR MANUFACTURING PROCESS

Proprietary Tooling produced in house to very tight tolerances

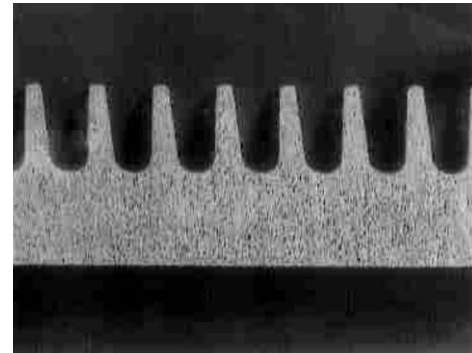
Very smooth Fin Profile with no stress risers

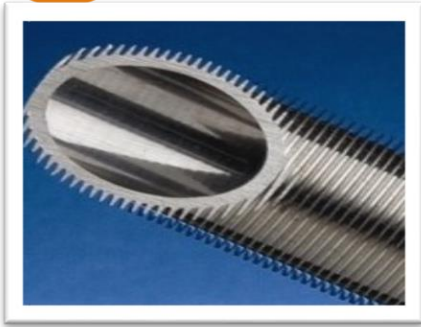
Low-fin OD Smooth Bore

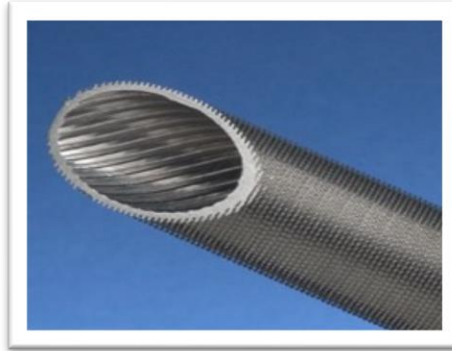
THERMO-C Condensing

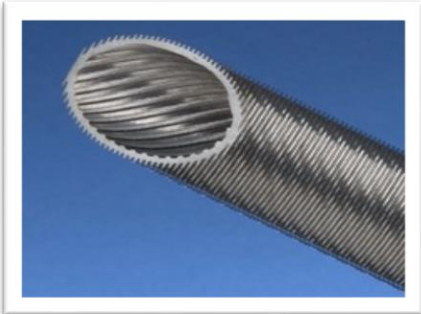
Low-fin OD Spiral Groove ID

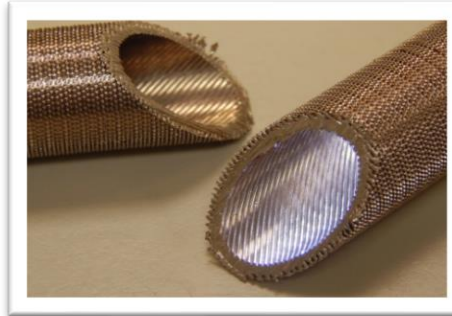
THERMO-B Boiling

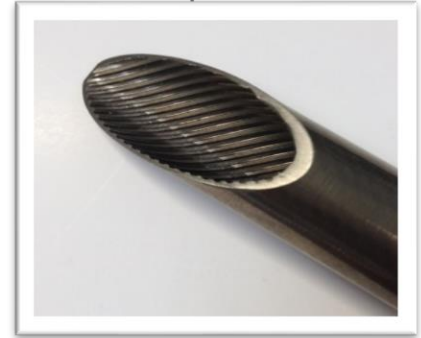
Smooth OD Spiral Groove ID

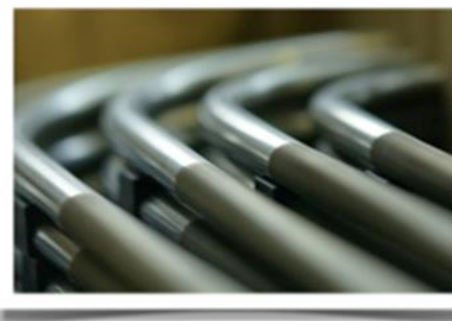
Finned and U-bent

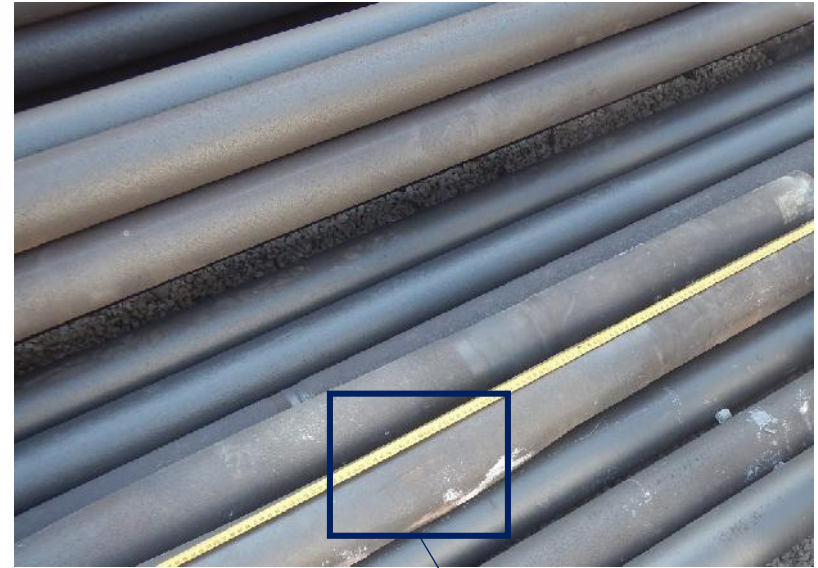
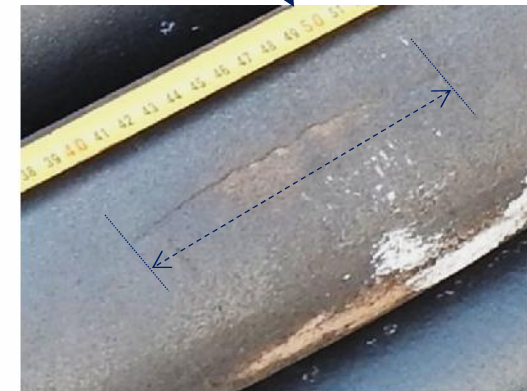
Furnace Tubes applied in Hydrogen production plants

- *Fe, Cr, Ni, C* based alloys; addition of other elements as micro-alloying (e.g. Nb, Ti)
- Centrifugally *Cast*
- *Service T* : 850 – 950 °C
- *Service stresses*: typically 10 + 15 MPa (as hoop stress)
- *Vertical arrangement* e filled with catalyst
- Design life 10^5 hrs (\cong 11 years)
- → *severe working conditions*

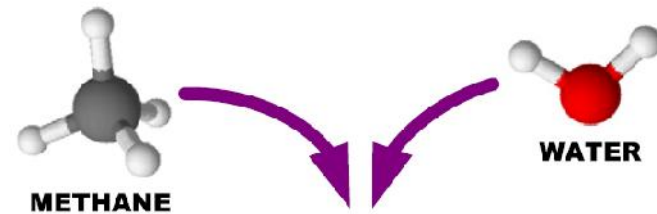
Steam reforming reactions: some chemistry

Endothermic

- Absorbs heat
- Controls tube Skin Temperature

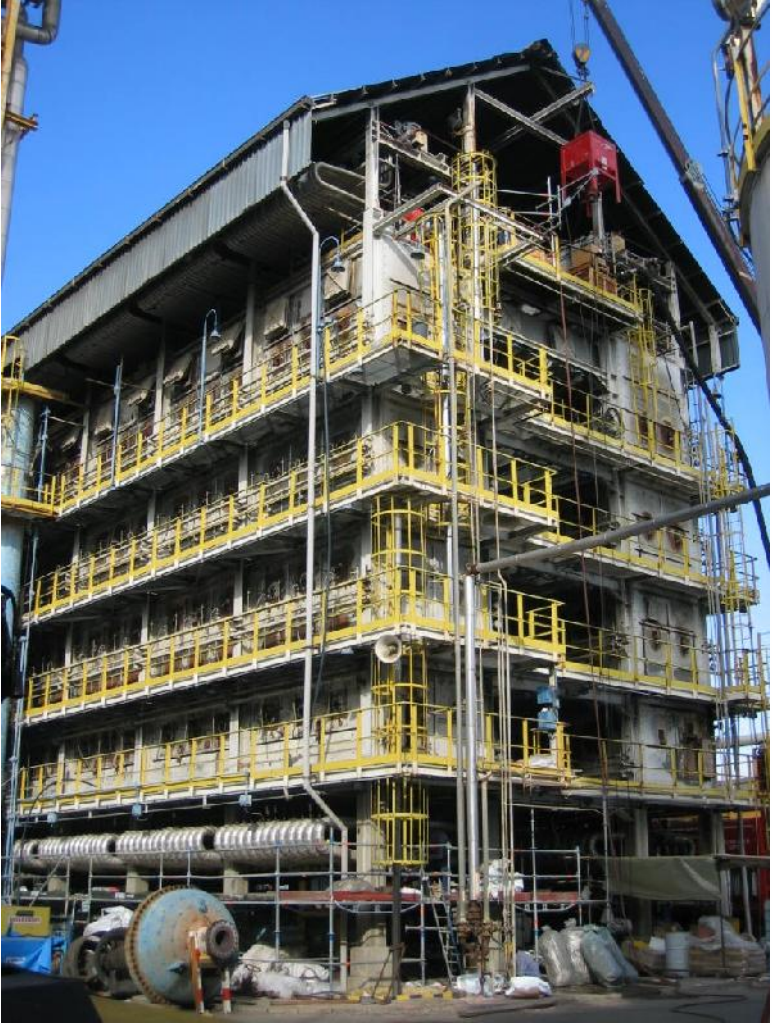
External

Steam reforming furnace

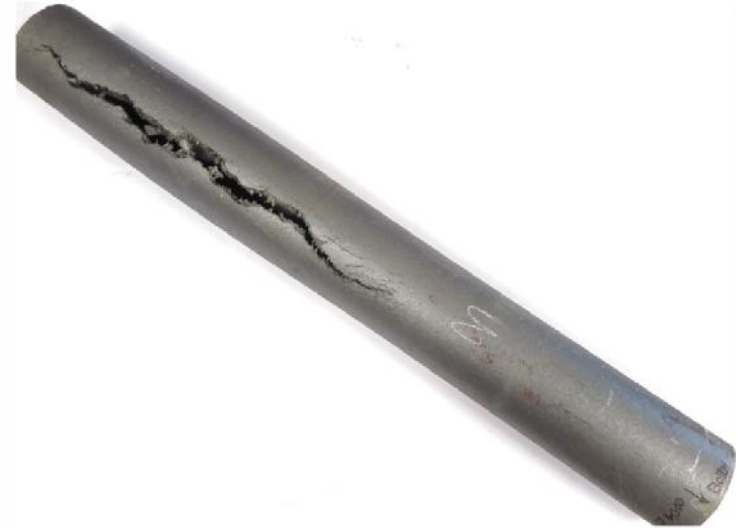
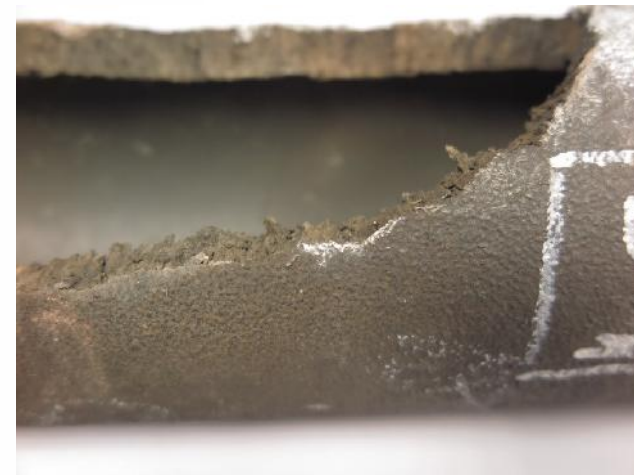
Typical damage mechanisms

- **Creep** failure
 - Normal End of Life (EoL)
 - Overheating (overfiring, flame impingement, CAT related problems)
- **Thermal fatigue**
- **Thermal shock**
- Stress Corrosion Cracking (**SCC**)
- **Dissimilar weld** cracking
