Participants EFC WP15 virtual meeting 9th September 2020

**EFC guide line 55 « Corrosion Under
Insulation » Flyer**

Corrosion
under
Insulation

Digitalisation with corrosion monitoring: uses cases for CUI, coatings, RBI

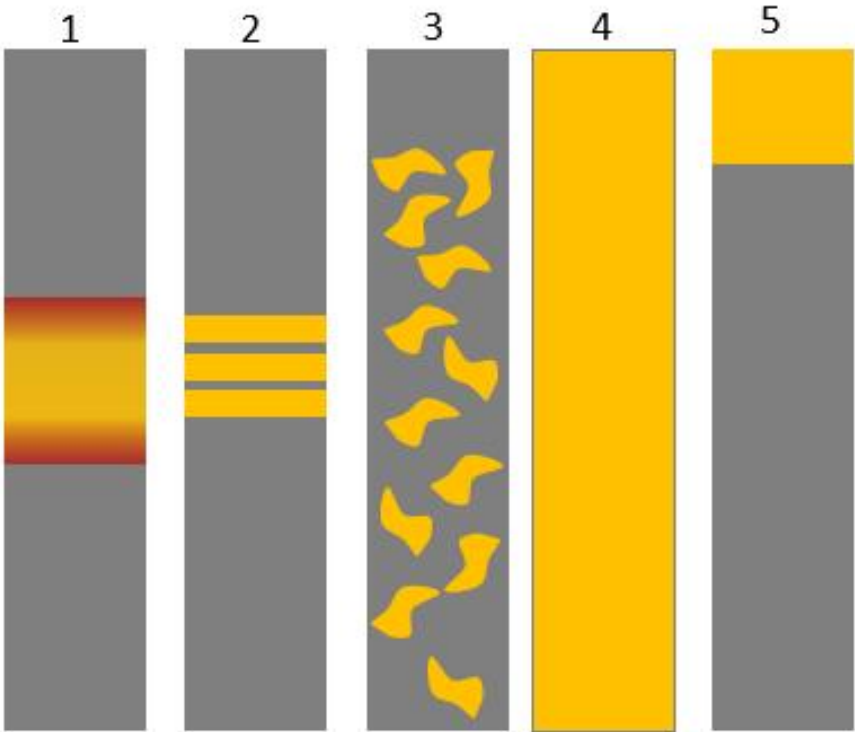
Difficult to predict EoL: overheating

- 1. HOT BAND
- 2. TIGER TAILING
- 3. GIRAF NECKING
- 4. HOT TUBE
- 5. CAT SETTLING

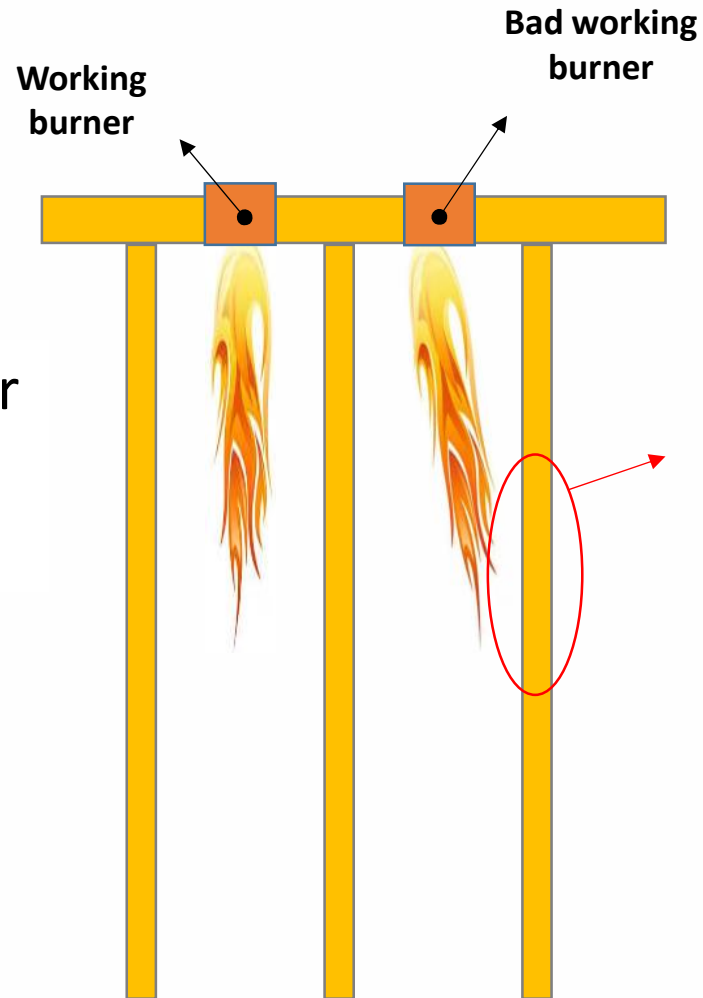
Flame impingement

- Related to burner control and maintenance

"Flame impingement"

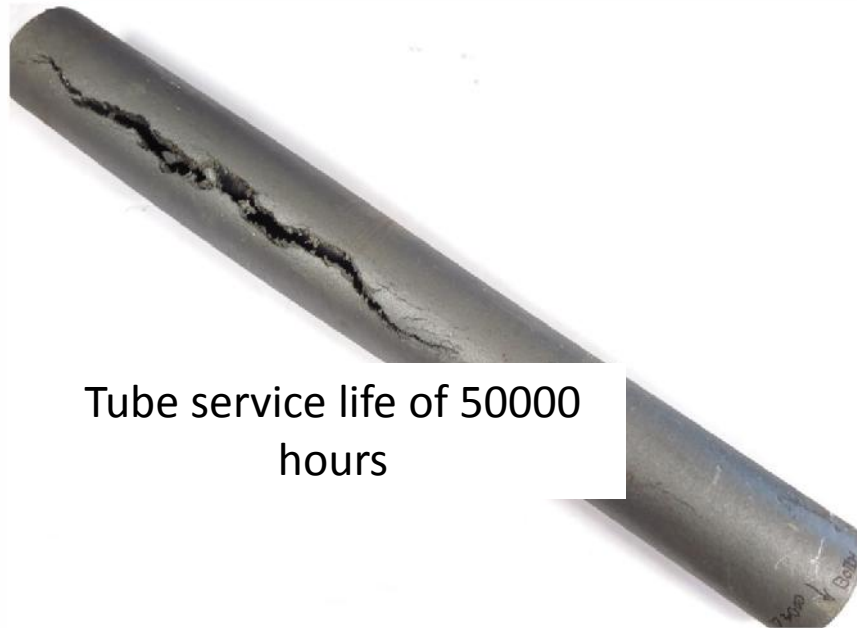
Catalyst Tube : example of failure during service

Same furnace, different failure mechanisms (50000 hrs e 3000 hrs)

Hoop stress = 10.5 MPa

Furnace service life = 50000 hours

Tube service life of 50000
hours

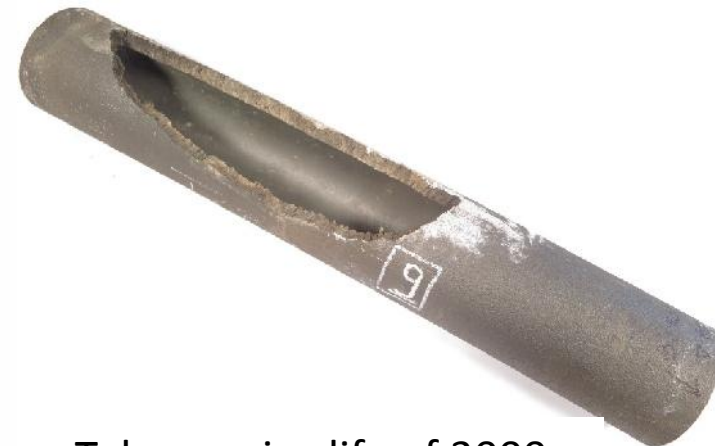
Tube service life of 3000
hours

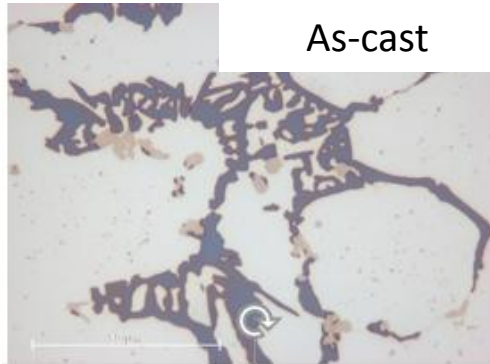
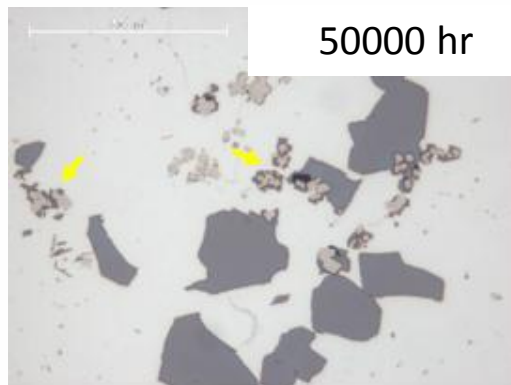
Phases evolution

Creep Damage – Microstructural evolution

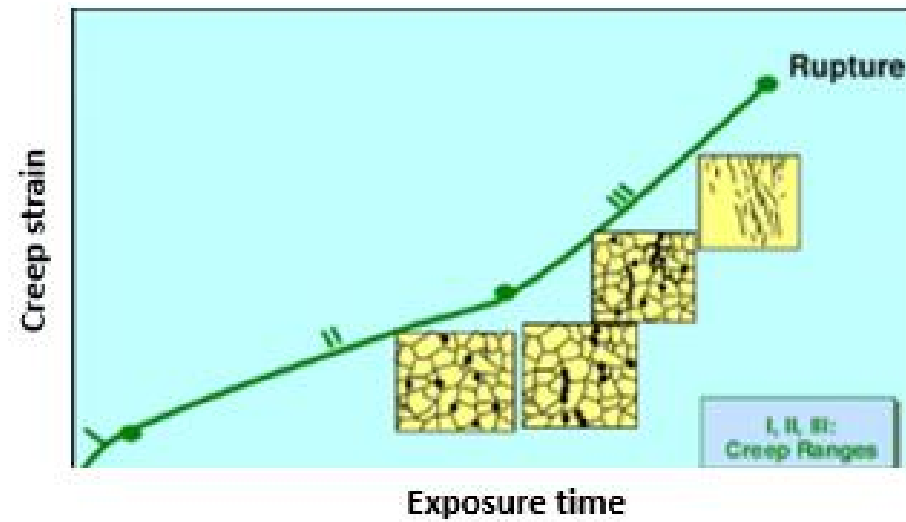
Voids- Cracks evolution

- I creep
- II creep
- III creep

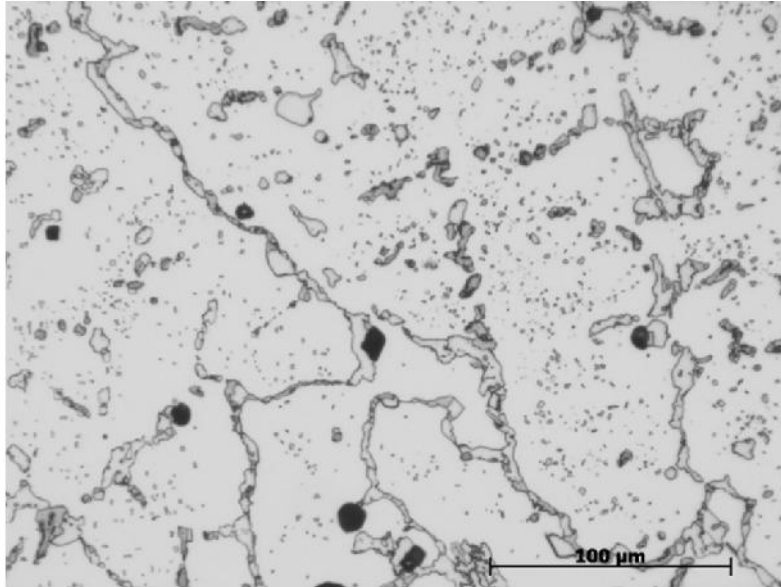
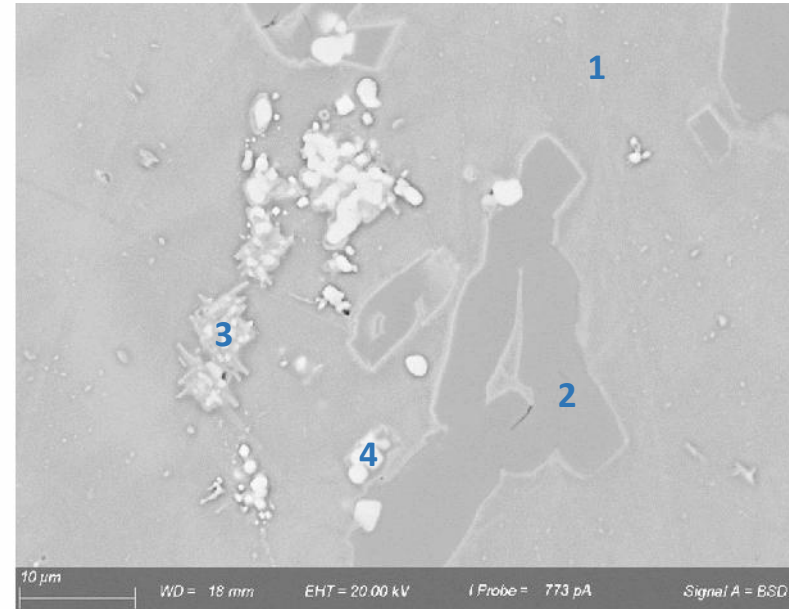
Examination of aged microstructure

50000 hr service life

Coalescence of primary carbides,
precipitation of secondary carbides
and new phases

- 1: Matrix
- 2: Primary Chromium carbide
- 3: G-phase (Ni-Nb-Si)
- 4: Nb, Ti carbide

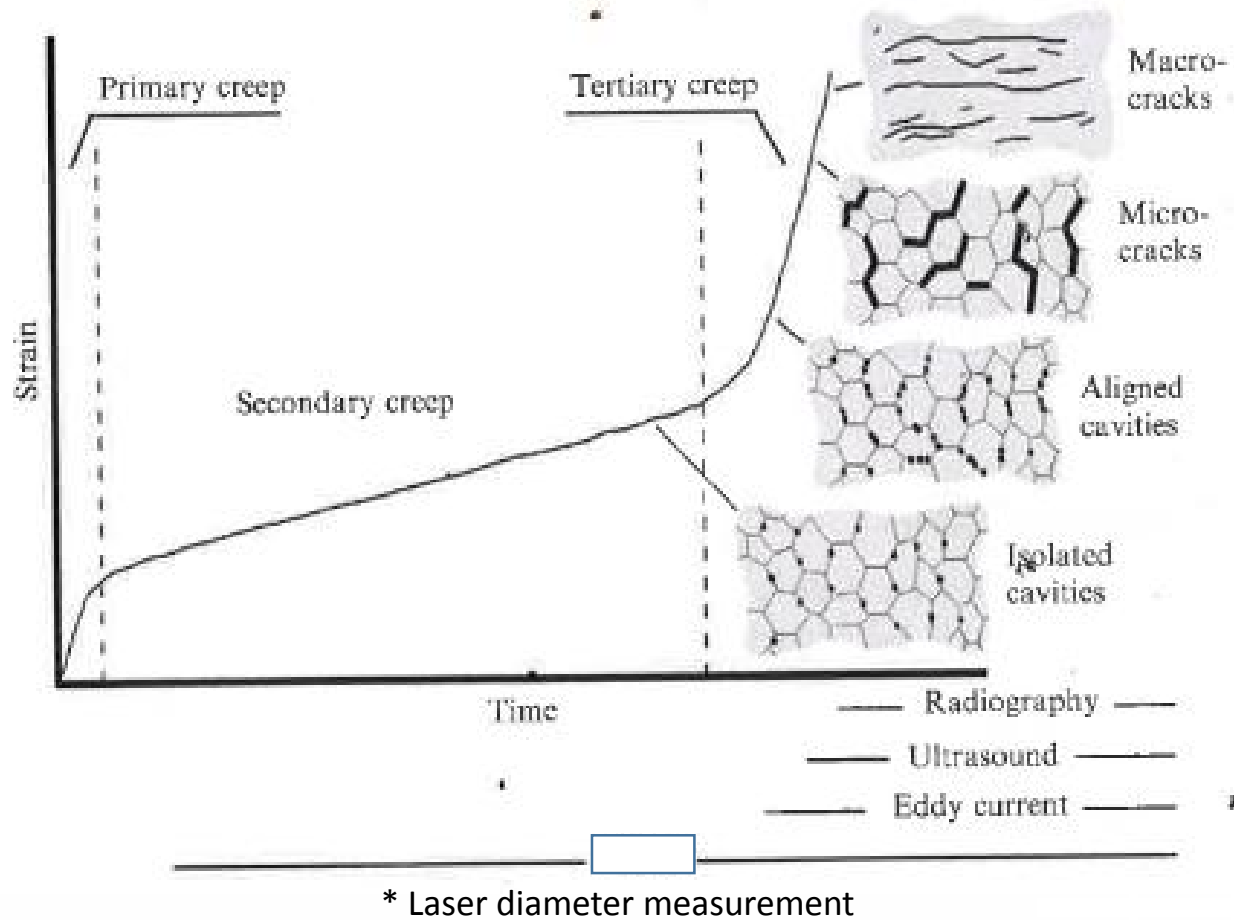
Creep stages and NDT

- ❖ Diametrical growth (expansion with creep) – Best for ***II/III creep***
- ❖ Wall thickness measurements (deformation with creep) - Best for ***III creep***
- ❖ Replication (advanced creep stages, aligned micro-voids, micro- and macro cracks)
- Best for ***II/III creeps (external surface only !)***
- ❖ Radiography (macro-cracking) - Best for ***III creep***
- ❖ Eddy current - Best for ***III creep***
- ❖ Ultrasonic test (attenuation and scattering; creep cracking) - Best for ***III creep***

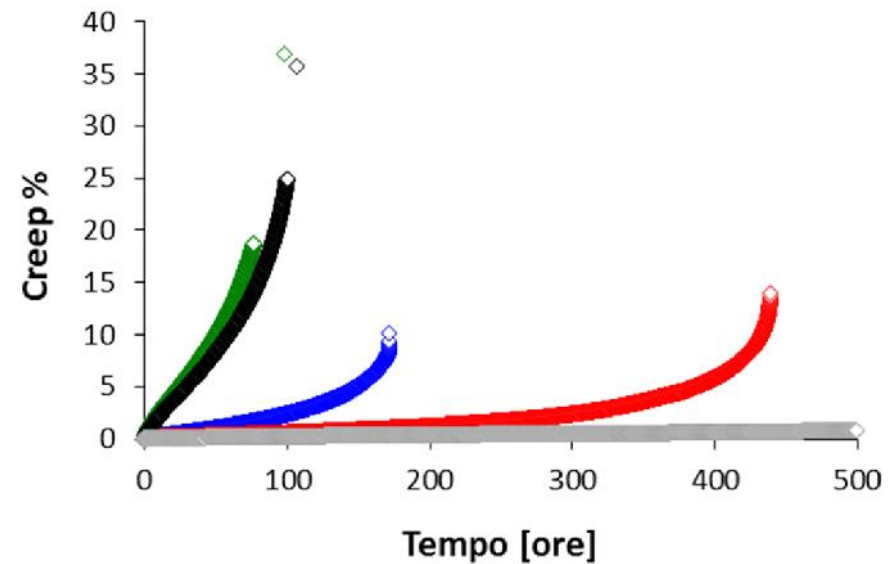
RLA BASED on creep tests

- Creep tests permit to obtain details of actual creep resistance for materials (*aged*) and consumed life.
- Different creep curves (with same test parameters) for different service histories of tube material

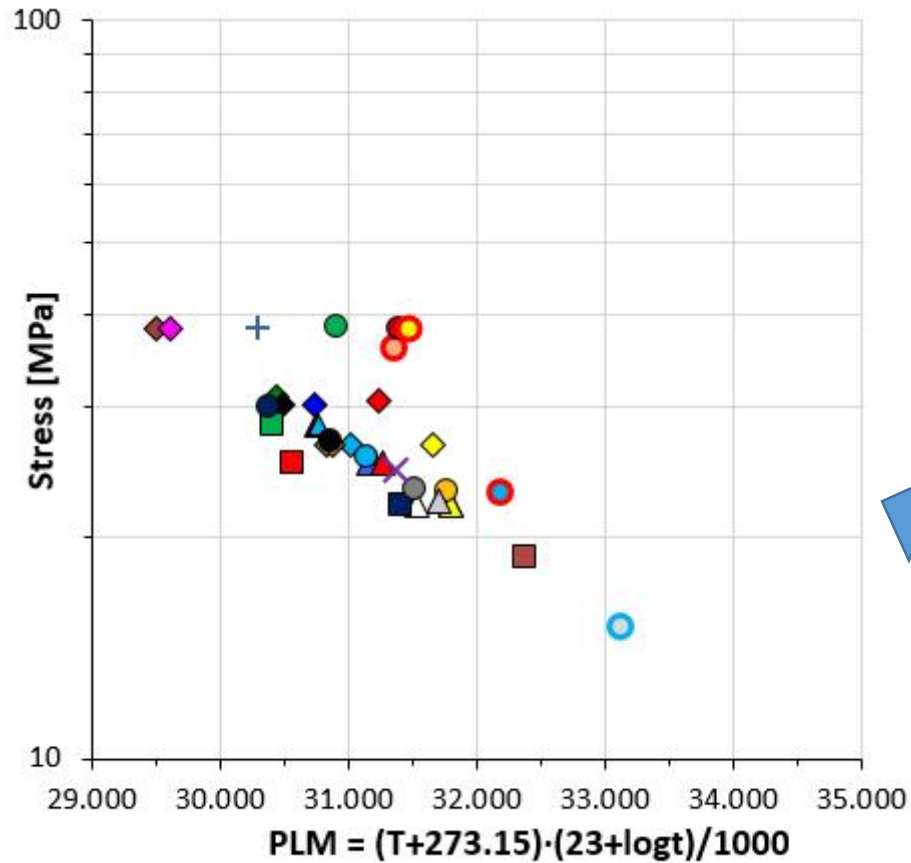
Post exposure data → analysis of results with LARSON MILLER

○ Interrupted

○ On-going

36 tests with 5000 duration at different T and s.

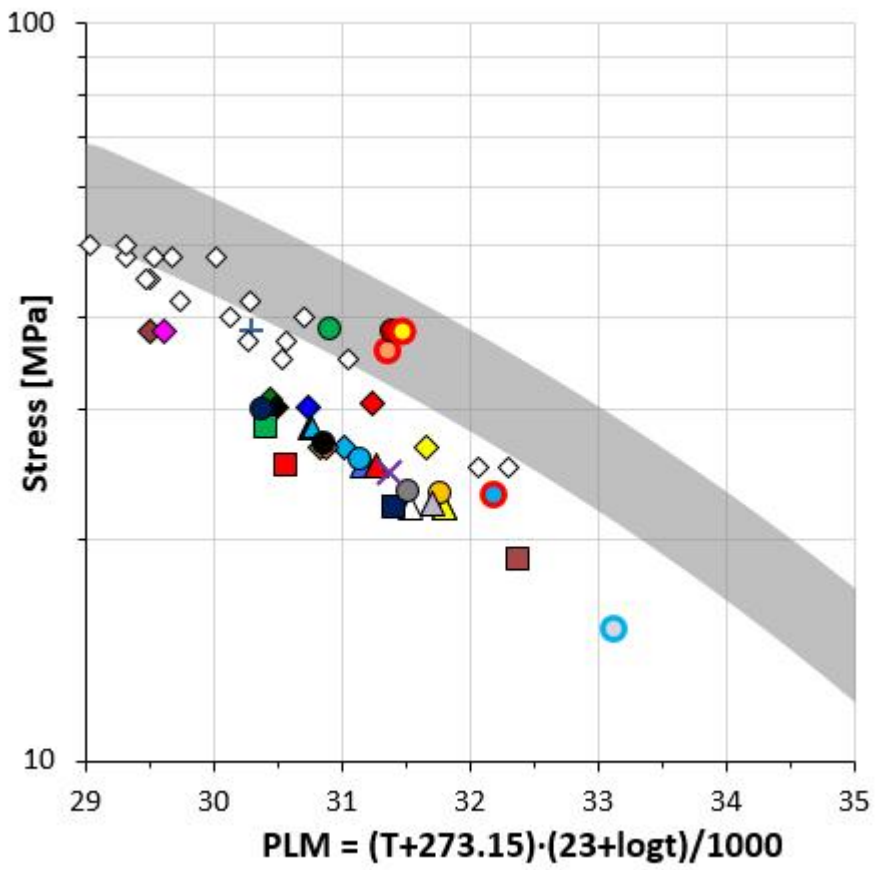
Comparison with as-cast materials (Manufacturer brochure data)

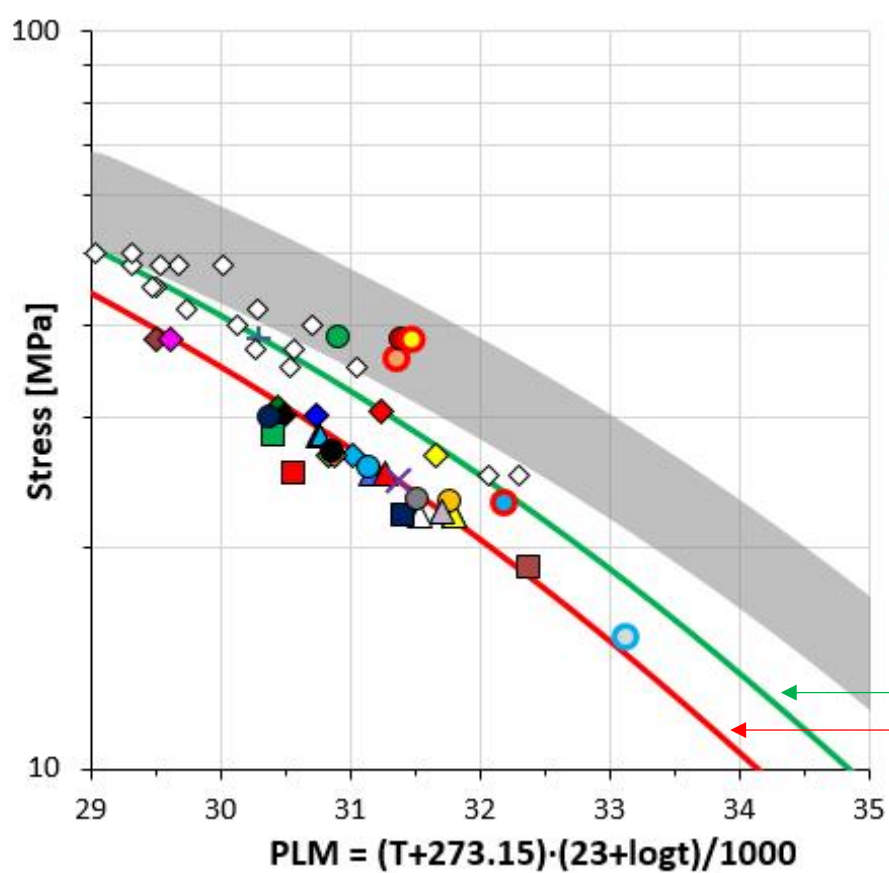
Post exposure data → analysis of results with LARSON MILLER

- As cast
- Interrupted
- On-going
- Guguloth et al
- Best fit 1
- Best fit 2

Experimental data interpolation (polynomial)

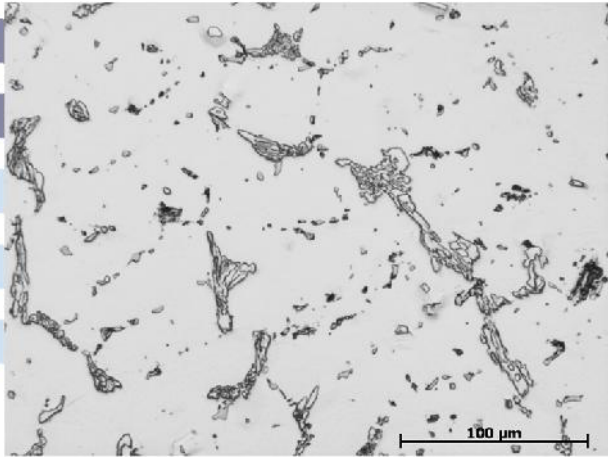
As-Cast

Microstructural degradation vs. Creep behavior

Sample	Description
As-cast	Primary eutectic carbides; HV > 200.
Slightly degraded	Slight carbide coalescence, scattered precipitation of secondary carbides; HV > 170; Creep-rupture elongation $\leq 10\%$; Slight diametric deformation (from NDT) < 2 %
Moderately degraded	Carbide coalescence, extensive precipitation of secondary carbides; HV < 170; Creep-rupture elongation > 30%; Diametric deformation (from NDT) >2%.

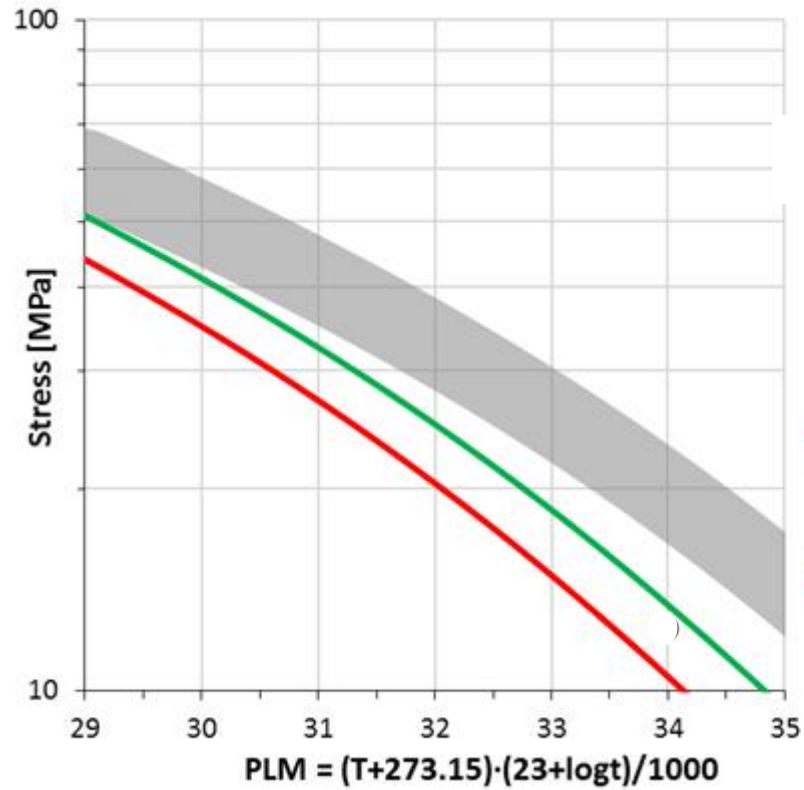
Fitting Curves and material degradation

As cast

Slightly degraded

Moderately degraded

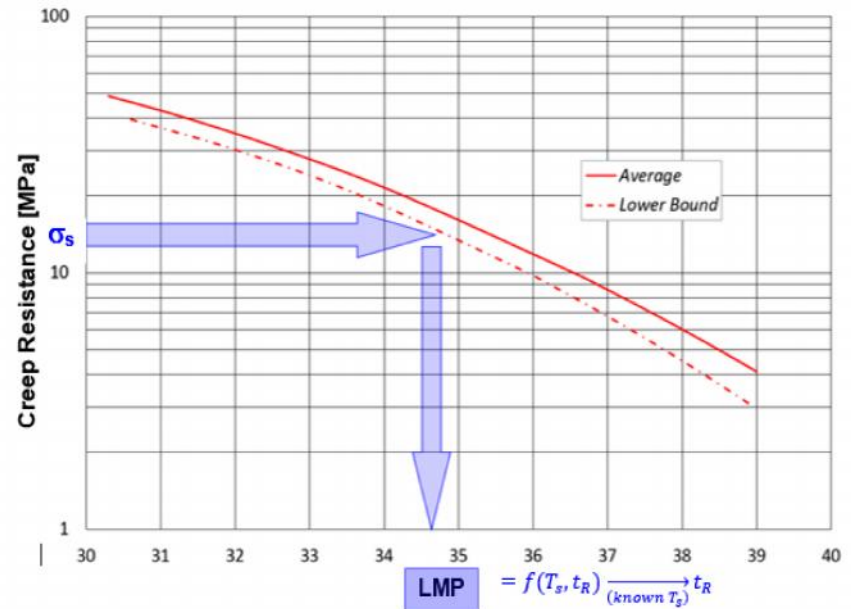
Master curve for as cast material (new)

$$PLM = (T+273.15) \cdot (23+\log t) / 1000$$

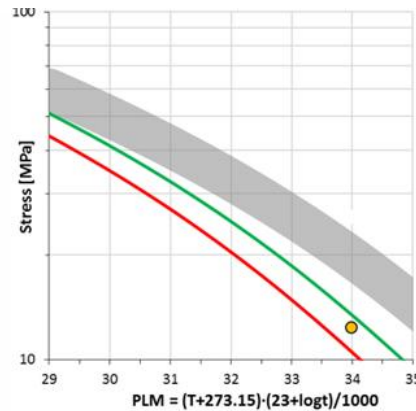
Remaining life assessment approach – Creep curves From metallurgical evaluation

Operating conditions: $\sigma_{op} = 12 \text{ MPa}$, $T_{op} = 950^\circ\text{C}$,

“as-cast” average curve	“as-cast”, lower bound curve	“Mod. degraded” curve (in red in Fig. 6)	“Slightly degraded” curve (in green in Fig. 6)
t_R (hours)	t_R (hours)	t_R (hours)	t_R (hours)
$> 10^6$	942,700	39,100	115,700

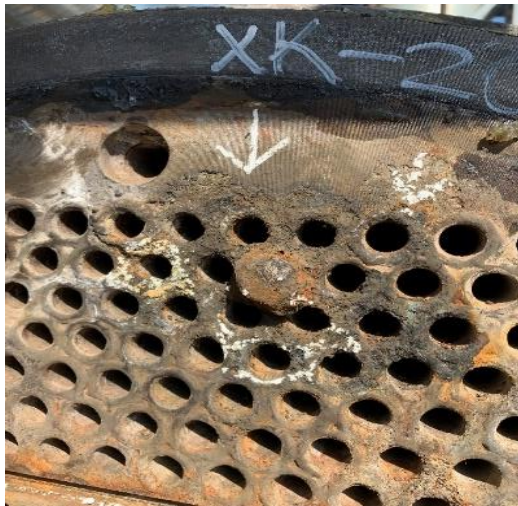
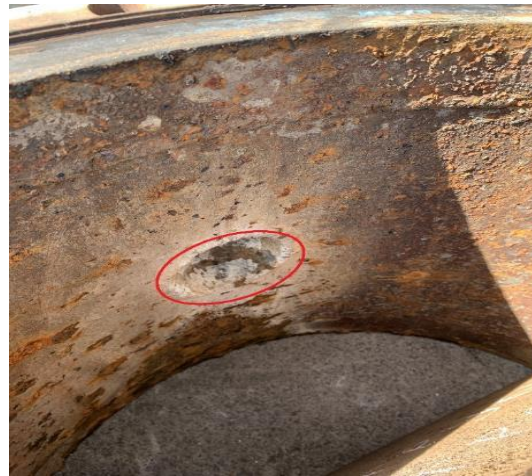
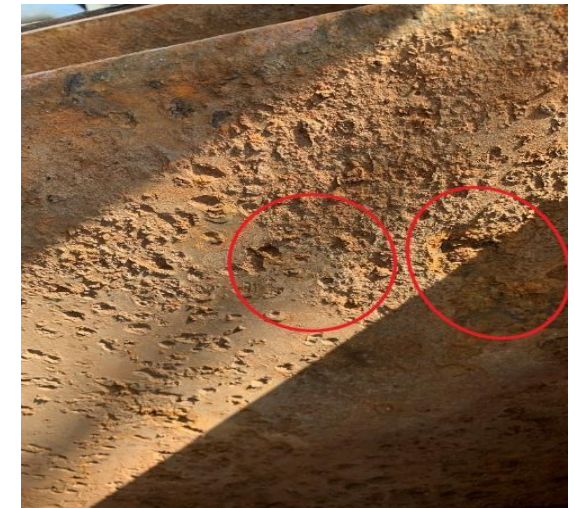
Case Study 1: Corrosion of overhead condenser at NHT*

- **Materials:** Tubes – Brass ЛОМw70-1-0.05 (C44300). Tube sheet - 09G2S steel (A 561 Gr70).
- **System:** NHT overhead condenser

- **Appearance:** deposits, scale and pits in headers, tube sheet and nozzles of heat exchanger.
- **Time from cleaning:** 1 year
- **Details:** calculated velocity of CW in tubes is **0.06 m/s**. The system was dirty when chemical treatment started. No chemical cleaning or passivation at start of program. Microbe number was not defined.

Physicochemical analysis of deposits: organic components (8 % wt.), which assumes the presence of microbiological part (there was no leak of hydrocarbons). Inorganics - 89 % wt.

Corrosion is probably the result of iron bacteria and SRB activity.

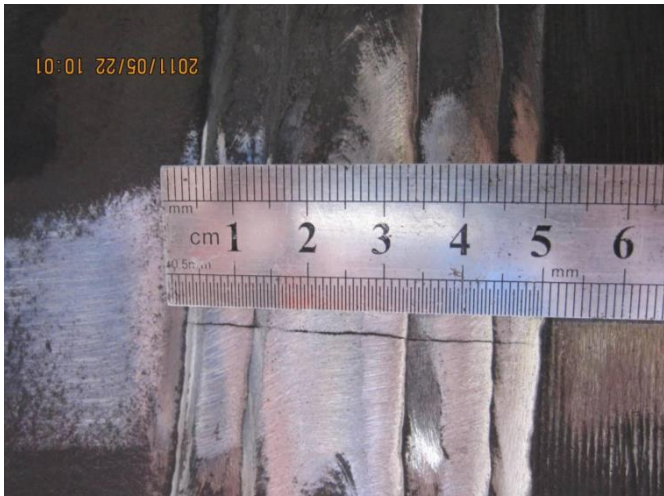
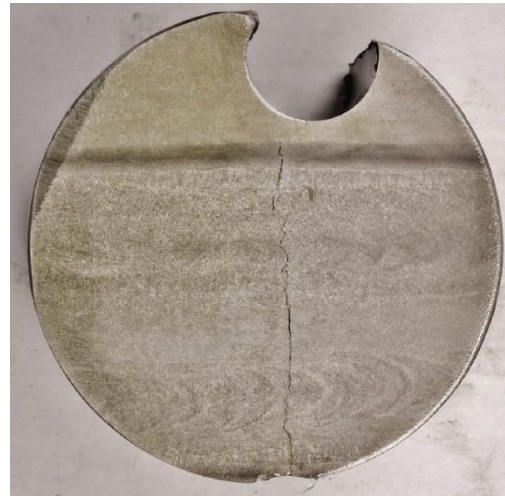
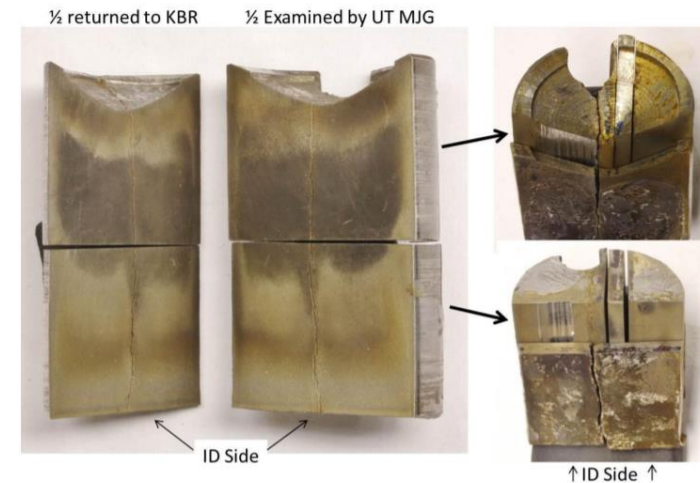
Case Study 2: Ammonia production (ammonia synthesis loop)

- **Material:** 2.25Cr-1Mo-0.25V Vanadium enhanced alloy.
- **System:** Heavy Wall Ammonia Converter. 200°C, 16.68 MPa. Mixture of H_2 , N_2 and NH_3 .
- **Time to failure:** 1.5 year.

- **Appearance:** **Transverse crack in circumferential weld.** The picture in the centre represents the macrograph of plane near the center of the plug sample. The cracking terminates in the base metal and is transverse to the weld direction.

- **Details:** *Twenty eight (28) start-up and shut-downs during 1.5 year of operation due to the problems with the upstream gasifier.*
- **Cause:** *the combined effects of high residual stresses remained in the weld due to improper PWHT*. This coupled with operation and hydrogen being presented in the weld, led to the fracture of the weld.*
- **Remedy action** *was to repair the weld using the recommended monitoring thermocouple locations for PWHT*.*

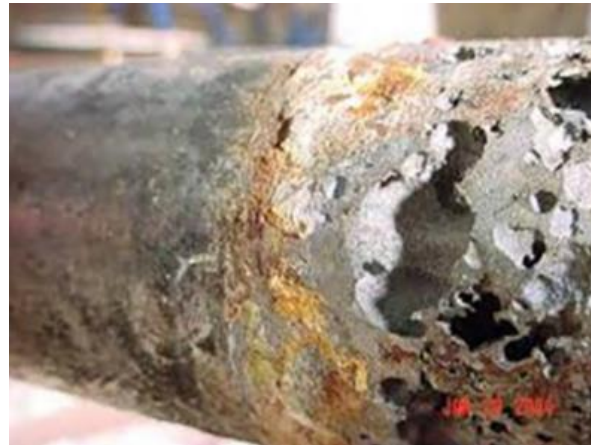
Case Study 3. Sea water pipeline

- **Material:** 304 SS.
- **System:** Sea water pipeline from heat exchanger 70°C, 0.5 MPa
- **Time to failure:** 6 months

- **Appearance:** Holes, pits, and deep crevices

- **Details:** *onshore refinery with no access to sources of fresh water. Sea water is used as cooling medium. Chloride content is 35,000 ppm.*
- **Cause:** *wrong selection of susceptible to pitting corrosion material.*
- **Remedy action** *was to replace the damaged pipeline with INCOLOY[®] 825 (40% Ni, 22% Cr, 3% Mo, 2% Cu, 1% Ti).*

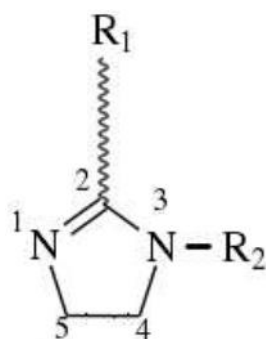
Figure 1. Scheme of an imidazoline molecule

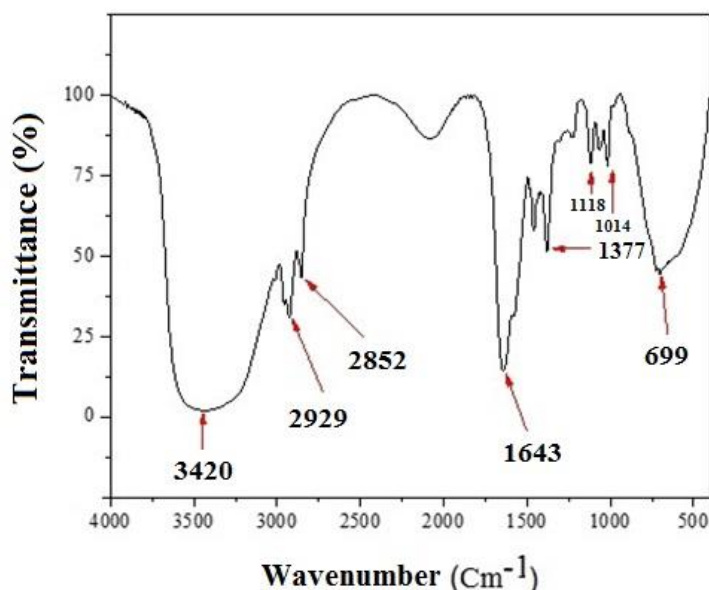
Figure 2: FTIR spectra of the fresh corrosion inhibitor

These corrosion inhibitors are usually injected into the flow stream as a mixture of chemicals containing surfactant molecules. The so-called “active component” in this mixture is most commonly an organic surfactant compound(s) with an amphiphilic molecular structure, consisting of a polar head group and nonpolar hydrophobic tail. The polar head is often based on nitrogen-containing groups, such as amines, amides, quaternary ammonium, or imidazoline- based salts as well as other functional groups containing oxygen, phosphorus, and/or sulfur atoms. The length of a hydrocarbon tail which is attached to a polar group typically varies between 12 and 18 carbon atoms. The function of the polar head-groups is to provide a bonding between inhibitor molecules and the steel surface. Hydrophobic tails are facing the solution, are thought to be important in establishment of self-assembled layer(s) of corrosion inhibitors on the metal surface and key to the protection they offer [9]. The injected corrosion inhibitor in sea-lines of south pars gas complex was analyzed by FTIR¹ Spectroscopy in order to find out its functional groups. FTIR spectra of this inhibitor is shown in Figure 2.

FTIR investigations on the samples of corrosion inhibitor which was applied in the sea-lines of South Pars Gas Complex identified its composition as a mixture of amides, imidazoline ring and salts of amines. So, this corrosion inhibitor is an imidazoline-amide based inhibitor. The injection rate depends on the gas flow rate, so that it is normally injected in the rate of 20–25 lit/hr. In order to make sure that the pipeline is under the corrosion control beside the annual measurement of the weight loss corrosion coupons (i.e. installed at the end of the pipeline) and scheduled inspections by NDT² methods, also a daily laboratory measurement of the residual concentration of the corrosion inhibitor are done. This laboratory measurement is carried out on the samples taken from the water phase of the liquid bottles at the end of the pipelines in slug catcher. According to the recommendations of the inhibitor’s manufacturer, the minimum allowable residual of the corrosion inhibitor in the samples taken from the end of the sea-lines must be 400 – 600 ppm, however there is no allowable upper limit for this concentration.

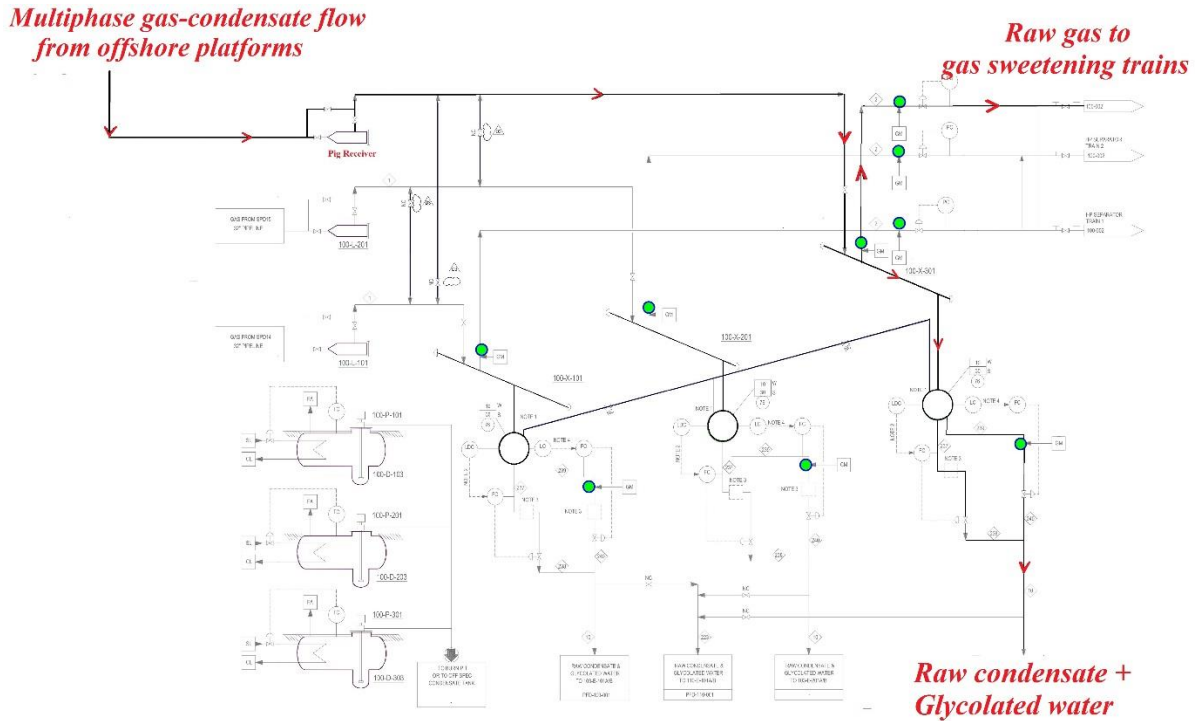
Figure 3: Piping flow diagram of platform pipelines to the slug catcher unit in onshore refinery

Piping flow diagram of the sea-lines and slug catcher has been illustrated in Figure 3. As it is observed on this flow diagram, a multi-phase wet gas-condensate flow has been transported by sea-lines from offshore platforms to the onshore facilities. The first unit which receives this multi-phase flow is called a finger type slug catcher. In this unit, sour gas stream is separated from the top of the inclined pipelines in the first section of the fingers and transported to gas treating units to be sweetened and at the end of the slug catcher, water phase and hydrocarbon condensate mix together and transported to condensate stabilization unit in order to reduce the vapor pressure of the condensate by removing its lighter

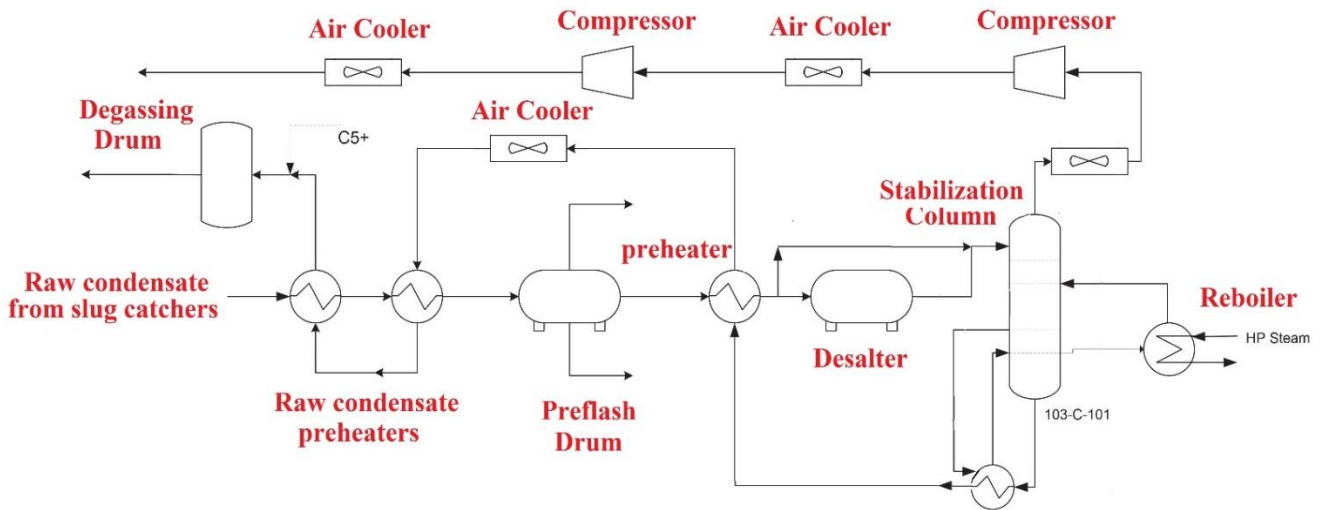
Figure 4: Piping flow diagram of condensate stabilization unit

Piping flow diagram of the condensate stabilization unit has been illustrated in Figure 4. The raw condensate from the slug catchers is preheated, then flashed before going through a desalter. Duty of this equipment is to remove the free aqueous phase, which can be salted or not, from the hydrocarbon phase so that in downstream of the desalter the maximum allowable water content shall be 500 ppm_v and maximum 10 mg/l of the salt content. After passing the desalter, raw condensate enters into the stabilization column.

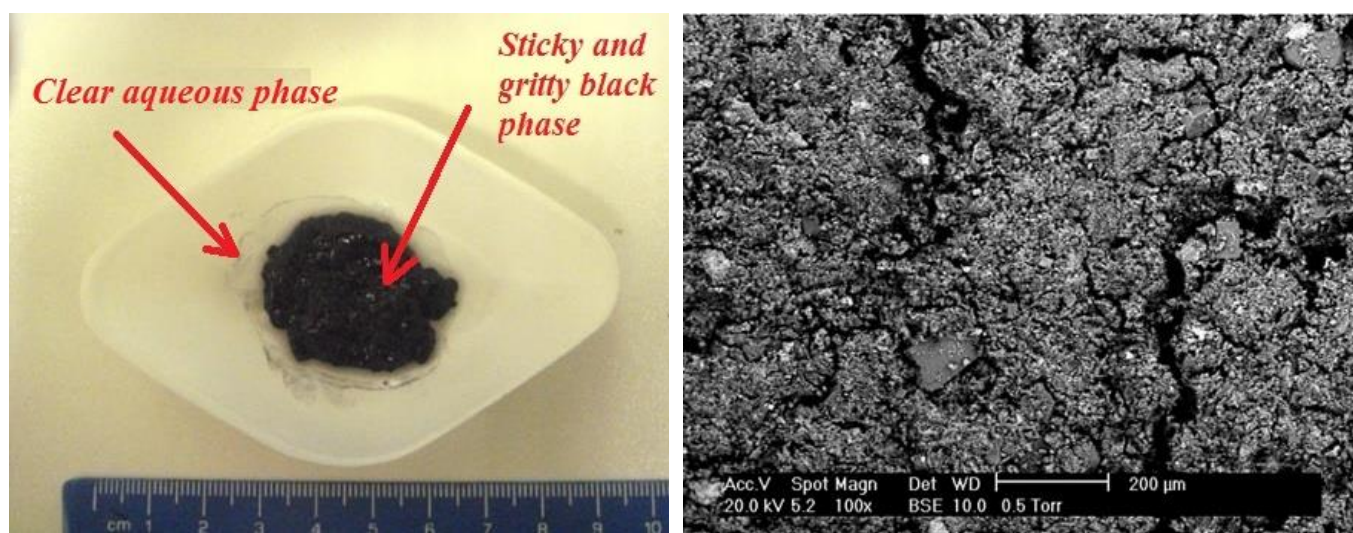
Figure 5: Sample taken from the surface of the tubes and SEM image of its black phase [11]

In order to analyze the origin of the sludge, it was decided to use analytical chemistry method by gas chromatography in order to analyze different components of the sludge. As it is shown in Figure 5, sludge consisted of two parts: a clear aqueous phase and a sticky and gritty black phase.

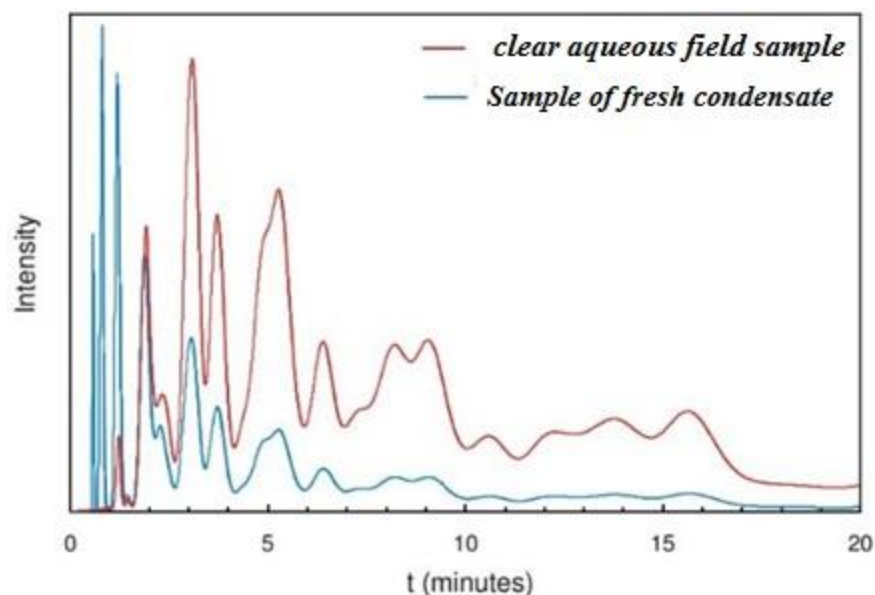
Figure 6: Gas chromatogram for the aqueous phase of field sample and condensate sample [11]

In order to analyze all components of the sludge, the clear aqueous phase was separated from the sticky and gritty black phase. Since the appearance of this aqueous phase was similar to the hydrocarbon condensate, so it was decided to take a sample of fresh hydrocarbon condensate and compare gas chromatograms of this sample with the clear aqueous phase of the field sample. Gas chromatograms of these two samples has been illustrated in Figure 6. As it is obvious there is an acceptable agreement in the peaks of the two samples and the clear aqueous phase could be the remained condensate on the tube bundle which was not drained completely and left on the tubes and sludges.

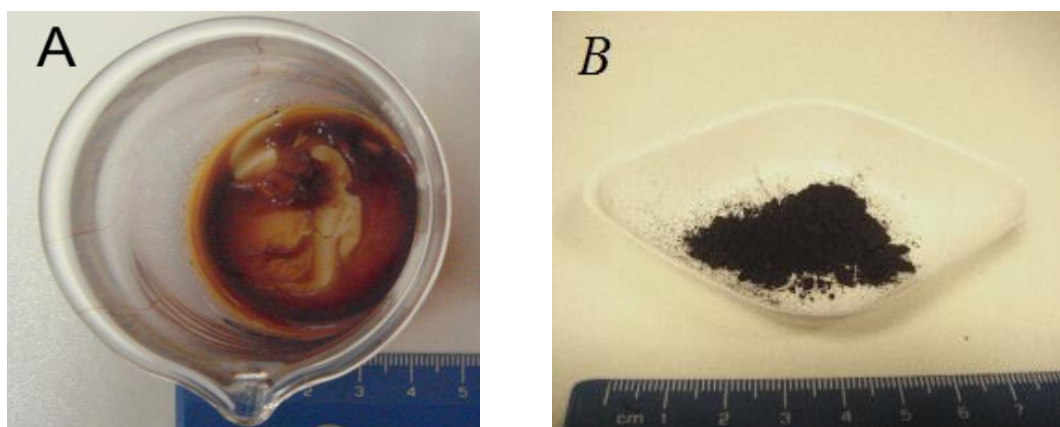
Figure 7: Separated parts of sticky and gritty sample: A: Sticky and viscous part after dissolving in methanol and heating in oven, B: Solid part after methanol dissolving, filtering and heating in oven [11]

Since the black sludge seemed to be containing solid particles like grit, so it was decided to separate the solid particles and analyze the solid part and sticky viscous parts separately. In order to do this, all the sample of gritty and sticky black sludge was dissolved in methanol as a solvent because organic corrosion inhibitors like imidazoline-amide based inhibitors are soluble in methanol and the appearance of the sticky and viscous part was like the applied corrosion inhibitor. After dissolving in the methanol, the sample was filtered to separate the solid parts and then heated in the oven to evaporate its remained volatile parts. Separated solid and viscous parts have been shown in Figure 7.

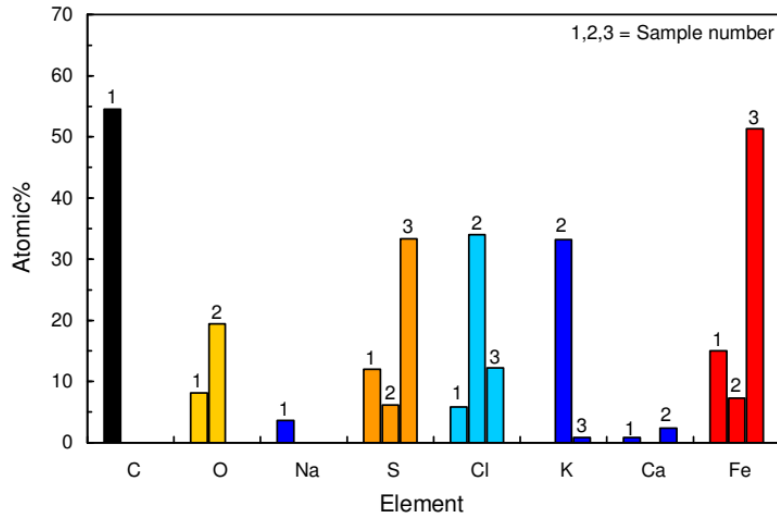
Figure 8: Results of EDX analysis on the solid sample [11]

Gravimetric measurements revealed that the solid particles made up approximately 55 wt.% of the sticky and gritty sludge. EDX³ spectroscopy was employed for the analysis of the solid particles. Results of EDX analysis has been shown in Figure 8.

As it is clear in Figure 8, the main elements were Fe, S, P, K, Na, O and C. The high carbon content observed for one sample likely represents crystallized heavy hydrocarbons from the condensate which were insoluble in methanol or possibly carbonized corrosion inhibitor active component which was remained on the solid particles. Fe and S elements could be the common corrosion product in sour services which form iron sulfide and sometimes are not able to form a stable film on the surface of the steel and circulate in the system. Other elements like K, P, Cl and Na are the salts of the production water which can be present in the stream when the desalter is not in service or is not working efficiently.

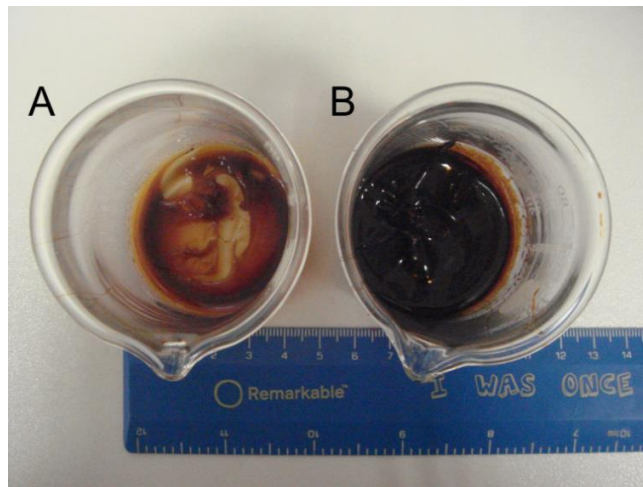
Figure 9: Viscous samples: A: sticky and viscous sample after dissolving in Methanol and heating in oven, B: Simulated fresh inhibitor's sample after heating to simulate solvent loss [11]

As it is obvious in Figure , since the appearance of oven-dried methanol filtered viscous part was similar to the poly-amide resins used in corrosion inhibitors, therefore, a sample of the fresh corrosion inhibitor was taken and heated to elevated field temperatures (i.e. 170⁰ C) to simulate solvent/volatiles loss (see Figure 9).

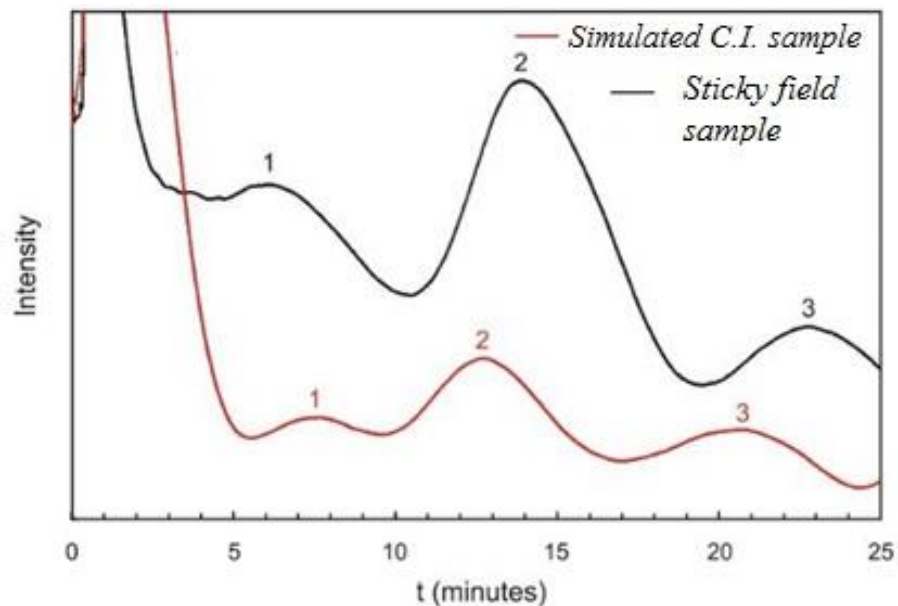
Figure 10: Gas chromatogram of simulated fresh corrosion inhibitor sample and sticky field sample after dissolving in methanol and heating in oven [11]

In Figure 10, the chromatogram of the simulated sample and field sample has been illustrated. The good agreement between the peaks confirmed that the other constituent and binder for black solid part of the reboiler could be the active poly-amide component of the corrosion inhibitor which remained when the solvent (Methanol) was evaporated.
