**Participants EFC WP15 meeting 15<sup>th</sup> April 2008 Leiden**

**EFC Working Party 15**  
**Corrosion Refinery Industry Meeting**  
**Oegstgeest/Leiden**  
15th April 2008 9h30 - 16h

## **Corrosion Under Insulation and Case Histories**

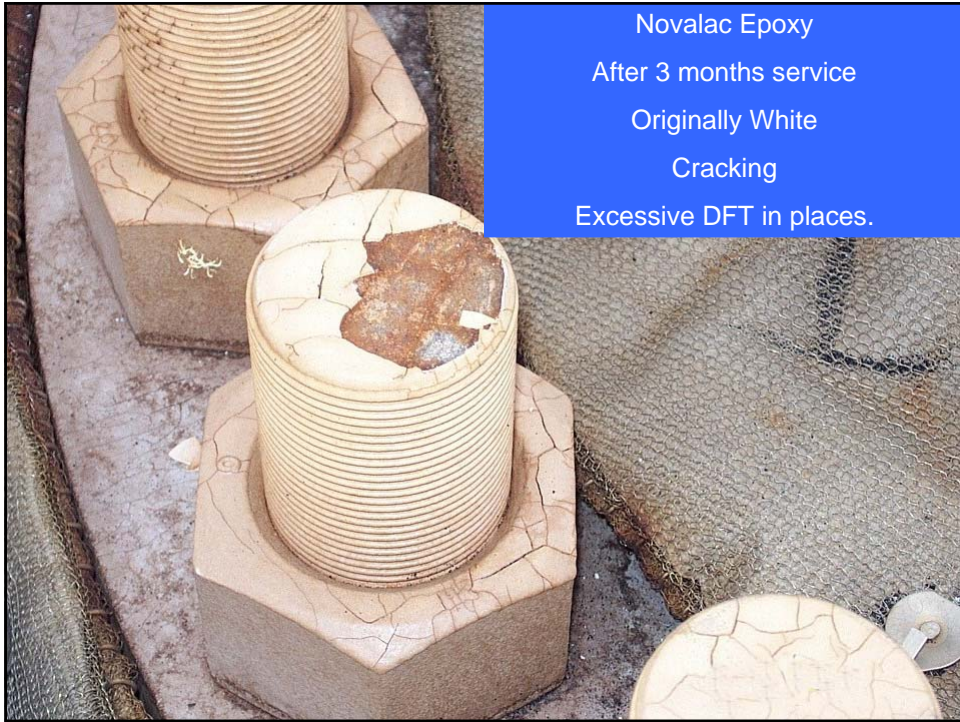
Novalac Epoxy  
After 3 months service  
Originally White  
Cracking  
Excessive DFT in places.

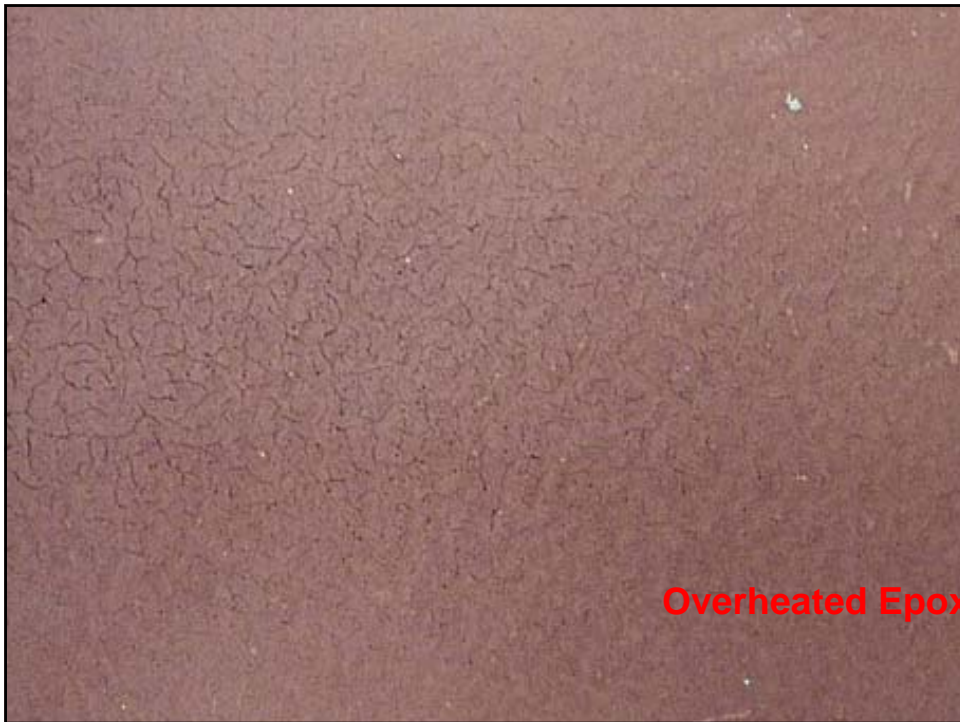
Overheated Epoxy

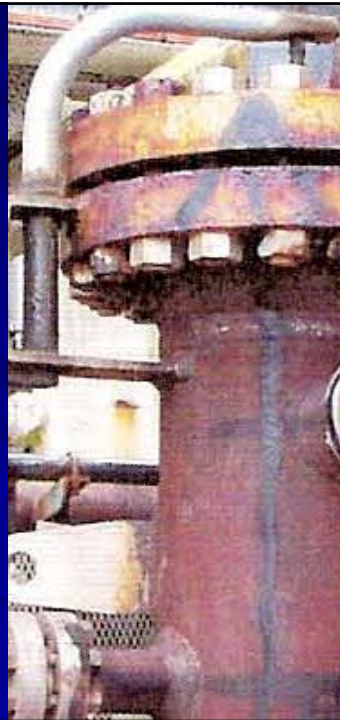
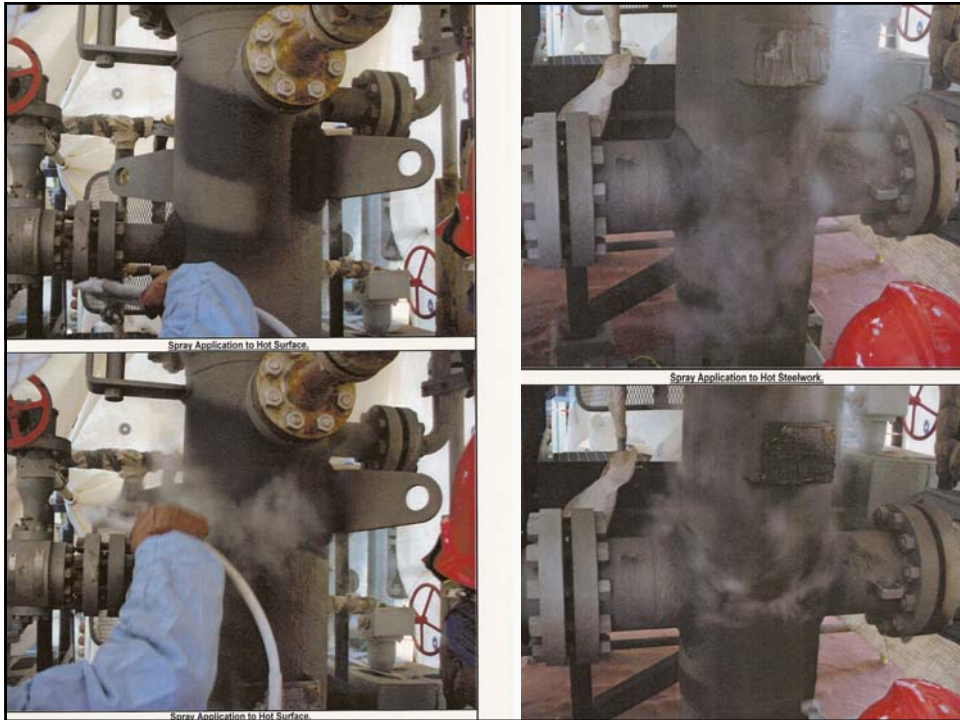
Coating applied to  
Regeneration heater that has  
cyclic temperatures ranging  
from  $-12^{\circ}\text{C}$  to  $160^{\circ}\text{C}$ . Once  
the coatings were applied  
several tests were done  
along with two follow up  
visits.

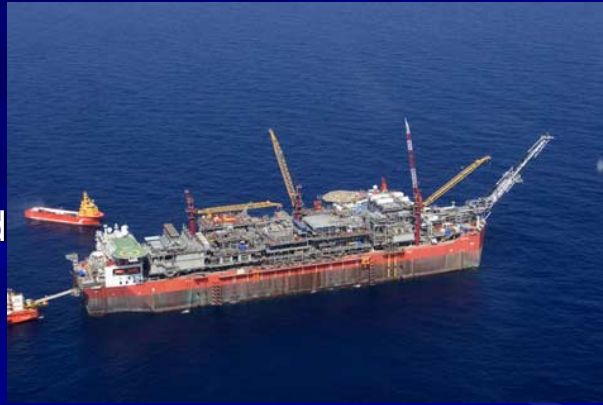
# Off Shore Nigeria (Shell Bonga)

Before

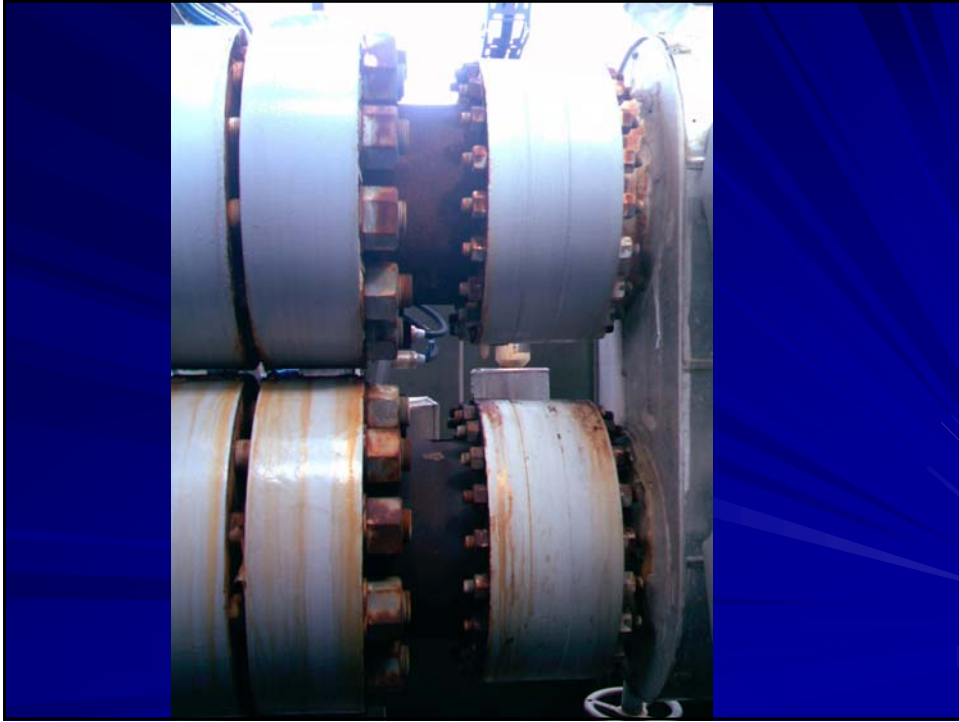
After Blast  
Cleaning

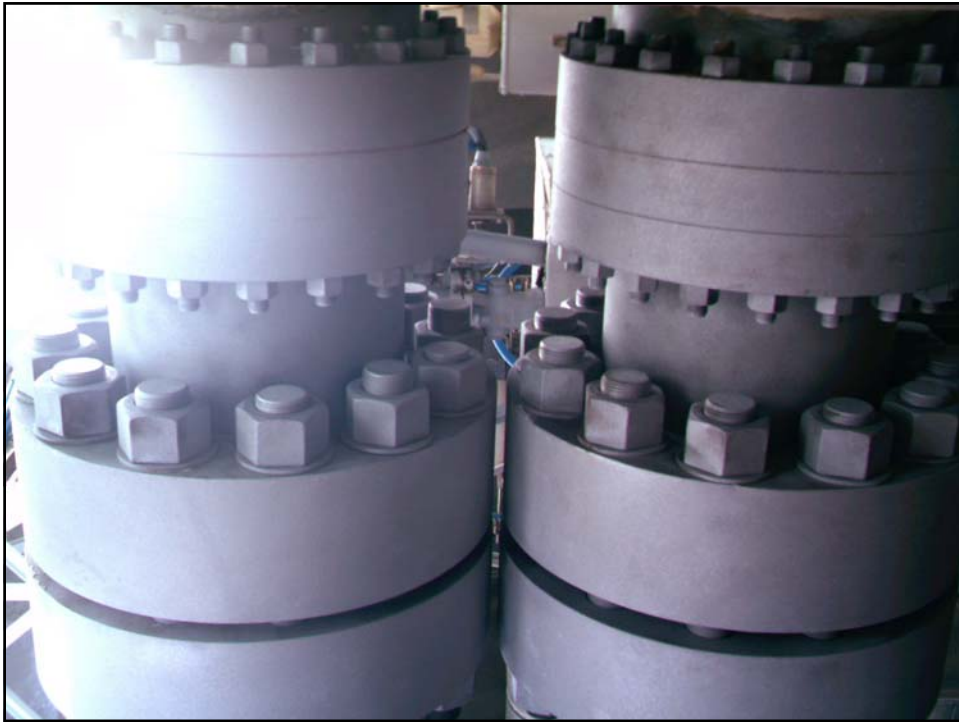
After 1027

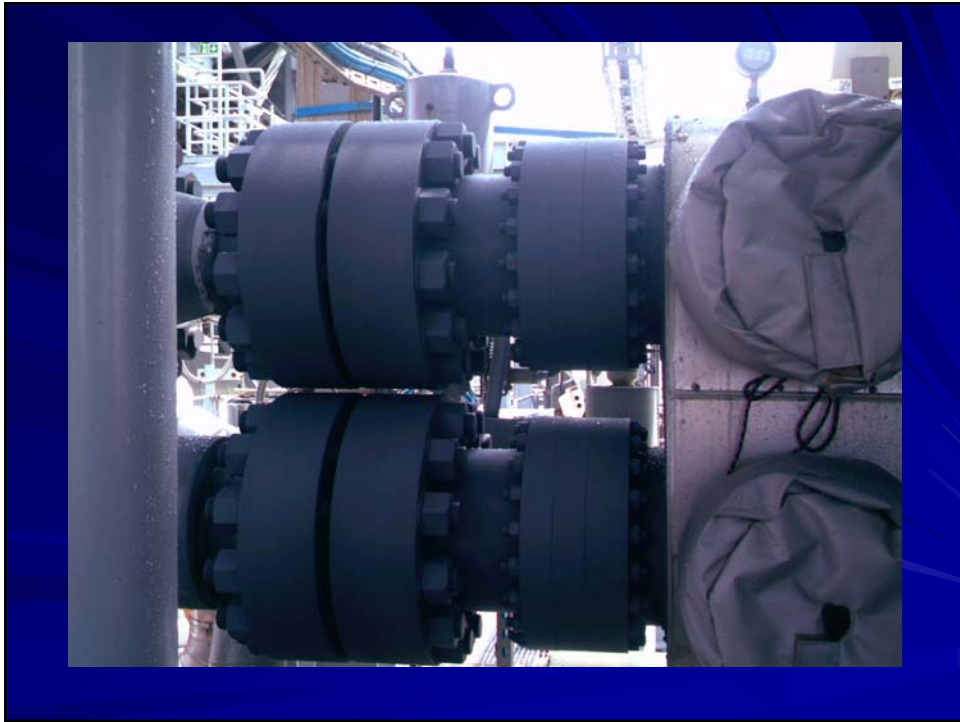
After 1000VHA

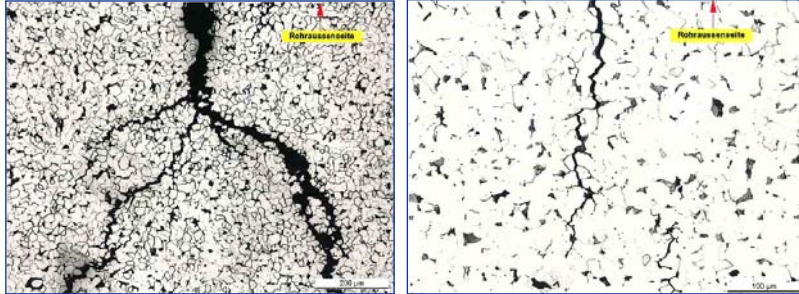
## Nitrate SCC of Carbon Steel

- Intergranular cracking that initiated from the external surface
- Cracking occurred away from any welds or other structural discontinuities
- Main crack direction is longitudinal to the pipe
- Wet chemical analysis from surface debris indicate high nitrate levels

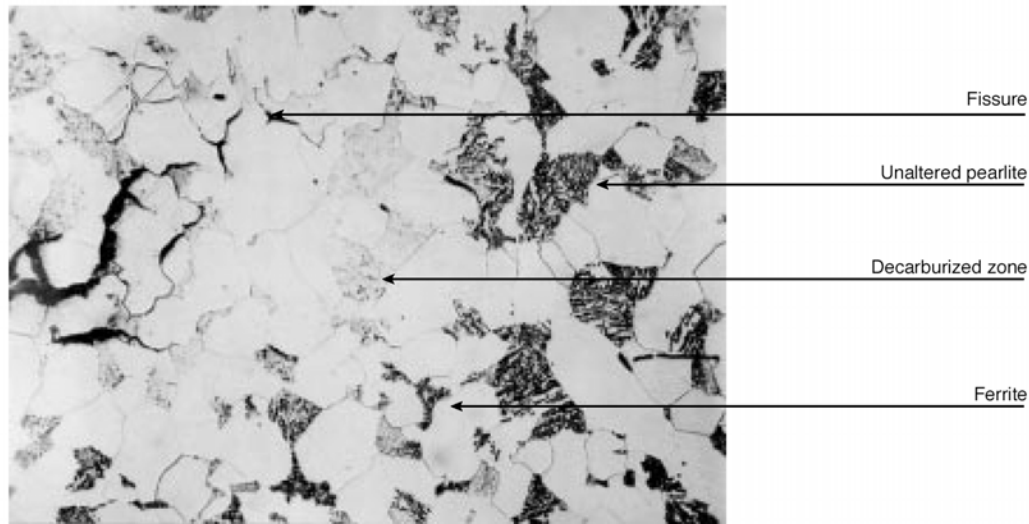
# Décarburation interne

- ▶ Hydrogen ingress penetration in the metal
- ▶ Reaction with carbon to form methane  $\text{CH}_4$
- ▶ Trapping of methane dans les discontinuities and at grain boundaries
- ▶ Internal stresses leads progressively to micro void formation, then micro cracks and cracks.
- ▶ Resistance to hydrogen attack is linked to carbide stability.

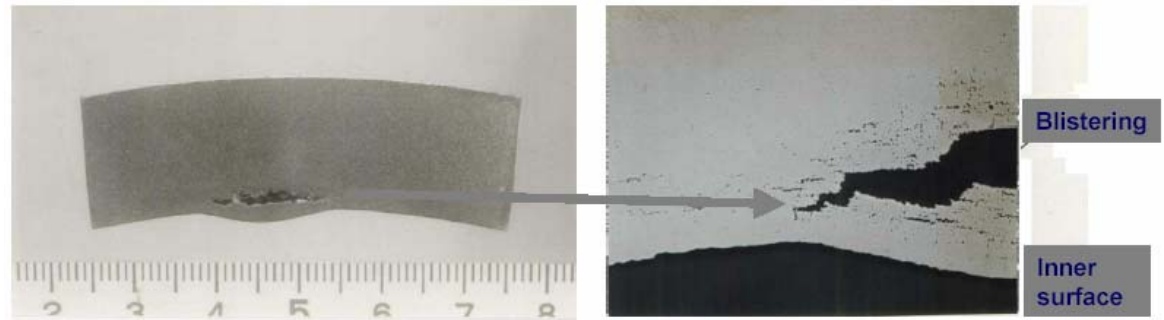
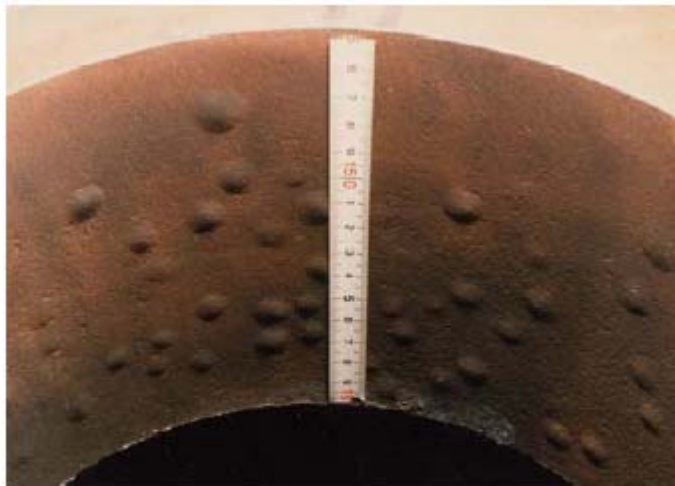
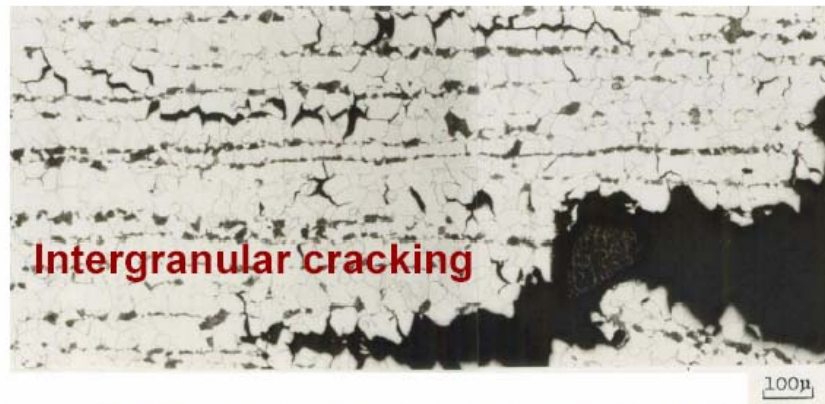
# HTHA exemples

Cross section of HTHA elbow

Figure 2 Blistering observed on C-0.5Mo nozzle flange used in Platformer unit

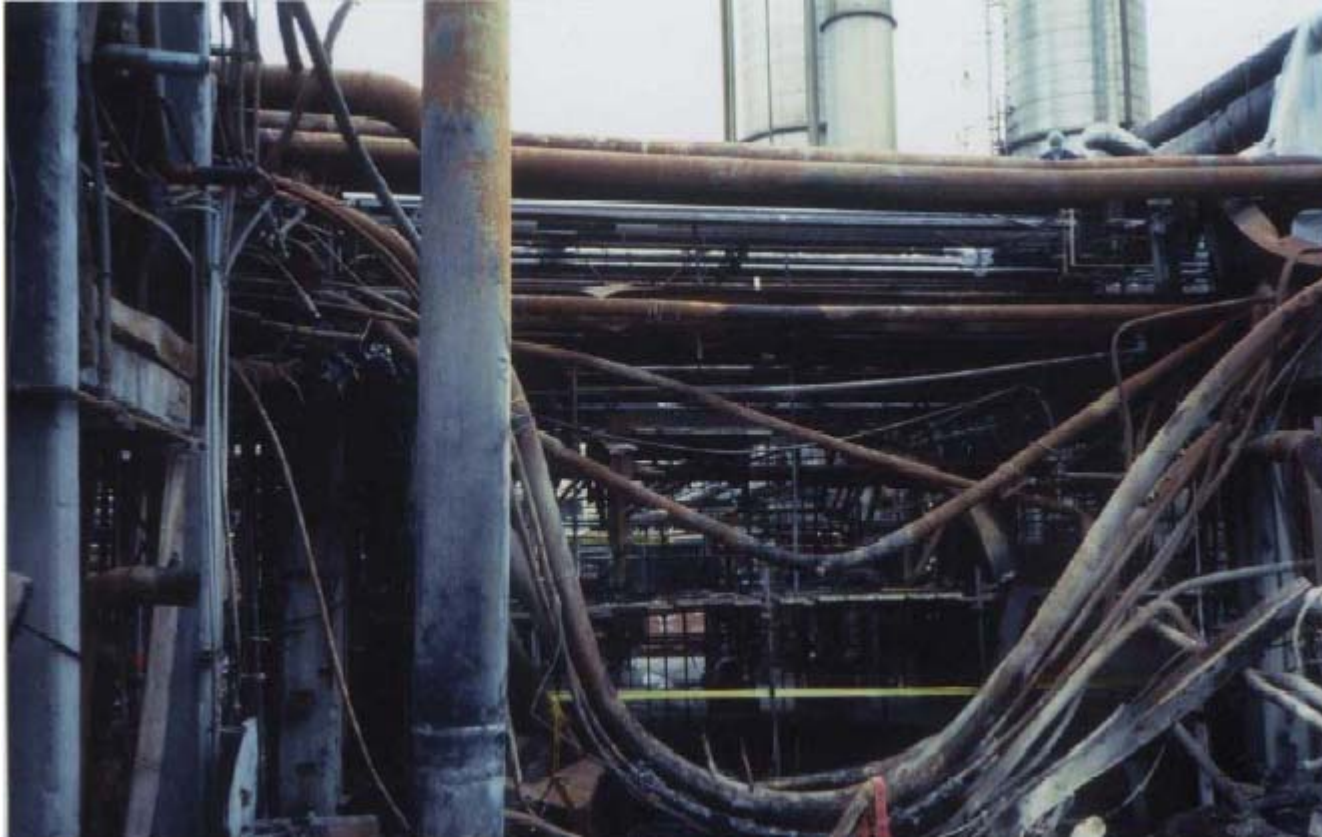
# Défaillance du à l'attaque à chaud

Réformeur 1989

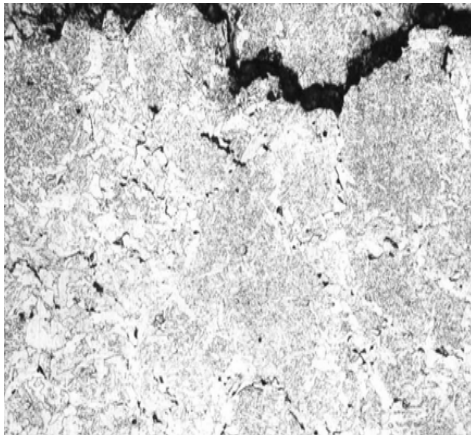
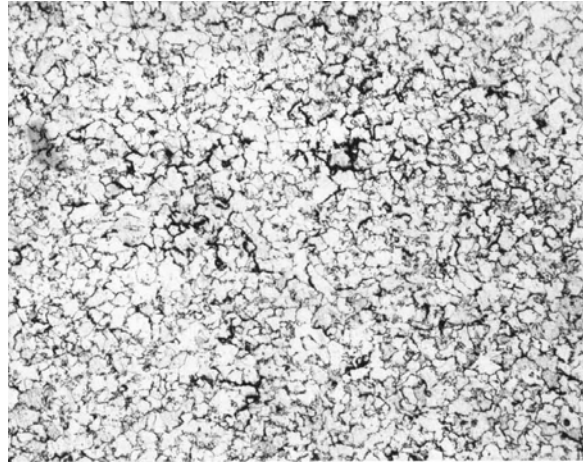
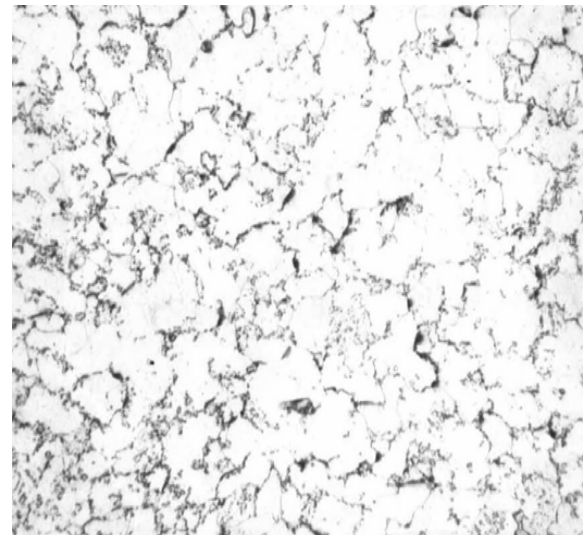
# Exemple d'attaque dans le raffinage TOTAL (2004)

- ▶ Réacteur d'hydrofinissage d'huile
- ▶ A 204 Gr B (0,5 % Mo), ép. 64 mm
- ▶ 260 à 350 °C
- ▶ ppH2 78 à 136 bars

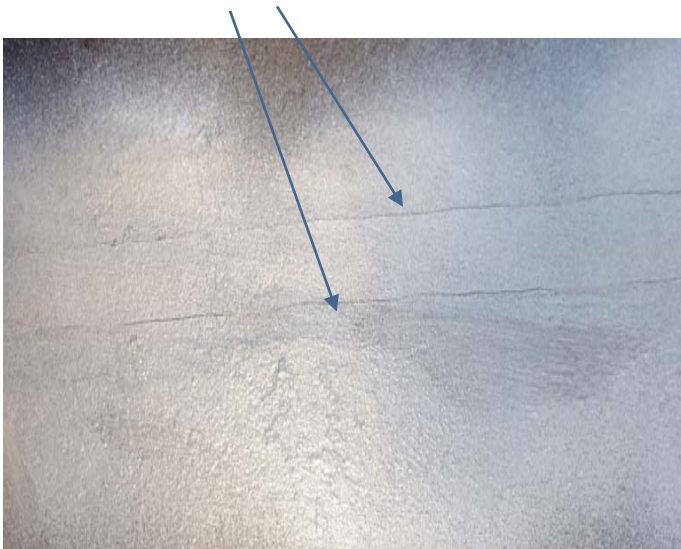
- Fissures longitudinales le long soudure L2 sur calandre E5J

- ▶ Fabrication 1967 – les 4 plus chauds: calandre A204 Gr.B (0,5 Mo) – TTAS – épaisseur 28mm
- ▶ Conditions de service pour les 4 plus chauds:
  - Température de service sortie calandre 420 à 450°C
  - Pression partielle d'hydrogène 12 à 18 bars
  - Durée d'exploitation 330 000 heures

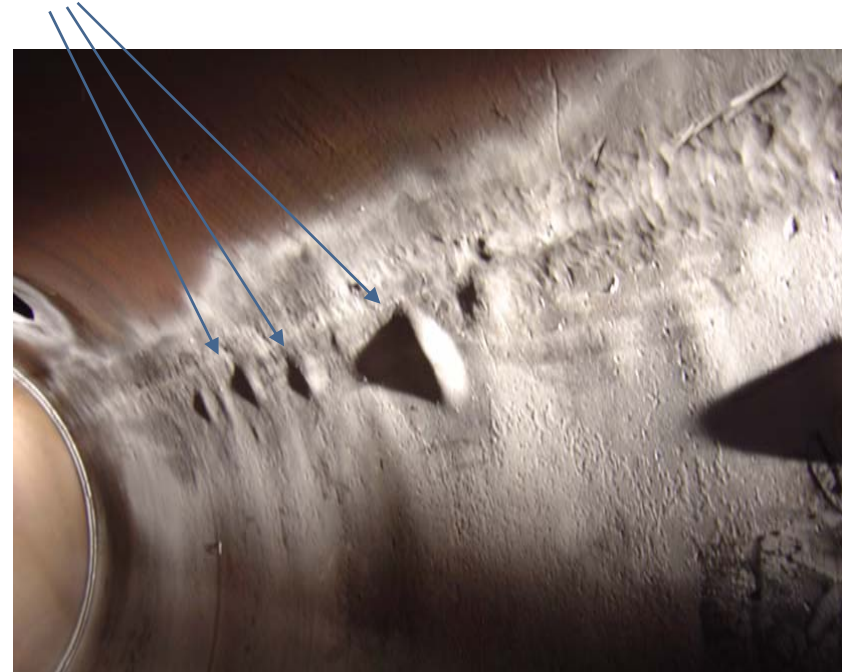
- Hernies  $\phi$  80/100 mm le long soudure L2 sur calandre E5E

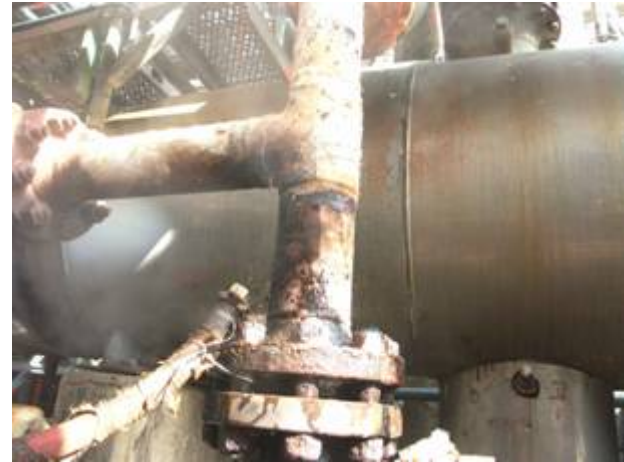
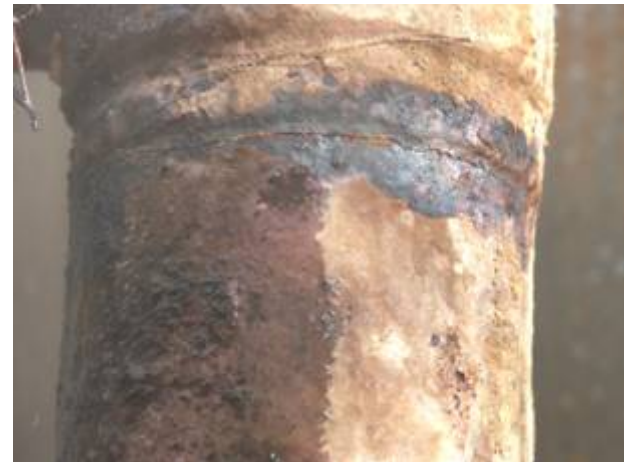
# ATOCHEM Carling (2007)

- ▶ fuite d'un mélange d'hydrogène / hydrocarbures
- ▶ Une soudure circulaire de la tuyauterie 4'' (DN100) ép 6 mm ASTM A53 Gr.A est fissurée sur  $\frac{3}{4}$  de sa section (fissure débouchante sur toute sa longueur).
- ▶ Condition de fonctionnement : 40 bar – # 300°C – mélange H<sub>2</sub> + hydrocarbures ( 50% H<sub>2</sub> molaire pour P totale 40 bar)
- ▶ Mise en service de la tuyauterie: 1968

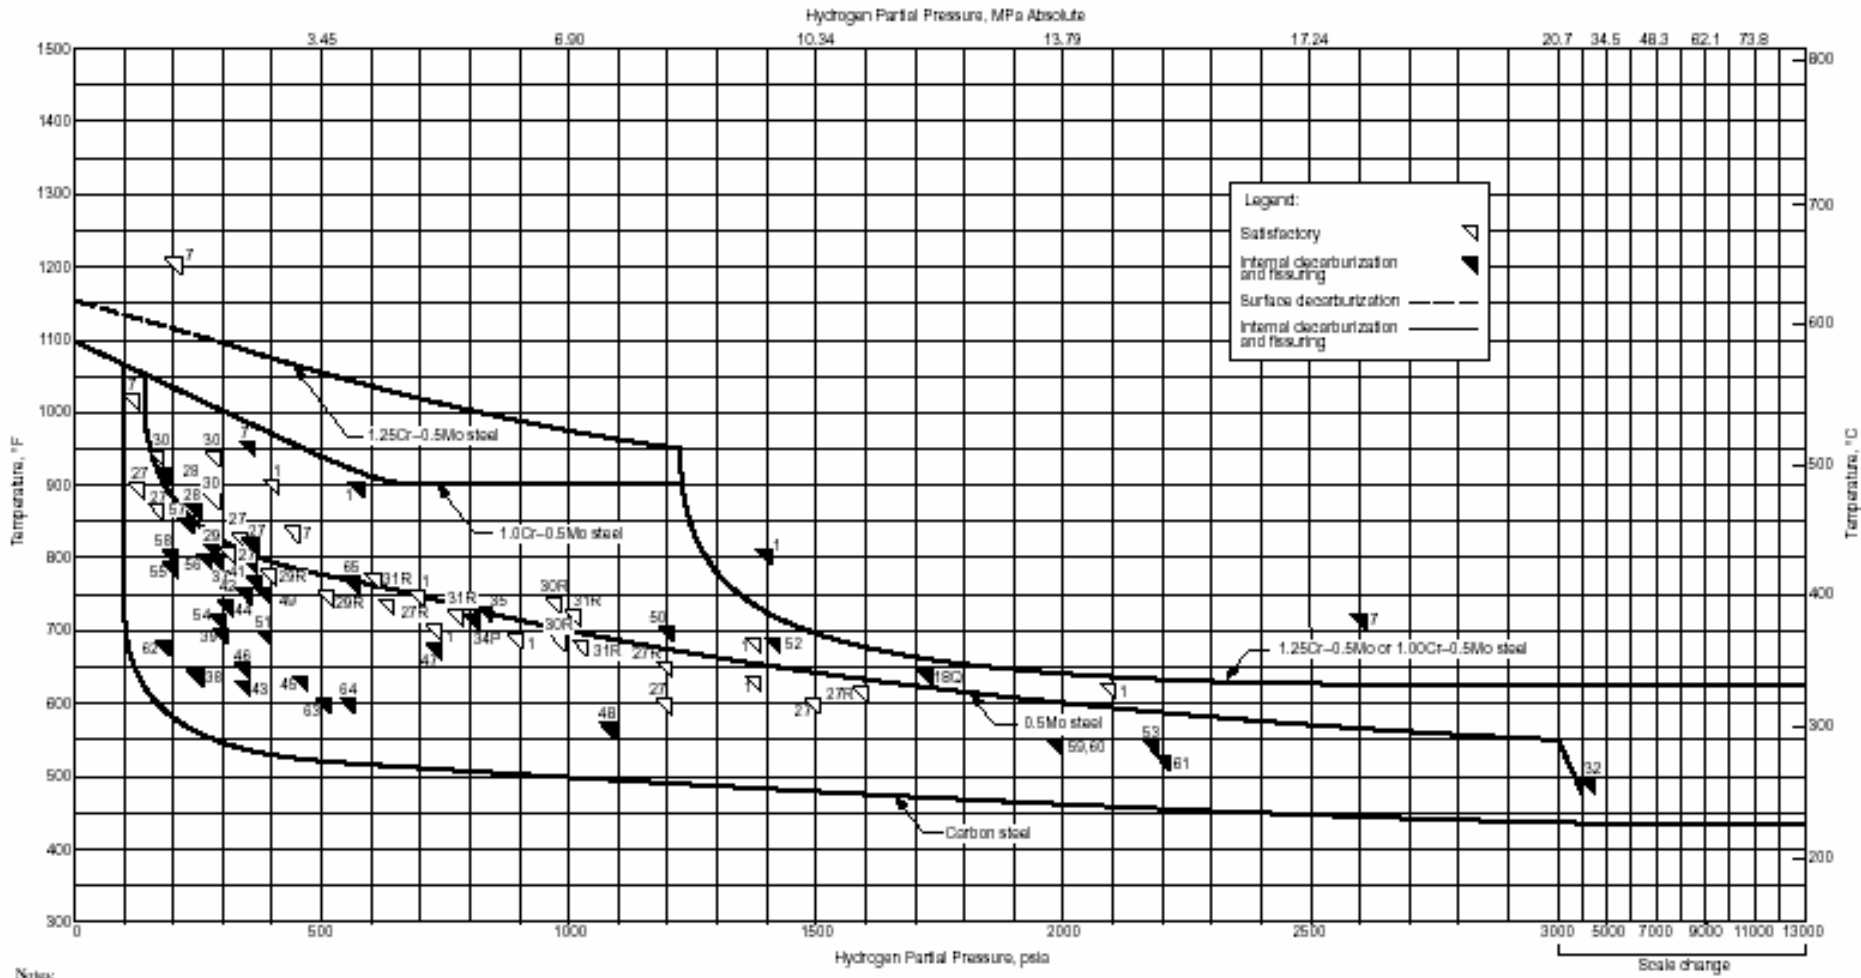
# Courbes de Nelson publiées en 1977

Notes:  
1. The curves are based on the data of Nelson et al. (1977).

- ▶ Ces courbes empiriques représentent l'expérience de l'industrie du raffinage
- ▶ Premières courbes publiées par George NELSON dans les années 40
- ▶ Première publication dans l'API 941 en 1969
- ▶ Les aciers à 0,5 % de Mo sont abaissés de 33°C en 1977 suite à des expériences défavorables
- ▶ Dans l'édition de 1983, une note particulière est émise concernant des cas de HTHA sur des réformeurs catalytiques.
- ▶ De nouveau cas d'attaque sur l'acier 0,5 % Mo sont observés jusqu'à 110 °C en dessous de la courbe publié en 1977
- ▶ En 1990 les courbes concernant l'acier à 0,5 % Mo sont retirées
- ▶ L'expérience semble montrer que l'acier à 0,5 % Mo a une résistance très variable

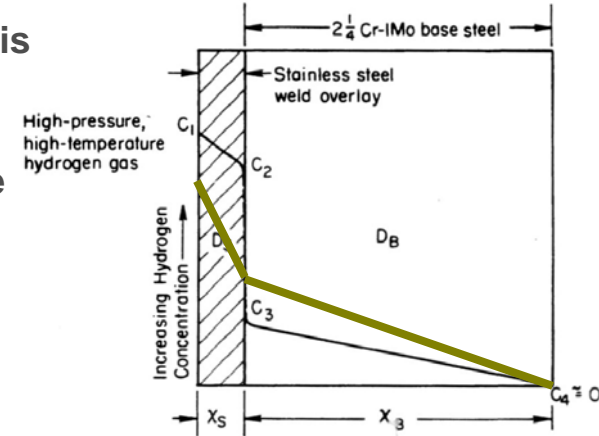
temperature	Thickness		PPH2	PPH2 Interface
	austenitic	Ferritic		
°C	mm	mm	bar	bar
390	2	70	35	16.3
390	4	70	35	9.4
390	3	20	35	3.0
300	3	20	35	1.0

FIGURE 4. SKETCH SHOWING HYDROGEN DISTRIBUTION IN A STAINLESS STEEL-WELD-OVERLAYED 2-1/4Cr-1Mo STEEL VESSEL EXPOSED TO HIGH-PRESSURE, HIGH-TEMPERATURE HYDROGEN

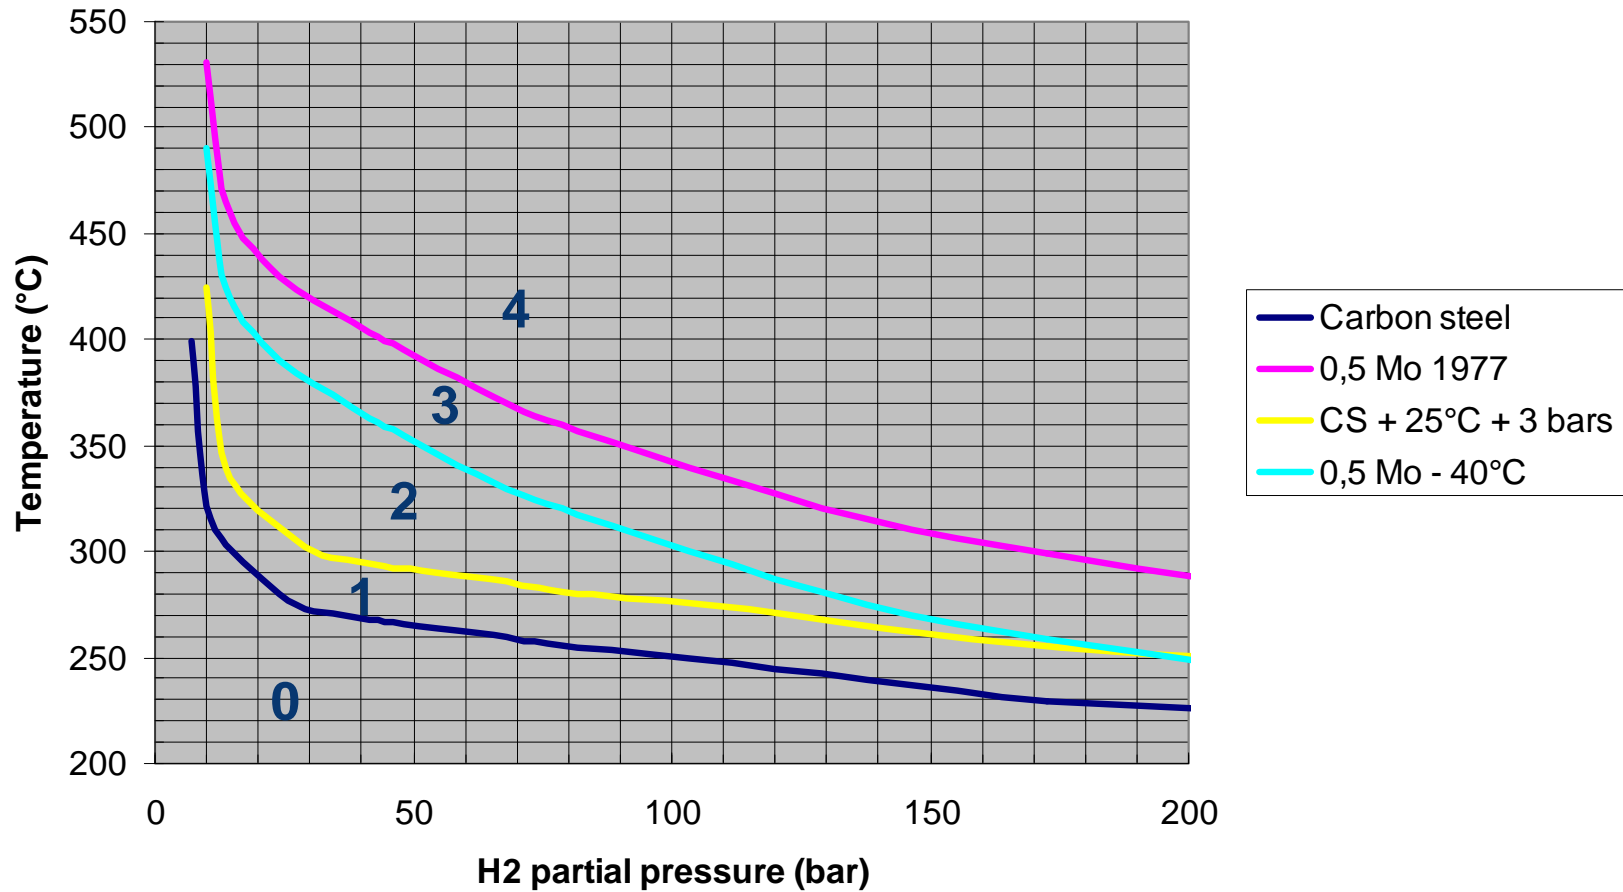
## Severity area for HTHA of 0,5 Mo

- ▶ **Area 0** – Below carbon steel curve. Degradation probability is considered as null
- ▶ **Area 1** – Between carbon steel curve and carbon steel + 3 bars and 25 °C. In this area no failure case on 0.5 % Mo steel has been reported. HTHA risk is considered as very low.
- ▶ **Area 2** – It is an intermediate area where risk is considered as low for equipment made of normalized steel and PWHT.
- ▶ **Area 3** – Between 1977 0.5 % Mo steel curve and 40°C below. In this area degradation risk is considered as high on old.
- ▶ **Area 4** – Located above 0.5 % Mo curve of 1977. This is an area where degradation risks are very high and unacceptable.

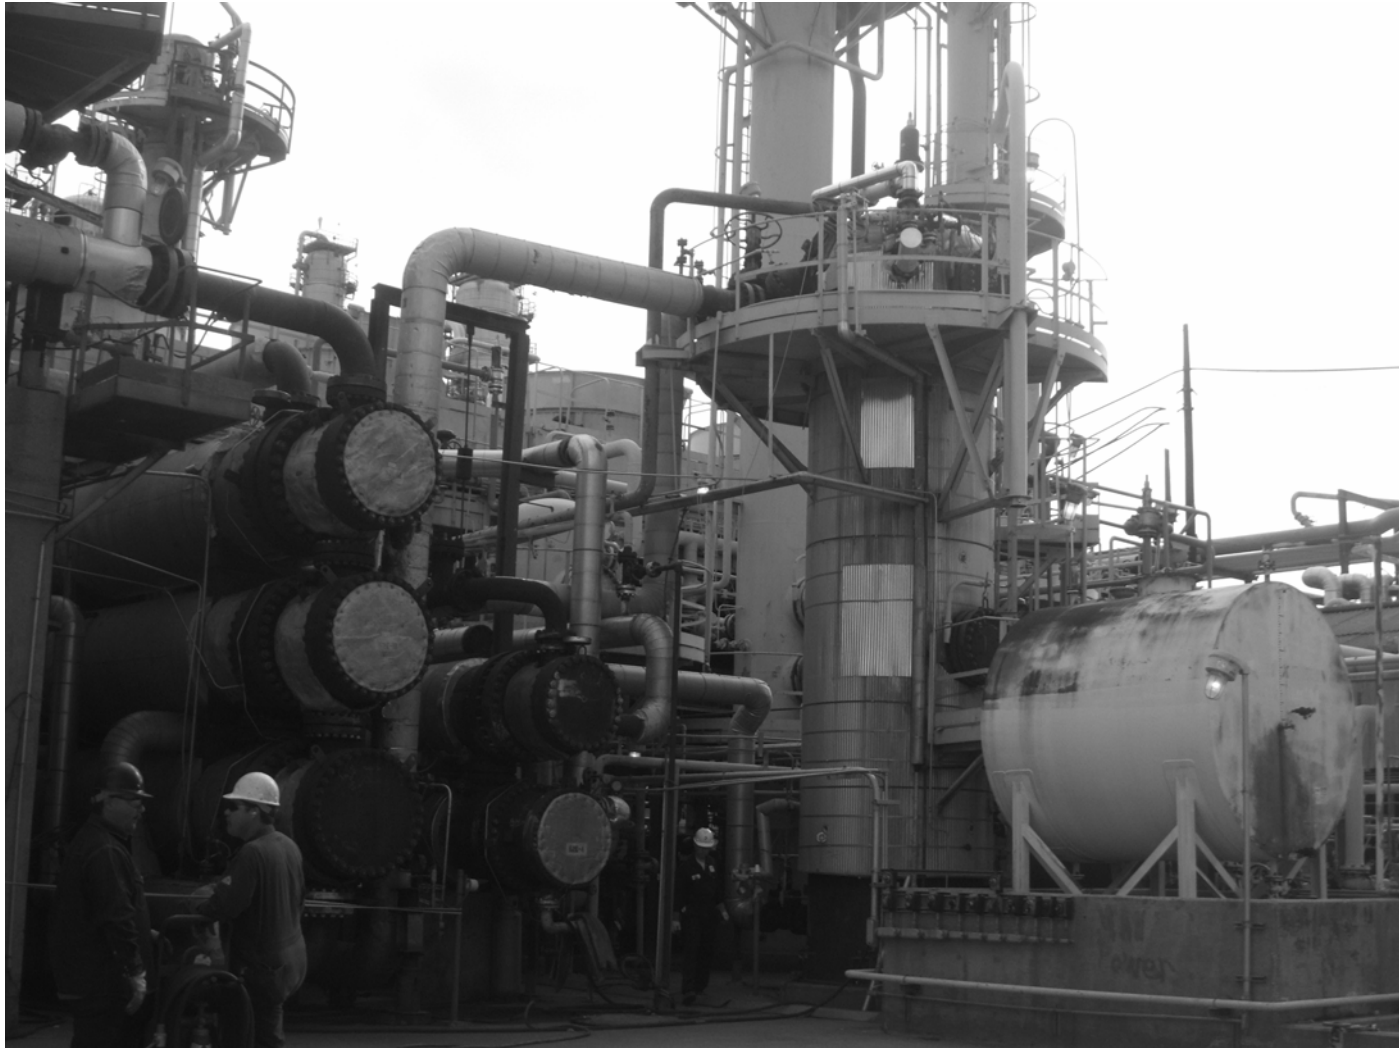
# 52V-2 Hot Separator

- ▶ Built in 1962 - 45 years in Hydrotreater Hot Separator Service
- ▶ Design Pressure 803 PSI
- ▶ Operating Hydrogen Partial Pressure 587 psia
- ▶ Design Temperature 600 degrees F
- ▶ Operating Temperature 595 degrees F
- ▶ Shell 6' Diameter Height 21'1"
- ▶ Shell Material A204 grade C with .078" TP 410 Clad

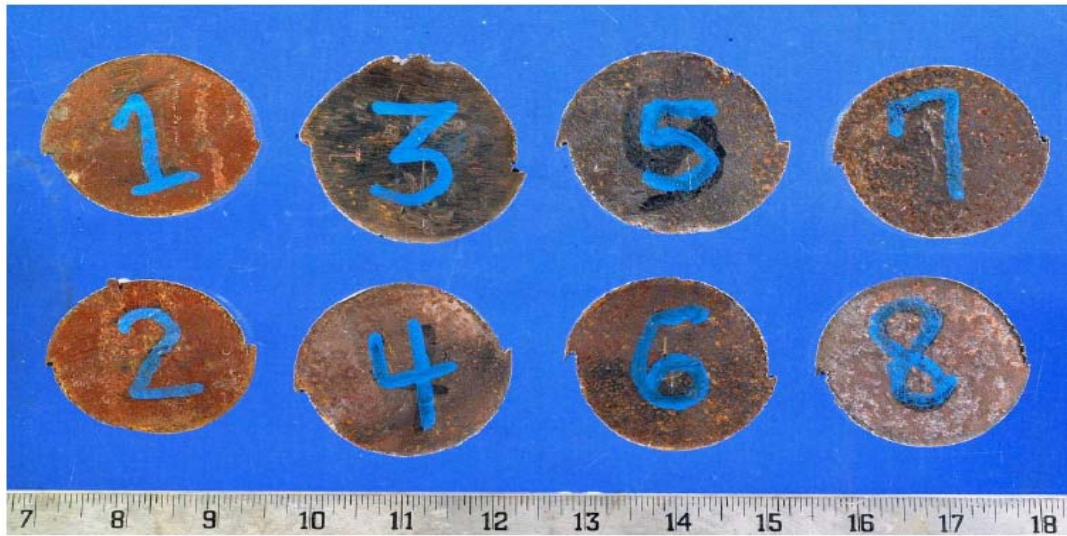
# Scoop Samples

Scoop Sample ID
Bottom Head	1 and 2
Bottom Course	3 and 4
Top Course	5 and 6
Top Head	7 and 8

Figure 1. OD surfaces of the removed Scoop Samples.

Figure 1 and 2 show the Scoop Samples that were removed from the vessel OD surface. These were removed using LR Capstone's proprietary Scoop Sampler<sup>SM</sup>. Depth of the resultant divots were less than the maximum allowable based on local thin area calculations that were previously performed in the 1999 evaluation. Therefore, the excavations were blended to minimize local stress concentrations with no further repairs needed.

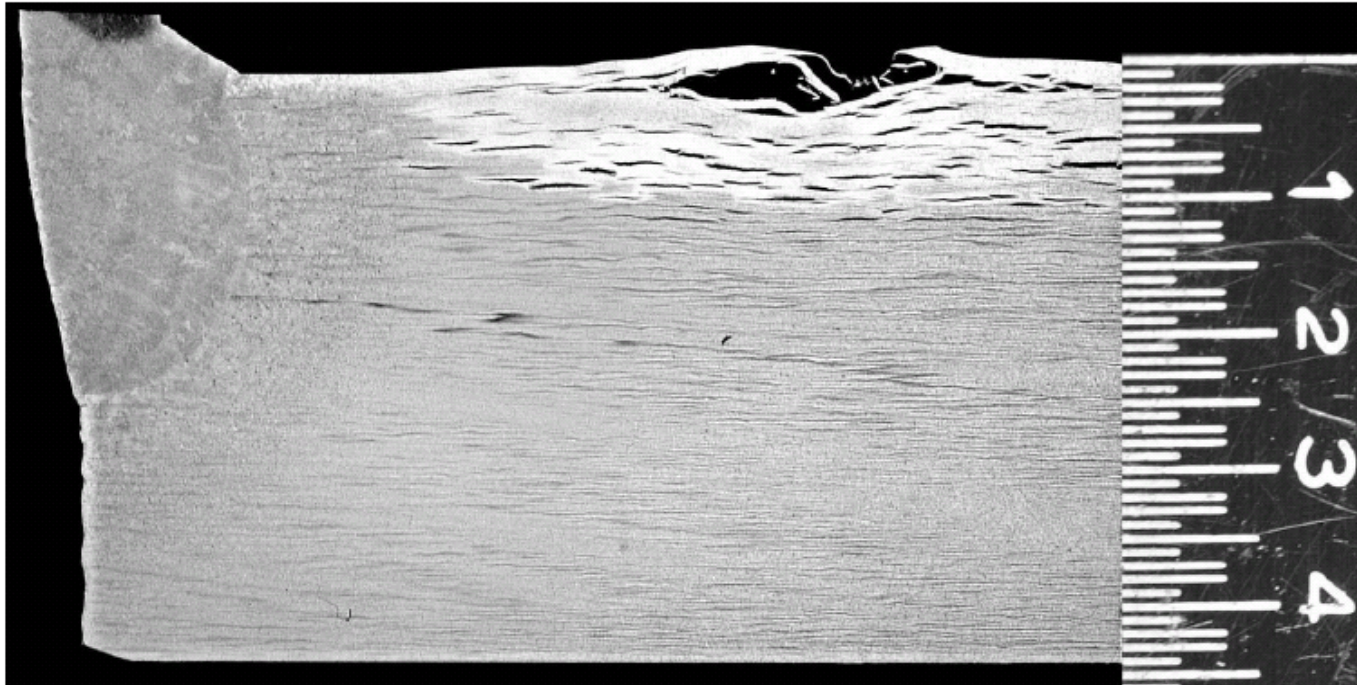
# Carbon Steel Reference Sample

Figure 4: Macroscopic view of a carbon steel reference sample at the accelerated test conditions, 100 hour exposure. Decarburization depth is approximately 0.1" (23% through wall). Depth of cracking was approximately 0.13" (30% through wall). 3% Nital Etch, 6.7X.

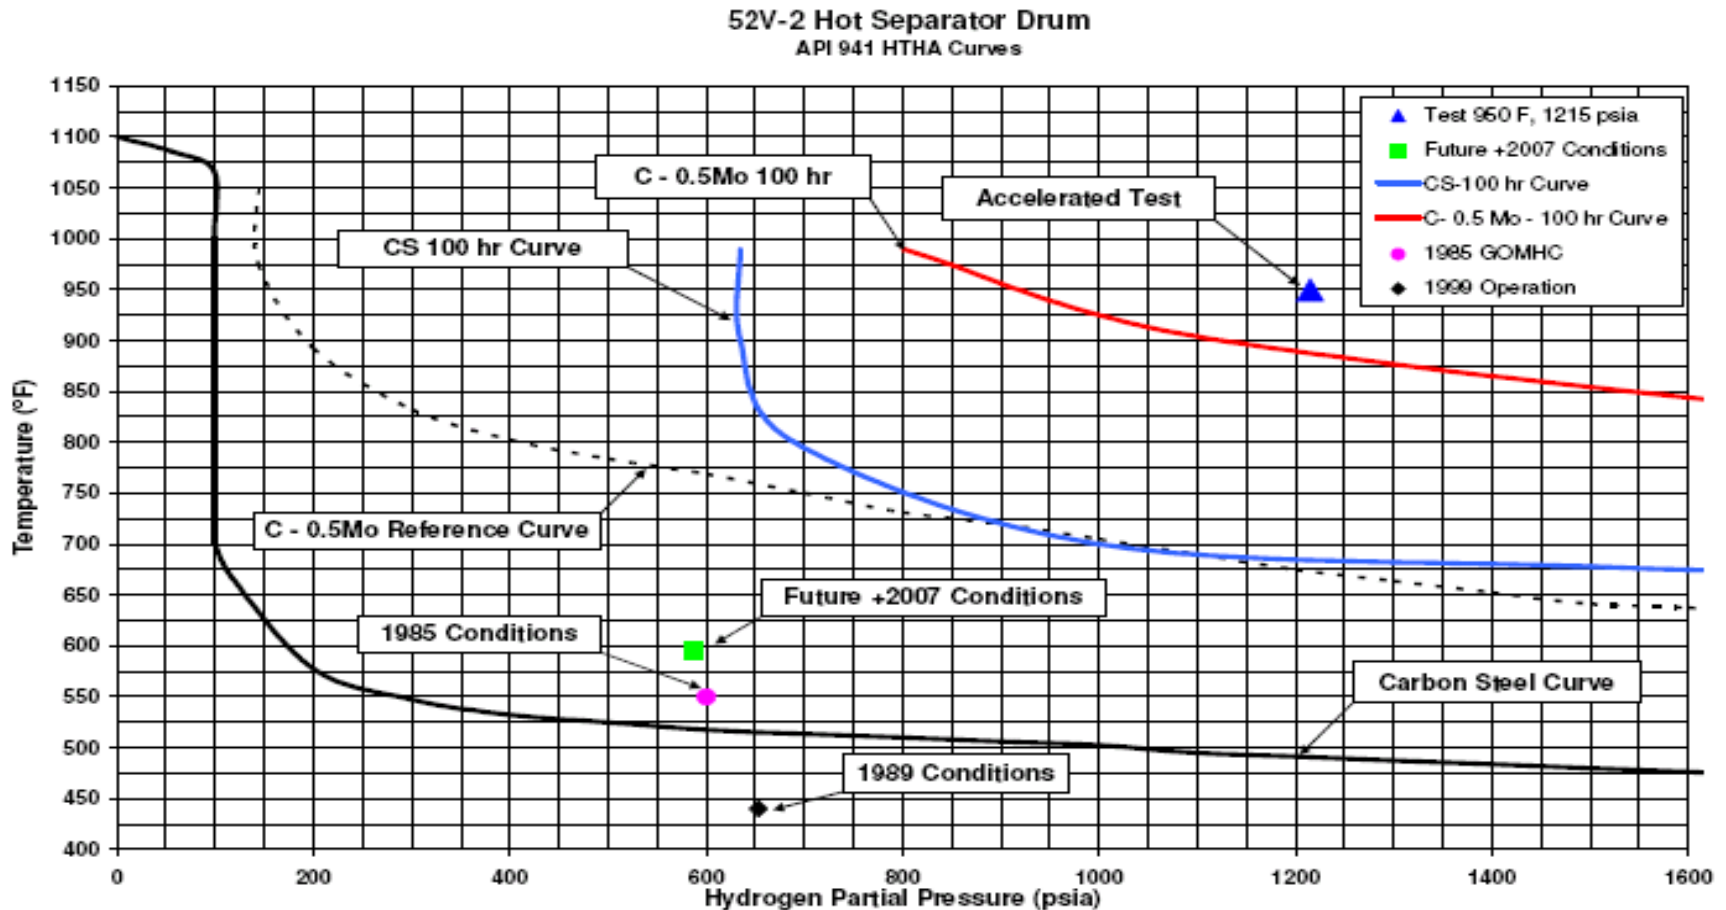
## Nelson Curve

Included in this figure are the 100 hour incipient damage curves for carbon steel and C- 0.5Mo steel and past and future operating conditions. It can be seen that the test conditions are very severe and if susceptible they should have produced damage in the test coupons.

Figure 3: HTHA damage curves from API 941. Past to future operating conditions plus the accelerated test conditions are plotted to show severity of the various operating conditions.

The test conditions were set approximately 65°F above the 100 hour C - ½ Mo steel incipient damage curve. It also corresponds to the 100 hour incipient damage as predicted using both  $P_v$  and  $P_w$  calculations. The equations used to calculate  $P_v$  is given below and are taken from the API 580 document. Critical values for  $P_v$  "worst case" annealed material is low susceptibility at 4.78, medium susceptible at  $P_v = 4.87$ , and a high susceptibility at  $P_v = 4.95$ . For "good" normalized material, low susceptibility starts at a  $P_v$  of 5.43, a medium susceptibility at  $P_v$  of 5.51, and a high susceptibility at  $P_v$  of 5.60. Based on published literature and some work by Japanese researchers, the critical value for "good" C - ½ Mo steel base metal is  $P_v$  of 5.80.

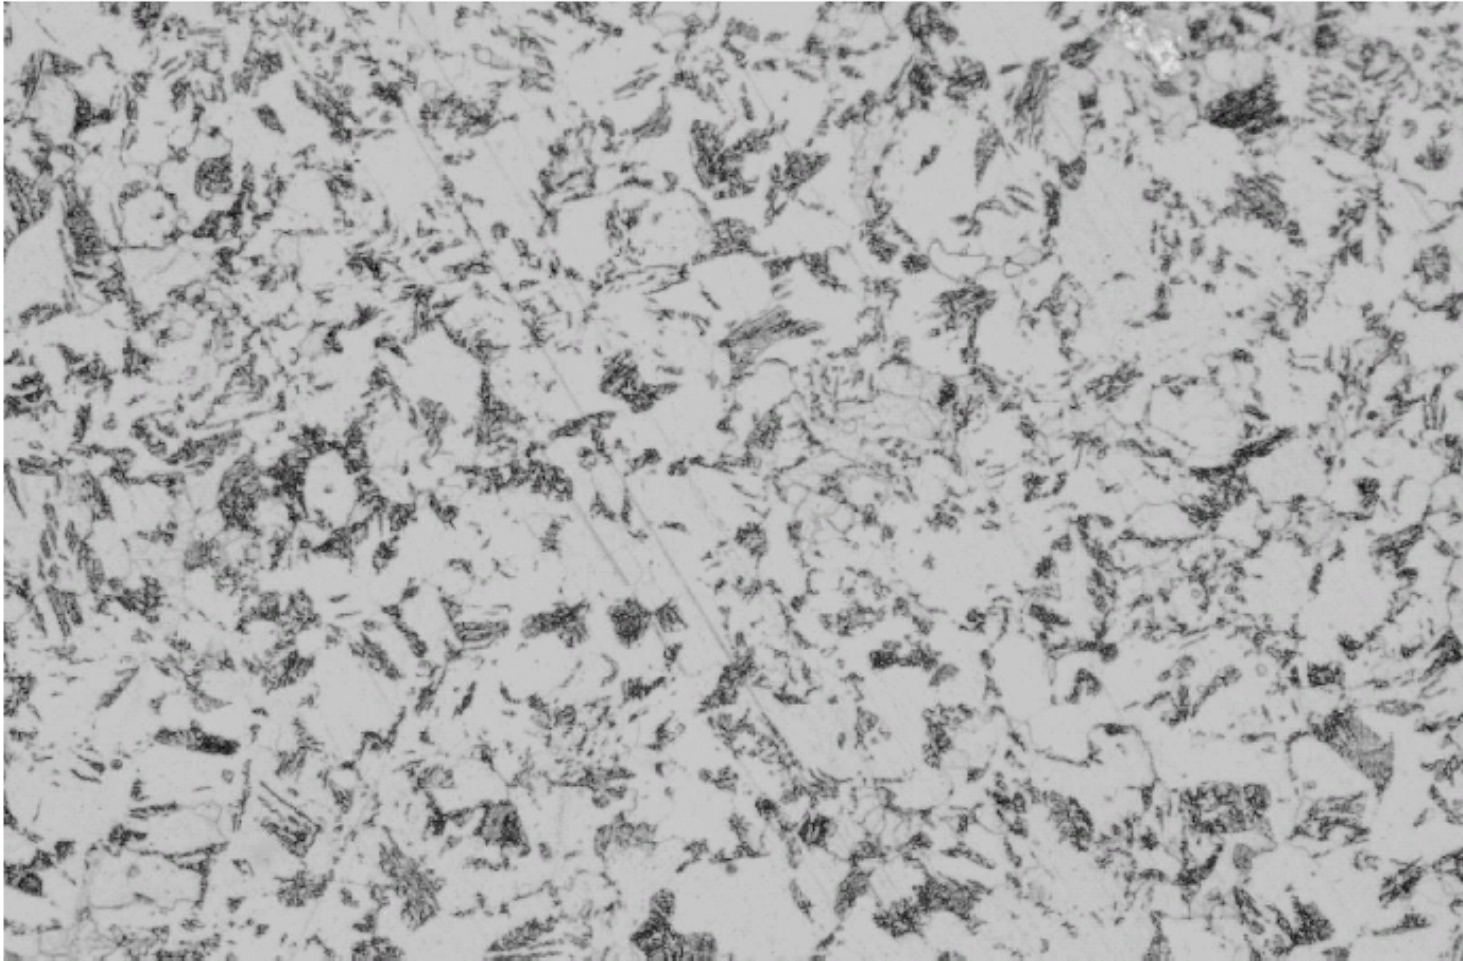
Figure 5. Scoop Sample 6, representative base metal microstructure, pre-exposure. 3% Nital Etch, 400X.

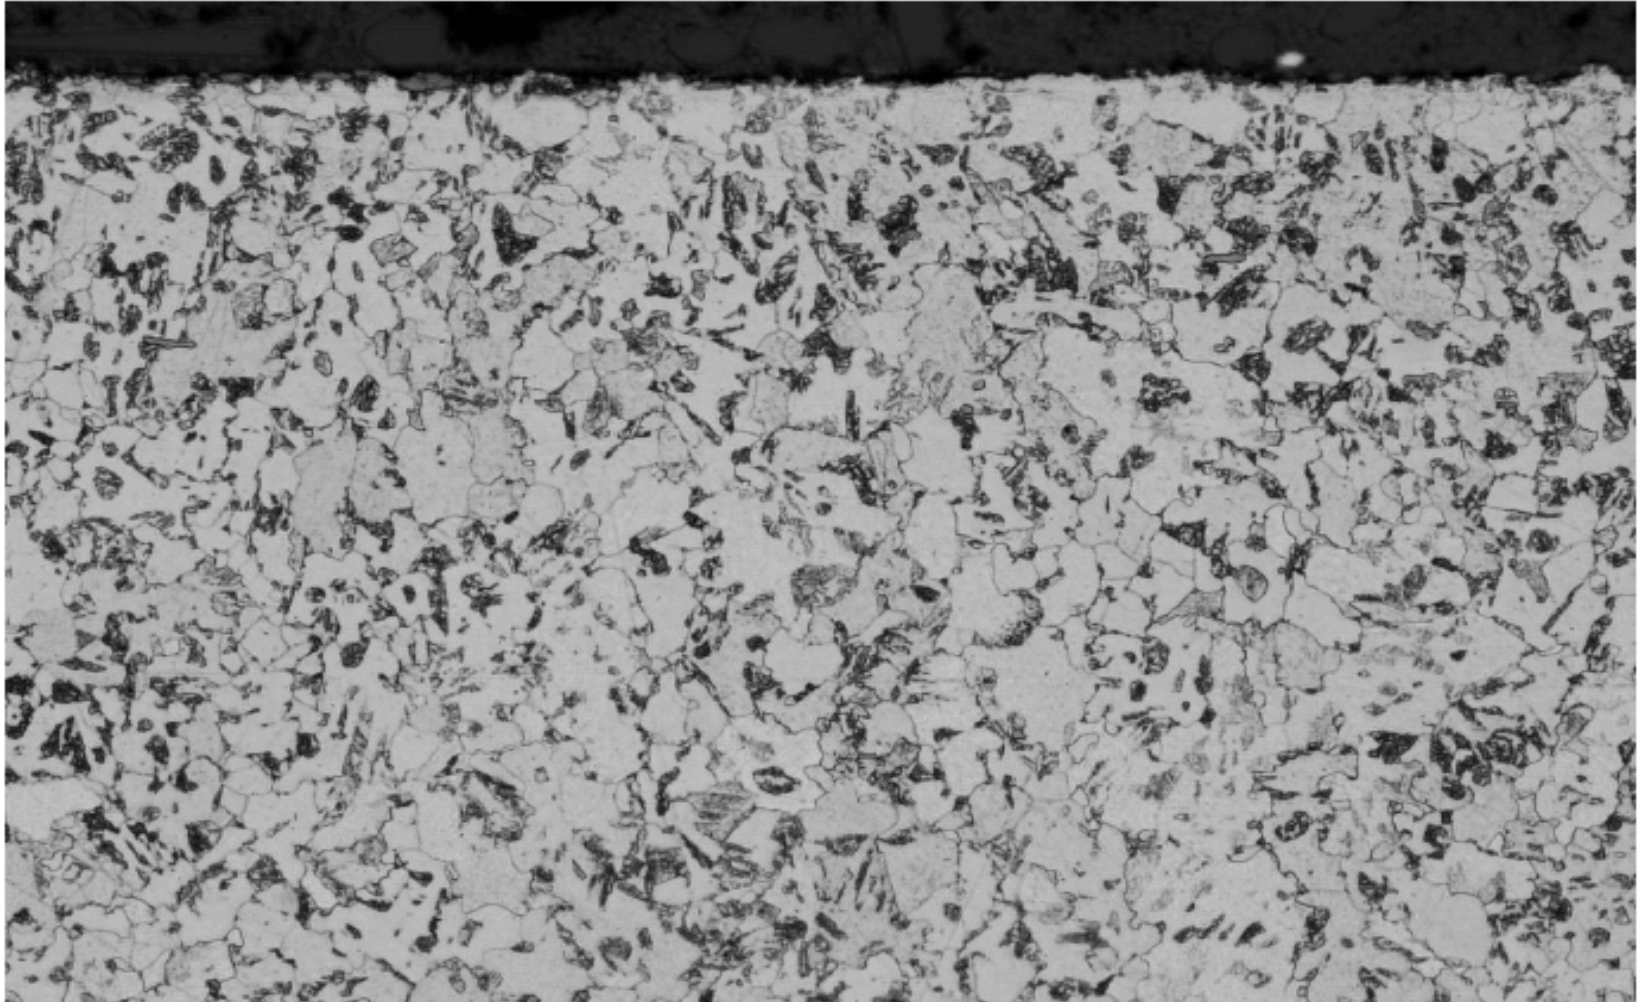
No evidence of decarburization, methane voids, or microfissuring was found in any of the samples.

Figure 6: Scoop Sample 1, representative base metal microstructure Test 1. 3% Nital Etch, 400X.
