**Participants EFC WP15 meeting 15<sup>th</sup> April 2008 Leiden**

**EFC Working Party 15**  
**Corrosion Refinery Industry Meeting**  
**Oegstgeest/Leiden**  
15th April 2008 9h30 - 16h

## **Corrosion Under Insulation and Case Histories**

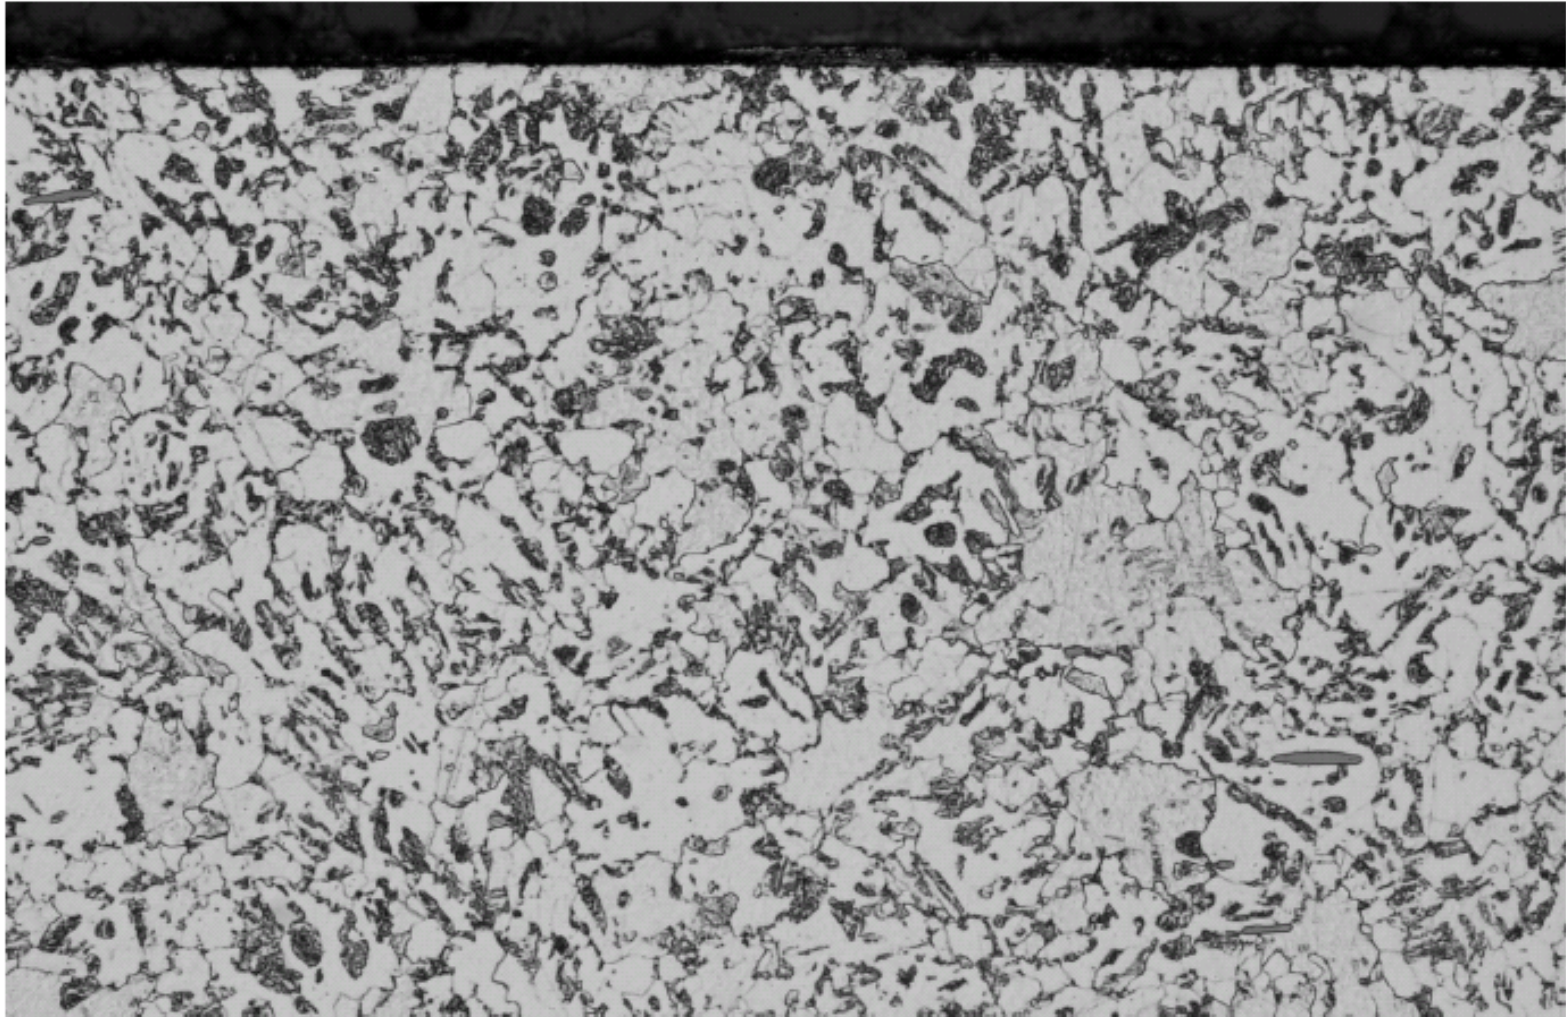
**All of the C-0.5 Mo steel materials displayed good resistance to HTHA type of damage.**

Figure 10: Scoop Sample 1, representative base metal microstructure Test 2. 3% Nital Etch, 400X

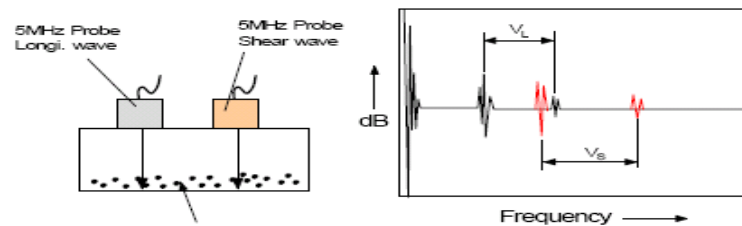
## Velocity Ratio Technique

Velocity Ratio =  $V_S/V_L$   
 $V_S/V_L \leq 0.55$  ----- No HTHA  
 $V_S/V_L > 0.55$  ----- HTHA

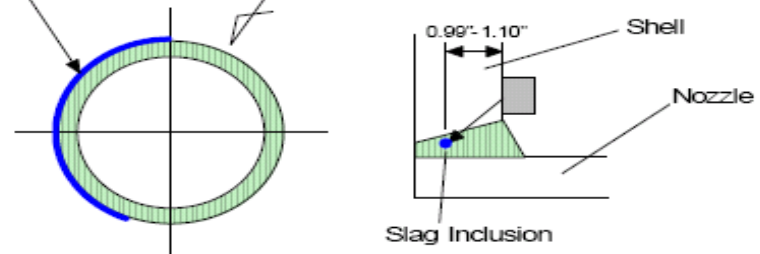
**Detail of Indication on Nozzle at Area #3**

Slag Inclusion  
Depth : 0.99" - 1.10"

Also, no crack-like indication was detected on the HAZ using ABSA on the longitudinal weld seam, circumferential weld seam and one nozzle weld. One long slag inclusion was detected on the nozzle weld. The detail of this indication is shown in Figure 2.

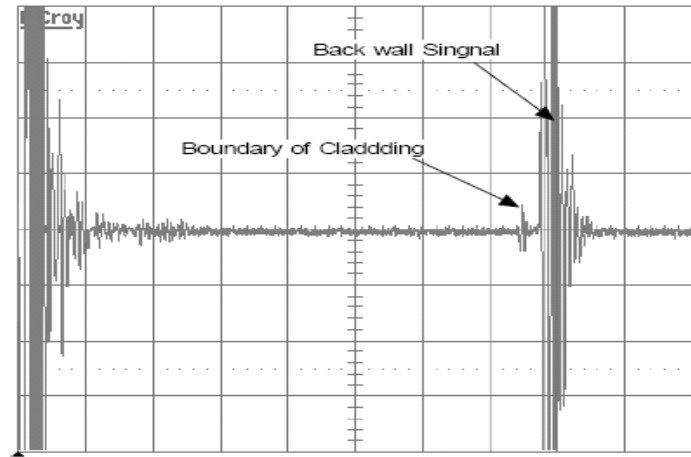
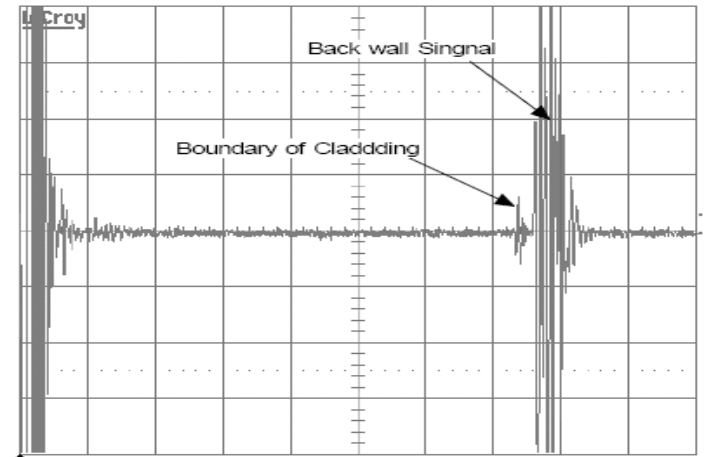
**Figure 7 : Typical signal form of Backscatter (Area 5 & 6)**

Backscatter Technique

In according to the results of Backscattering Technique and Spectrum Analysis 0 degree, **no evidence of advanced or micro fissuring due to (HTHA) was detected in the scanned areas of Reactor.** Indications such as inclusions were detected in the base metal on the area #7 of 52V-2 Reactor. These Indications of base metal were not described in this report. Typical signal forms of Backscatter Technique and Spectrum Analysis are shown in Figures 5, 6, 7 & 8.

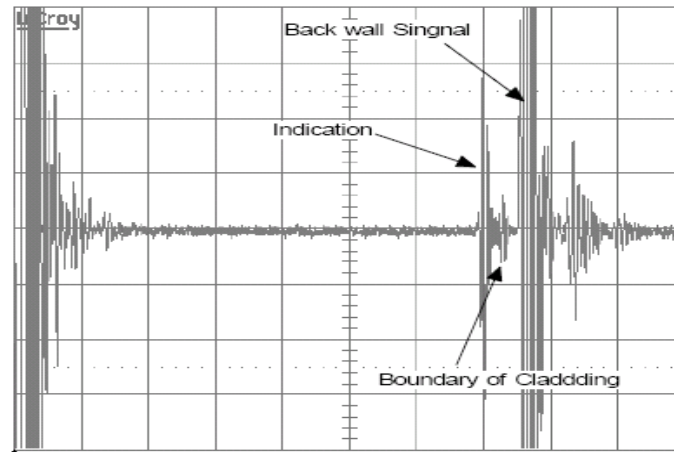
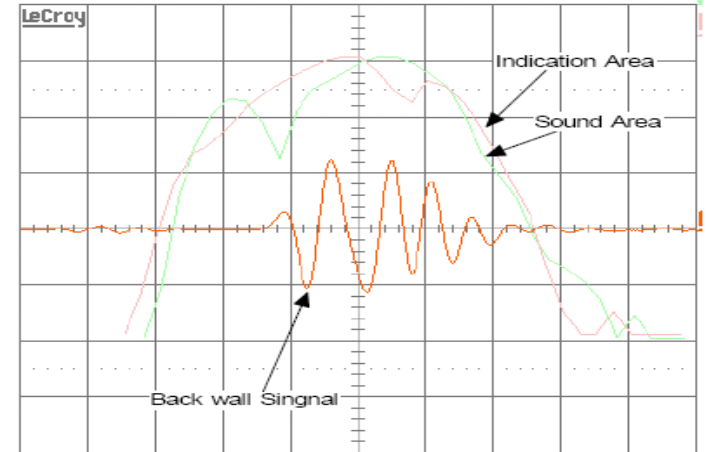
**Figure 8 : Typical signal form of Backscatter / Spectrum Analysis (Area 7)**

Backscatter Technique

Spectrum Analysis

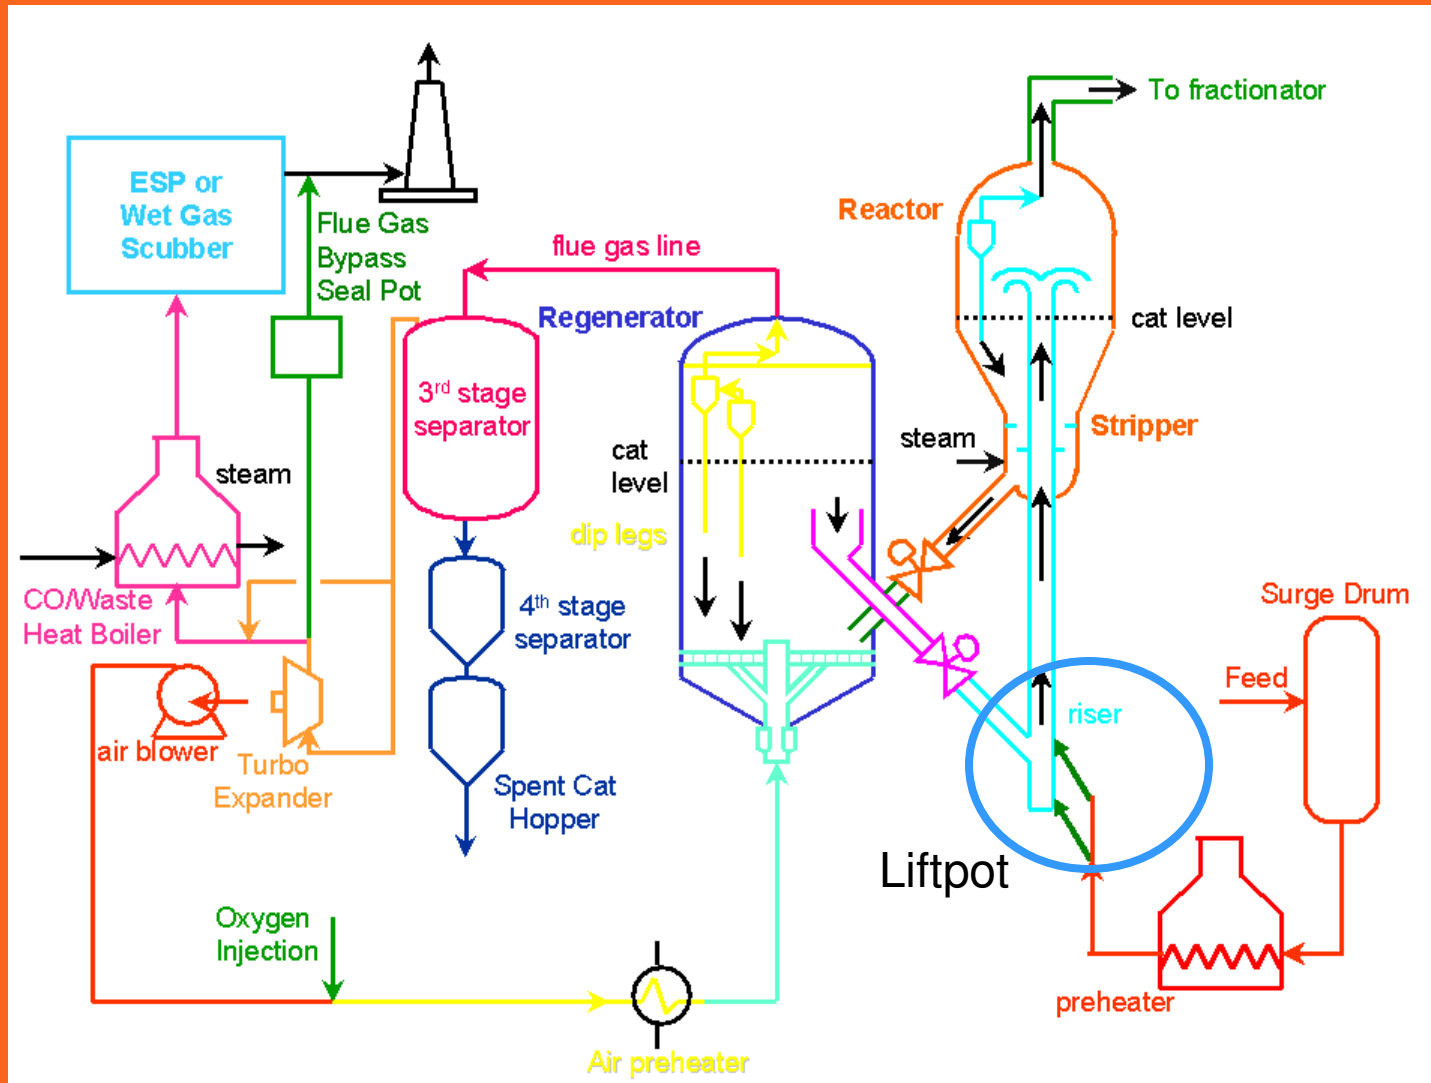
# The Process: Catalytic Cracker Unit

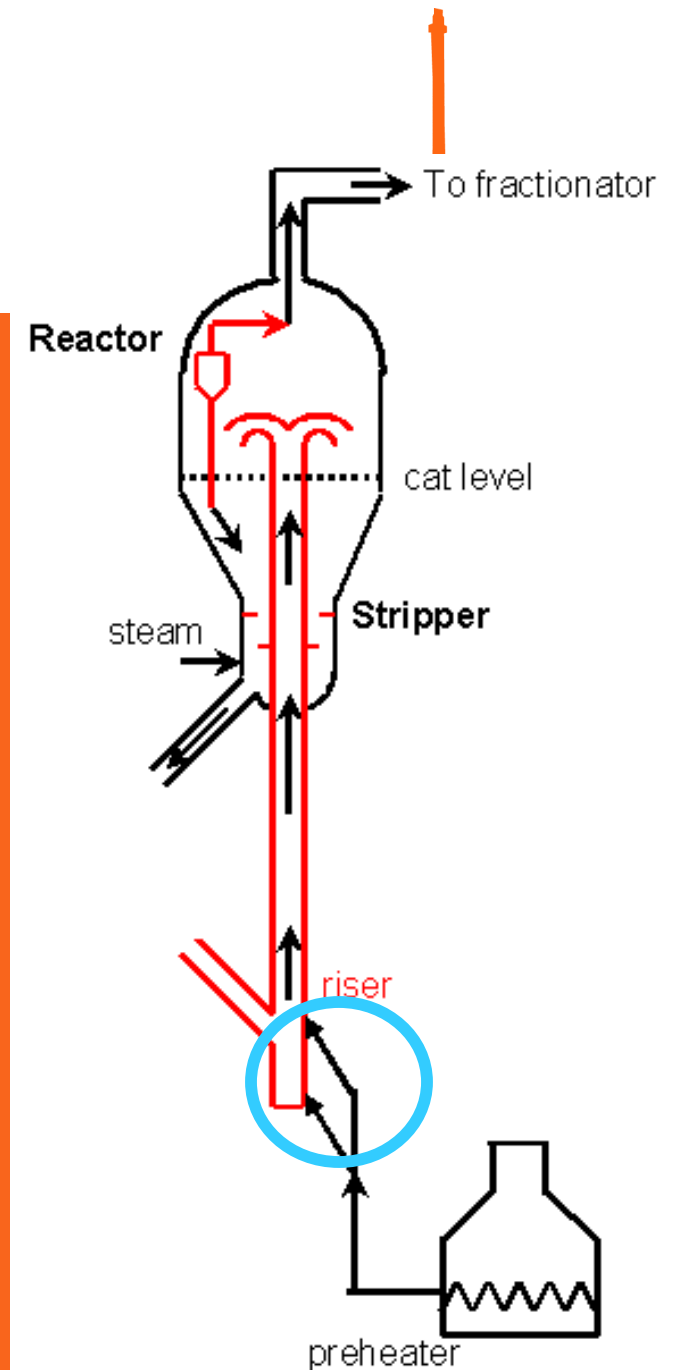
# Process “Liftpot”

- Feed mixes with Catalyst of 680 degC
- Mix of Feed and Cat “cools” to 520 degC @ 2.5 barg Riser outlet
- Steam ring at bottom of riser liftpot to enhance/assist mixing and transport of catalyst.
- Medium: Oxygen, Air, H<sub>2</sub>S, Steam/water, Salts(?), Hydrocarbons

- Reactor liftpot Avesta 253MA (austenitic SS ~ SS 304H)
- Wall thickness head/wall 40mm / 25mm
- Erosion resistant liner of 35 mm.
- Dished end filled with insulating concrete
- Other riser parts SS 304H

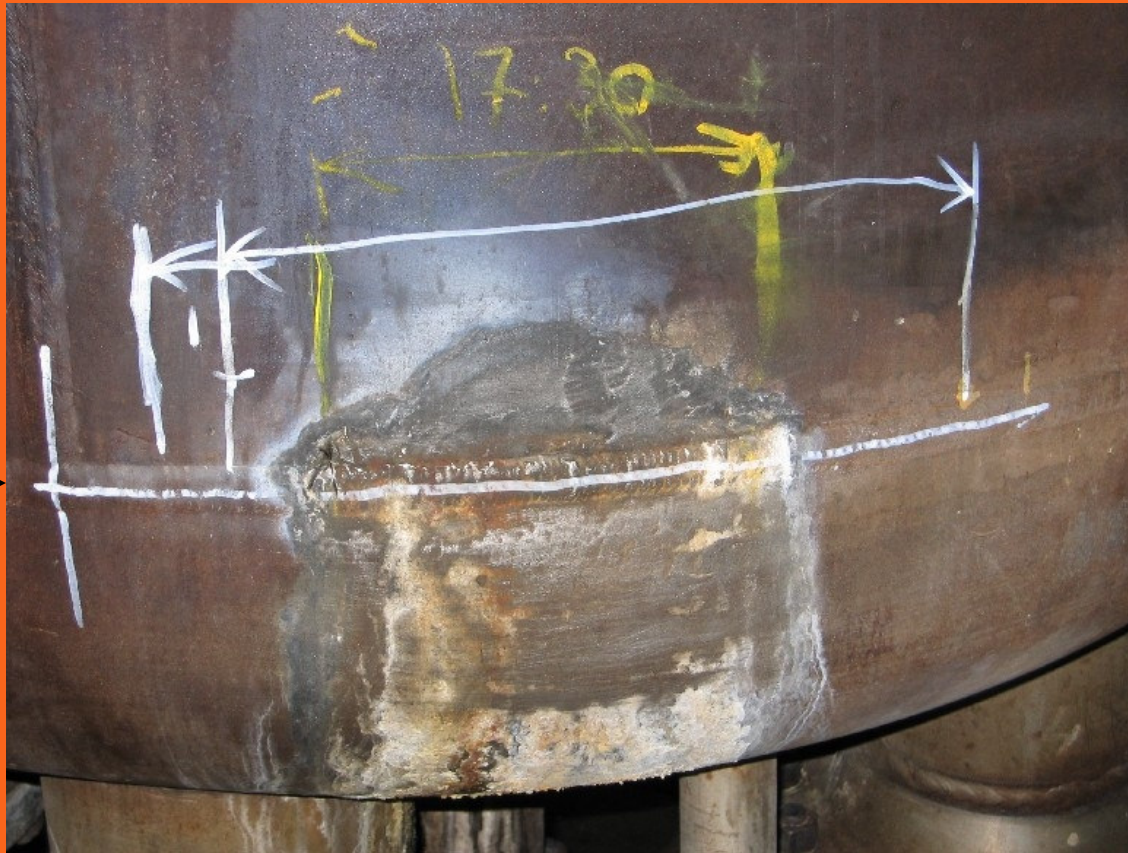
# Crack in Liftpot Body

**Weld**

- Leakage (Inspection, operations)
- Visual/NDT: Crack in Circumferential weld
- Metallurgical investigation:
  - Sensitized HAZ weld,
  - Inter-crystalline attack in HAZ,
- NDT: Other welds and (plate) material free from cracks

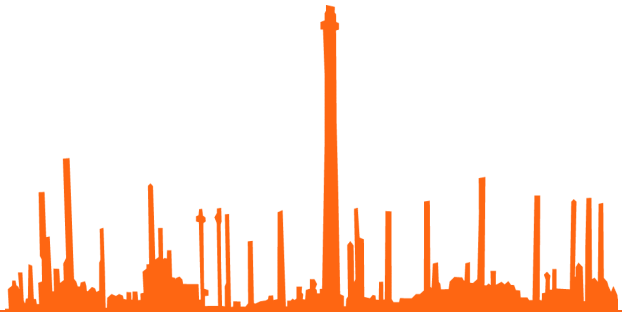
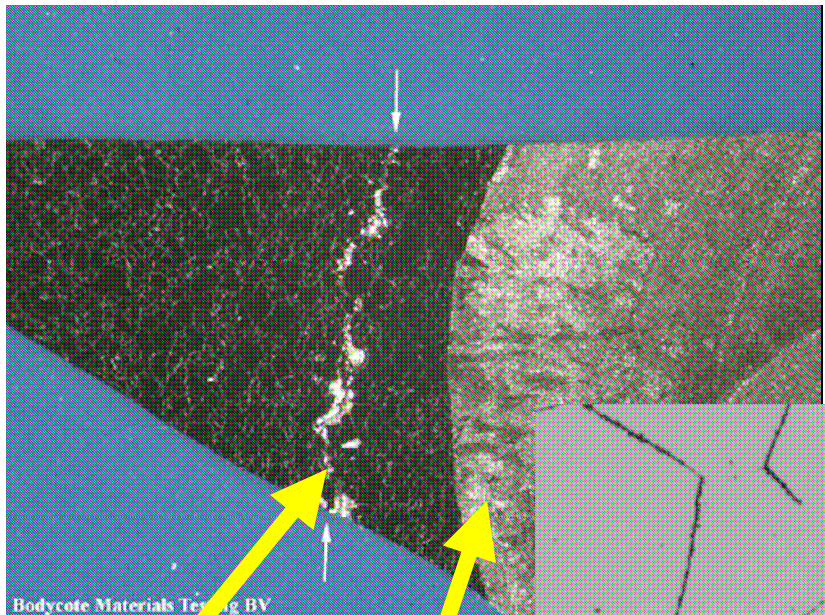
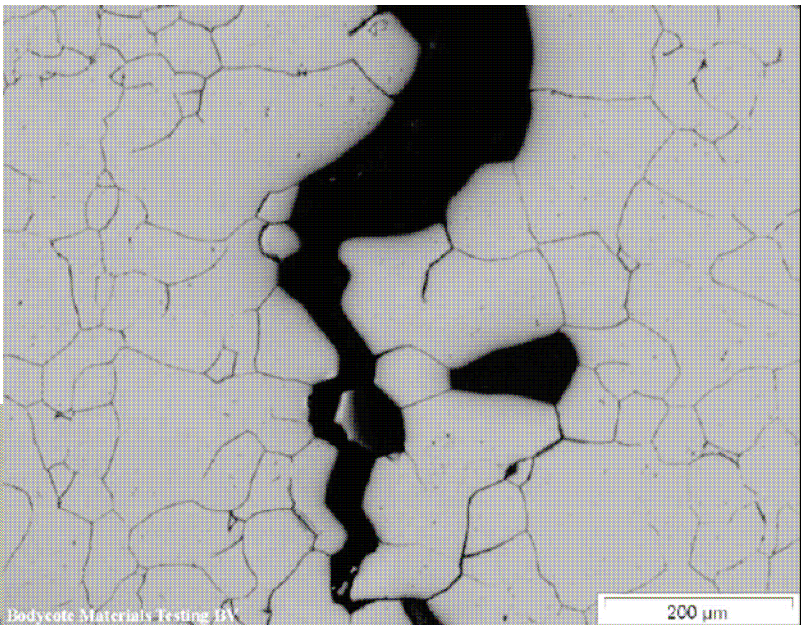
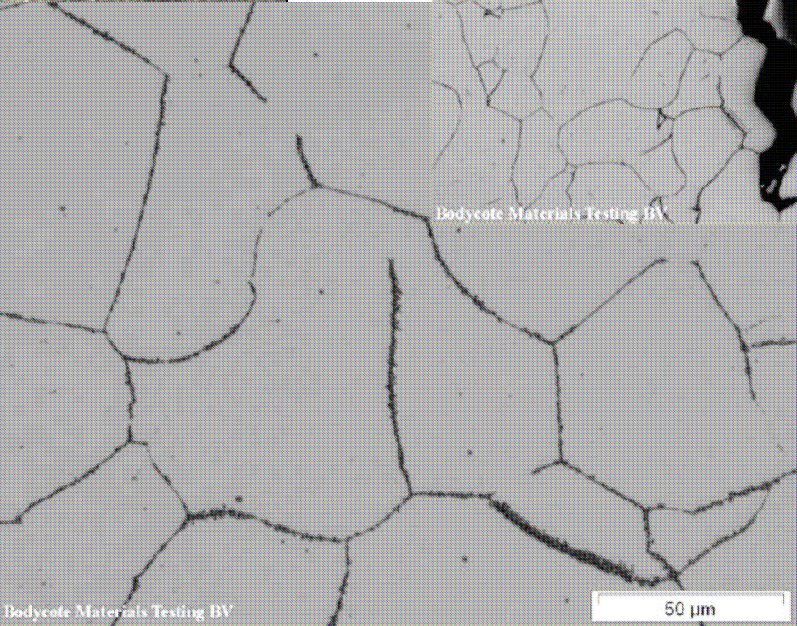
# Metallography of Crack (Boat Sample)

Crack in HAZ

Weld

- Polythionic Stress Corrosion Cracking of sensitized weld area.

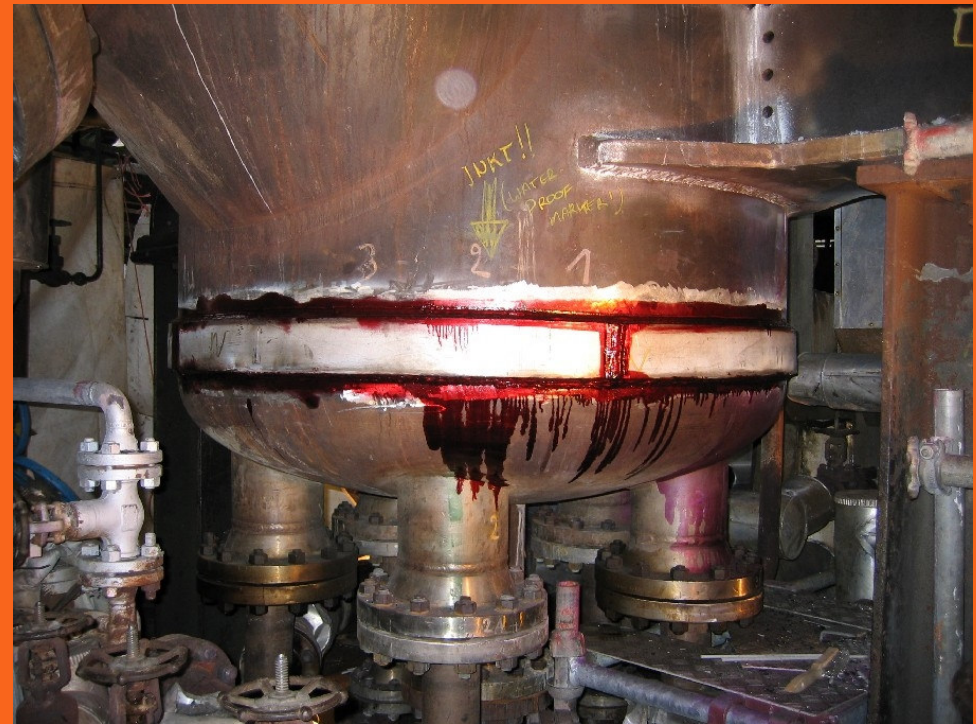
# Solution Short/Long-term

- Short-term actions:
  - Repair with external reinforcing ring.
- Long-term actions:
  - SCC resistant material
  - Different design

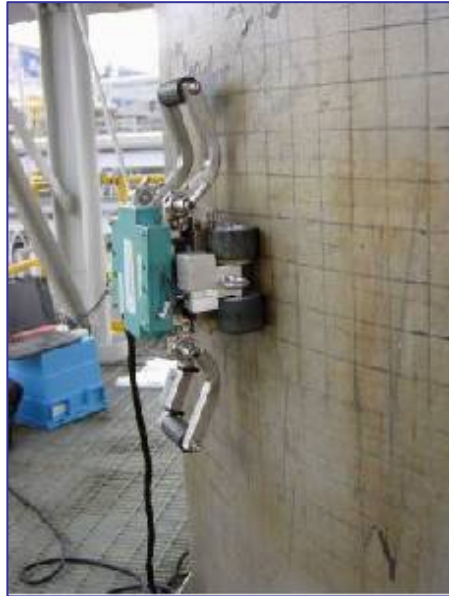
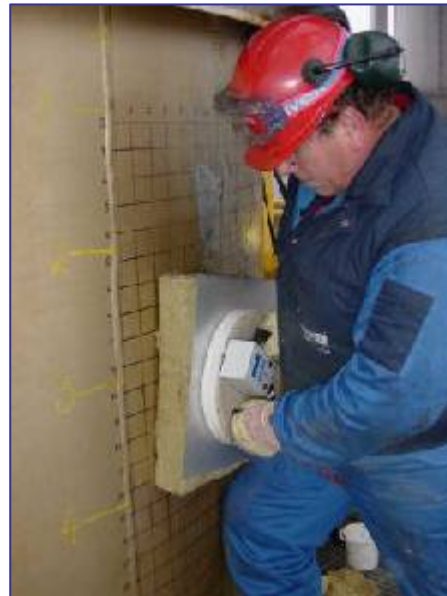
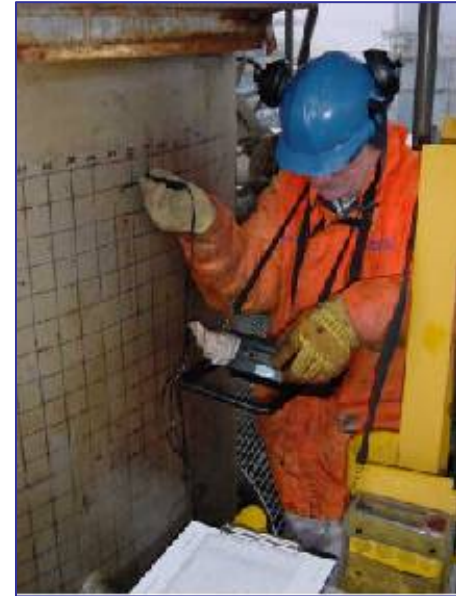
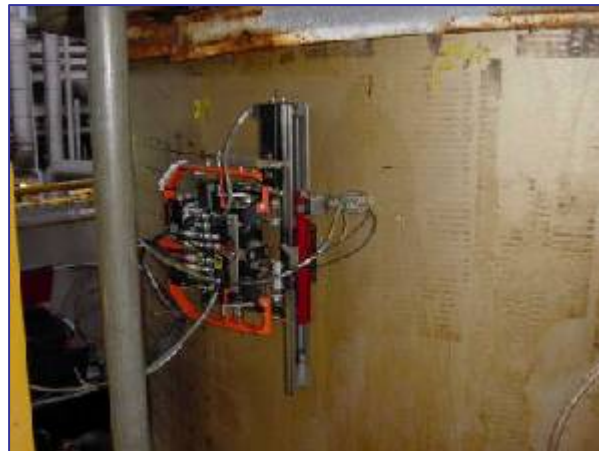
- ⊕ A vessel was inspected by using four different NDT techniques
  - Automated C-scan
  - INCOTEST
  - UT raster
  - Slofec

# 4 technologieën

- ⊕ 1 Day
- ⊕ Insulation removal & surface prep
- ⊕ Highest resolution
- ⊕ 100% coverage
- ⊕ Accurate WT reading

- ⊕ 2 hours
- ⊕ Insulation removal only
- ⊕ High resolution
- ⊕ 100% coverage
- ⊕ No absolute WT reading
