Effect of surface preparation on oxidation of austenitic SS 304L in high temperature water

Keywords: surface film, high temperature water, machining, oxides

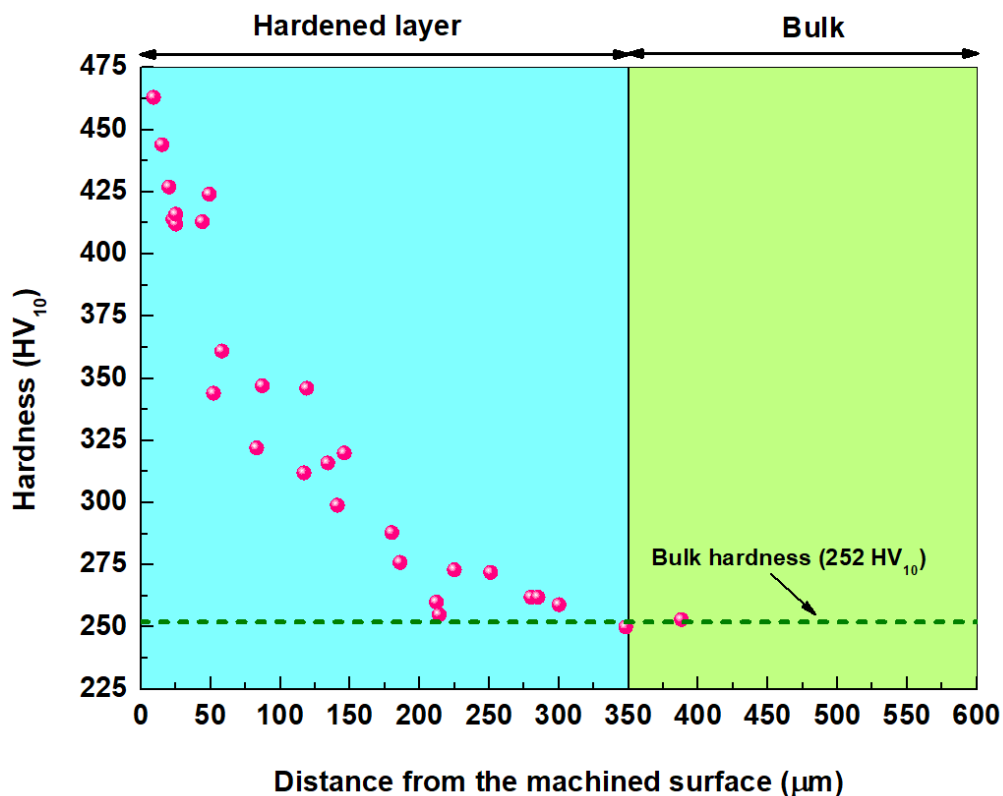
Fig 5. Cross-sectional microhardness

Fig 5 shows the variation in hardness along the cross-section of the machined specimen. The highest hardness was 463 HV₁₀ at 9 μm from the surface, which was the minimum distance at which measurements could be accurately taken. Subsequently, a smooth transition to bulk hardness values (252 HV₁₀) was observed over a thickness of up to 350 μm from the surface. As evidenced from cross-sectional SEM and KAM maps (Fig. 3 and 4), the SPD layer varies nonuniformly up to 10 μm from the surface. Hence, hardness values in this region would be highest. The first 50 μm shows a significantly higher hardness (414 - 463 HV₁₀) than the bulk. This region is seen in the KAM map (FIG ___) to have clear strain localisations, both within the grain (nearer to the surface) and at the grain boundaries (further down towards the bulk) and the extend of deformation (viz. misorientations) goes down inwards into the bulk.

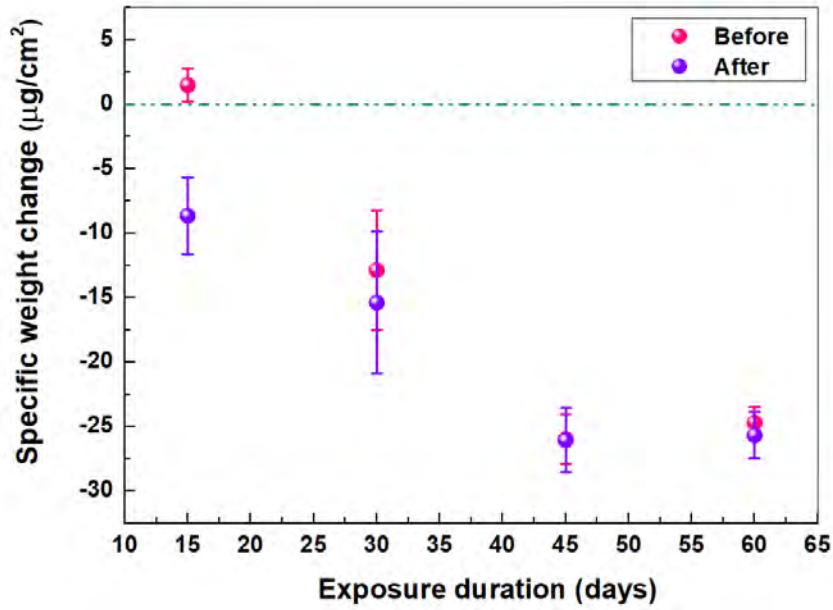
Fig 9. Change in specific weights of machined SS304L coupons exposed to high temperature DM water for different durations - before and after ultrasonic cleaning.

Fig 9 shows the variation in specific weight change in M15 – M60 with time of exposure. The specific weight changes before and after ultrasonic cleaning follow the same trend. Initially, the M15 reports a small positive change in specific weight ($1.50 \mu\text{g}/\text{cm}^2$) before ultrasonication. Post ultrasonic cleaning, a negative specific weight change is reported by M15 ($-8.65 \mu\text{g}/\text{cm}^2$). This may be attributed to the loss of loose outer oxide particles (Fig 7a,b, Fig 8a). Subsequently, all samples showed a weight loss with increasing duration of exposure (M30 – M60). However, the effect of ultrasonic cleaning is reduced as specific weights before and after cleaning remained nearly the same for M45 and M60. As shown in Fig 7 and 8, the number of outer oxides decrease with exposure time and are progressively more adherent, once formed. Hence, ultrasonic cleaning does not lead to significant change in specific weights. The negative weight change for SS samples exposed to high temperature phenomenon is an interesting observation and needs further exploration.
